ILLINOIS DEPARTMENT OF PUBLIC HEALTH
AHERA THREE YEAR REINSPECTION
ASBESTOS ABATEMENT PROGRAM
SCHOOL INFORMATION FORM

THREE-YEAR REINSPECTION

Alcott High School for the Humanities

2957 N. Hoyne Avenue
Chicago, IL, 60618

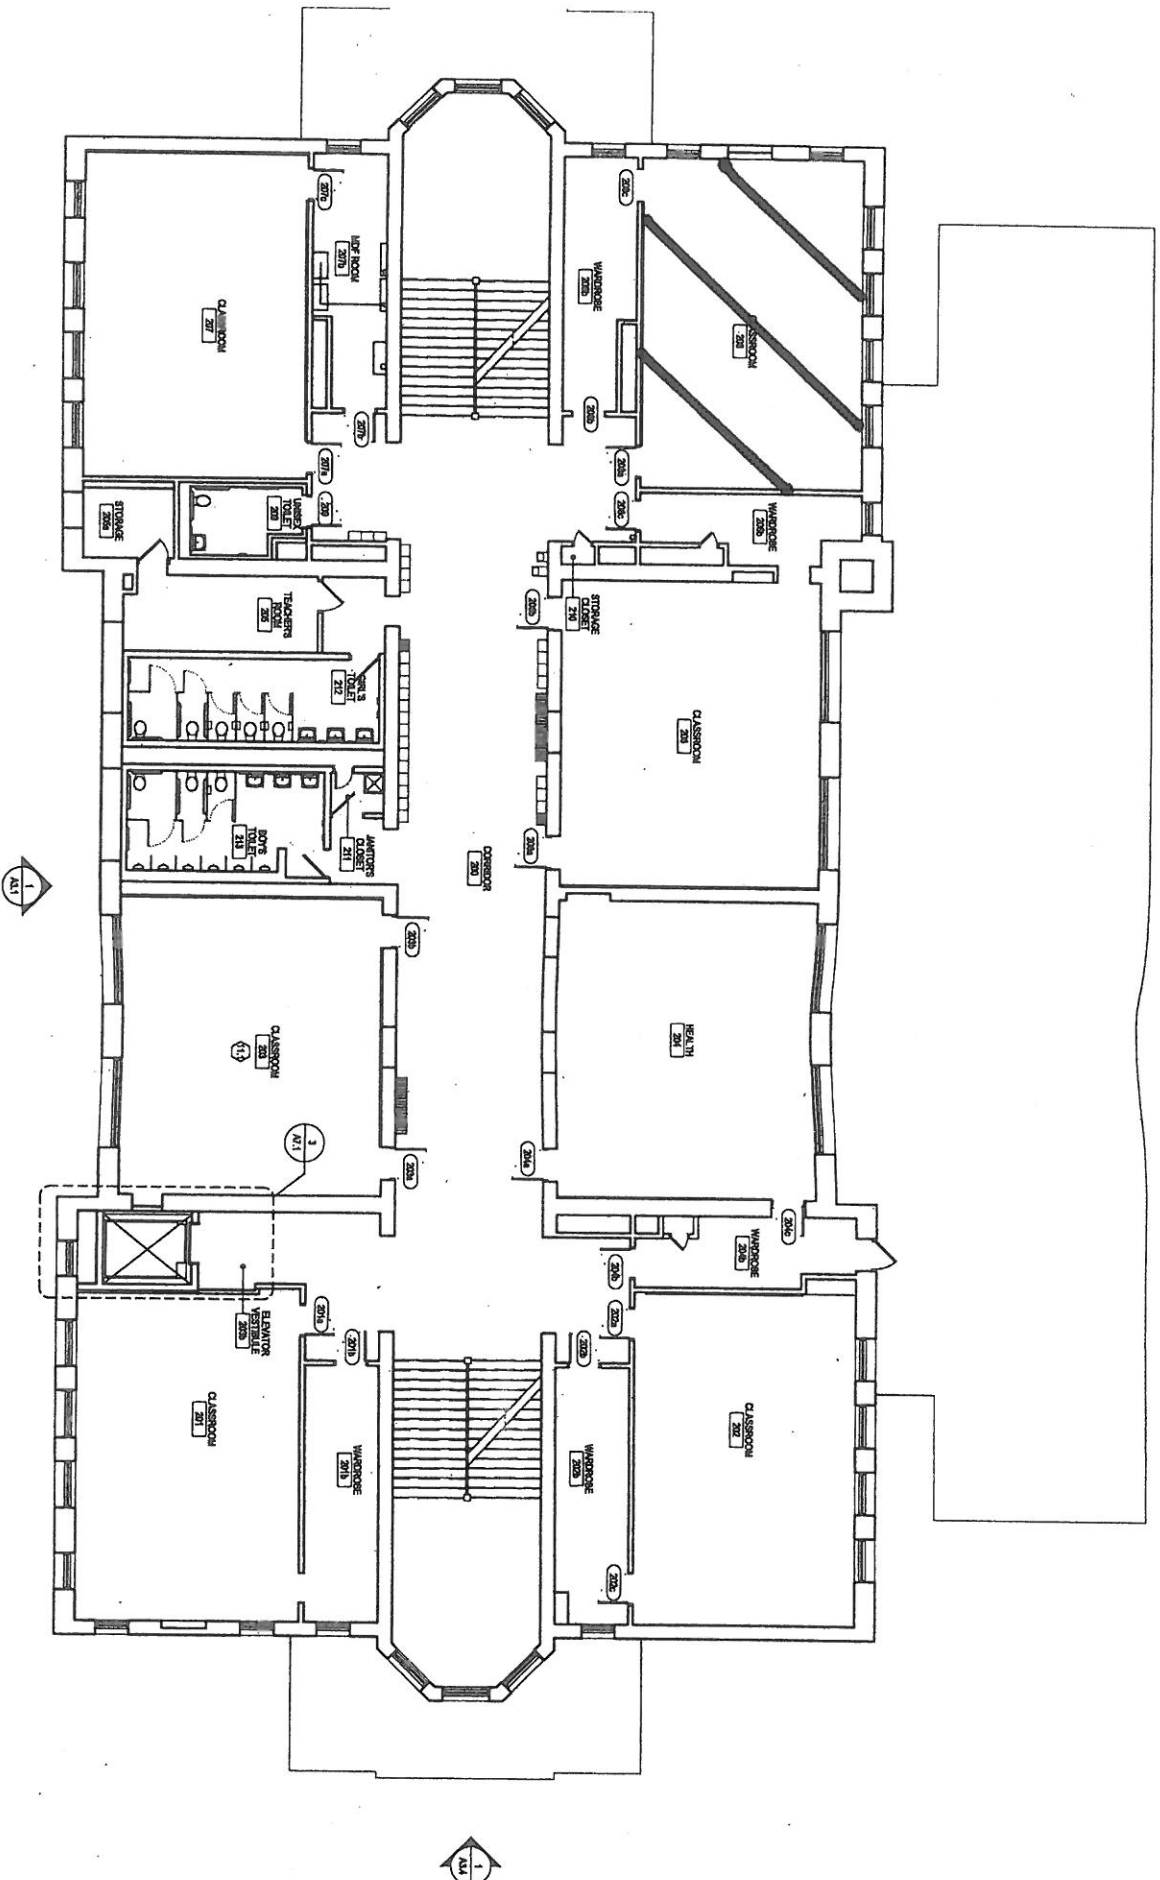
NEW LAB
HA# 47 - BLACK VINYL SINKS

50 S.F.

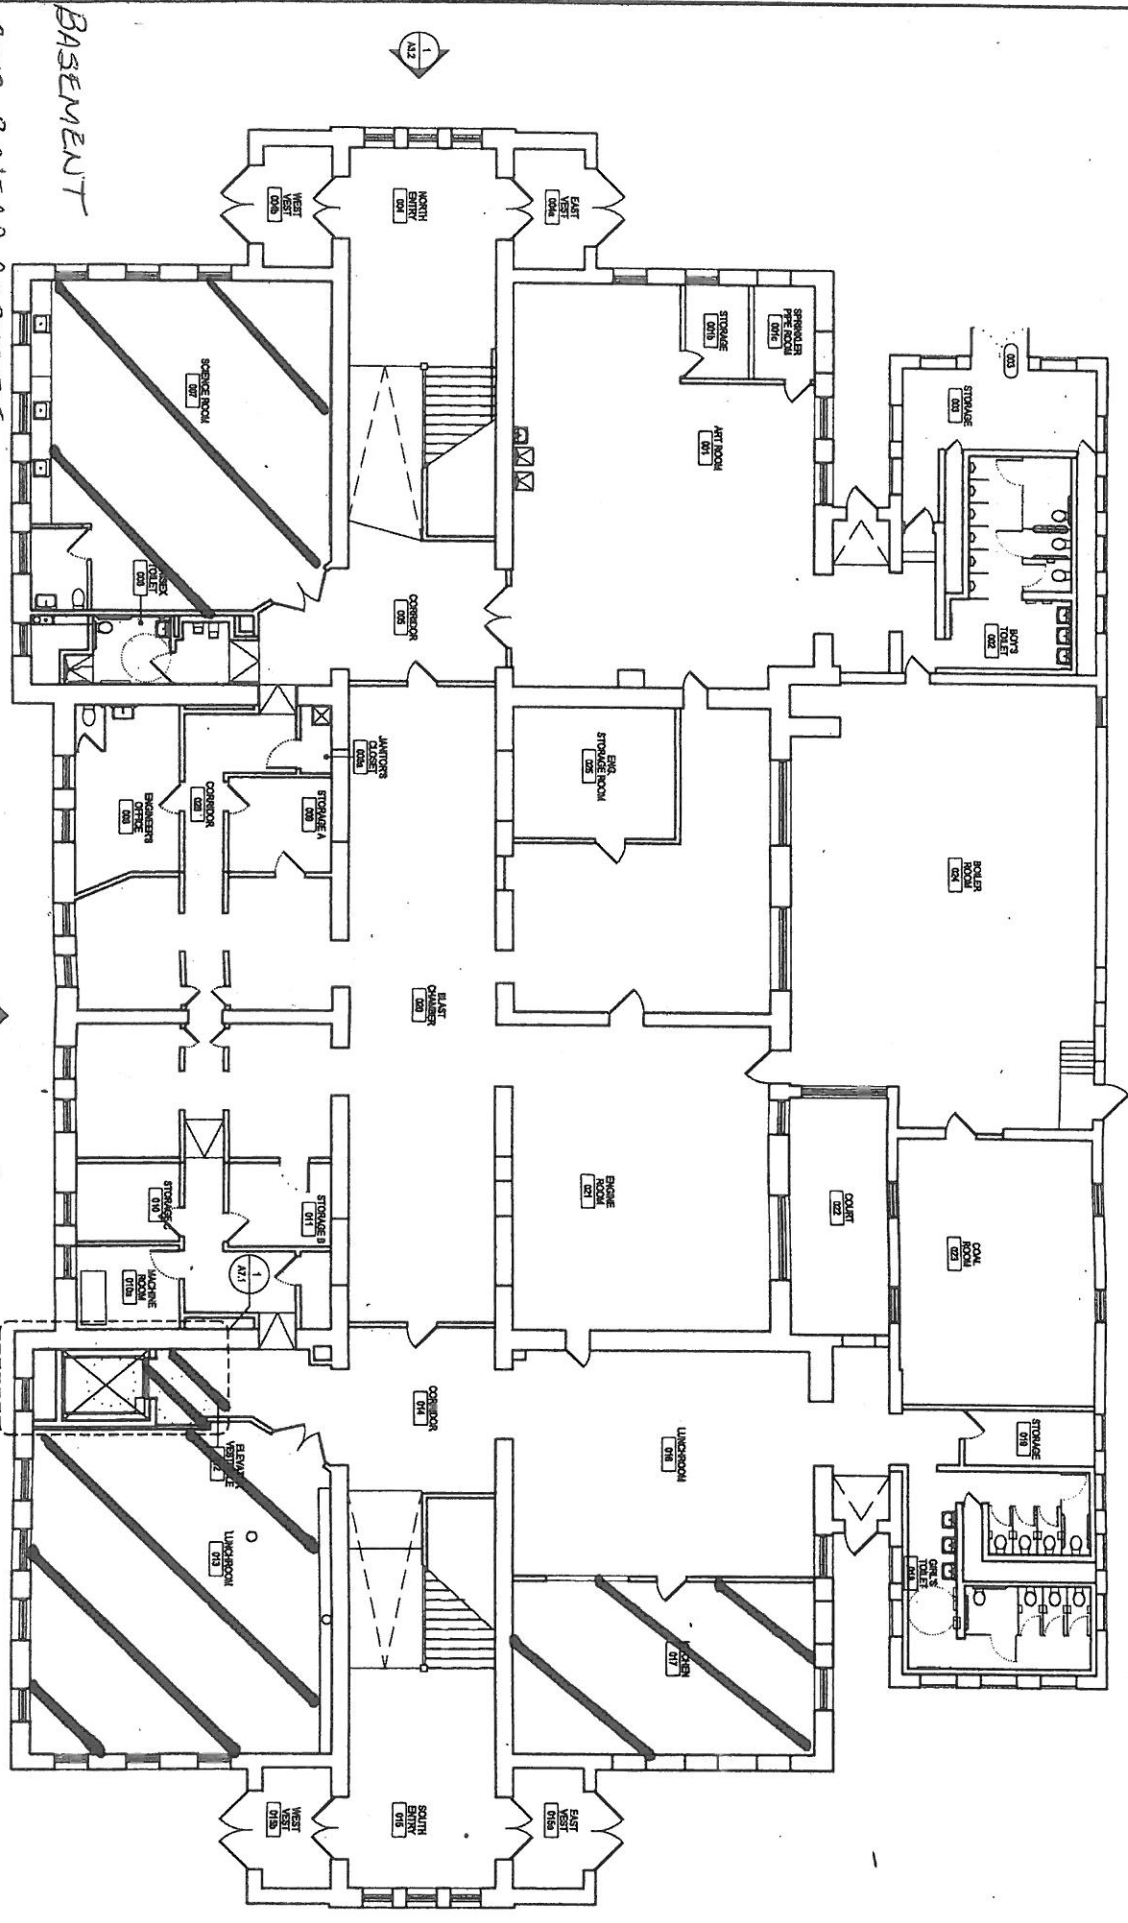
NEW 55 - GRAY VINYL BASEBOARD
HA # 56 - MASTIC ASSOCIATED WITH
HA # 55

150 L.F.

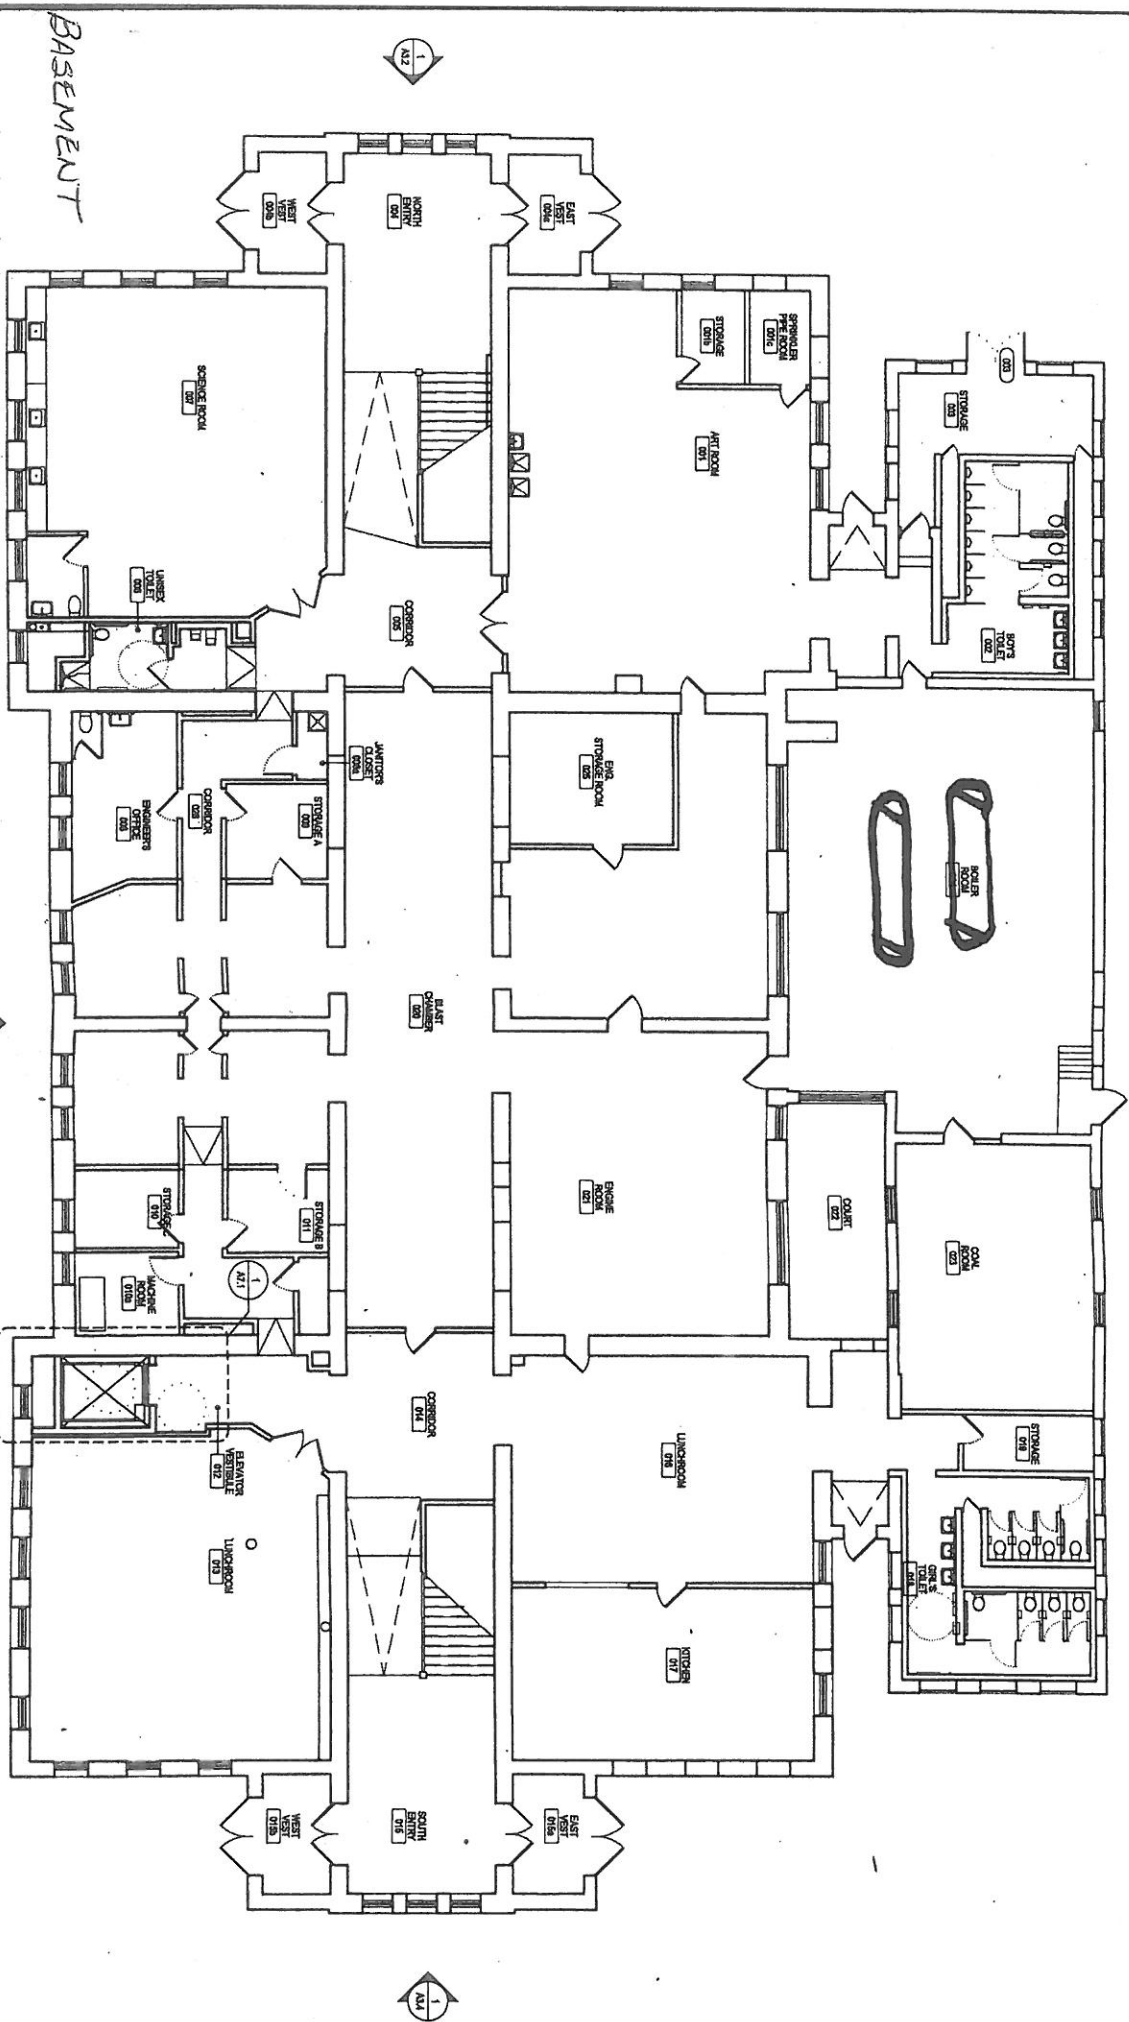
600 L.F.

Boiler #1 + Boiler #2

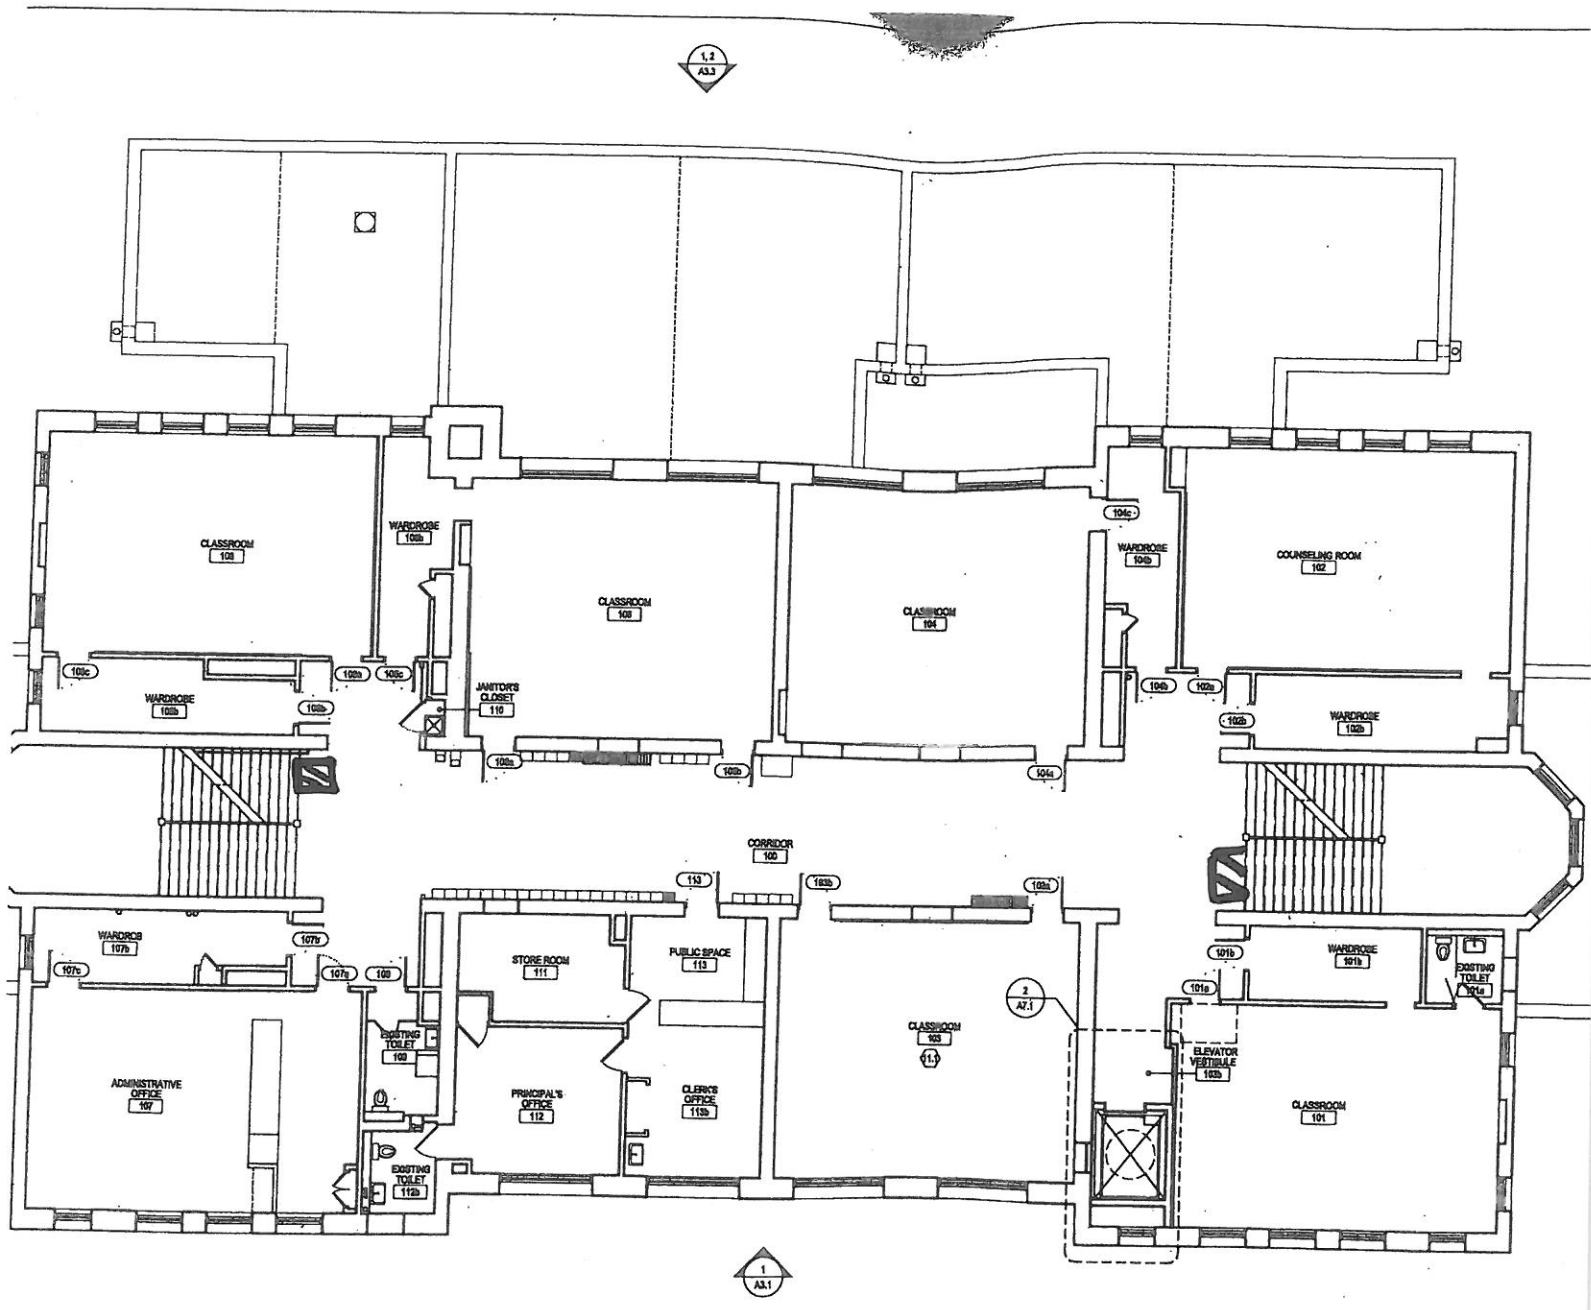
240 S.F. EACH

NEW HA # 64 - MASTIC + ASSOCIATED WITH HA # 63

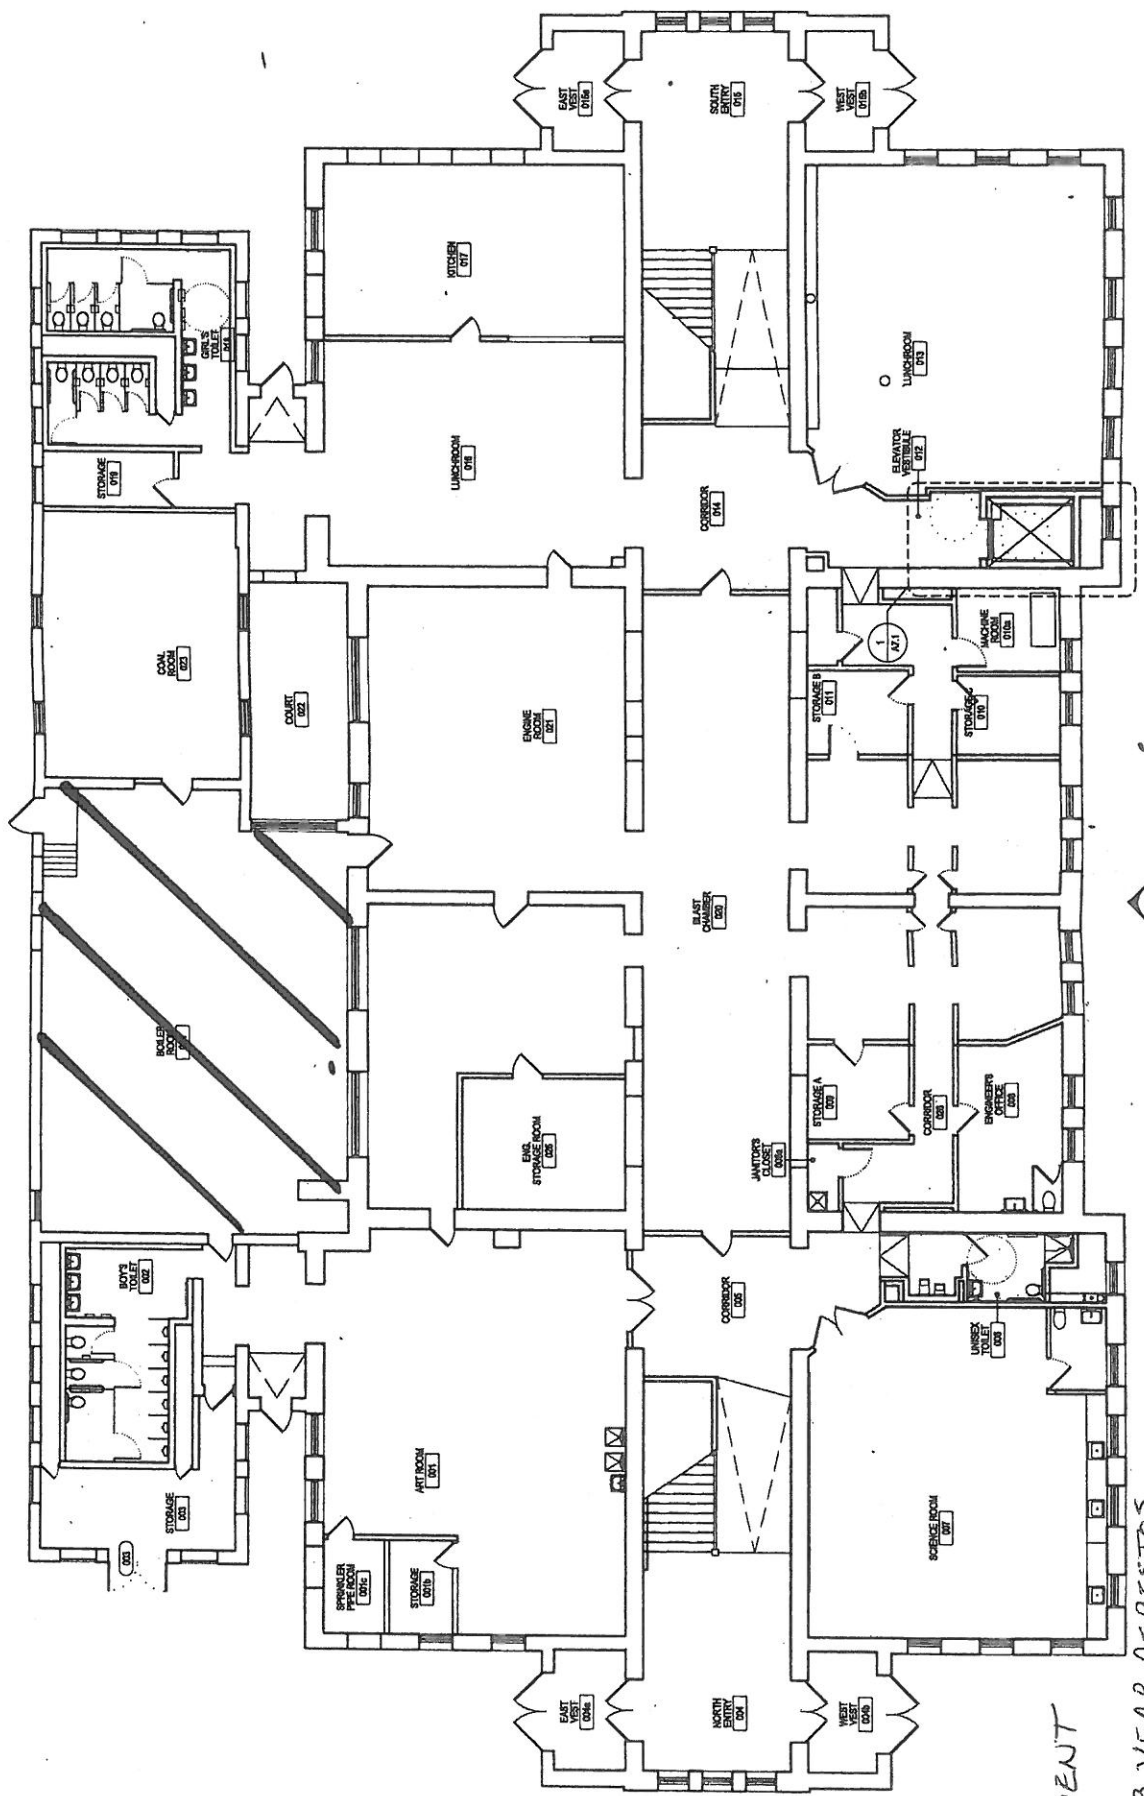
NEW DUCT INSULATION HA # 602

200 S.F.

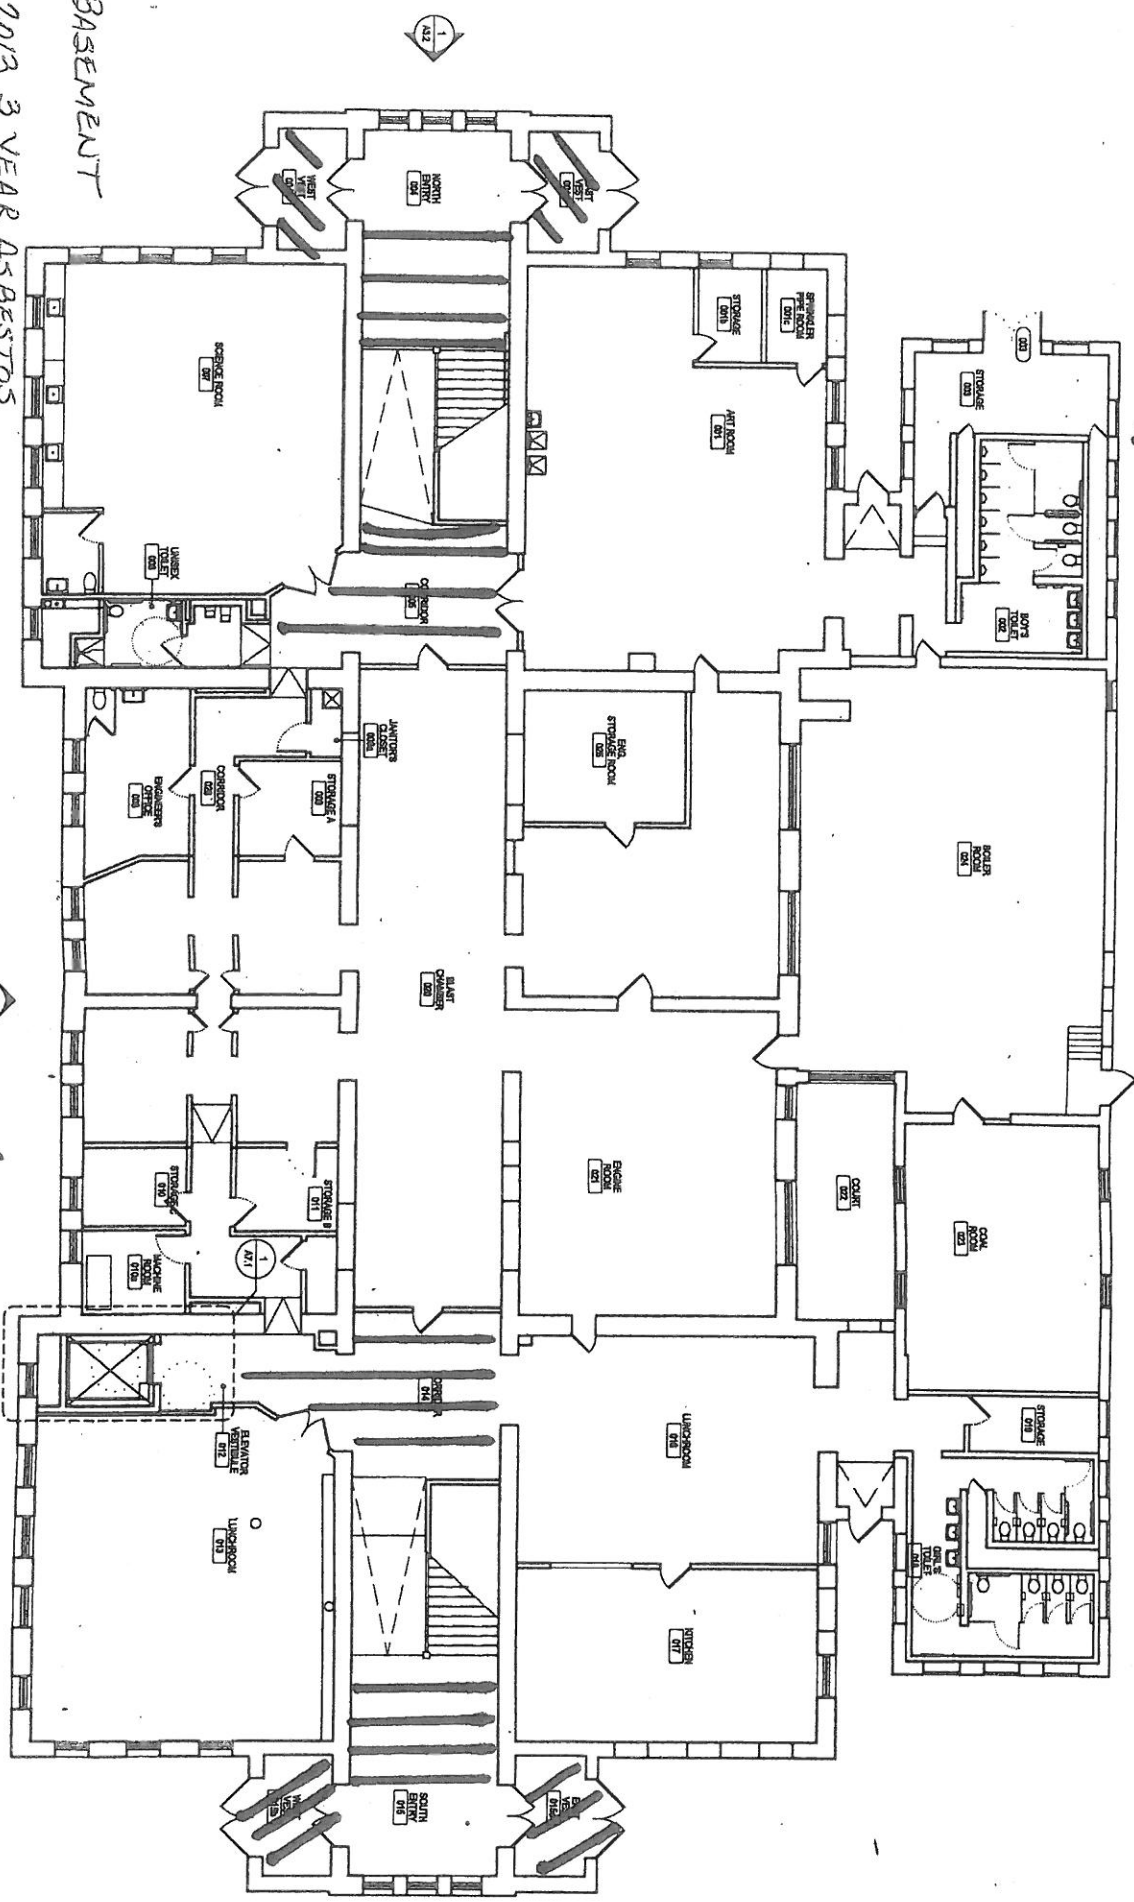
NEW
 HA # 51 - GRAY LINOLEUM
 HA # 52 - GRAY LINOLEUM MASTIC
 750 S.F. EA.

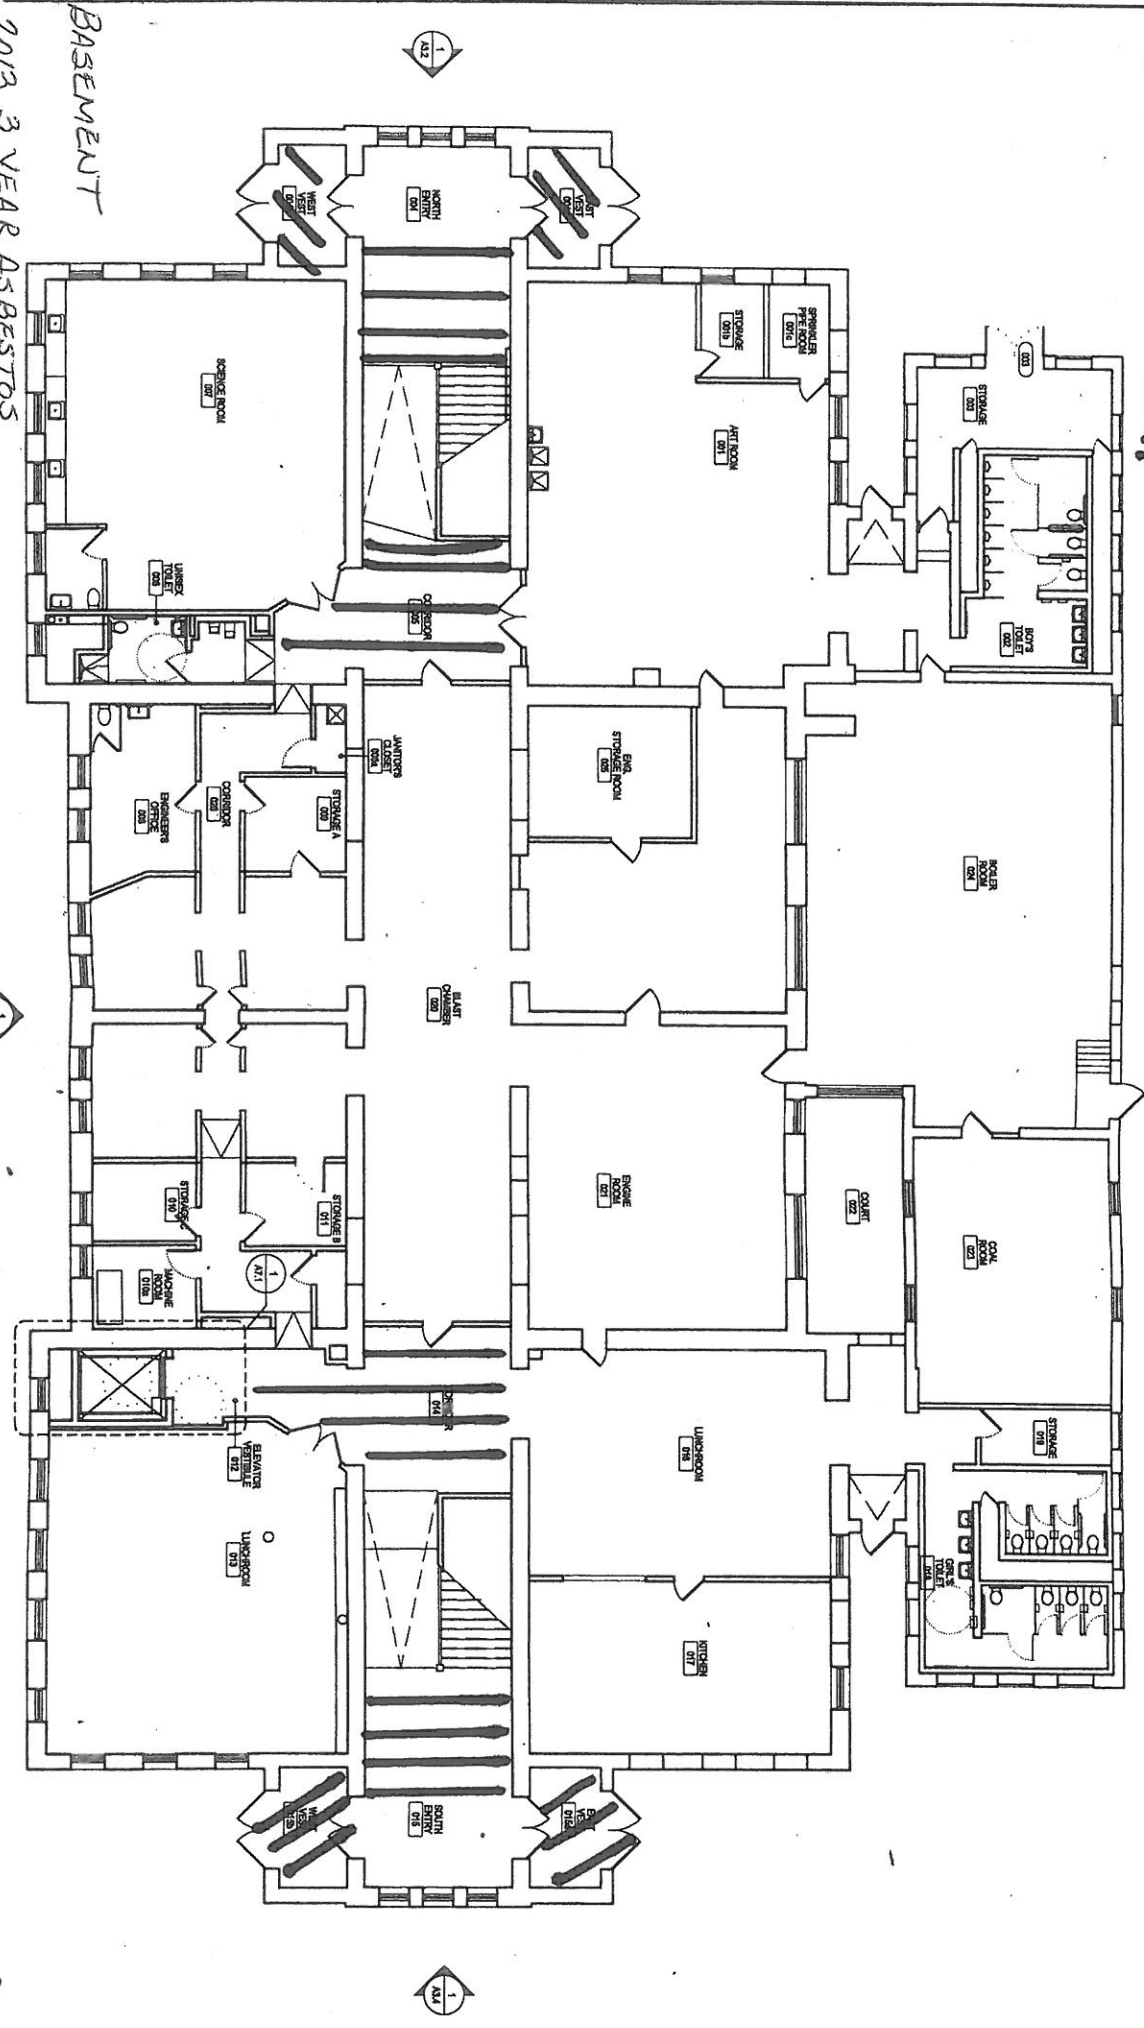
NEW 51 - GRAY LINOLEUM

HA # 52 - GRAY LINOLEUM MASTIC

750 S.F. EA.

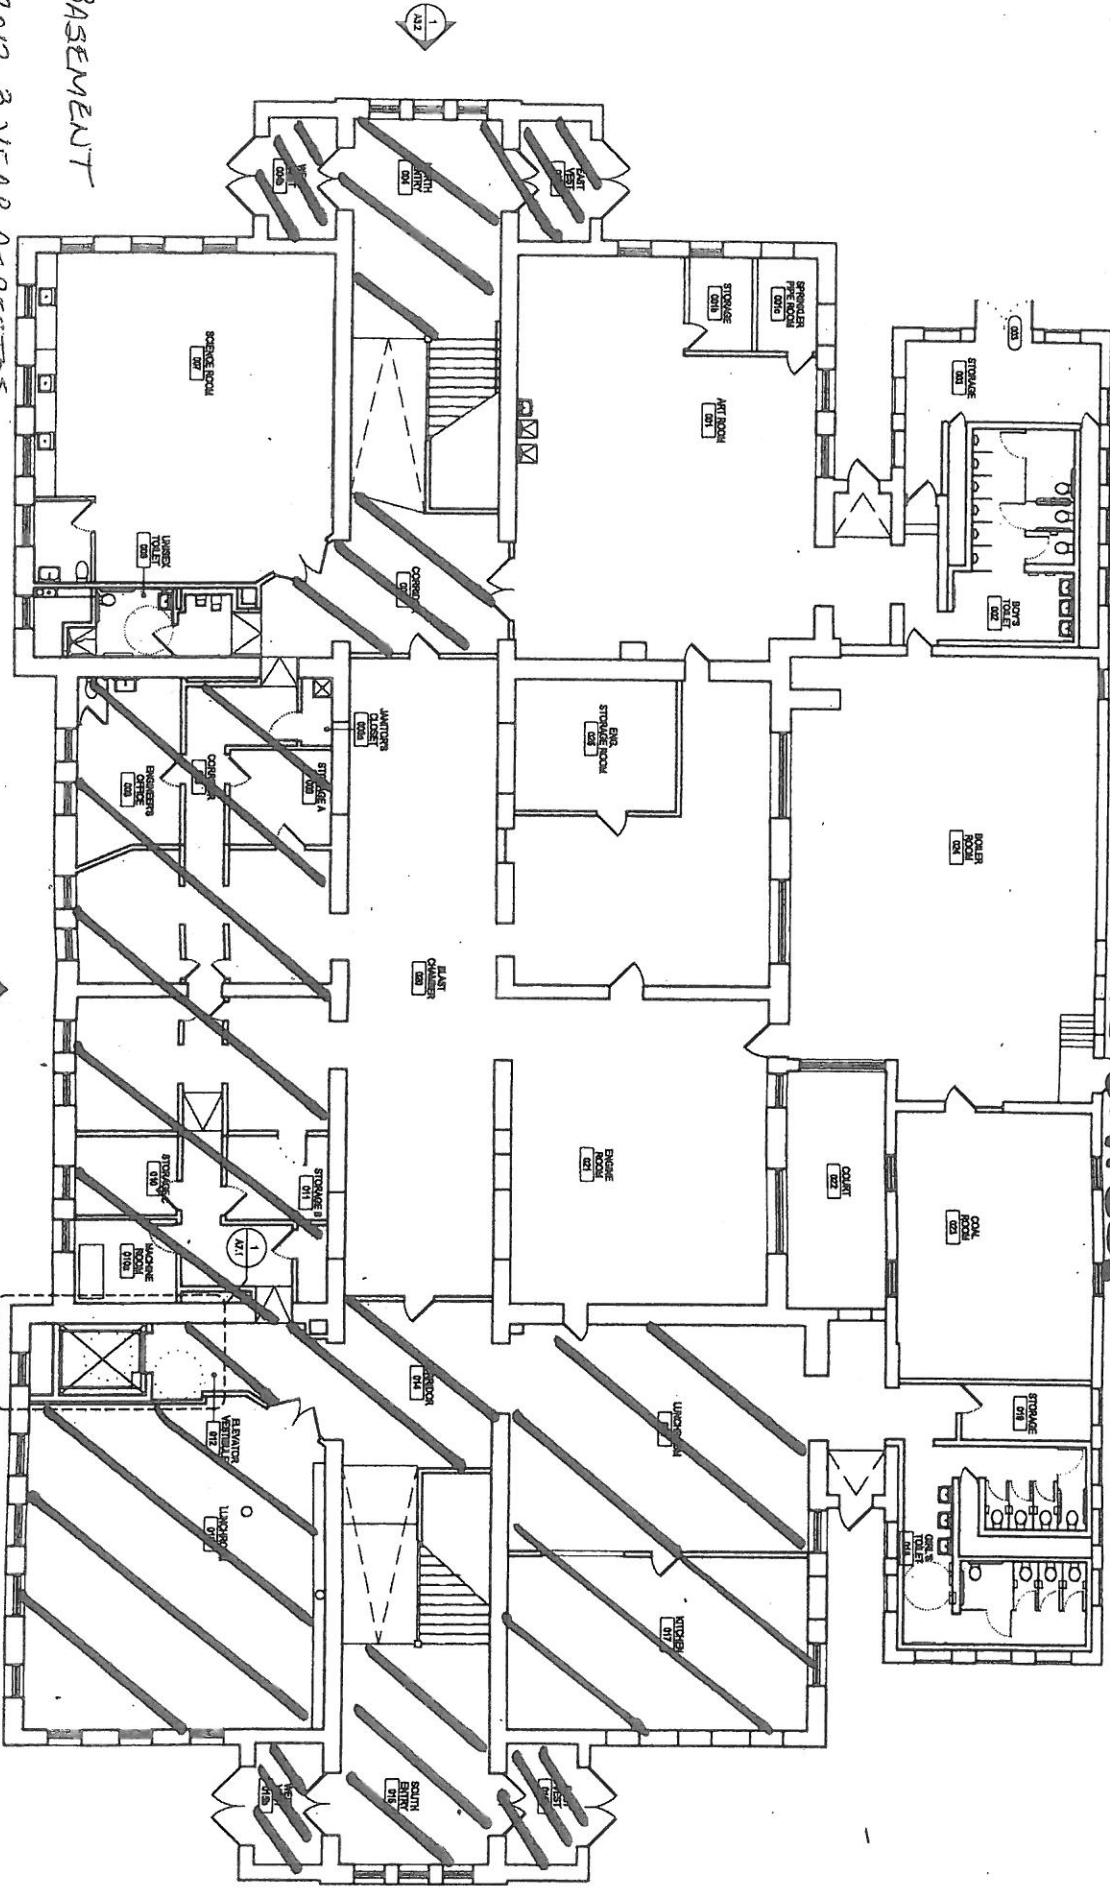
HA # 53

THROUGHOUT BASEMENT LOWER WAREHOUSE

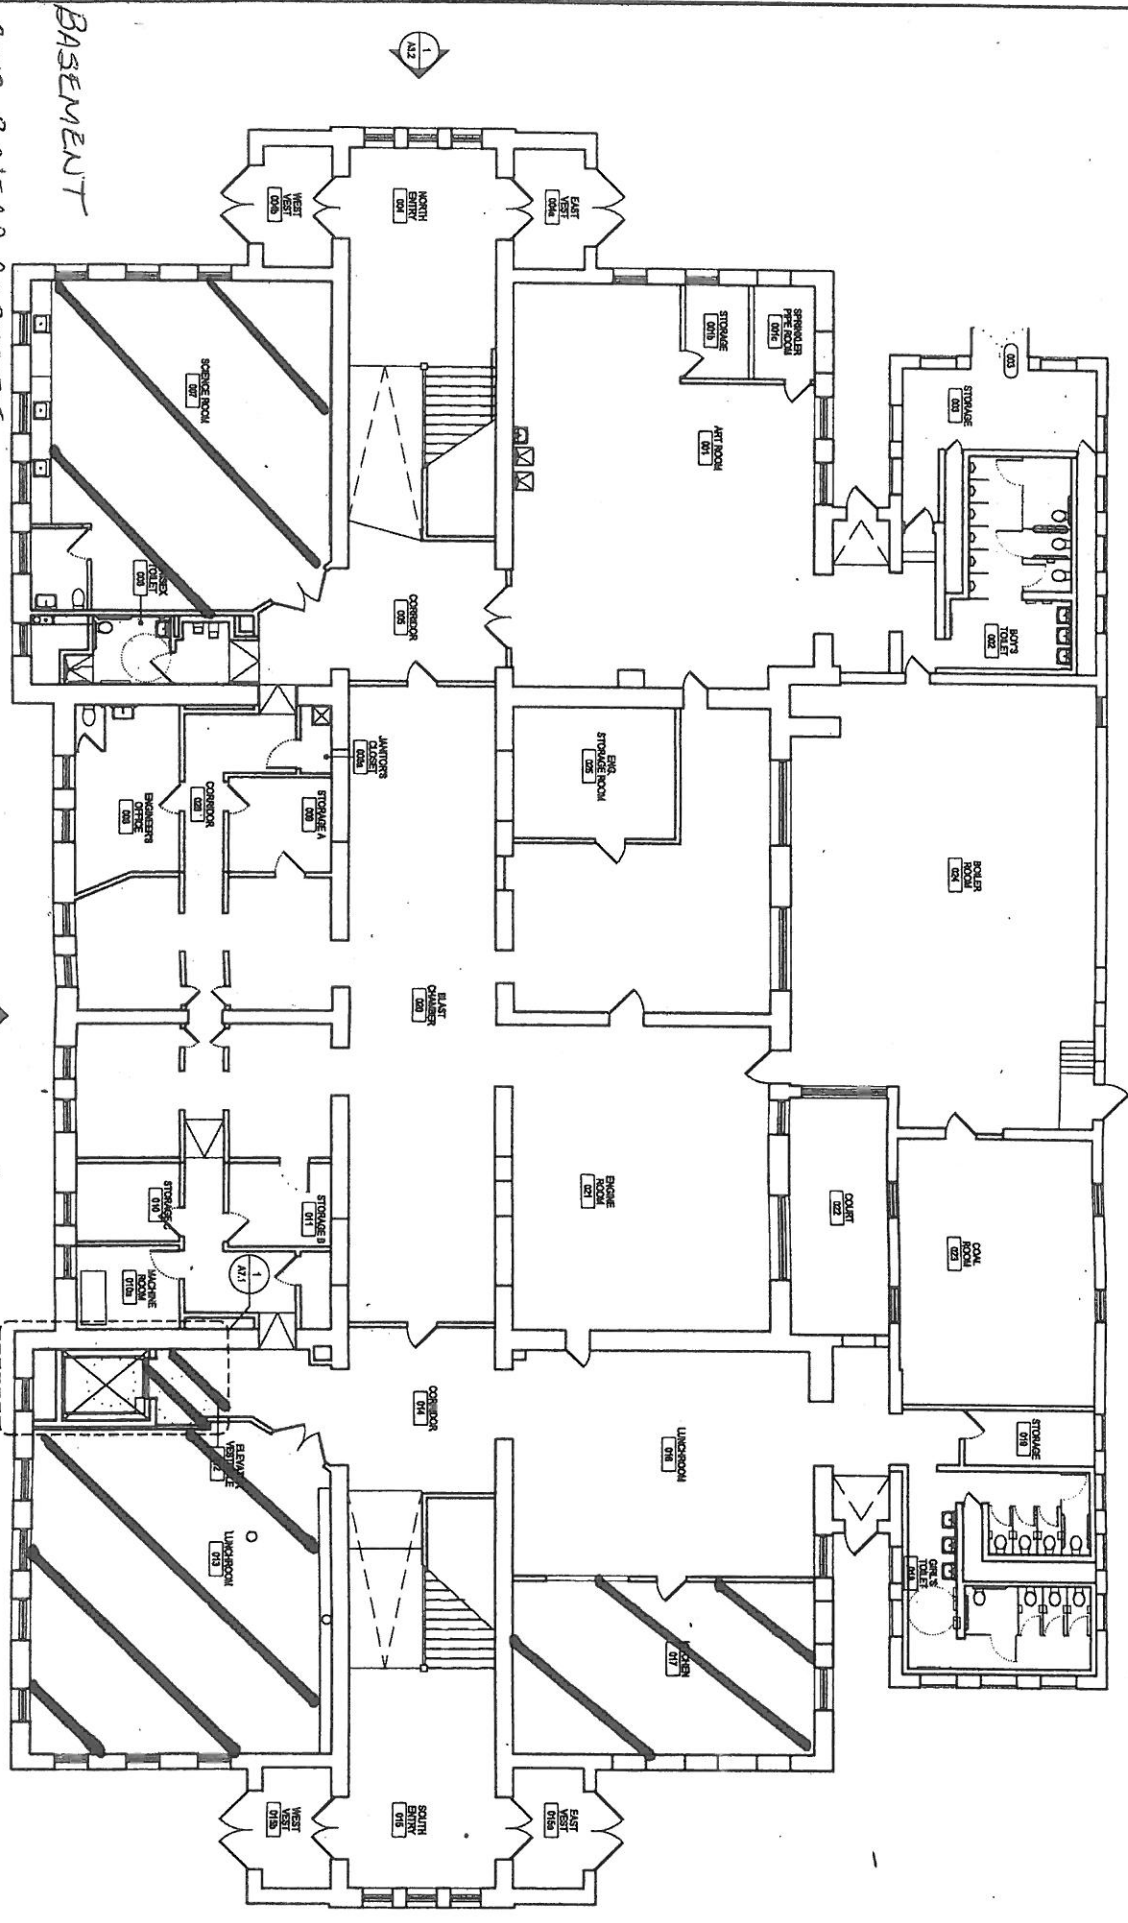
NEW 55 - GRAY VINYL BASEBOARD
HA # 56 - MASTIC ASSOCIATED WITH
HA # 55

150 L.F.

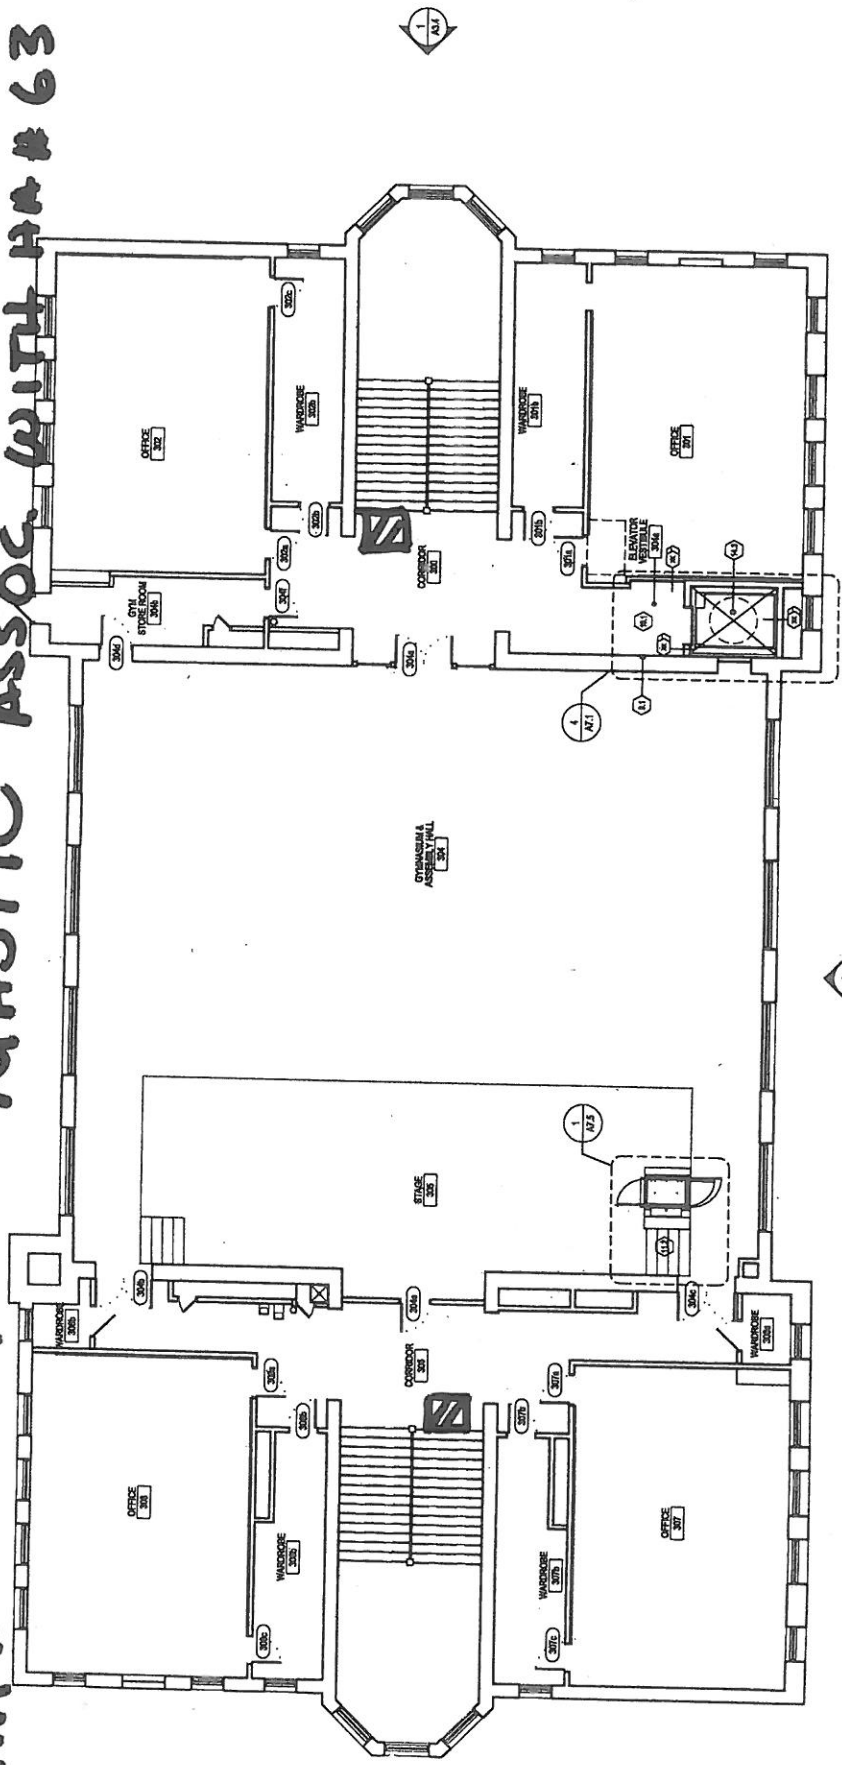
NEW - 63 - GRAY RUBBER
 HA# - 63 - SKID PROOF
 FLOORING
 NEW - 64 - MASTIC ASSOC. WITH HA# 63

240 S.F.
 EACH

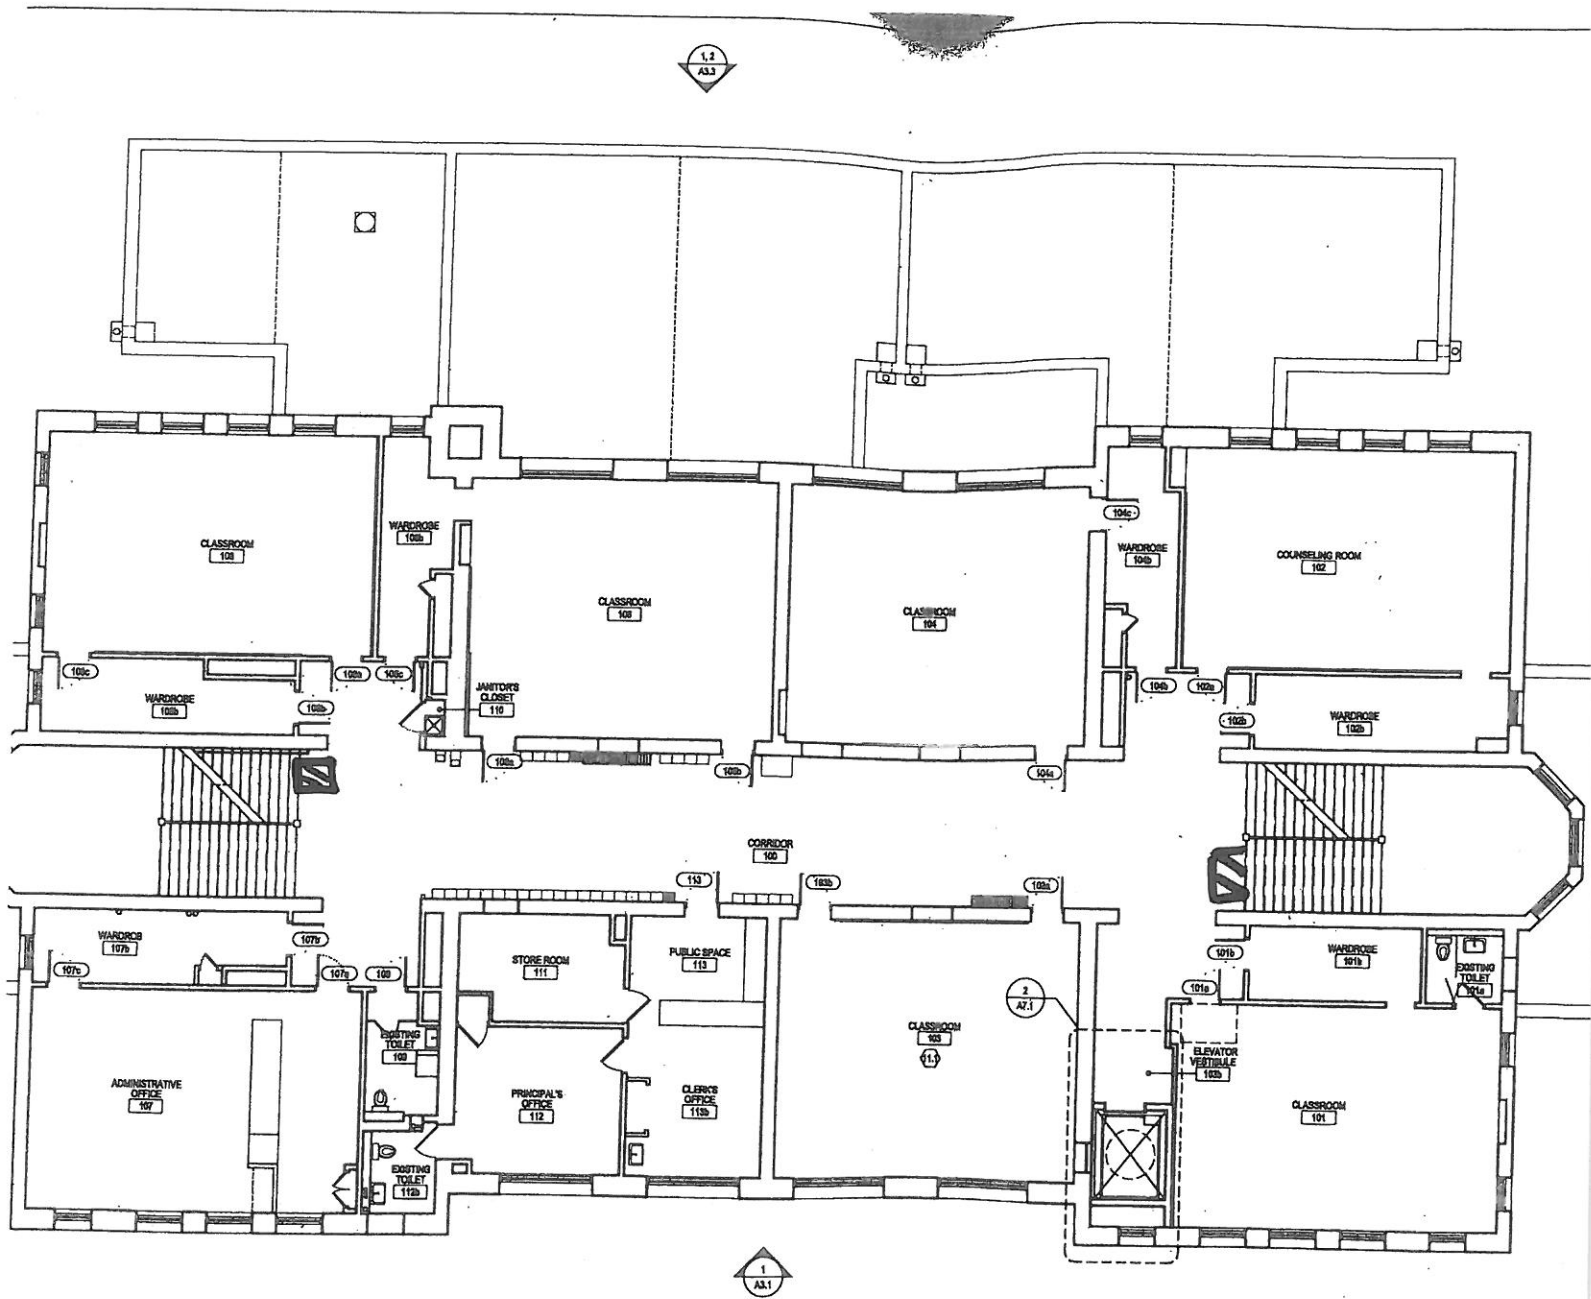
240 S.F. EACH

NEW HA # 64 - MASTIC ASSOCIATED WITH HA # 63
