ILLINOIS DEPARTMENT OF PUBLIC HEALTH
AHERA THREE YEAR REINSPECTION
ASBESTOS ABATEMENT PROGRAM
SCHOOL INFORMATION FORM

THREE-YEAR REINSPECTION

Alcott High School for the Humanities

2957 N. Hoyne Avenue
Chicago, IL, 60618

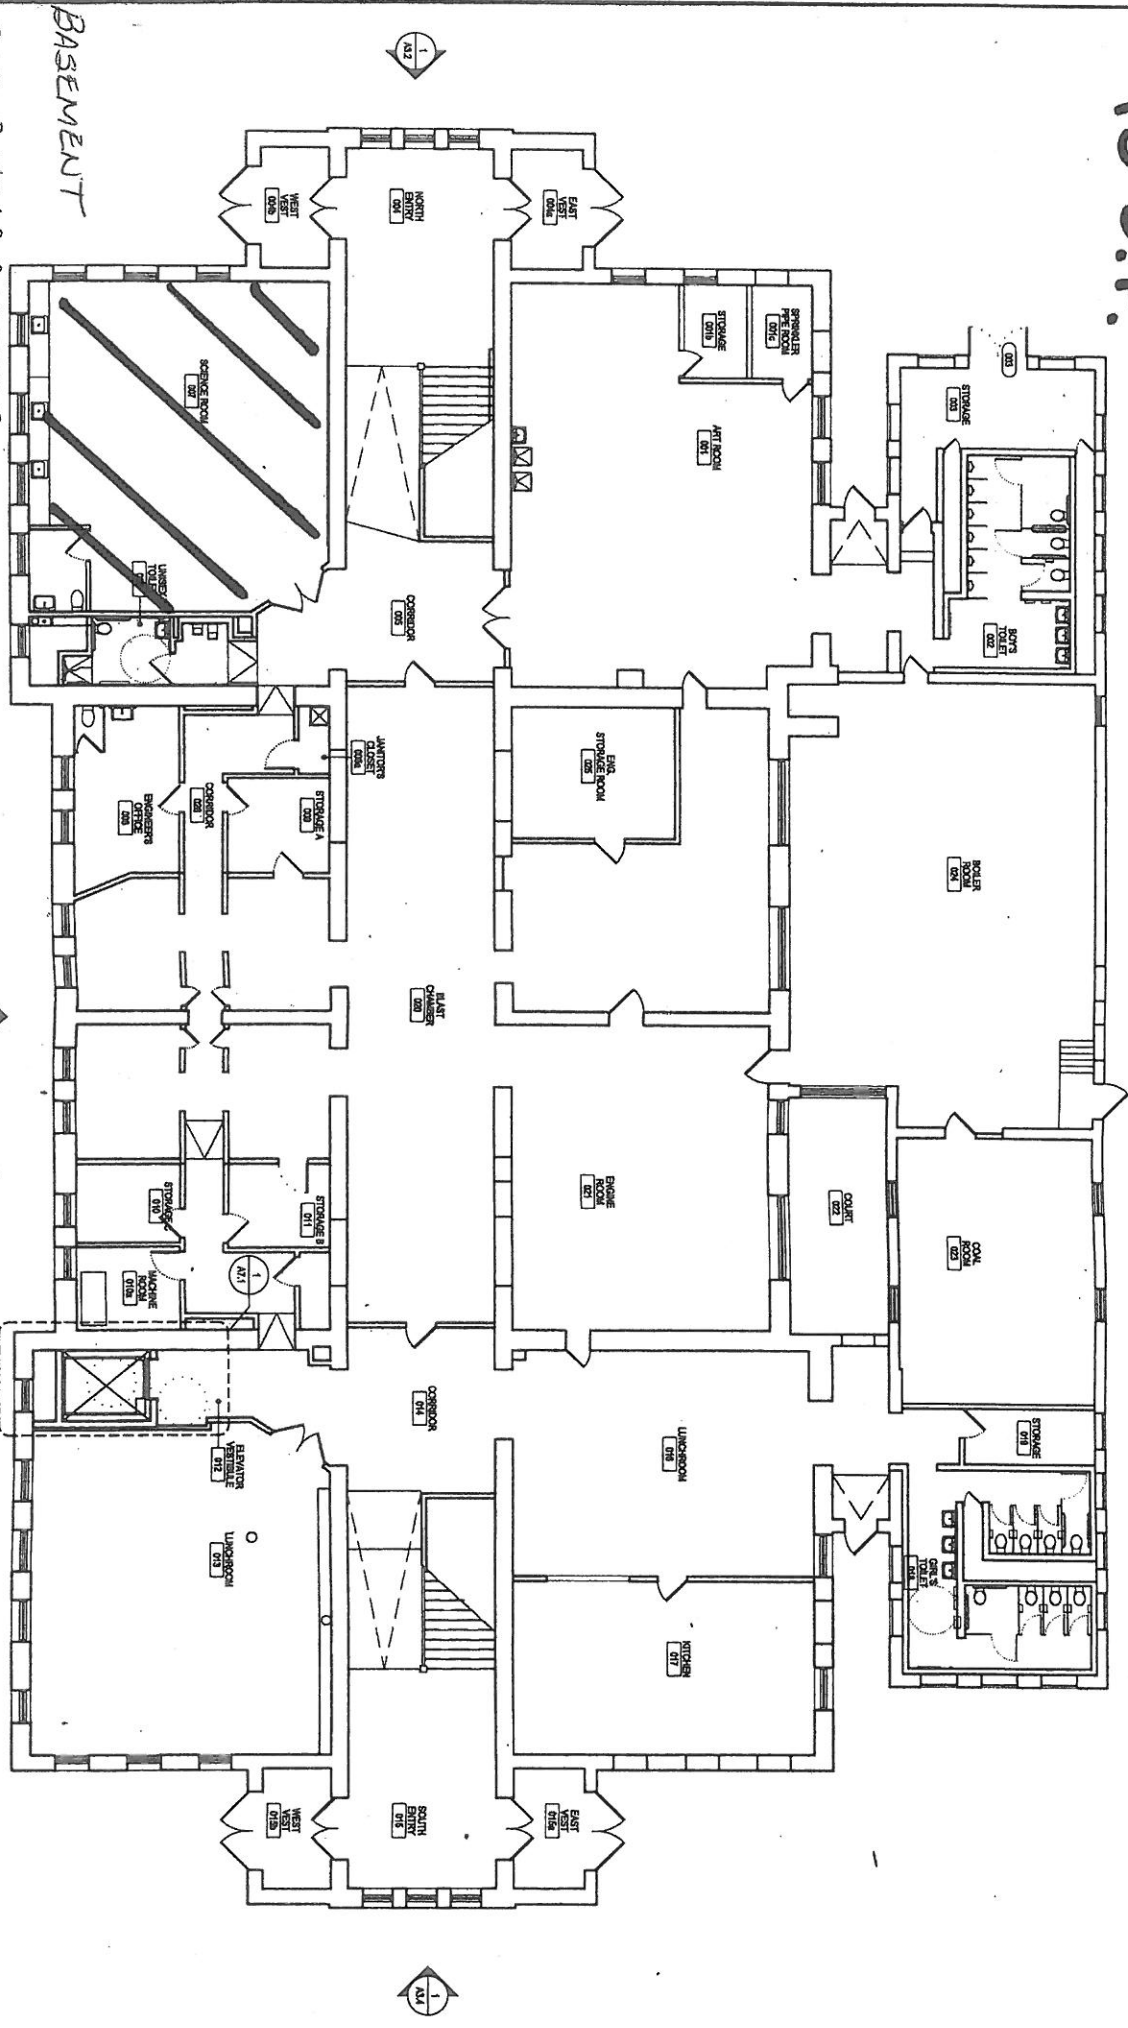
NEW HA# 57 - GRAY SPRAY ON SINK UNDERCOATING

15 S.F.

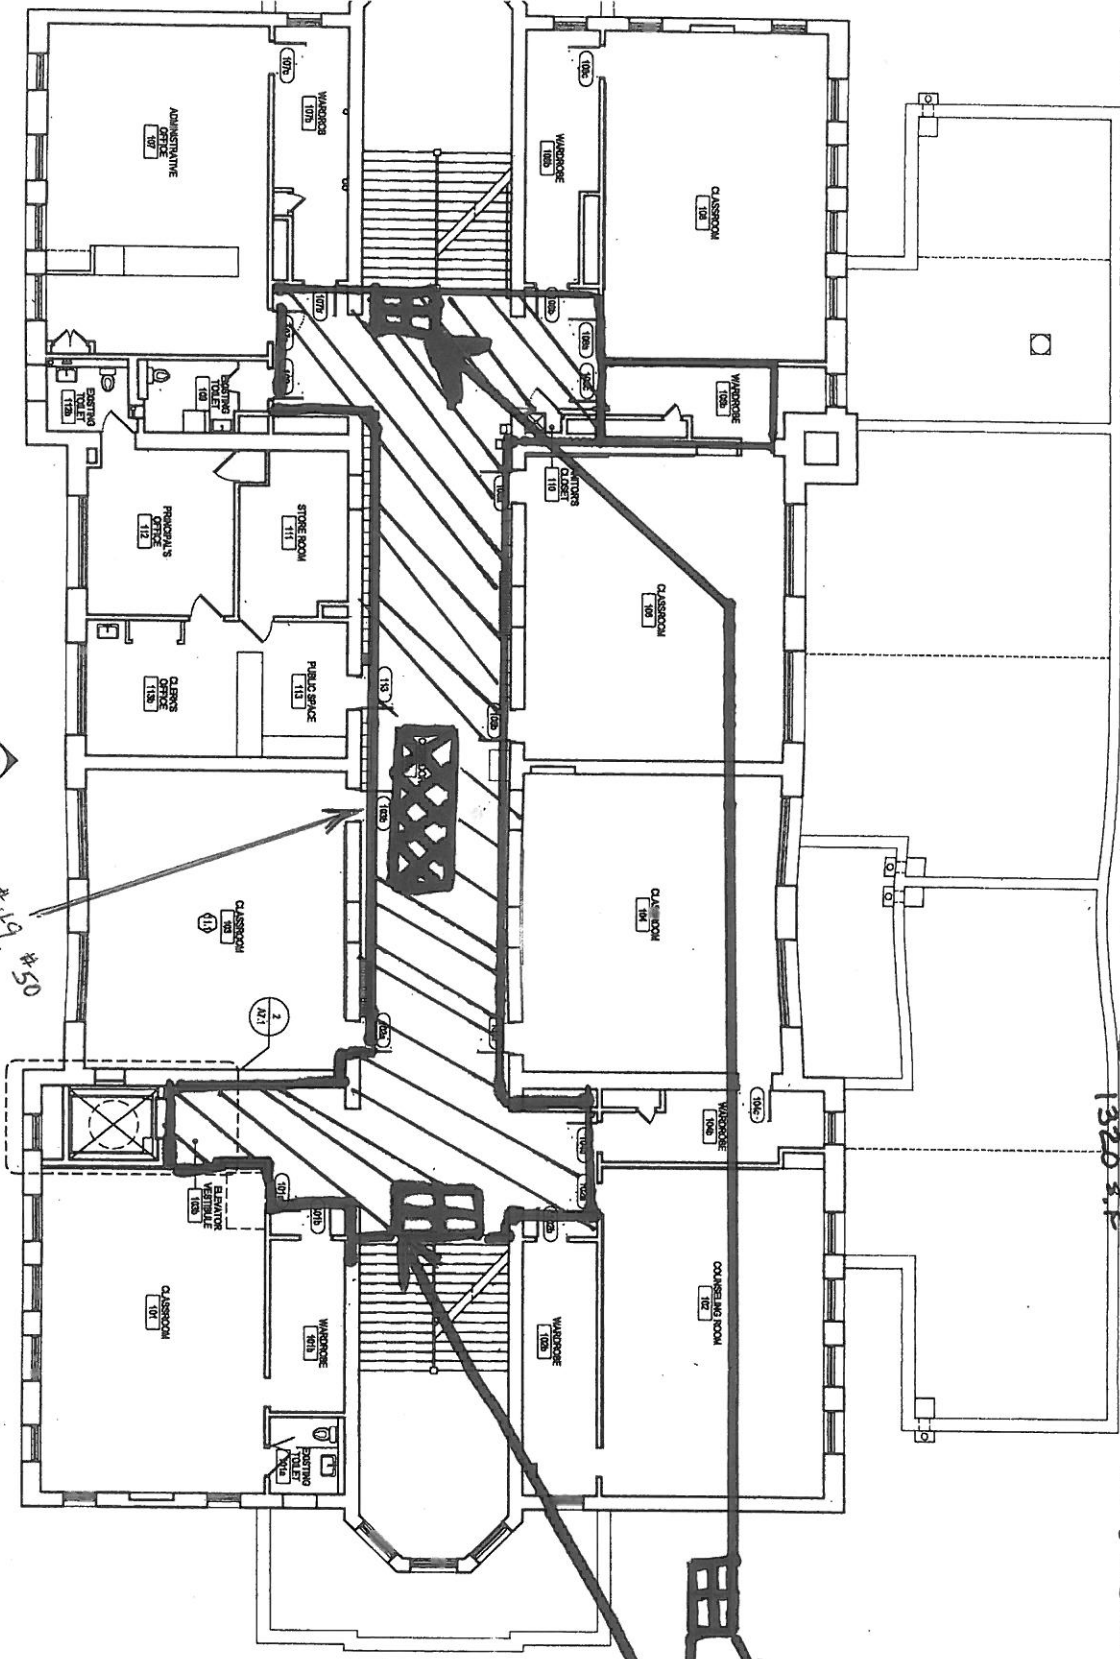
NEW HA # 43

NEW HA # 42 - VFT
 NEW HA # 43 - MASTIC
 12" X 12" TAN WITH
 LT. BROWN + WHITE
 STREAKS

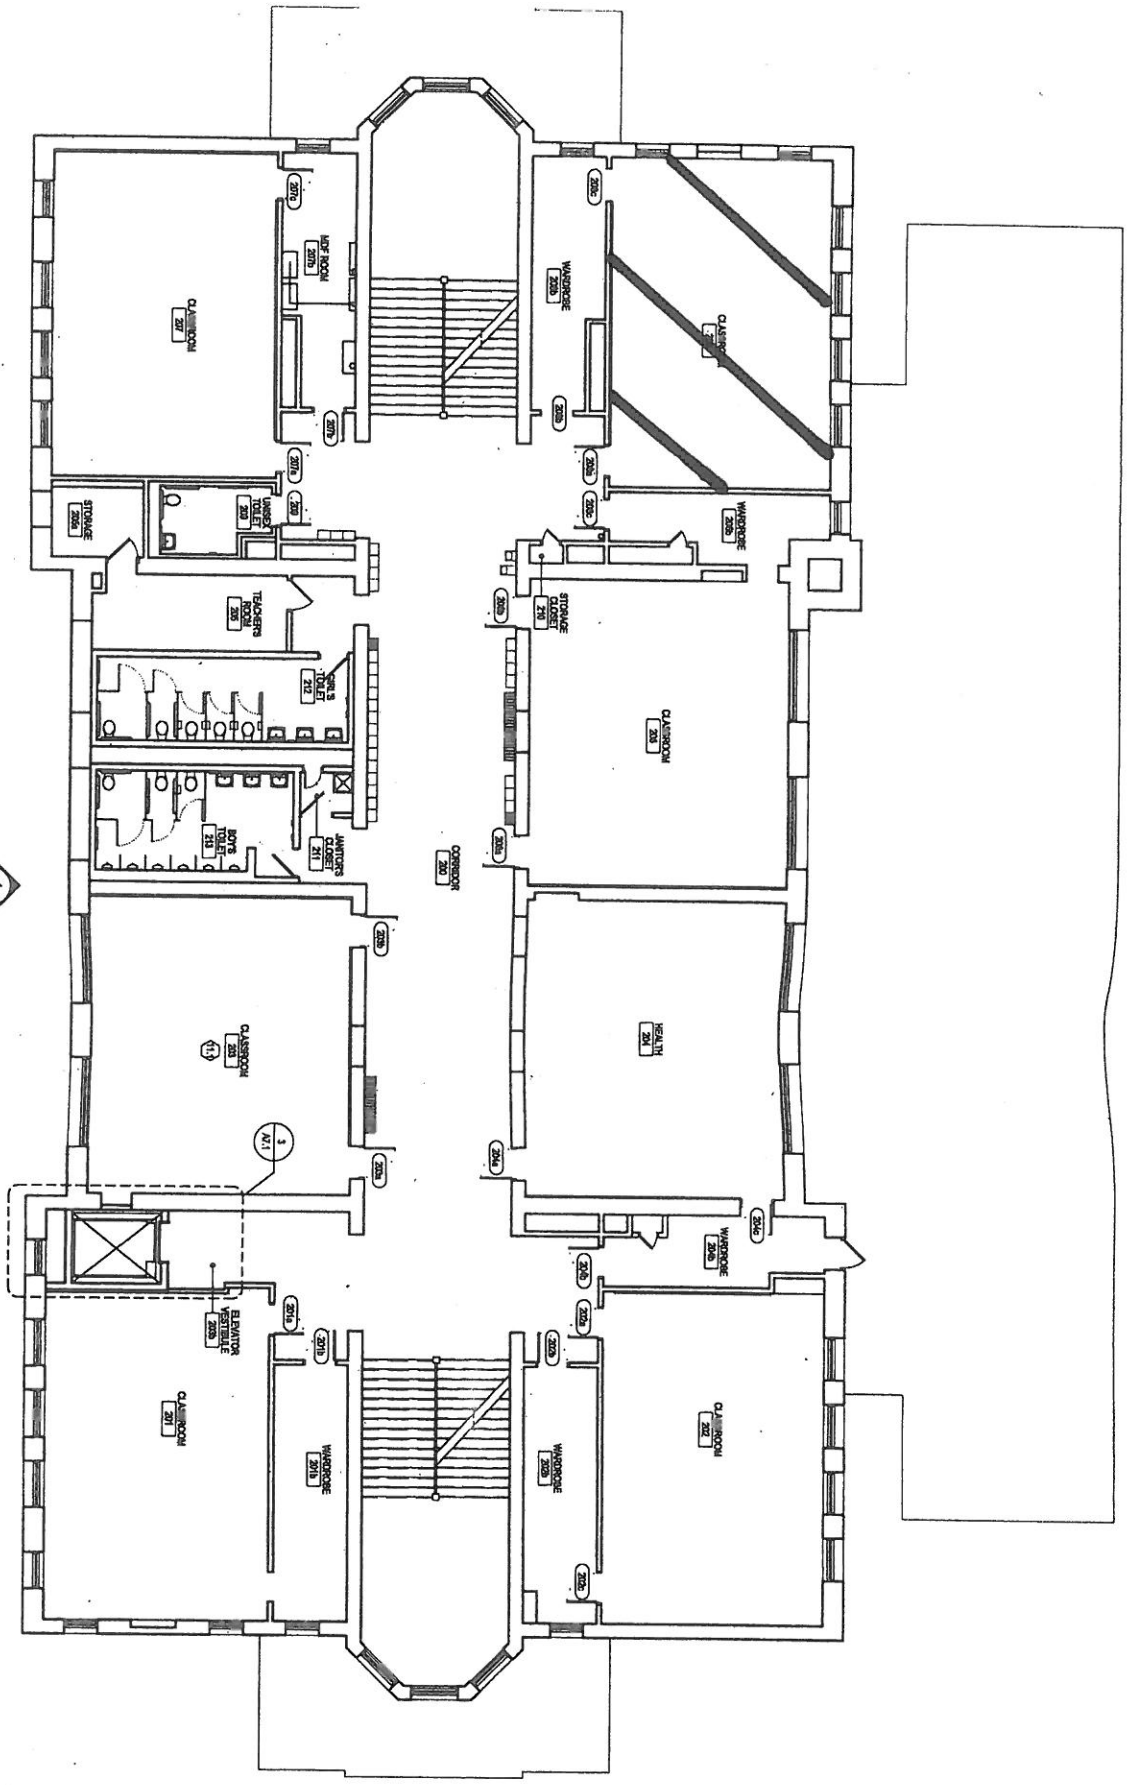
NEW LAB
HA# 48
FUME HOOD

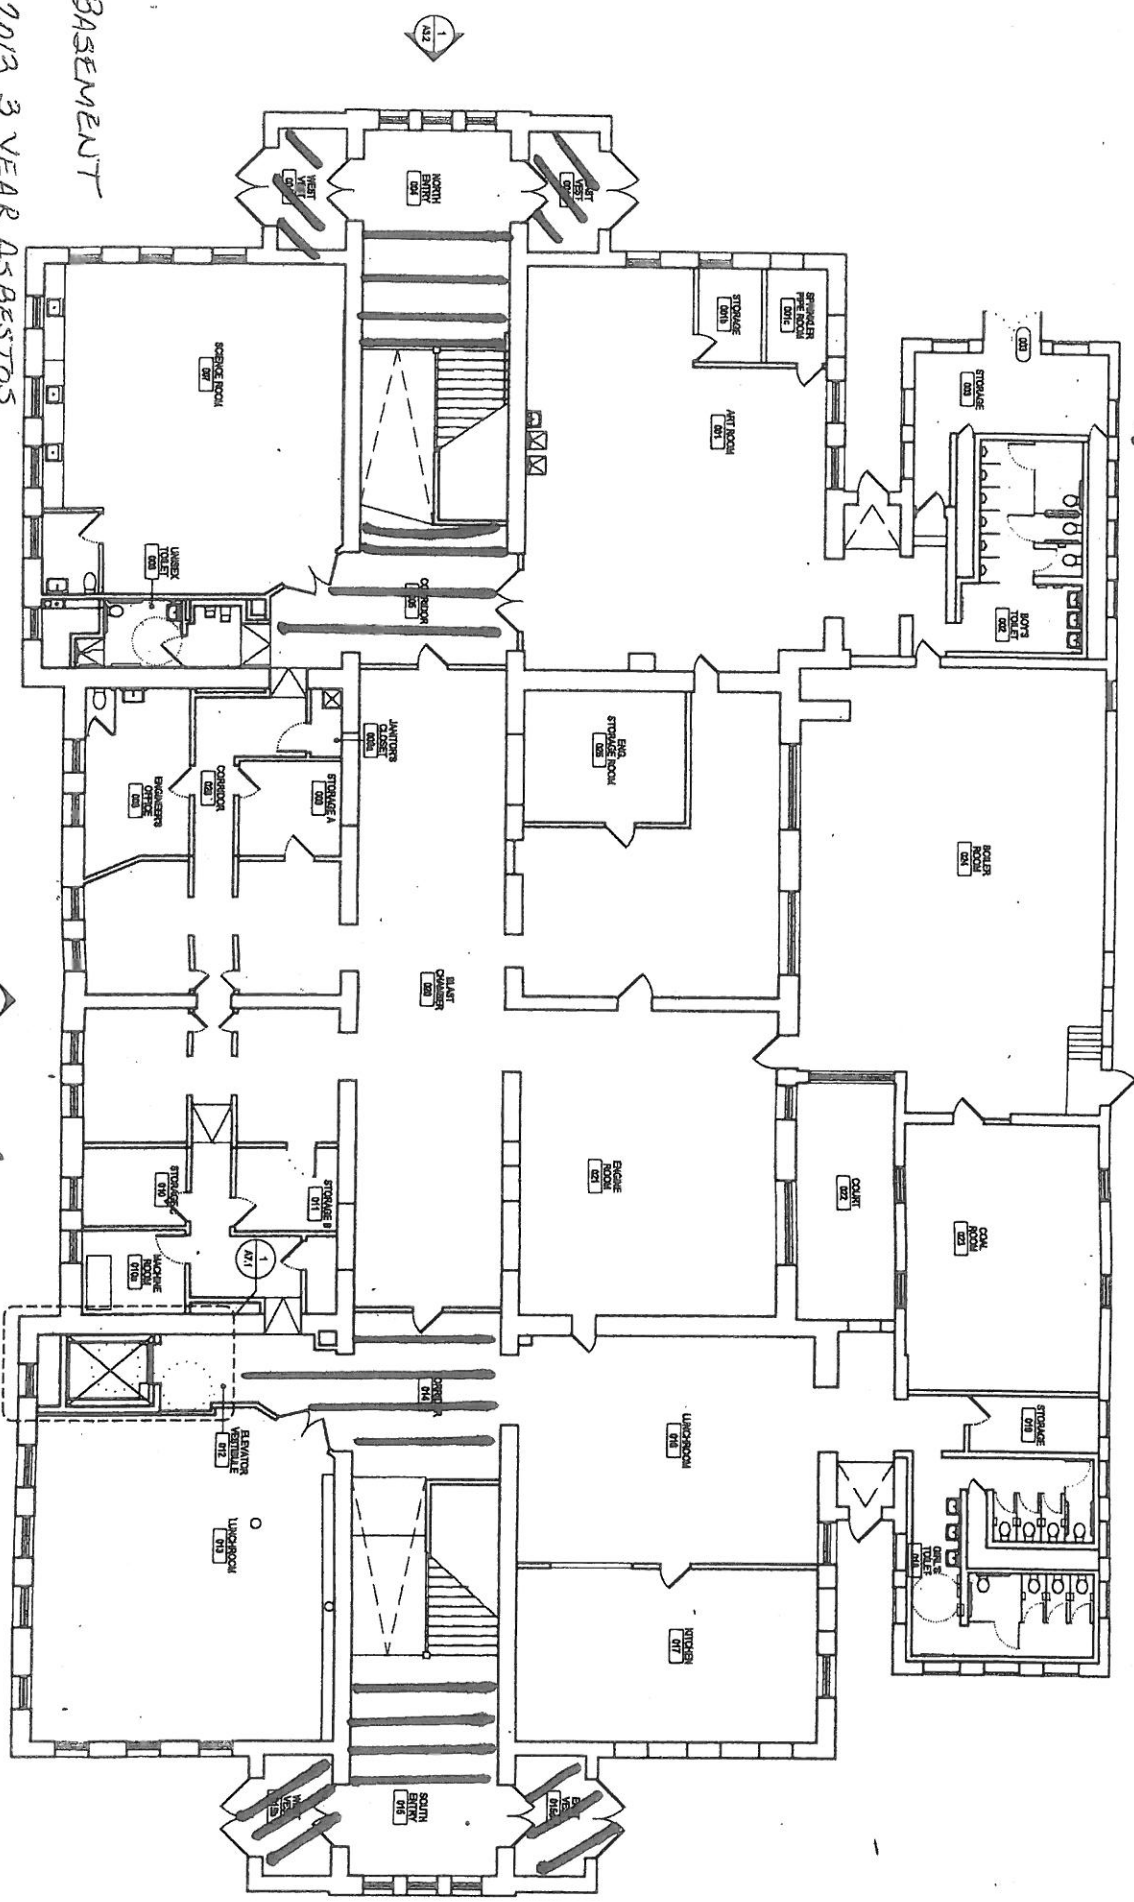
NEW
 HA # 51 - GRAY LINOLEUM
 HA # 52 - GRAY LINOLEUM MASTIC
 750 S.F. EA.

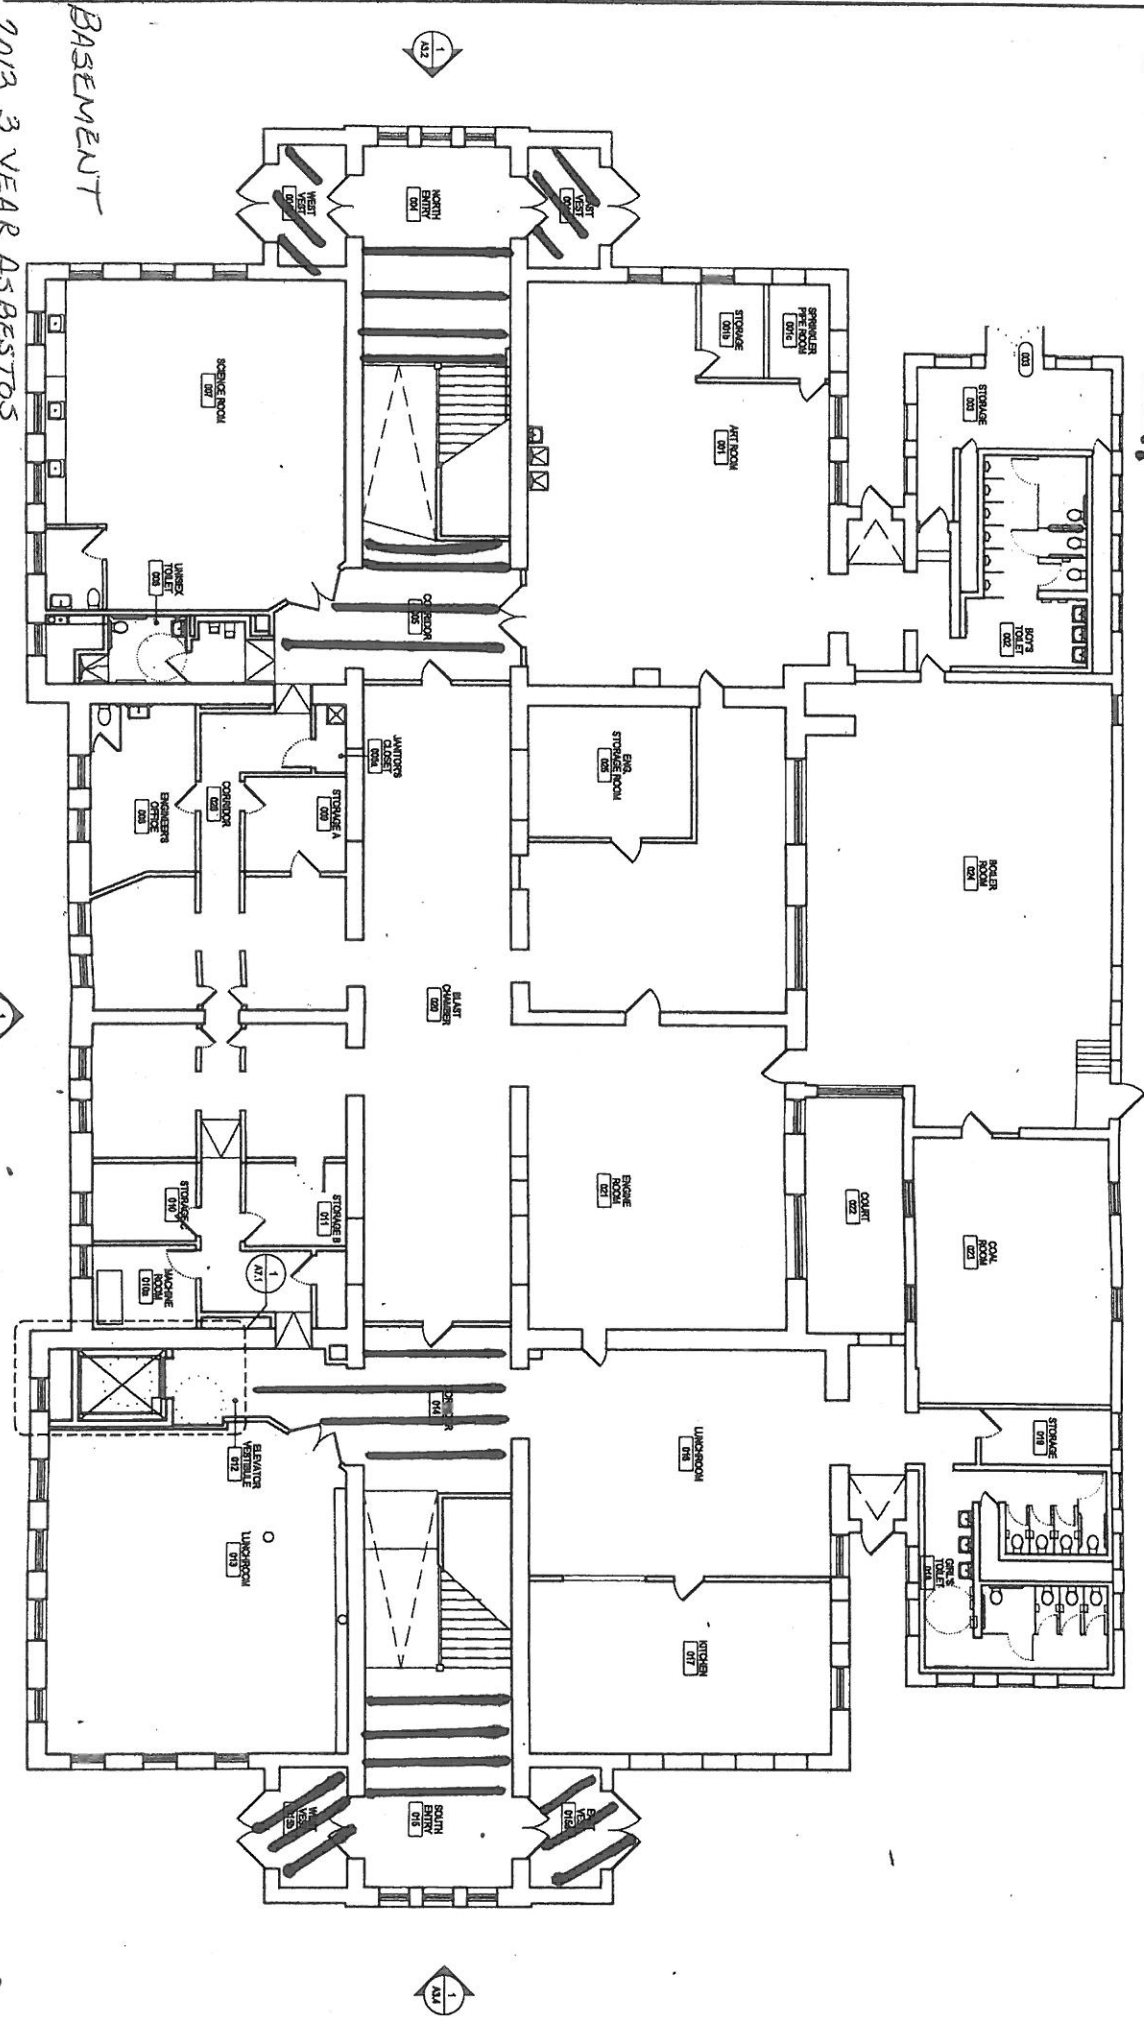
NEW 51 - GRAY LINOLEUM

HA # 52 - GRAY LINOLEUM MASTIC

750 S.F. EA.

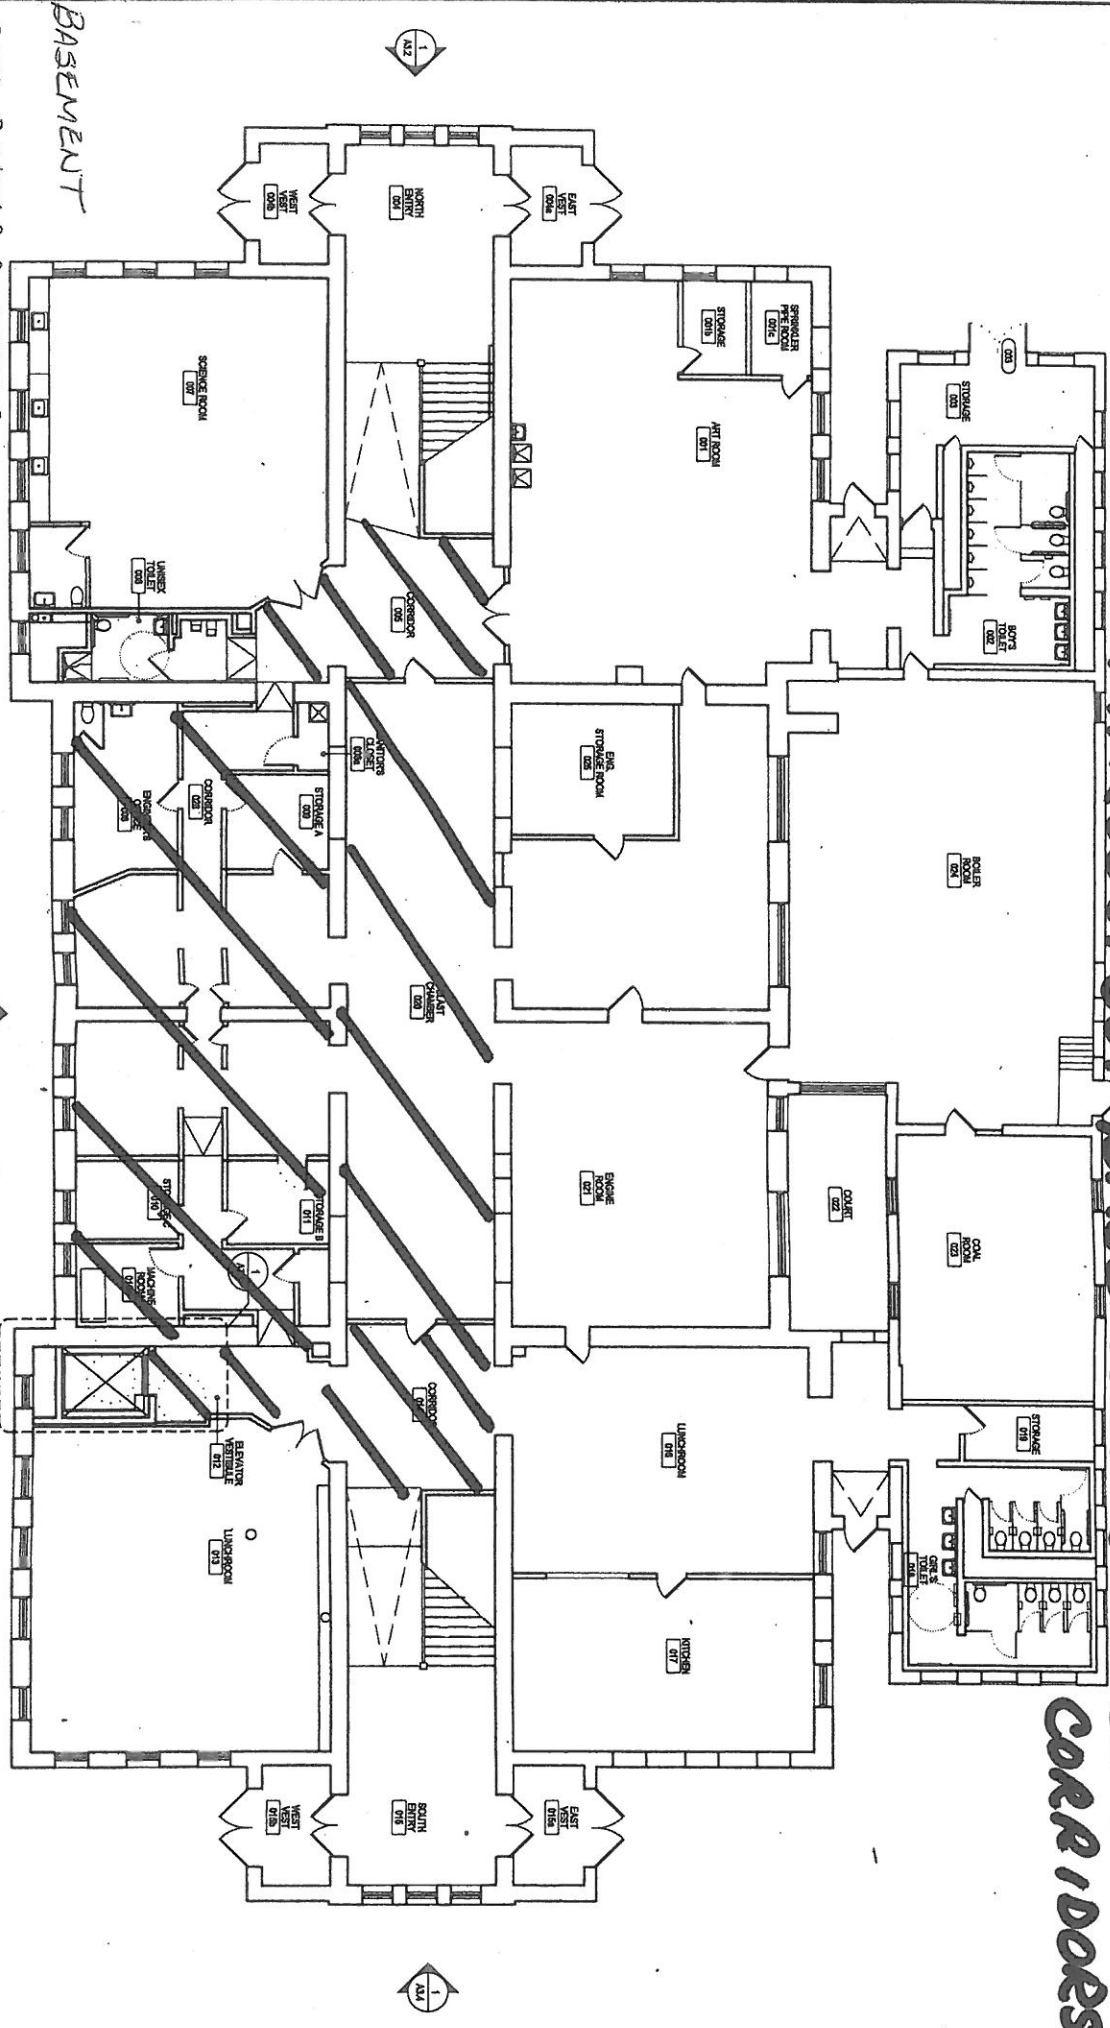
7500 S.F.

THROUGHOUT BASEMENT OFFICES +
CORRIDORS

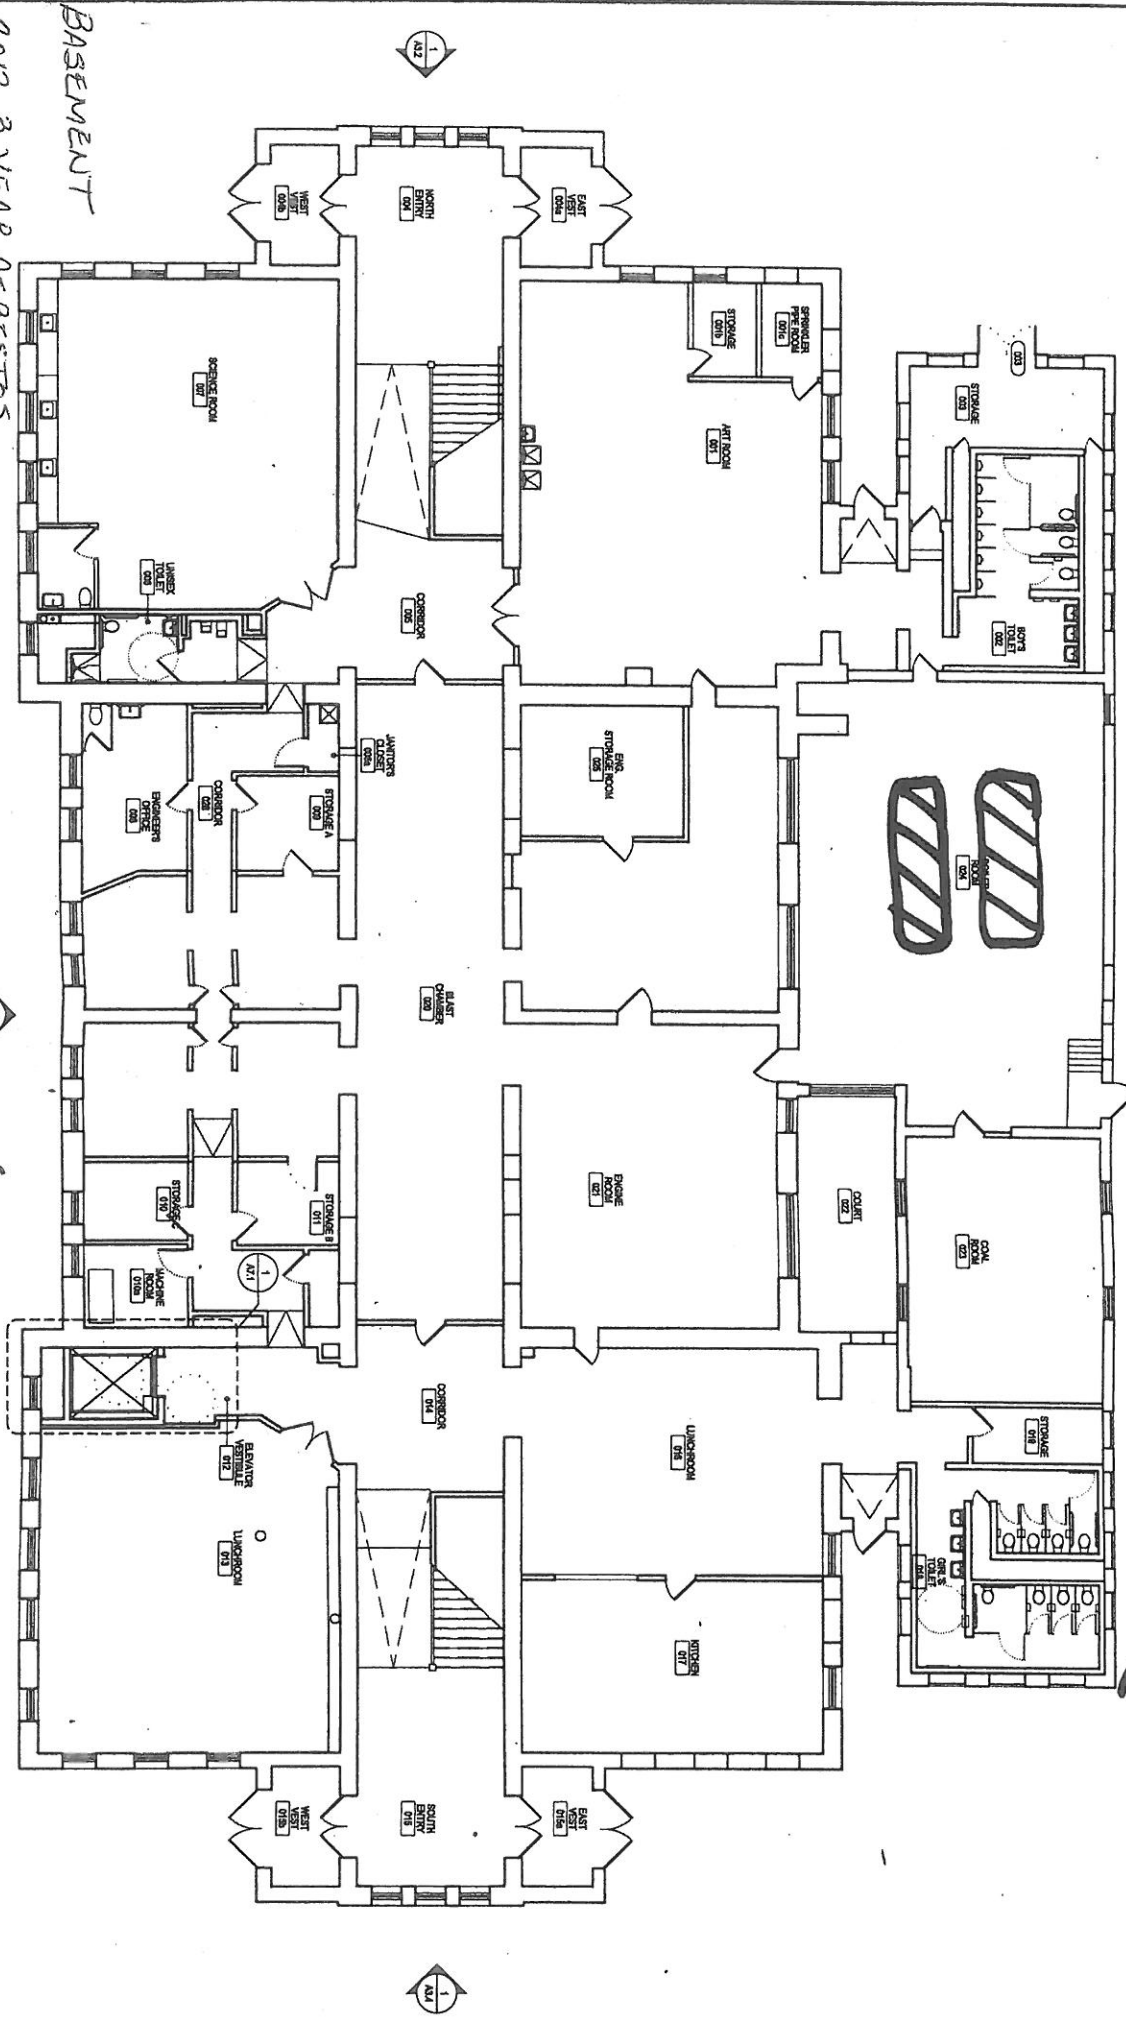
NEW HA # 60

90 S.F. - ON BOILER #1 + BOILER #2 (INTERIOR)

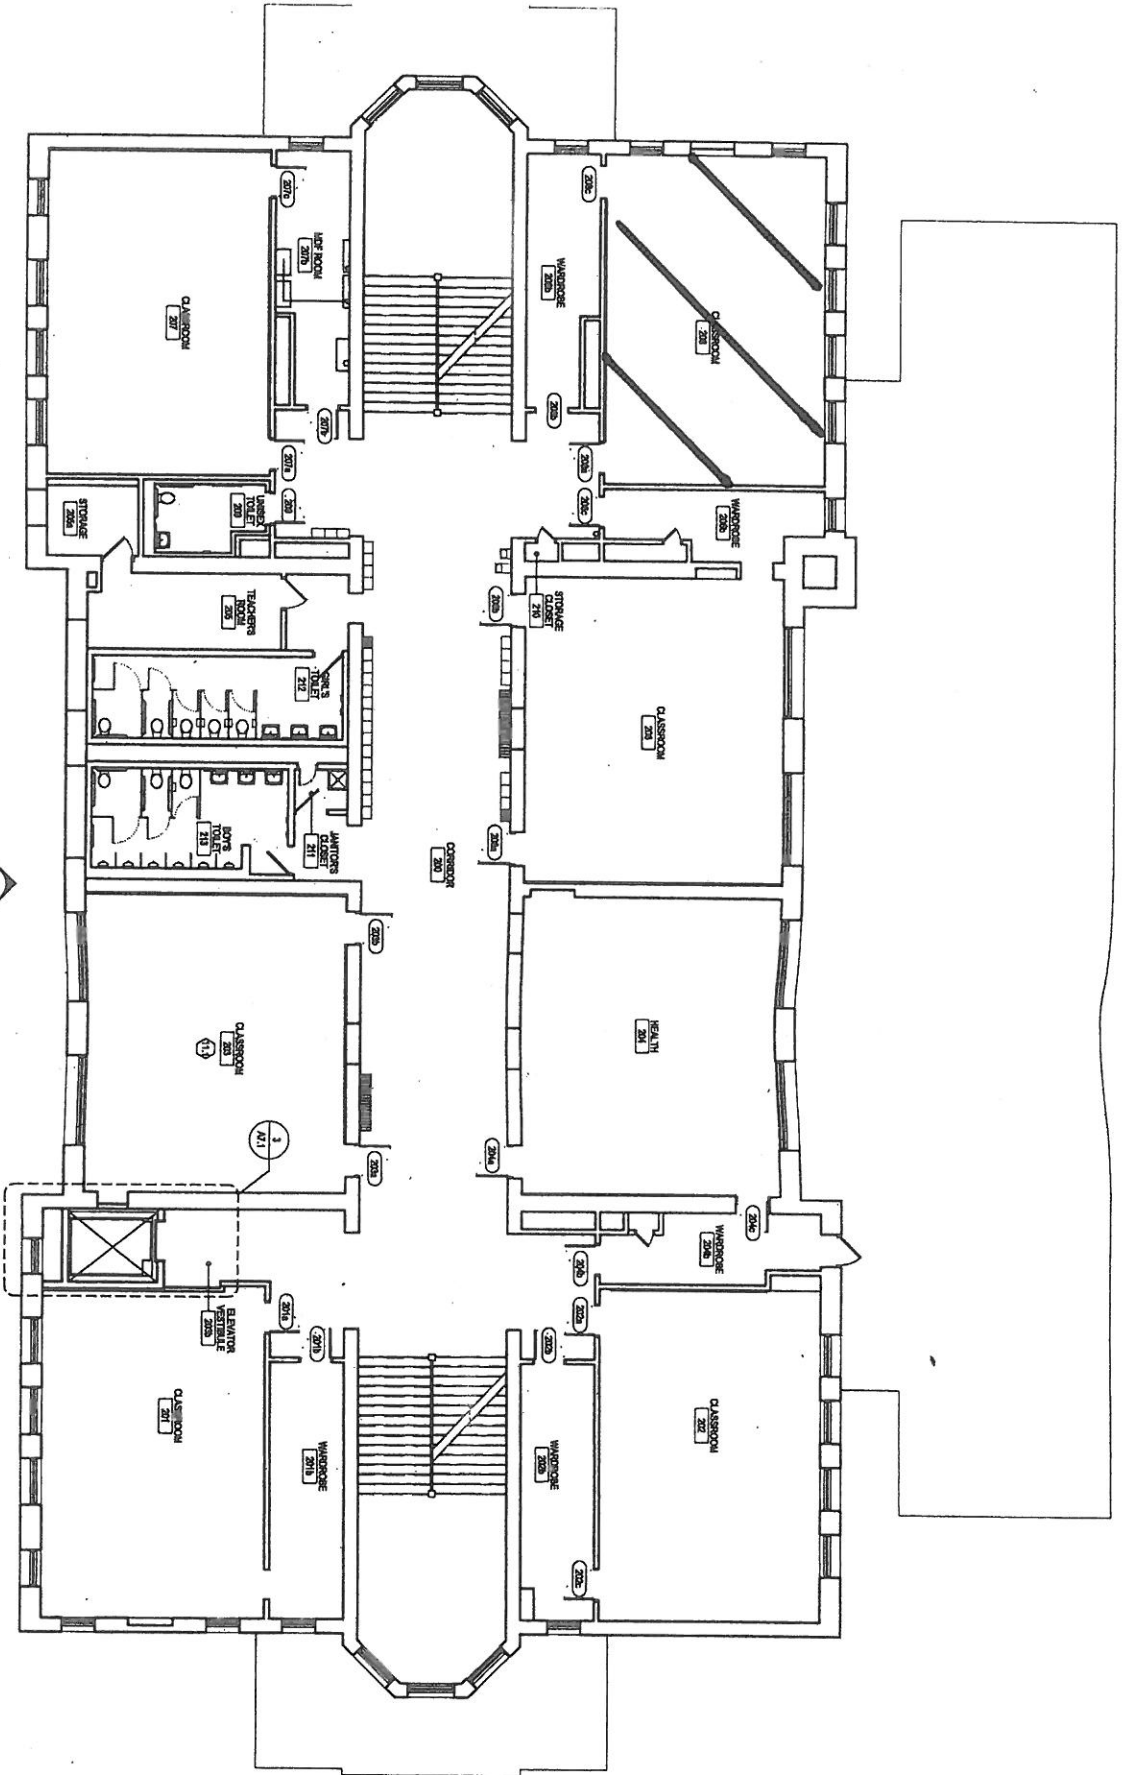
NEW
HA# 46
LAB TABLE TOPS
+ COUNTERTOPS
