**ILLINOIS DEPARTMENT OF PUBLIC HEALTH
AHERA THREE YEAR REINSPECTION
ASBESTOS ABATEMENT PROGRAM
SCHOOL INFORMATION FORM**

THREE-YEAR REINSPECTION

Avalon Park School

Friday, March 29, 2013

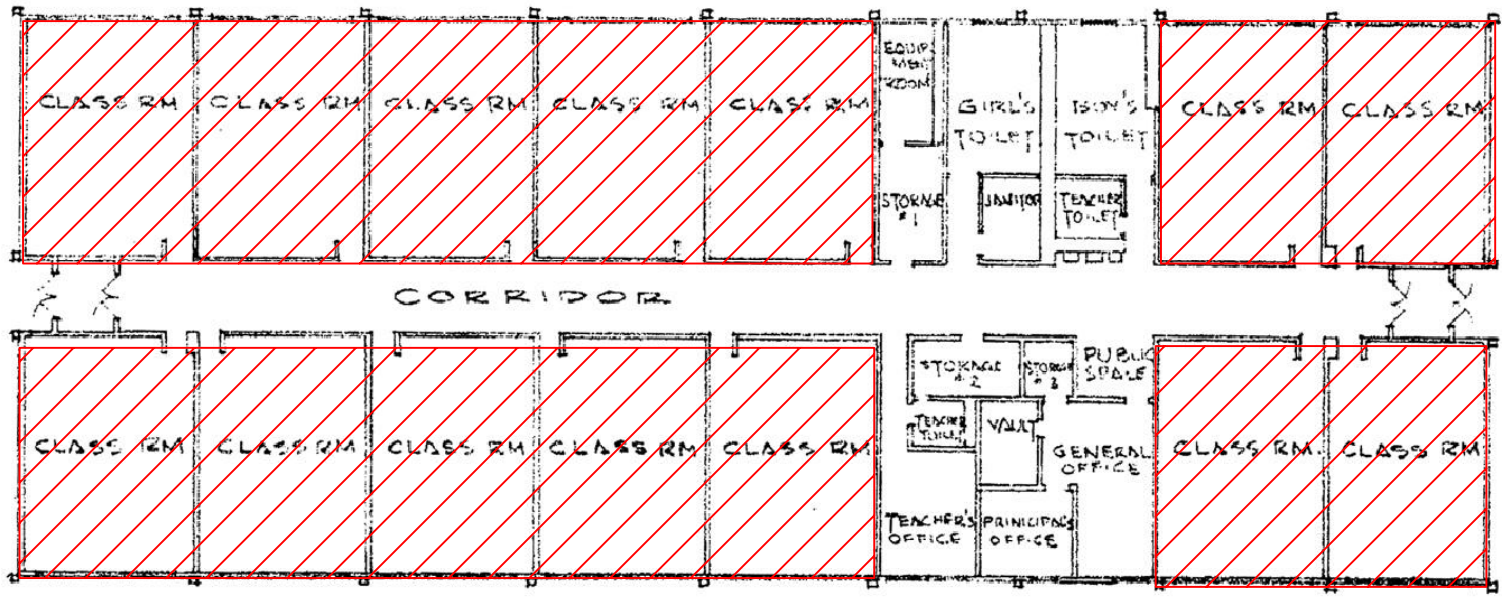
KCPSS 08112013 Three Year Asbestos Reinspection Region 5-Avalon Park School-Avalon Park Annex First Flooring

HA-AA 12"x 12" Light Blue Floor Tile

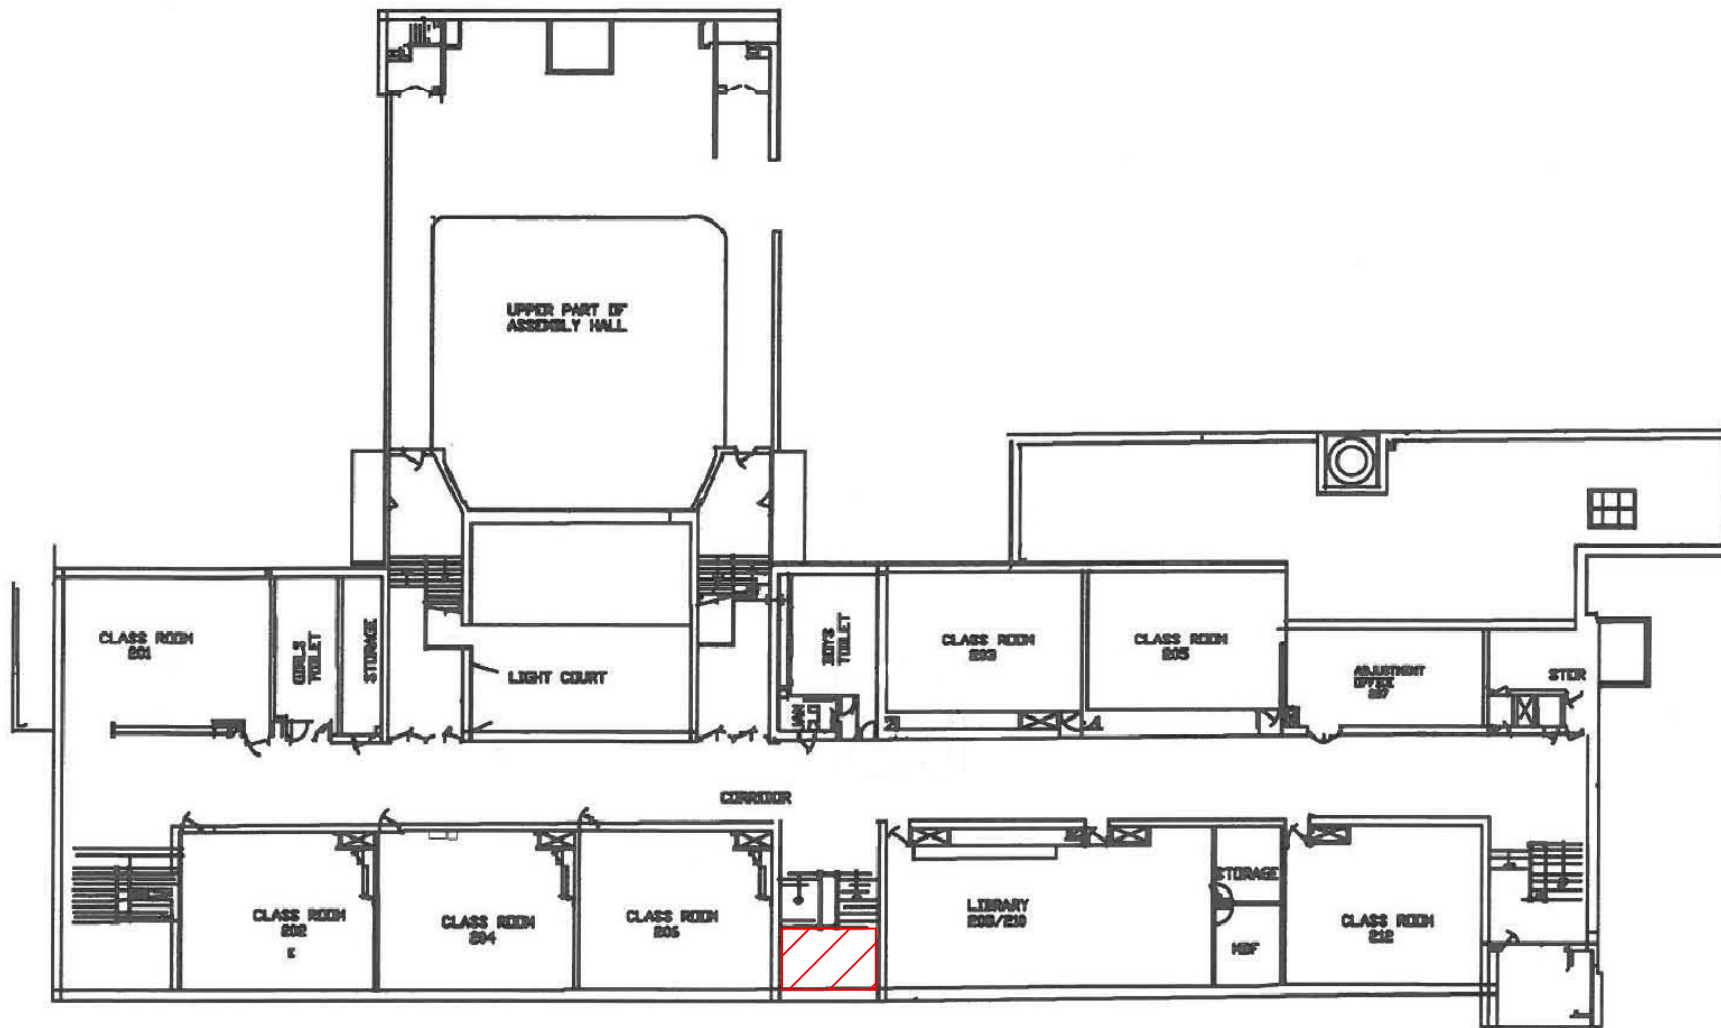
K:\CPS 2011\2013 Three Year\Avalon Park School\Avalon Park Main Bldg Second Floor.dwg

HA-AB 12"x 12" Tan with Speckles Floor Tile
