**ILLINOIS DEPARTMENT OF PUBLIC HEALTH
AHERA THREE YEAR REINSPECTION
ASBESTOS ABATEMENT PROGRAM
SCHOOL INFORMATION FORM**

THREE-YEAR REINSPECTION

Beaubien School

Friday, May 10, 2013

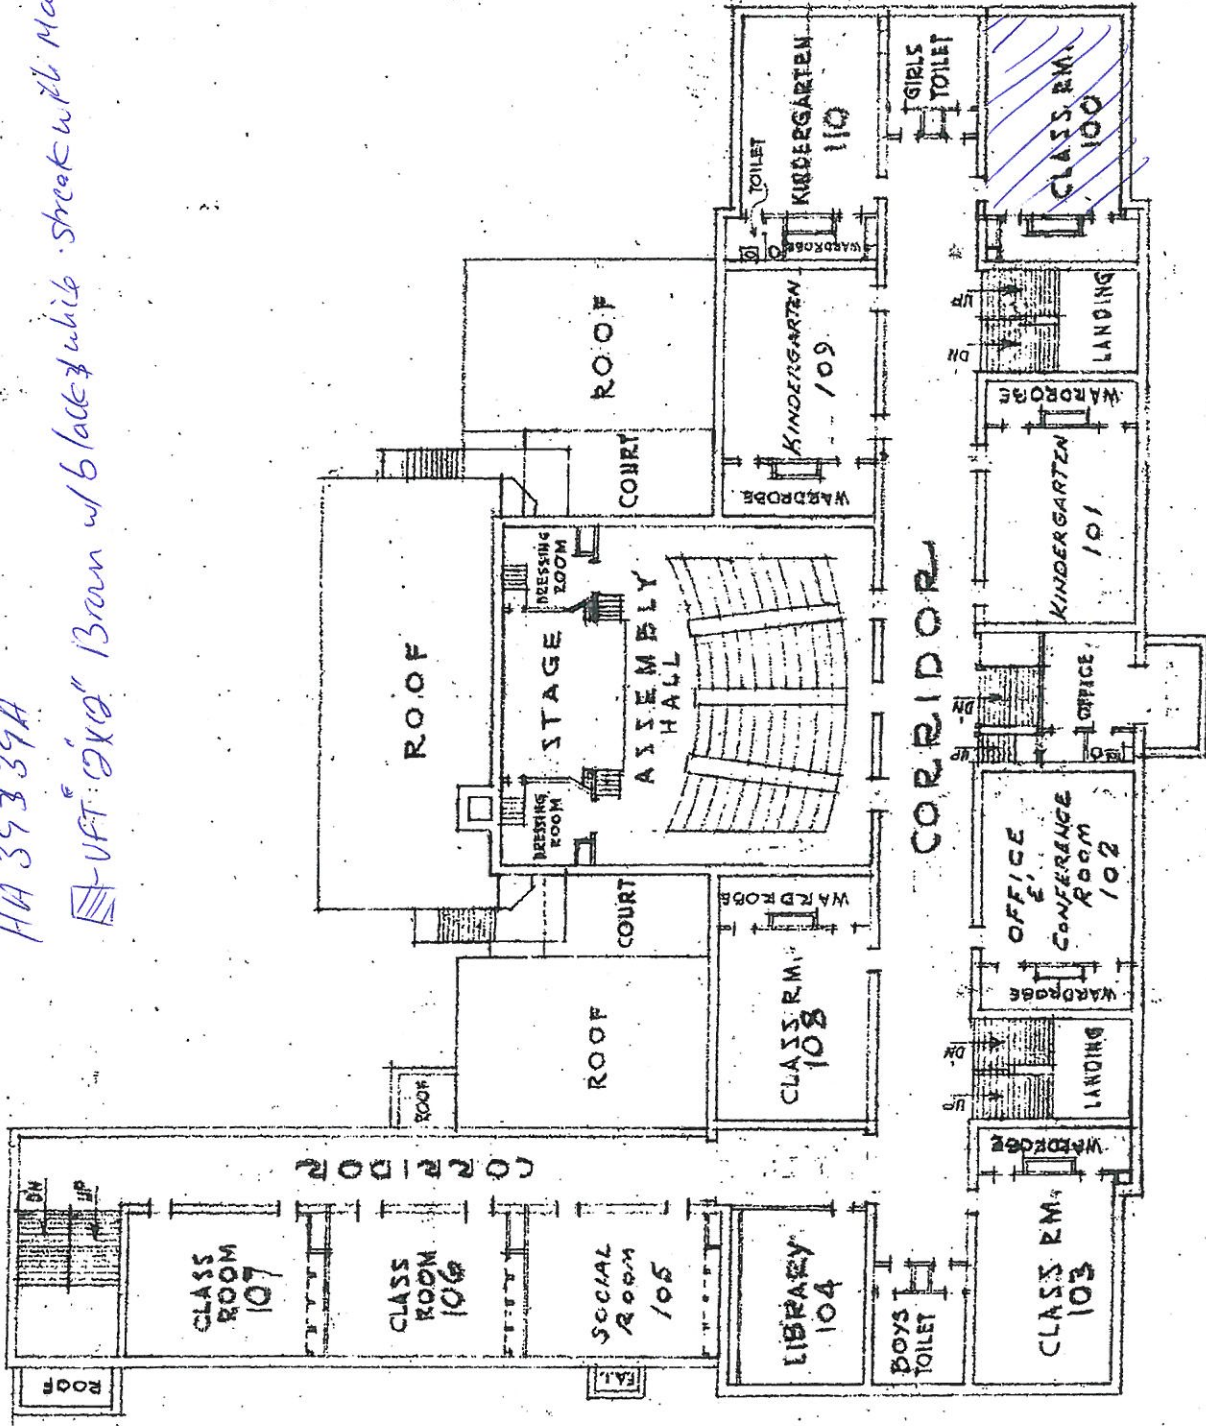
HA 39339A

| HA No | Material Description | Material Quantity | Material Units | Material Location | Asbestos Type | Material Category | Friable | Damage Type | Damage Quantity | Damage Units | Change in Assessment Category | Damage Category | Damage Reason | Disturbance Potential |
|---|---|---|---|--|---|---|---|---|---|---|---|---|---|---|
| 39 | 12"x12" Brown w/ black and white streaks VFT | 900 | SF | Room 100 | ASSUMED | MISC | N | NONE | 0 | | | ACBM with the potential for damage | | LOW |
| 39A | 12"x12" Brown w/ black and white streaks VFT MASTIC | 900 | SF | Room 100 | ASSUMED | MISC | N | NONE | 0 | | | ACBM with the potential for damage | | LOW |

UFT 2'x2' Bran w/ black & white streak w/ Mashic

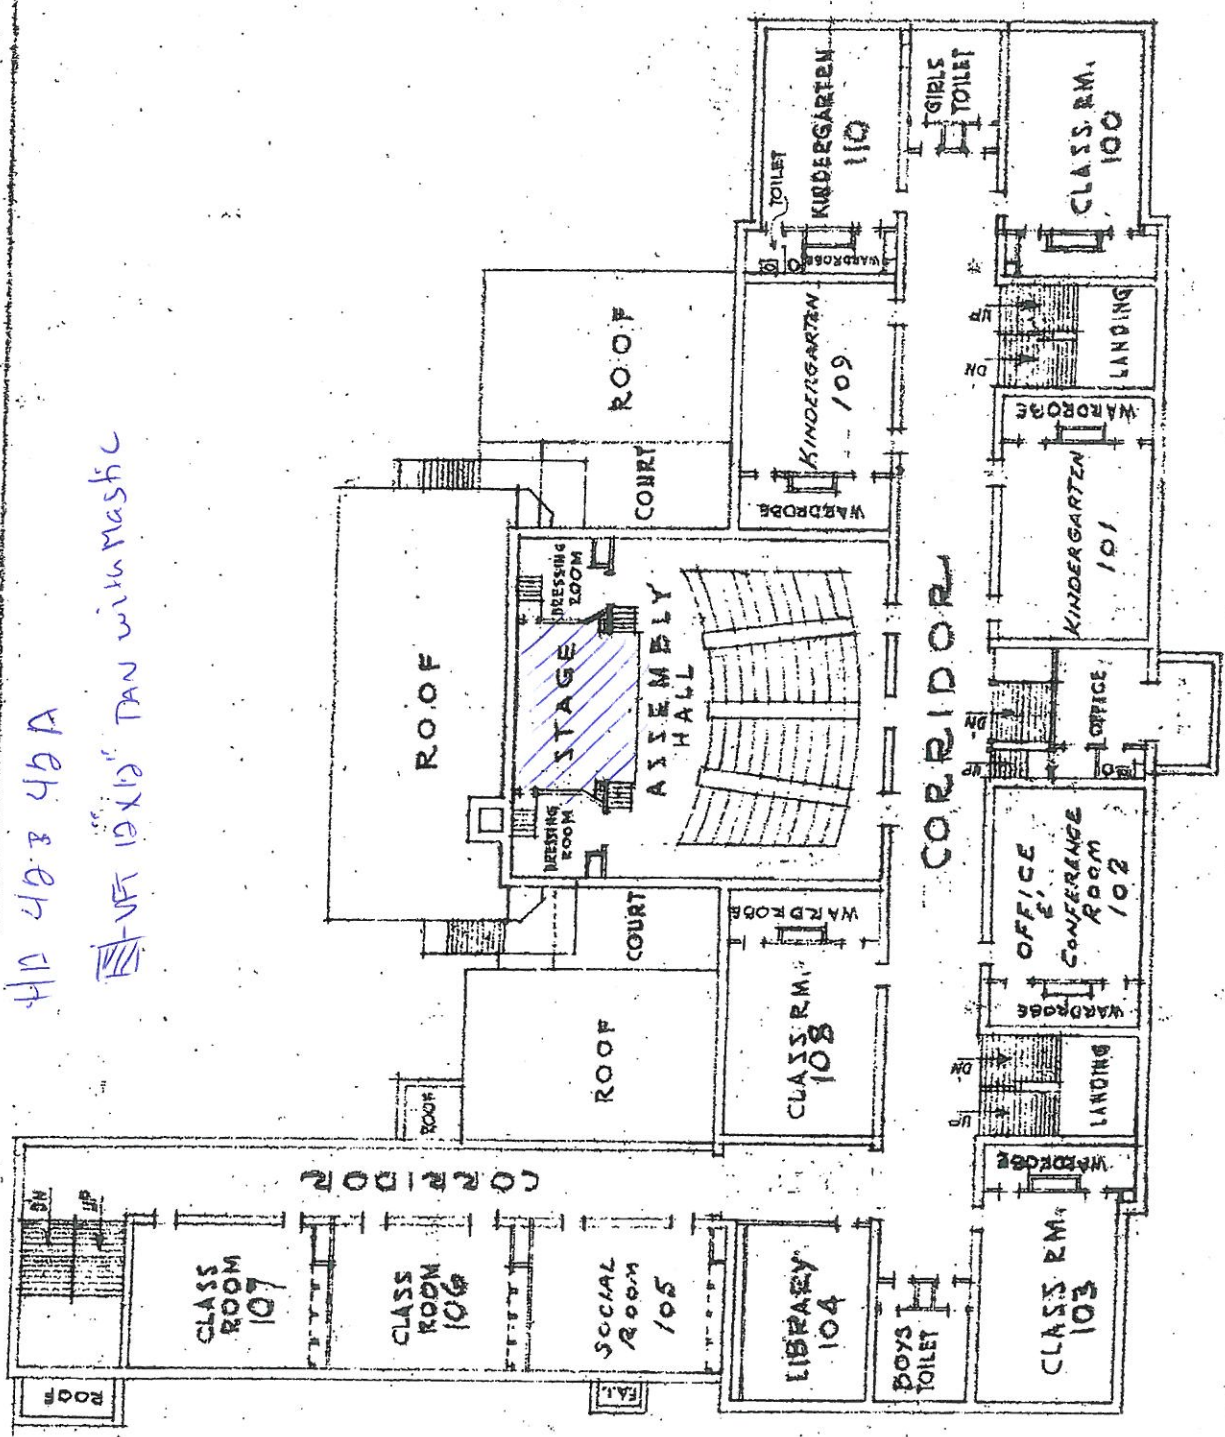
410 403 40A

| HA No | Material Description | Material Quantity | Material Units | Material Location | Asbestos Type | Material Category | Friable | Damage Type | Damage Quantity | Damage Units | Change in Assessment Category | Damage Category | Damage Reason | Disturbance Potential |
|---|---|---|---|--|---|---|---|---|---|---|---|---|---|---|
| 40 | 12"x12" tan w/ brown & white streaks VFT | 1,600 | SF | Lunchroom | ASSUMED | MISC | N | LOC | 7 | | | ACBM with the potential for damage | | LOW |
| 40A | 12"x12" Tan w/ brown & white VFT MASTIC | 1,600 | SF | Lunchroom | ASSUMED | MISC | N | NONE | 0 | | | ACBM with the potential for damage | | LOW |

1/2" VFT 10' X 12" TAN with Mastic

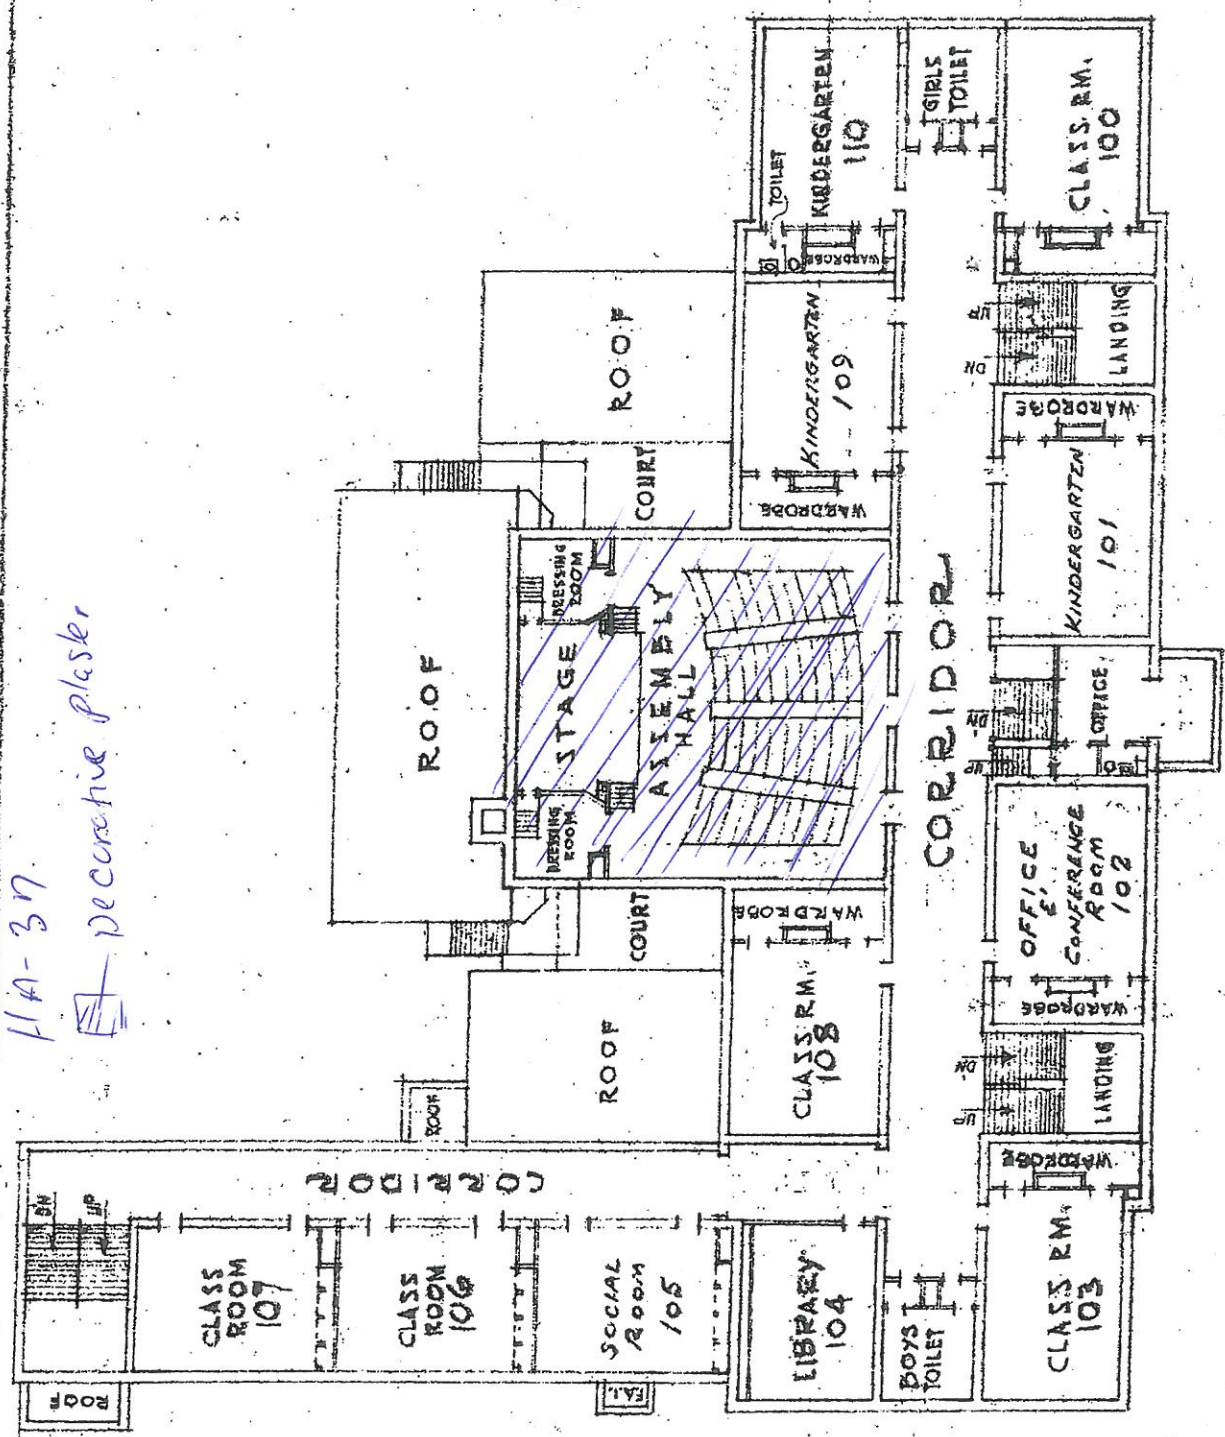
HA-317
Decorative plaster

| HA No | Material Description | Material Quantity | Material Units | Material Location | Asbestos Type | Material Category | Friable | Damage Type | Damage Quantity | Damage Units | Change in Assessment Category | Damage Category | Damage Reason | Disturbance Potential |
|---|---|---|---|--|---|---|---|---|---|---|---|---|---|---|
| 37 | Decorative plaster | 1,800 | SF | Auditorium, stage, balcony, assembly hall | ASSUMED | MISC | N | NONE | 0 | | | ACBM with the potential for damage | | LOW |

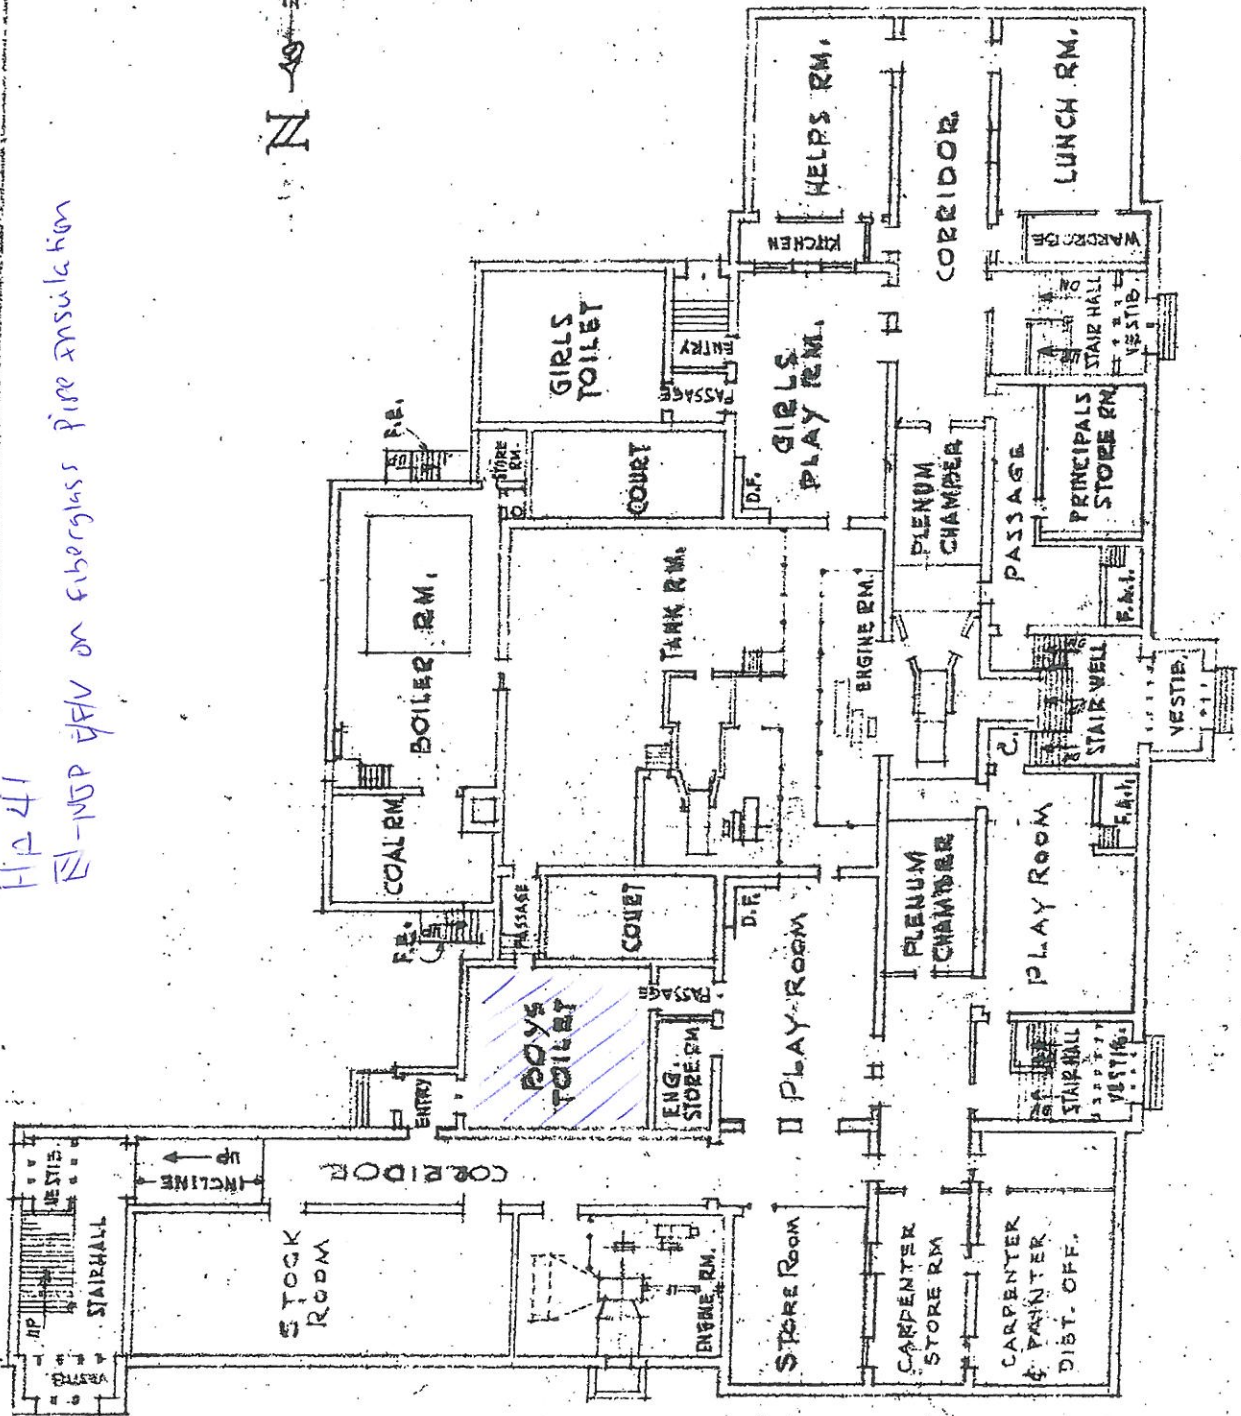
H/A 41
NIP FAV on fiberglass pipe insulation

| HA No | Material Description | Material Quantity | Material Units | Material Location | Asbestos Type | Material Category | Friable | Damage Type | Damage Quantity | Damage Units | Change in Assessment Category | Damage Category | Damage Reason | Disturbance Potential |
|---|---|---|---|--|---|---|---|---|---|---|---|---|---|---|
| 41 | MJP E/F/V on fiberglass pipe insulation | 12 | LF | Basement Boys' toilet | ASSUMED | TSI | Y | LOC | 7 | | | Damaged or significantly damaged friable thermal system insulating ACBM | 5 | MODERATE |

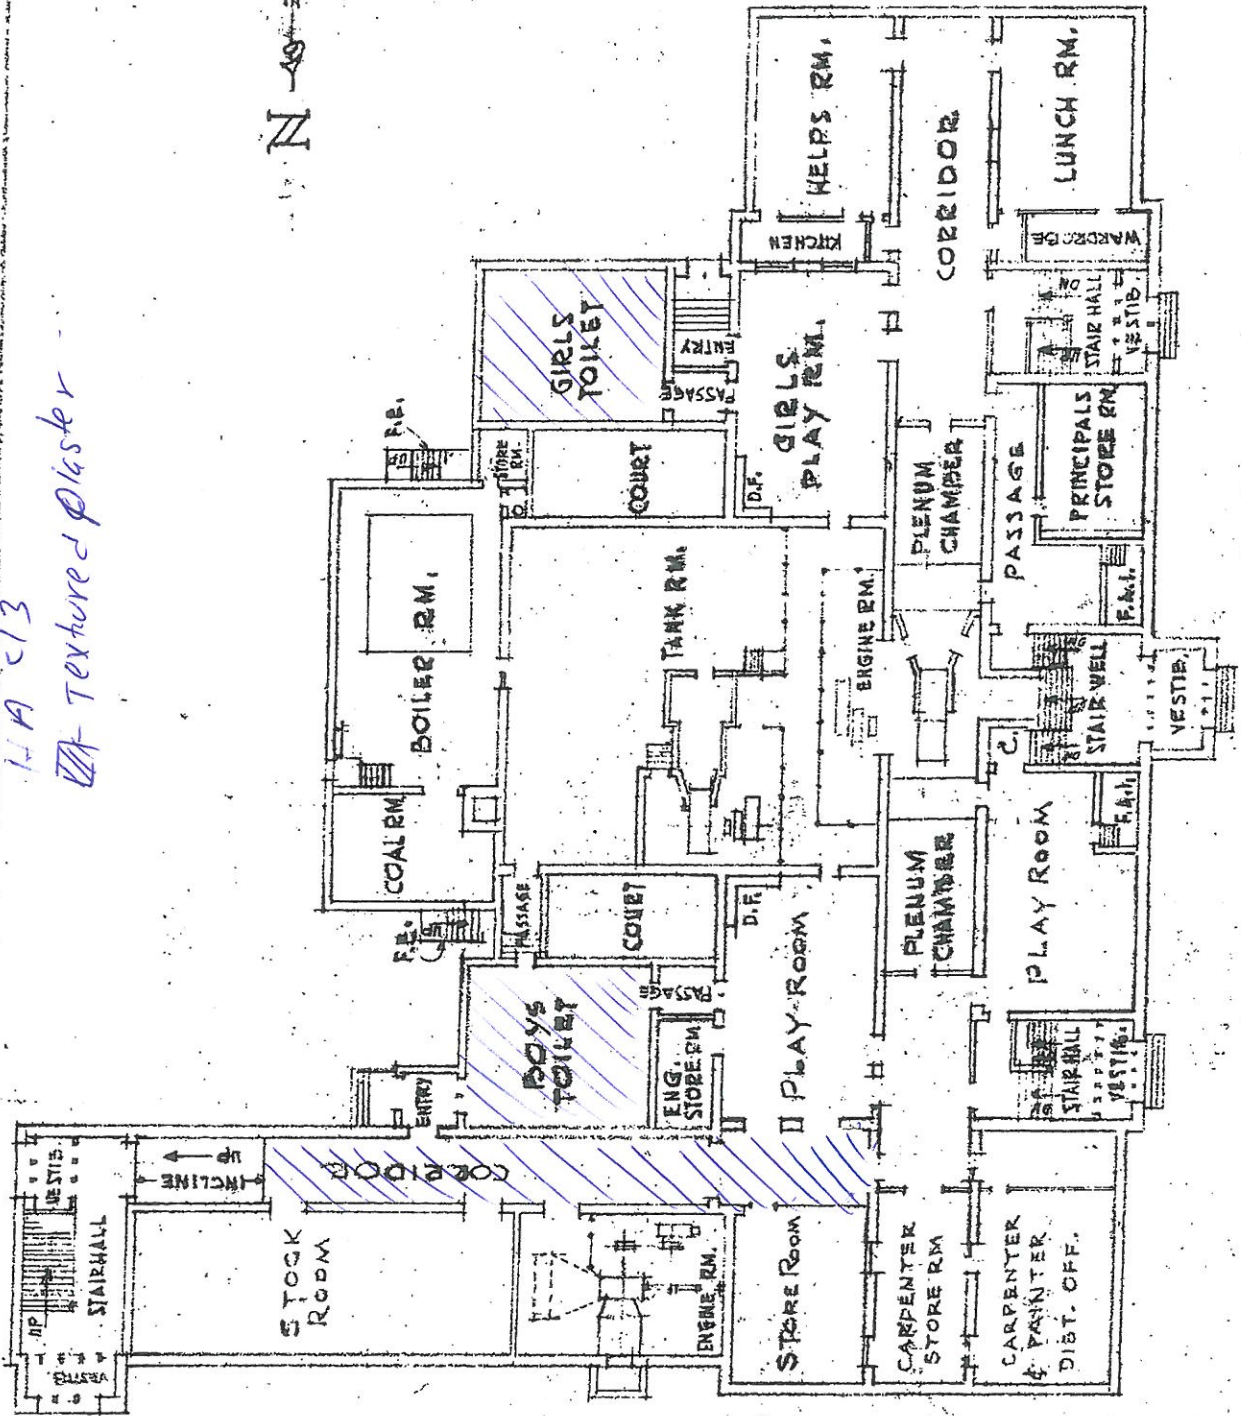
1-A C13
A Textured Plaster

| HA No | Material Description | Material Quantity | Material Units | Material Location | Asbestos Type | Material Category | Friable | Damage Type | Damage Quantity | Damage Units | Change in Assessment Category | Damage Category | Damage Reason | Disturbance Potential |
|---|---|---|---|--|---|---|---|---|---|---|---|---|---|---|
| 43 | Textured plaster | 1,600 | SF | Basement corridor from carpenter room - stockroom. Boys' and girls' toilets | ASSUMED | MISC | N | NONE | 0 | | | ACBM with the potential for damage | | LOW |

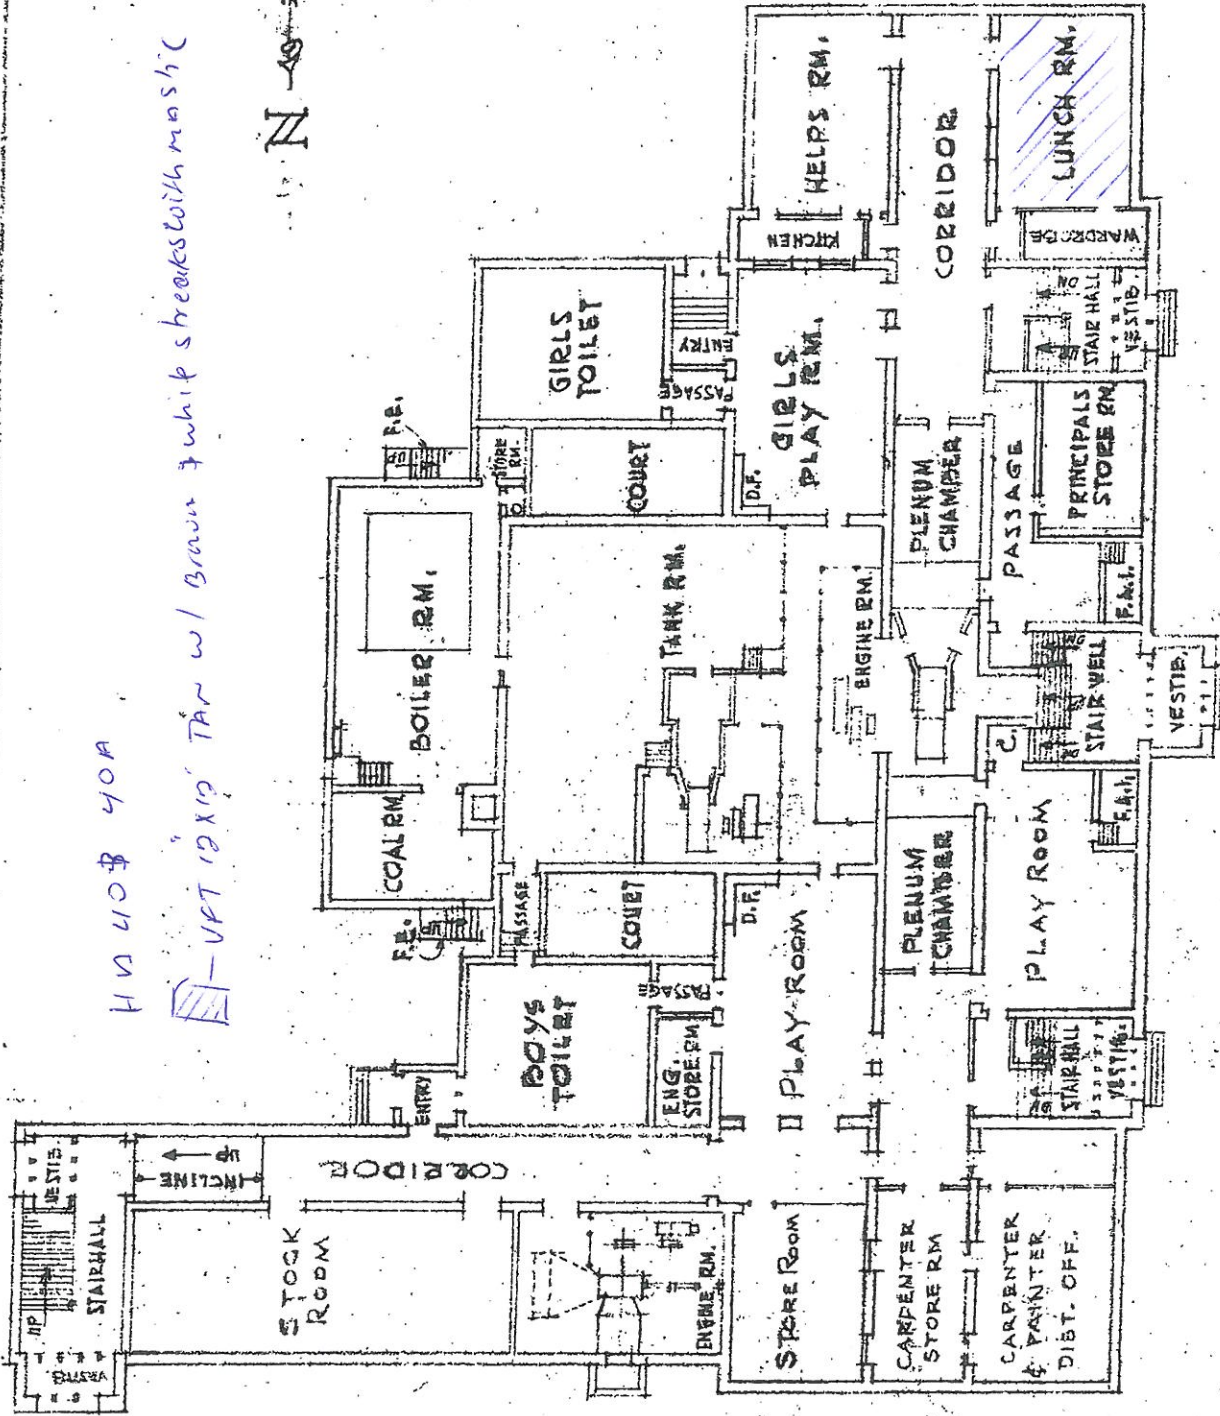
HN 408 40A

UFT 12X12 TAN w/ Brown & white streak with mastic

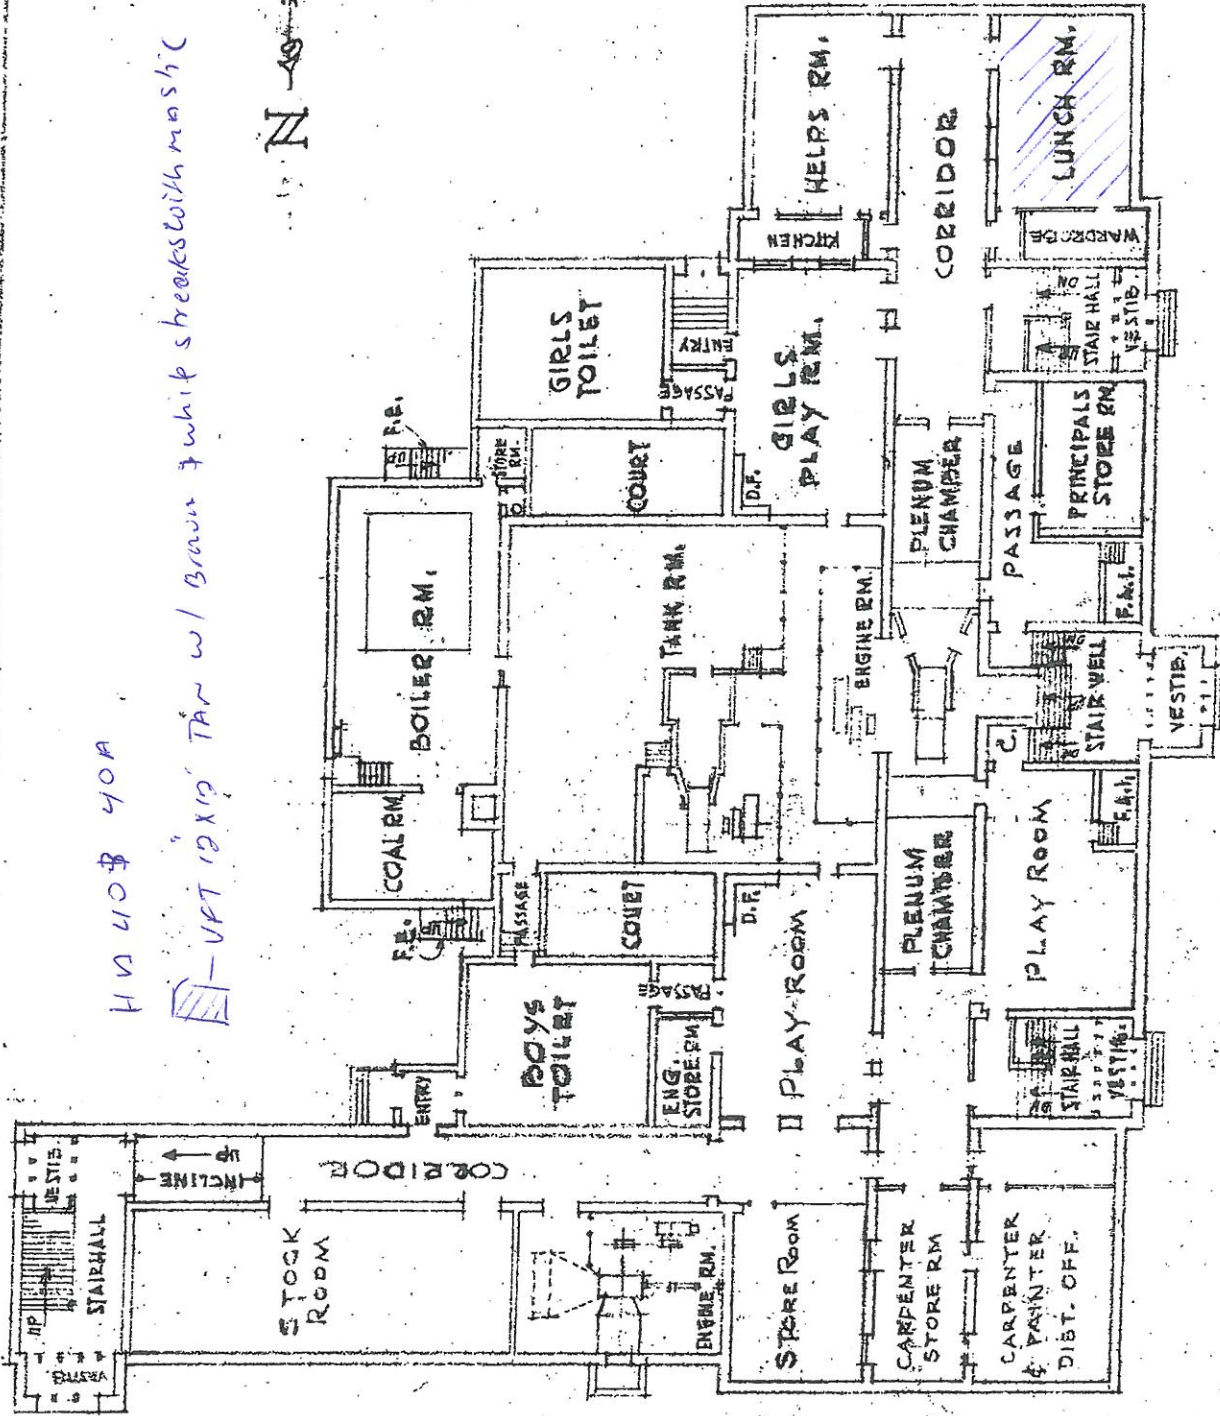
HN 408 40A

UFT 12X12 TAN w/ Brown & white streak with mastic

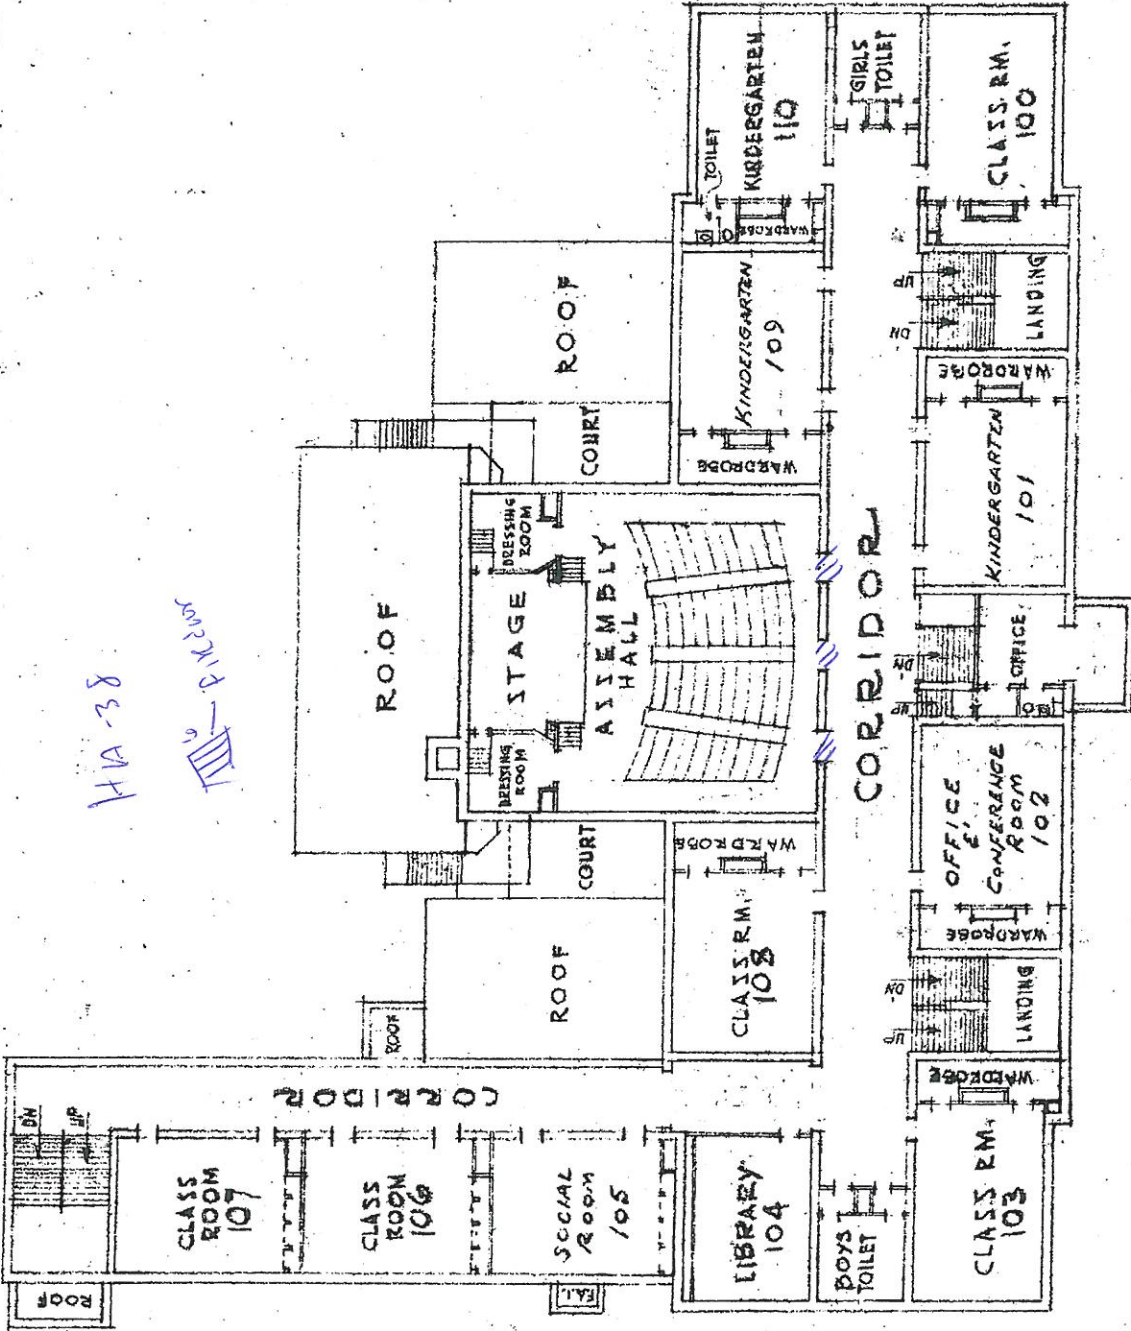
HA-38

| HA No | Material Description | Material Quantity | Material Units | Material Location | Asbestos Type | Material Category | Friable | Damage Type | Damage Quantity | Damage Units | Change in Assessment Category | Damage Category | Damage Reason | Disturbance Potential |
|---|---|---|---|--|---|---|---|---|---|---|---|---|---|---|
| 38 | Fire doors | 8 | EA | Balcony, assembly hall | ASSUMED | MISC | N | NONE | 0 | | | ACBM with the potential for damage | | LOW |

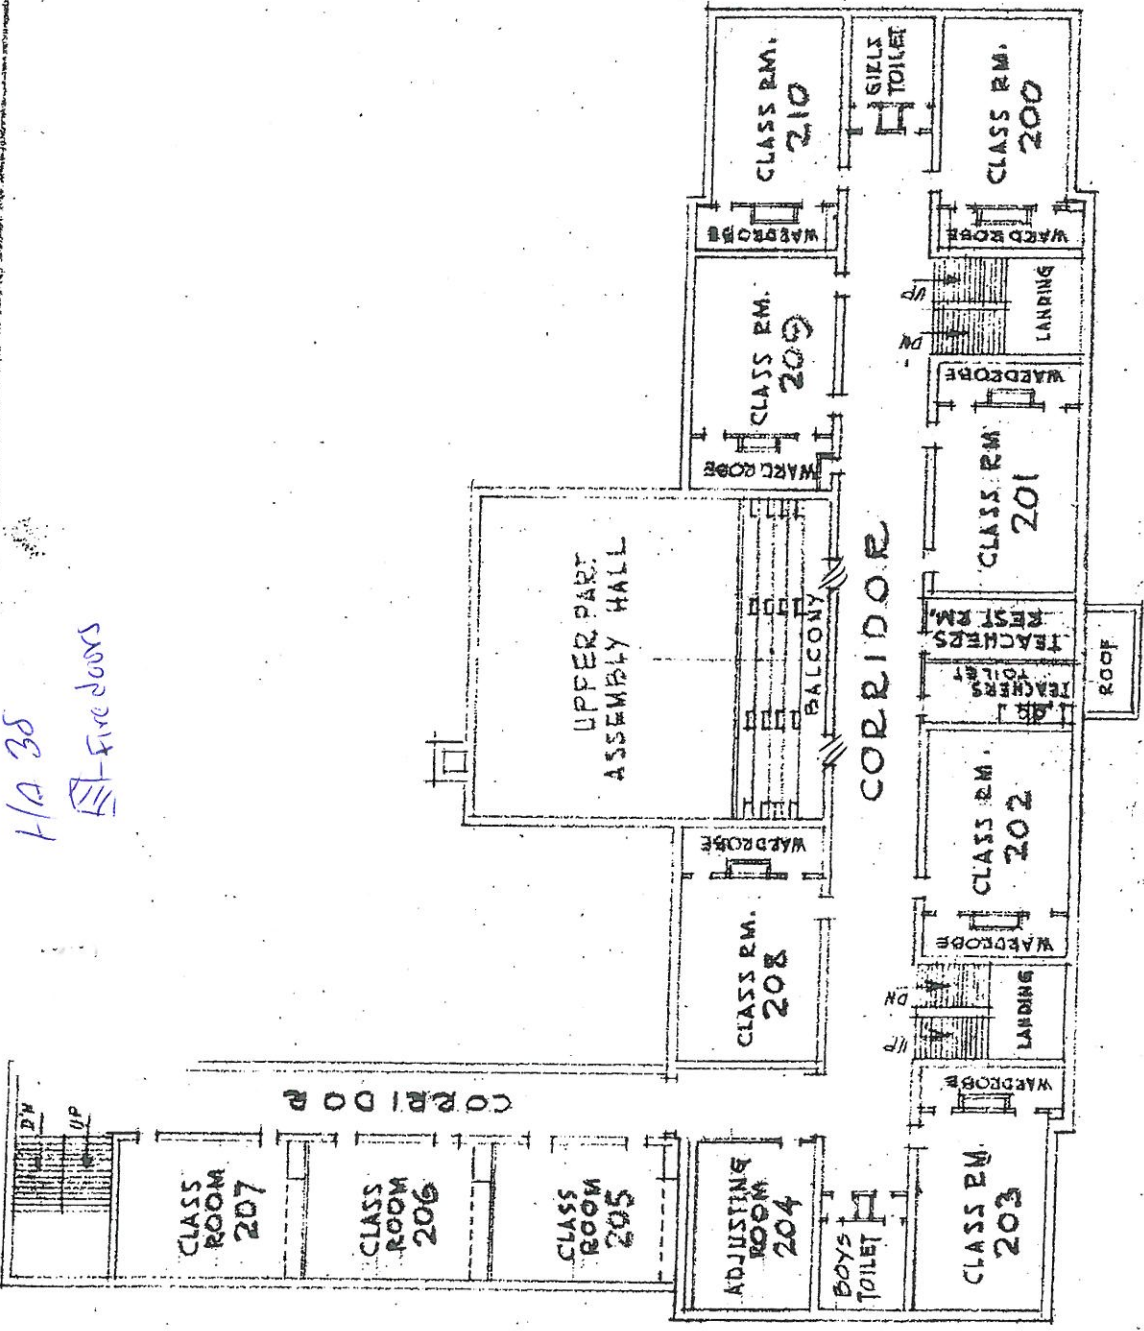
HA 38

Fire doors

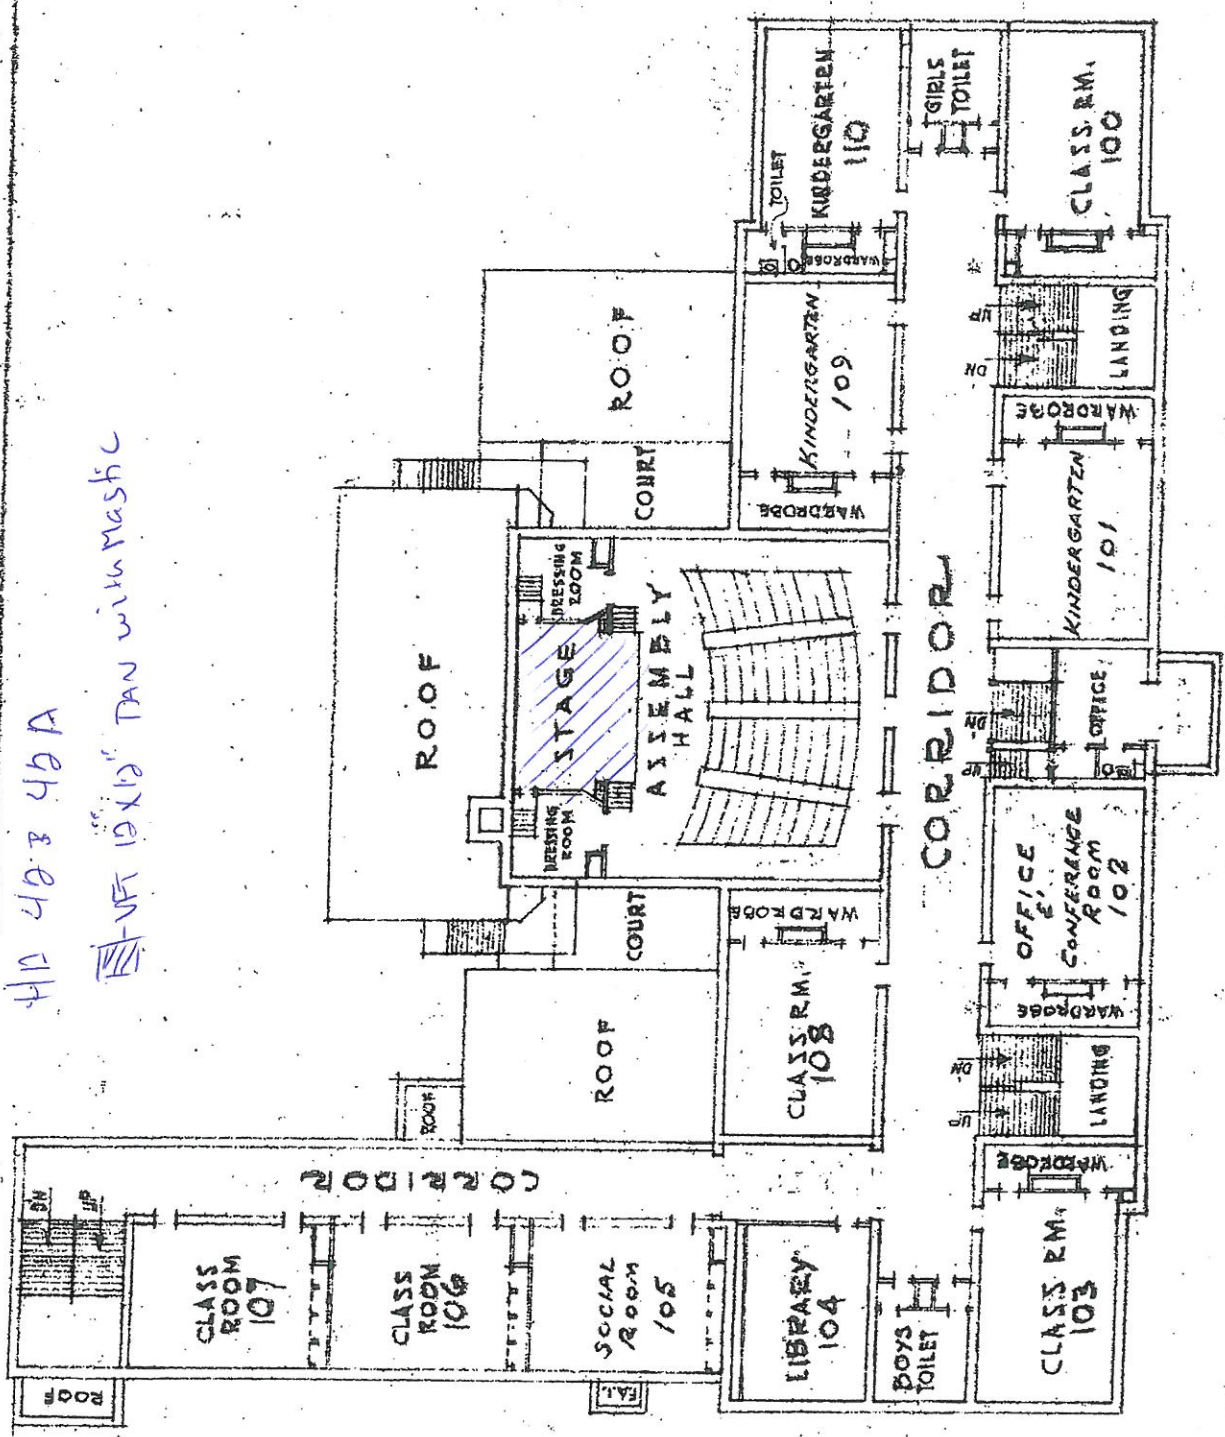
410 403 40A

1/2" VFT 10' X 12" TAN with Mastic

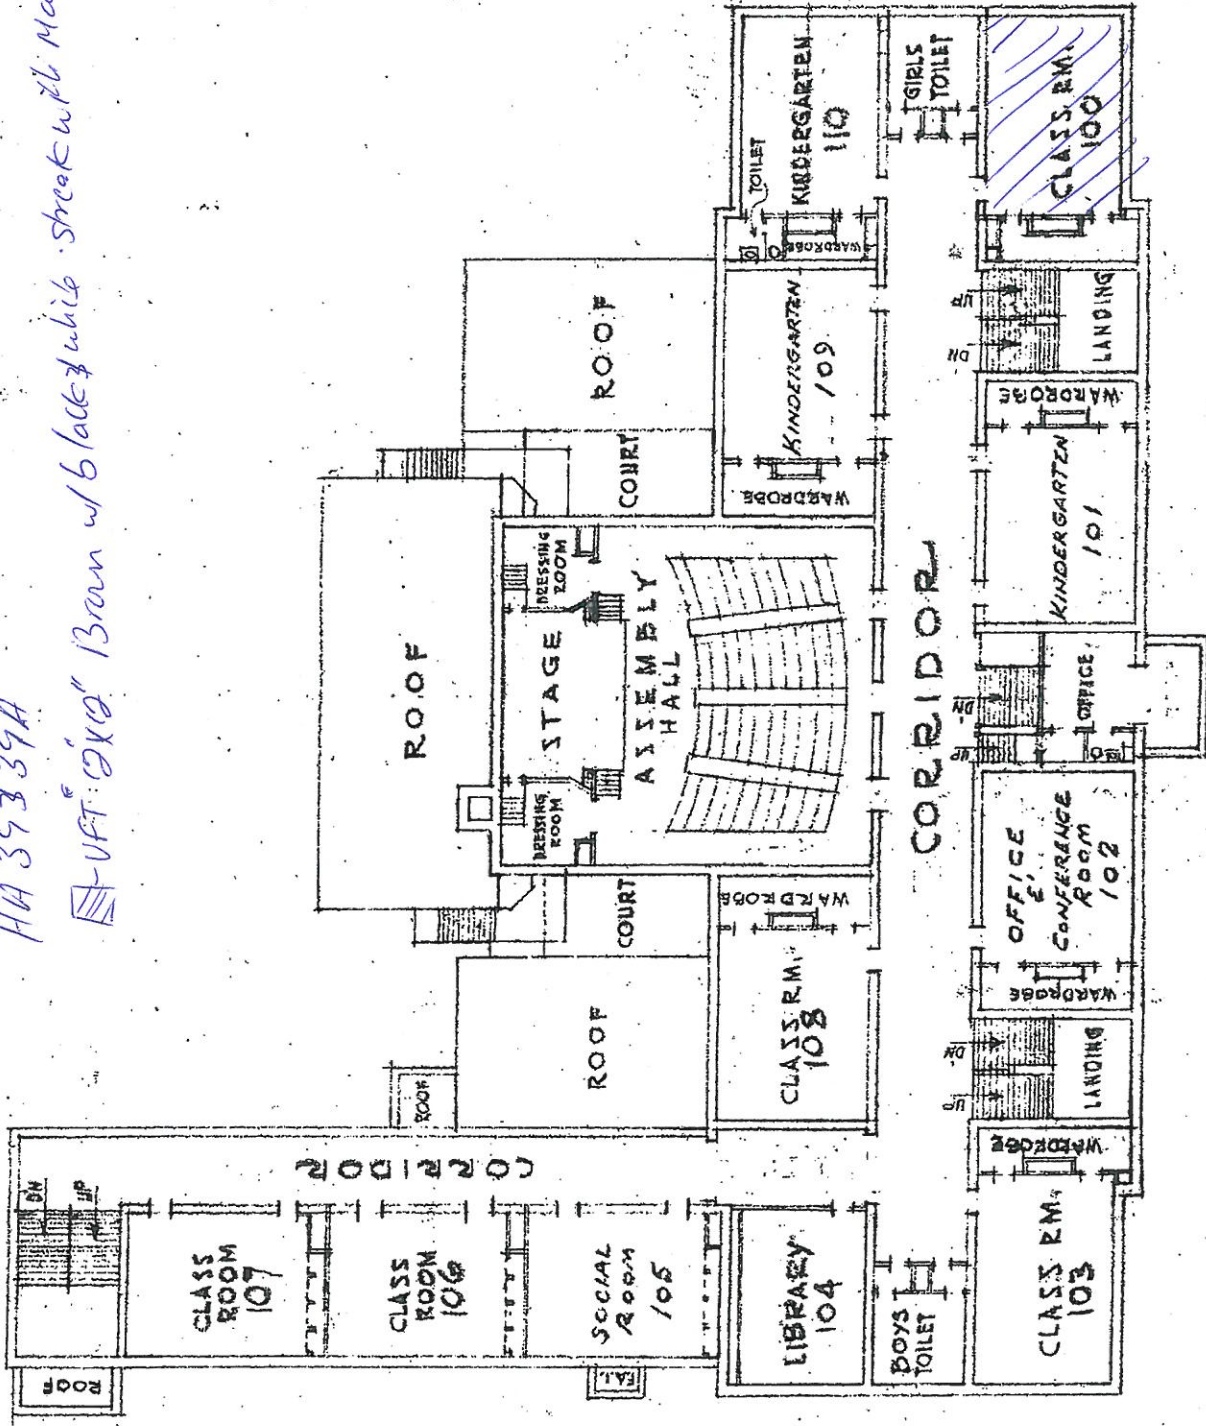
HA 39339A

UFT 2'x2' Bran w/ black & white streak w/ Mashic
