**ILLINOIS DEPARTMENT OF PUBLIC HEALTH
AHERA THREE YEAR REINSPECTION
ASBESTOS ABATEMENT PROGRAM
SCHOOL INFORMATION FORM**

THREE-YEAR REINSPECTION

Bell School

3730 N Oakley Avenue
Chicago, IL, 60618

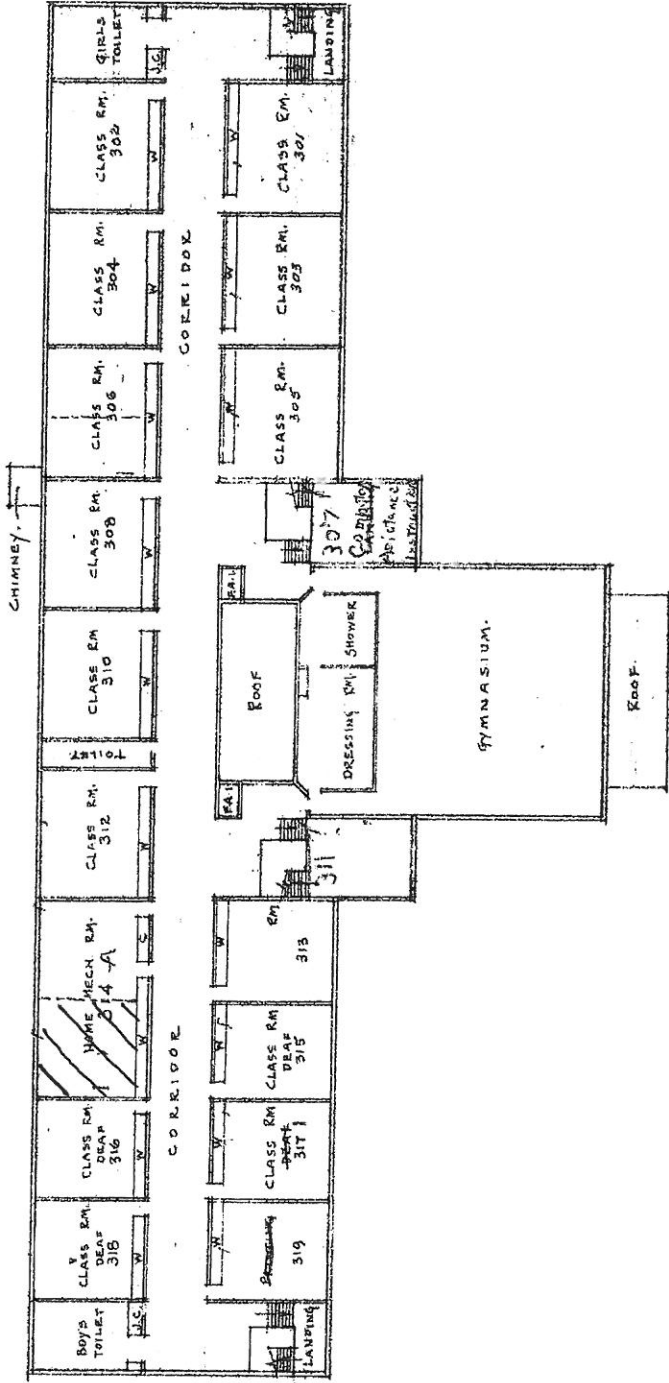
THIRD FLOOR PLAN
 SCALE 1"=40'-0"
 ALEXANDER GRAHAM BELL SCHOOL
 OAKLEY AVE. GRACE ST & WAVELAND AVE

HA # 31
 12"X12" Light beige w/ beige & white streaks vft
 HA # 31A
 MASTIC

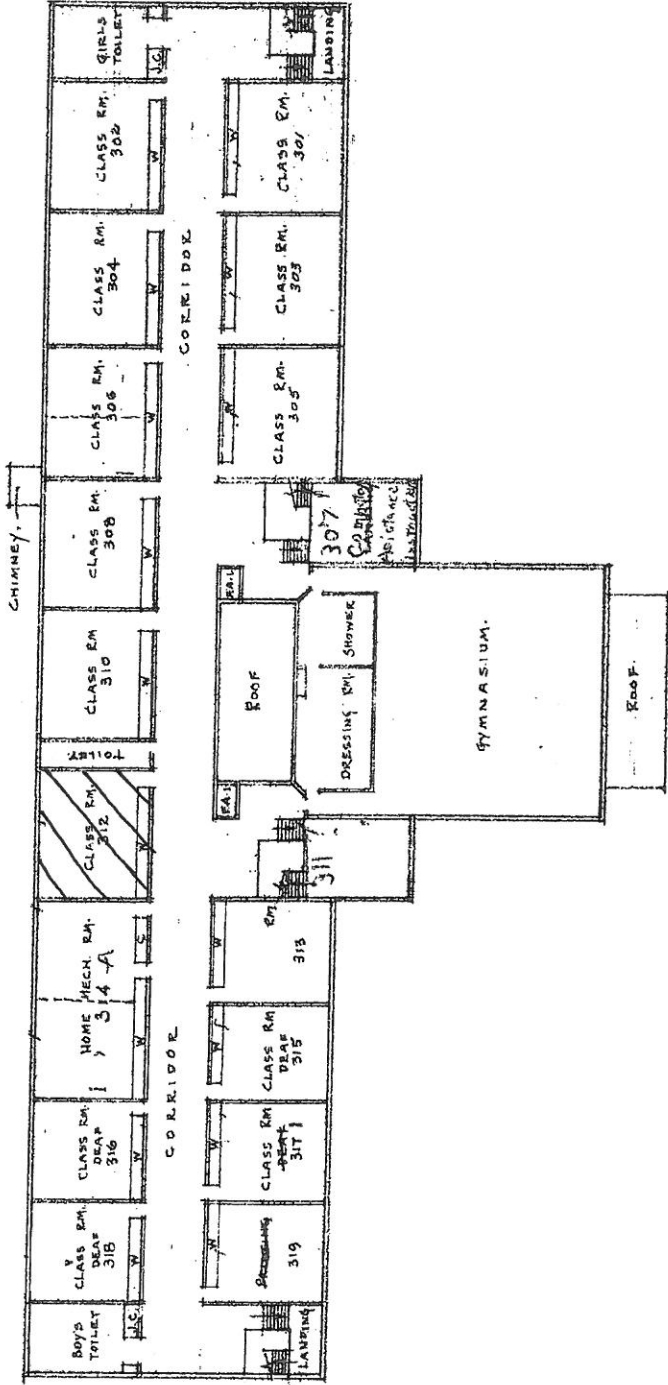
THIRD FLOOR PLAN
 SCALE 1" = 40'-0"
 ALEXANDER GRAHAM BELL SCHOOL
 OAKLEY AVE. GRACE ST & WAYLAND AVE

HA # 32
 12" X 12" White w/ black specks VFT and
 HA # 32 A
 MASTIC

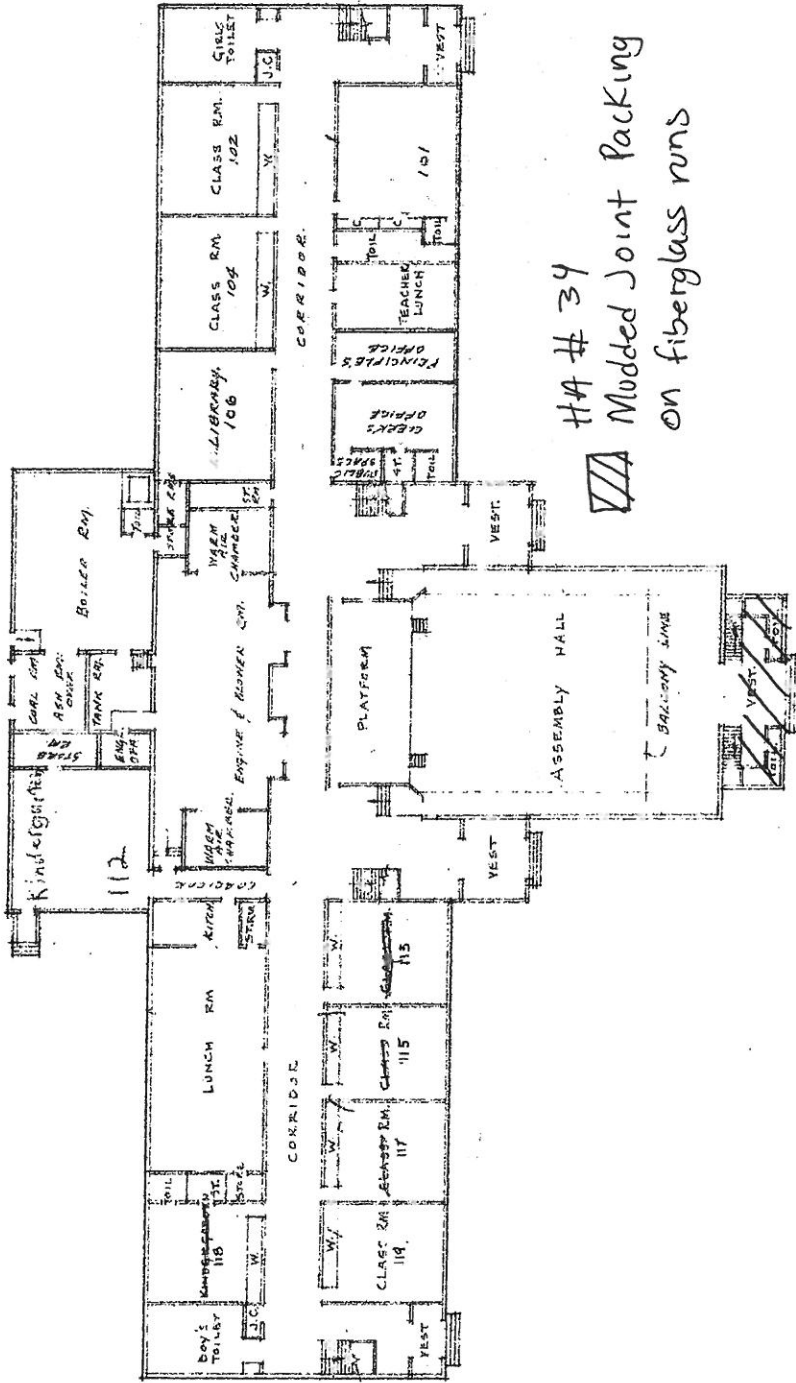
FIRST FLOOR PLAN
 SCALE 1/4" = 1'-0"
 ALEXANDER GRAHAM BELL SCHOOL
 OAKLEY AVE. GEORGE ST & WAVELAND AVE.

HA # 34
 Mud Joint Packing (MJP)
 on fiberglass runs

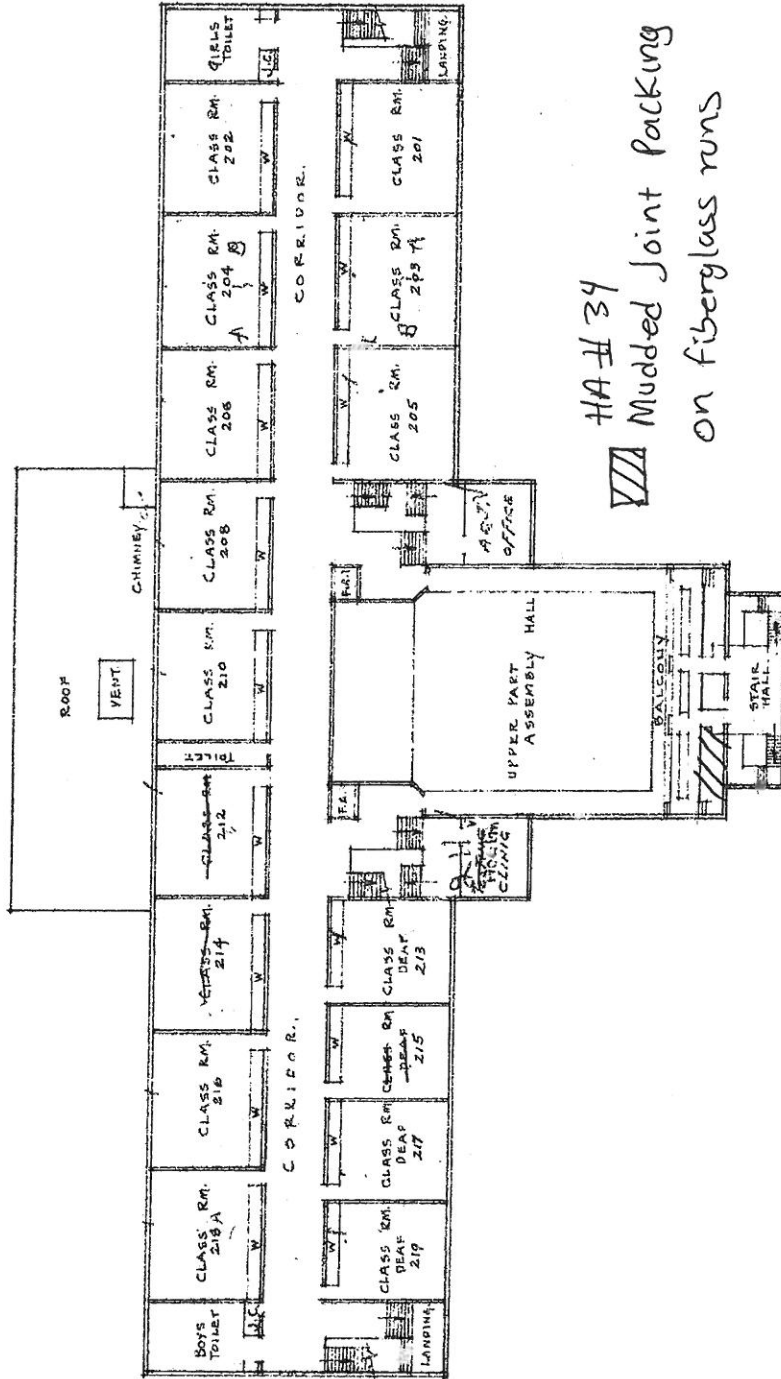
SECOND FLOOR PLAN
 SCALE 1/4" = 1'-0"
 ALEXANDER GRAHAM BELL SCHOOL
 OAKLEY AVE. GRACE ST & WAVELAND AVE.

HA # 34
 Mudded Joint Packing (mJP)
 on fiberglass runs

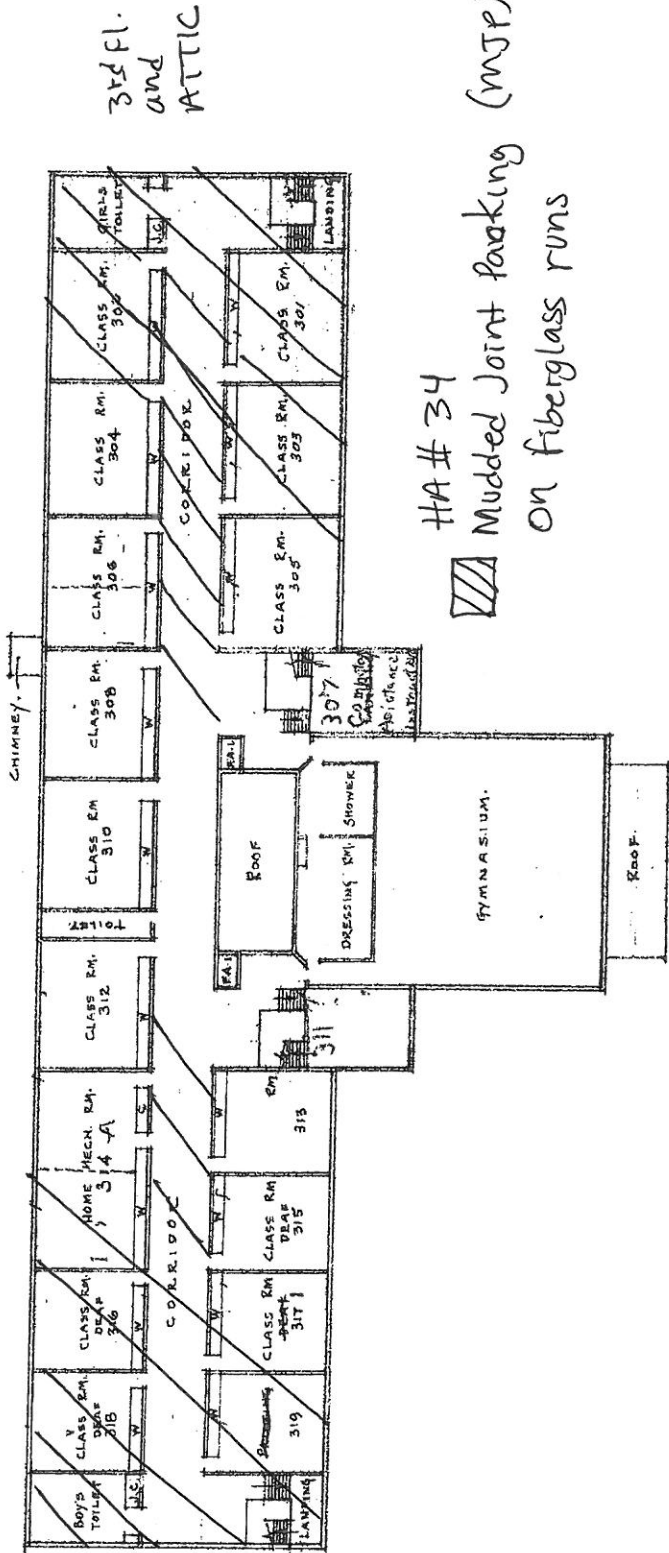
3rd Fl.
and
ATTIC

HA # 34
Mudded Joint Parking (MJP)
on fiberglass runs

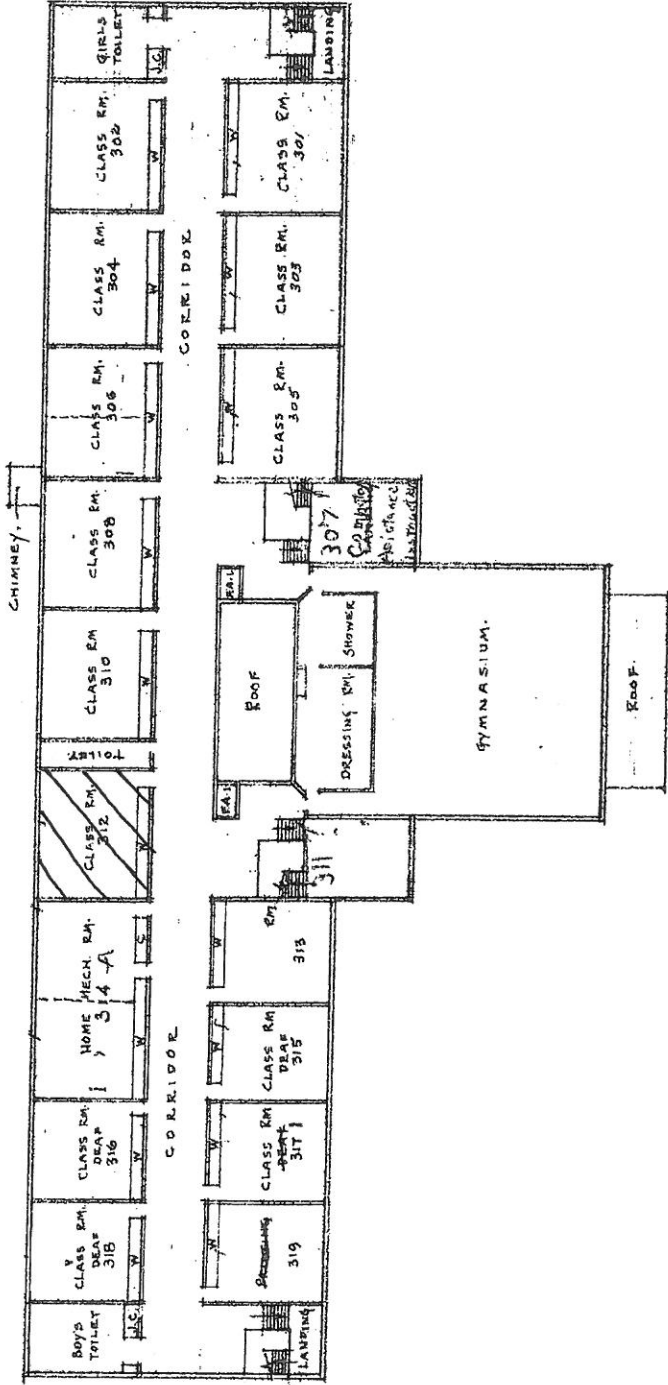
THIRD FLOOR PLAN
 SCALE 1" = 40'-0"
 ALEXANDER GRAHAM BELL SCHOOL
 OAKLEY AVE. GRACE ST & WAVELAND AVE

HA # 32
 12" X 12" White w/ black specks VFT and
 HA # 32 A
 MASTIC

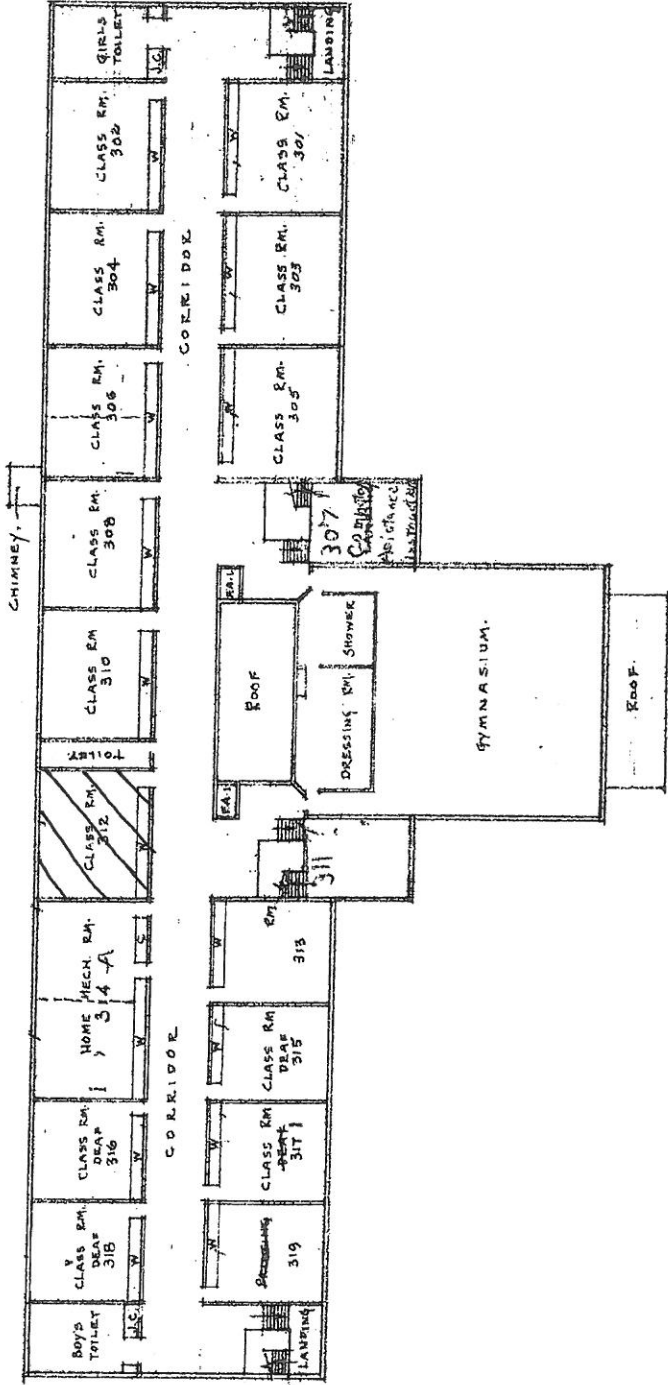
THIRD FLOOR PLAN
 SCALE 1" = 40'-0"
 ALEXANDER GRAHAM BELL SCHOOL
 OAKLEY AVE. GRACE ST & WAVELAND AVE

HA # 32
 12" X 12" White w/ black specks VFT and
 HA # 32 A
 MASTIC

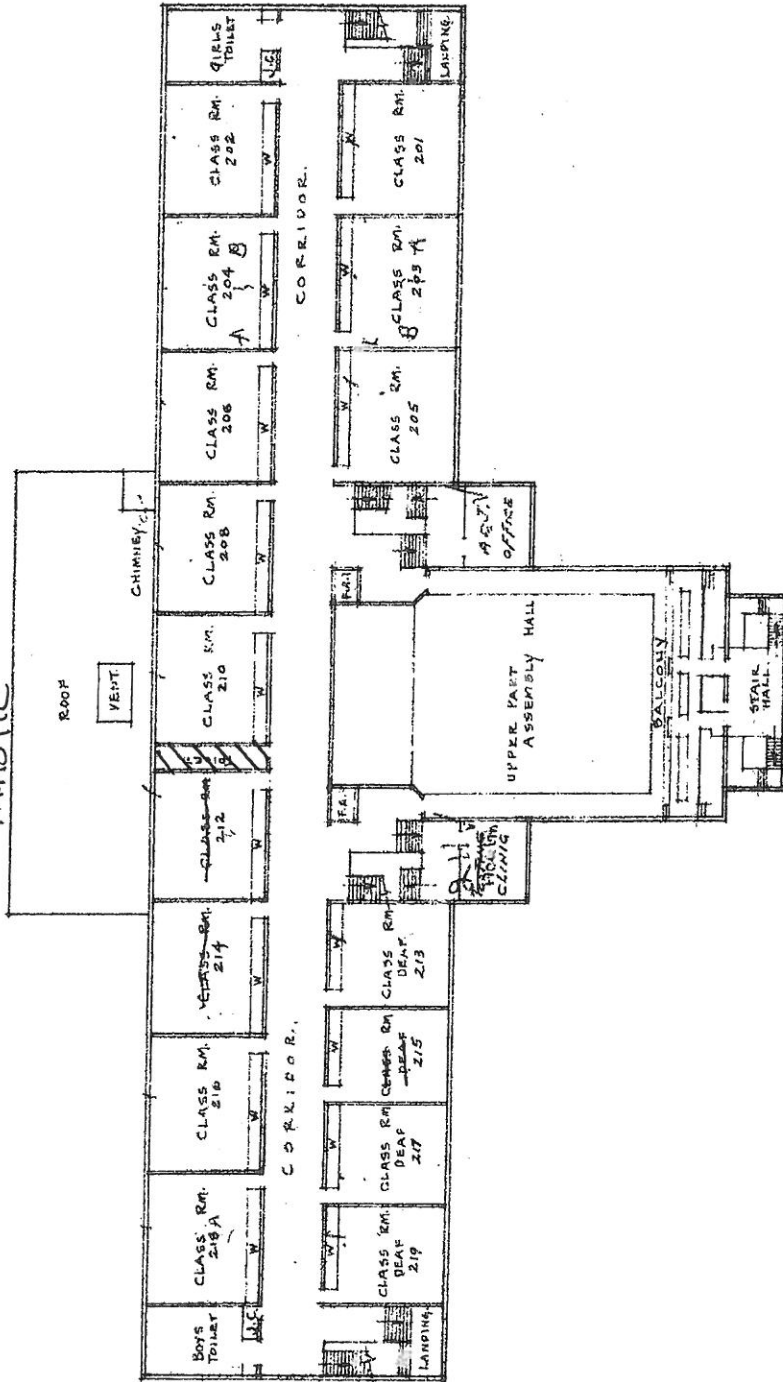
SECOND FLOOR PLAN
 SCALE 1" = 40'-0"
 ALEXANDER GRAHAM BELL SCHOOL
 OAKLEY AVE GRACE ST & WAVELAND AVE.

HA # 33
 18" x 18" Brown VFT and
 HA # 33A
 MASTIC

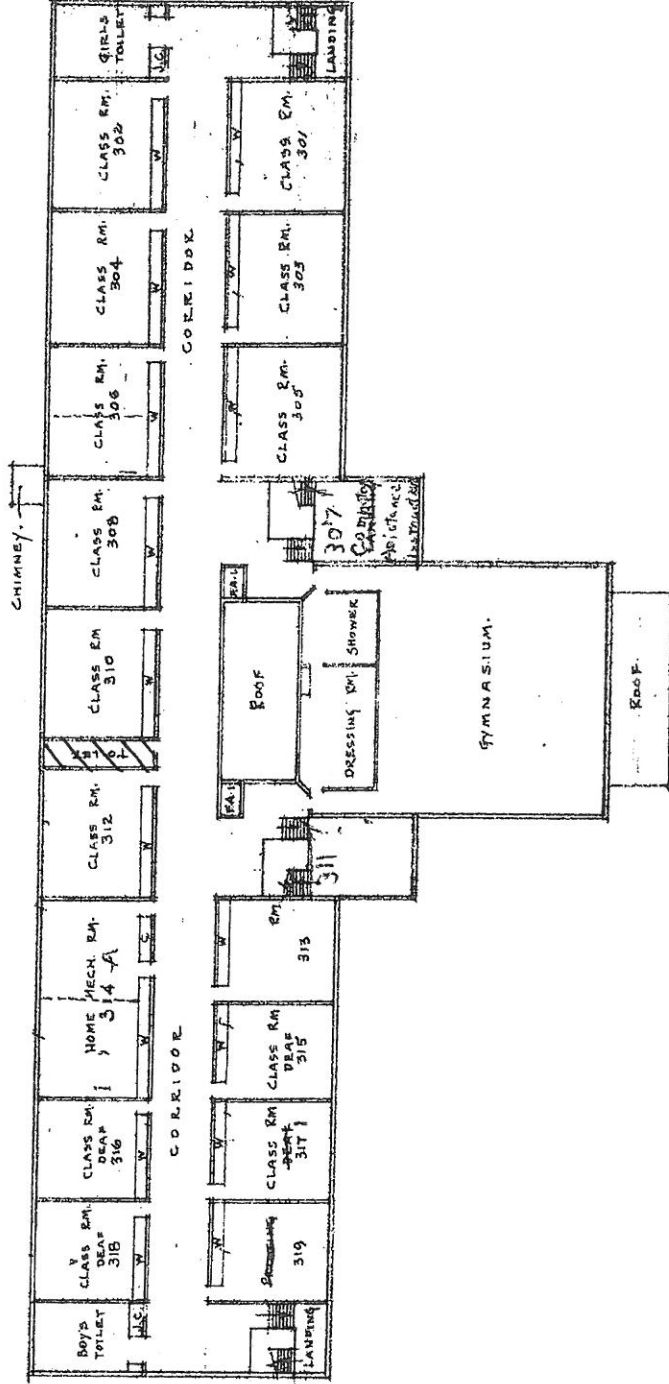
THIRD FLOOR PLAN
 SCALE 1" = 40'-0"
 ALEXANDER GRAHAM BELL SCHOOL
 OAKLEY AVE. GRACE ST & WAVELAND AVE

HA # 33
 18" X 18" Brown VFT and
 HA # 33A
 MASTIC

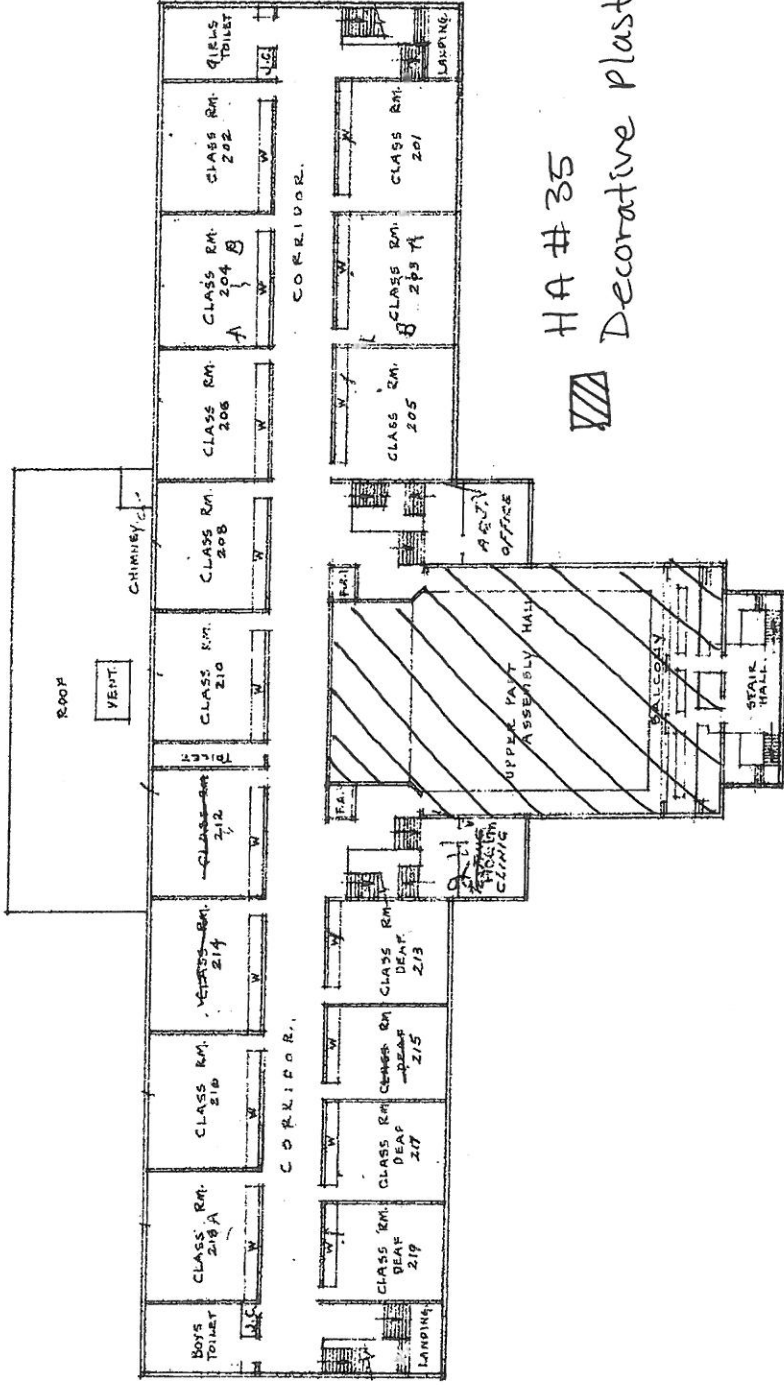
SECOND FLOOR PLAN
SCALE 1" = 40'-0"
ALEXANDER GRAHAM BELL SCHOOL
OAKLEY AVE GRACE ST & WAVELAND AVE.

HA # 35
Decorative Plaster

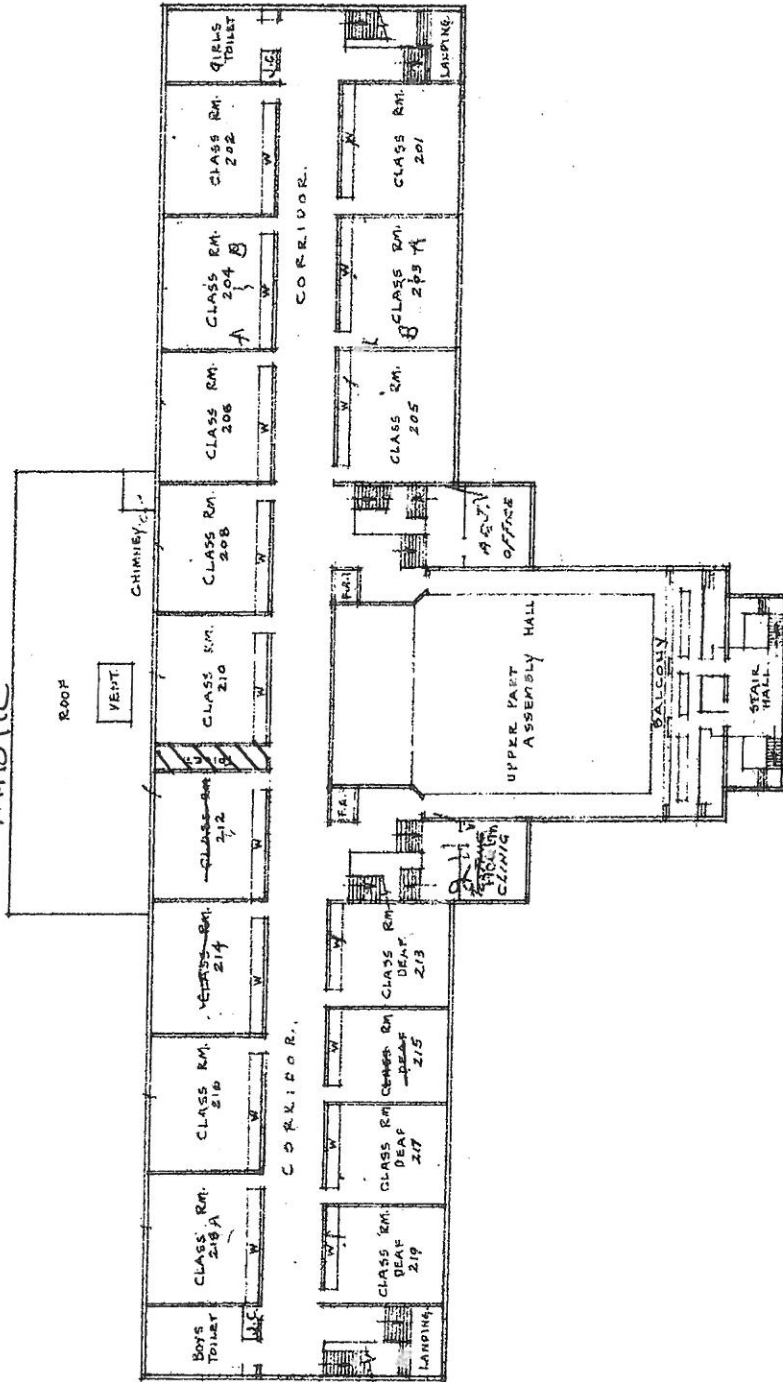
SECOND FLOOR PLAN
 SCALE 1" = 40'-0"
 ALEXANDER GRAHAM BELL SCHOOL
 OAKLEY AVE GRACE ST & WAVELAND AVE.

HA # 33
 18' x 18" Brown VFT and
 HA # 33A
 MASTIC

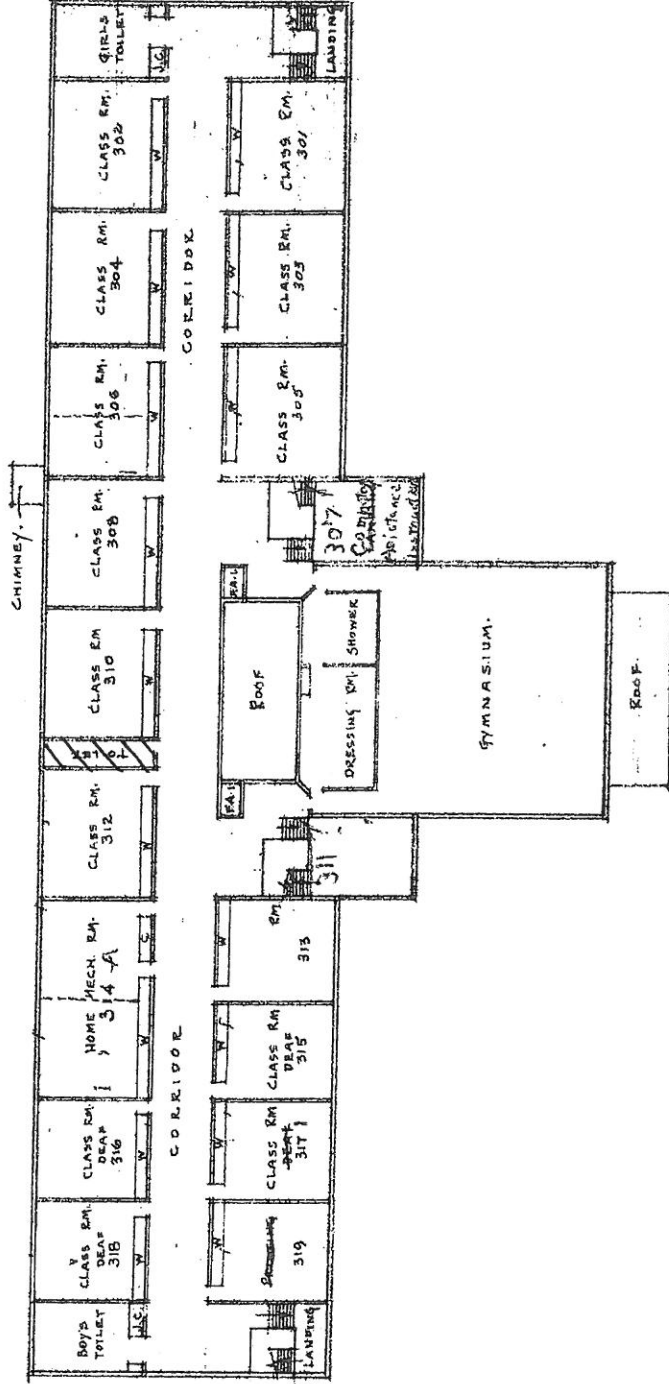
THIRD FLOOR PLAN
 SCALE 1" = 40'-0"
 ALEXANDER GRAHAM BELL SCHOOL
 OAKLEY AVE. GRACE ST & WAVELAND AVE

HA # 33
 18" X 18" Brown VFT and
 HA # 33A
 MASTIC

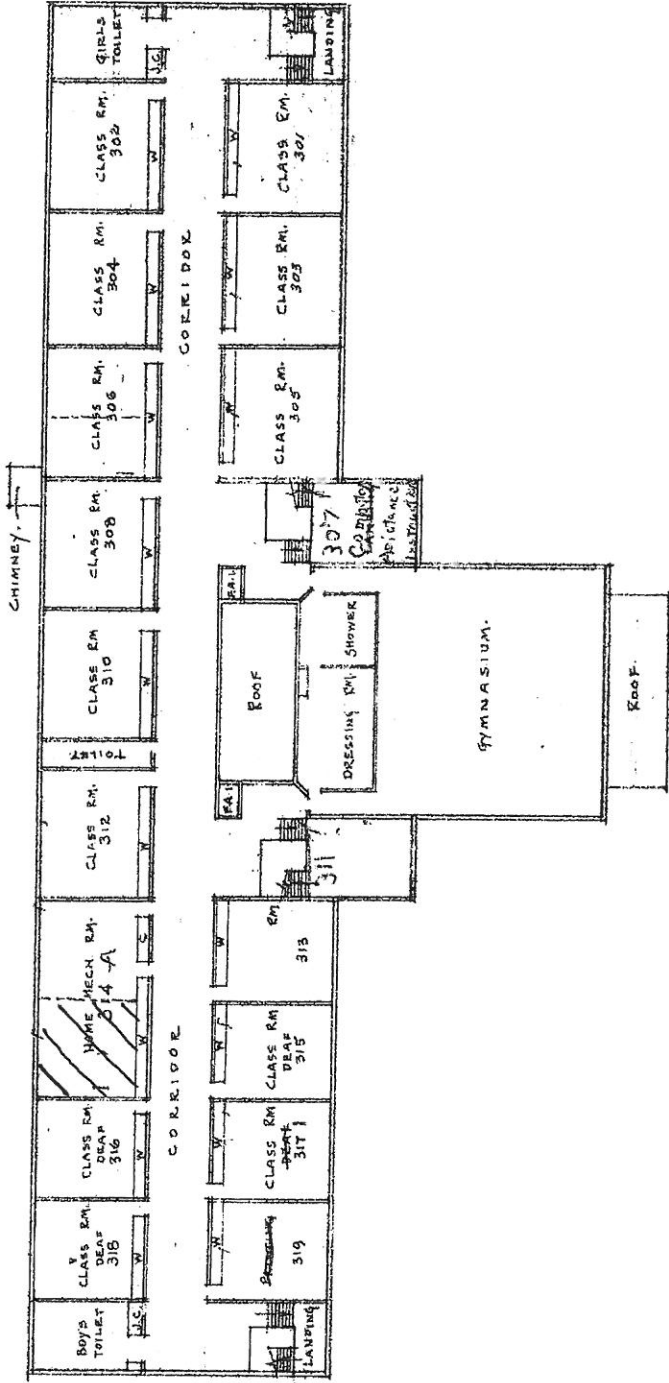
THIRD FLOOR PLAN
 SCALE 1" = 40'-0"
 ALEXANDER GRAHAM BELL SCHOOL
 OAKLEY AVE. GRACE ST & WAVELAND AVE

HA # 31
 12"X12" Light beige w/ beige & white streaks vft
 HA # 31A
 MASTIC
