ILLINOIS DEPARTMENT OF PUBLIC HEALTH  
AHERA THREE YEAR REINSPECTION  
ASBESTOS ABATEMENT PROGRAM  
SCHOOL INFORMATION FORM

**THREE-YEAR REINSPECTION**

**Greeley School**

**REPORT DATE:**

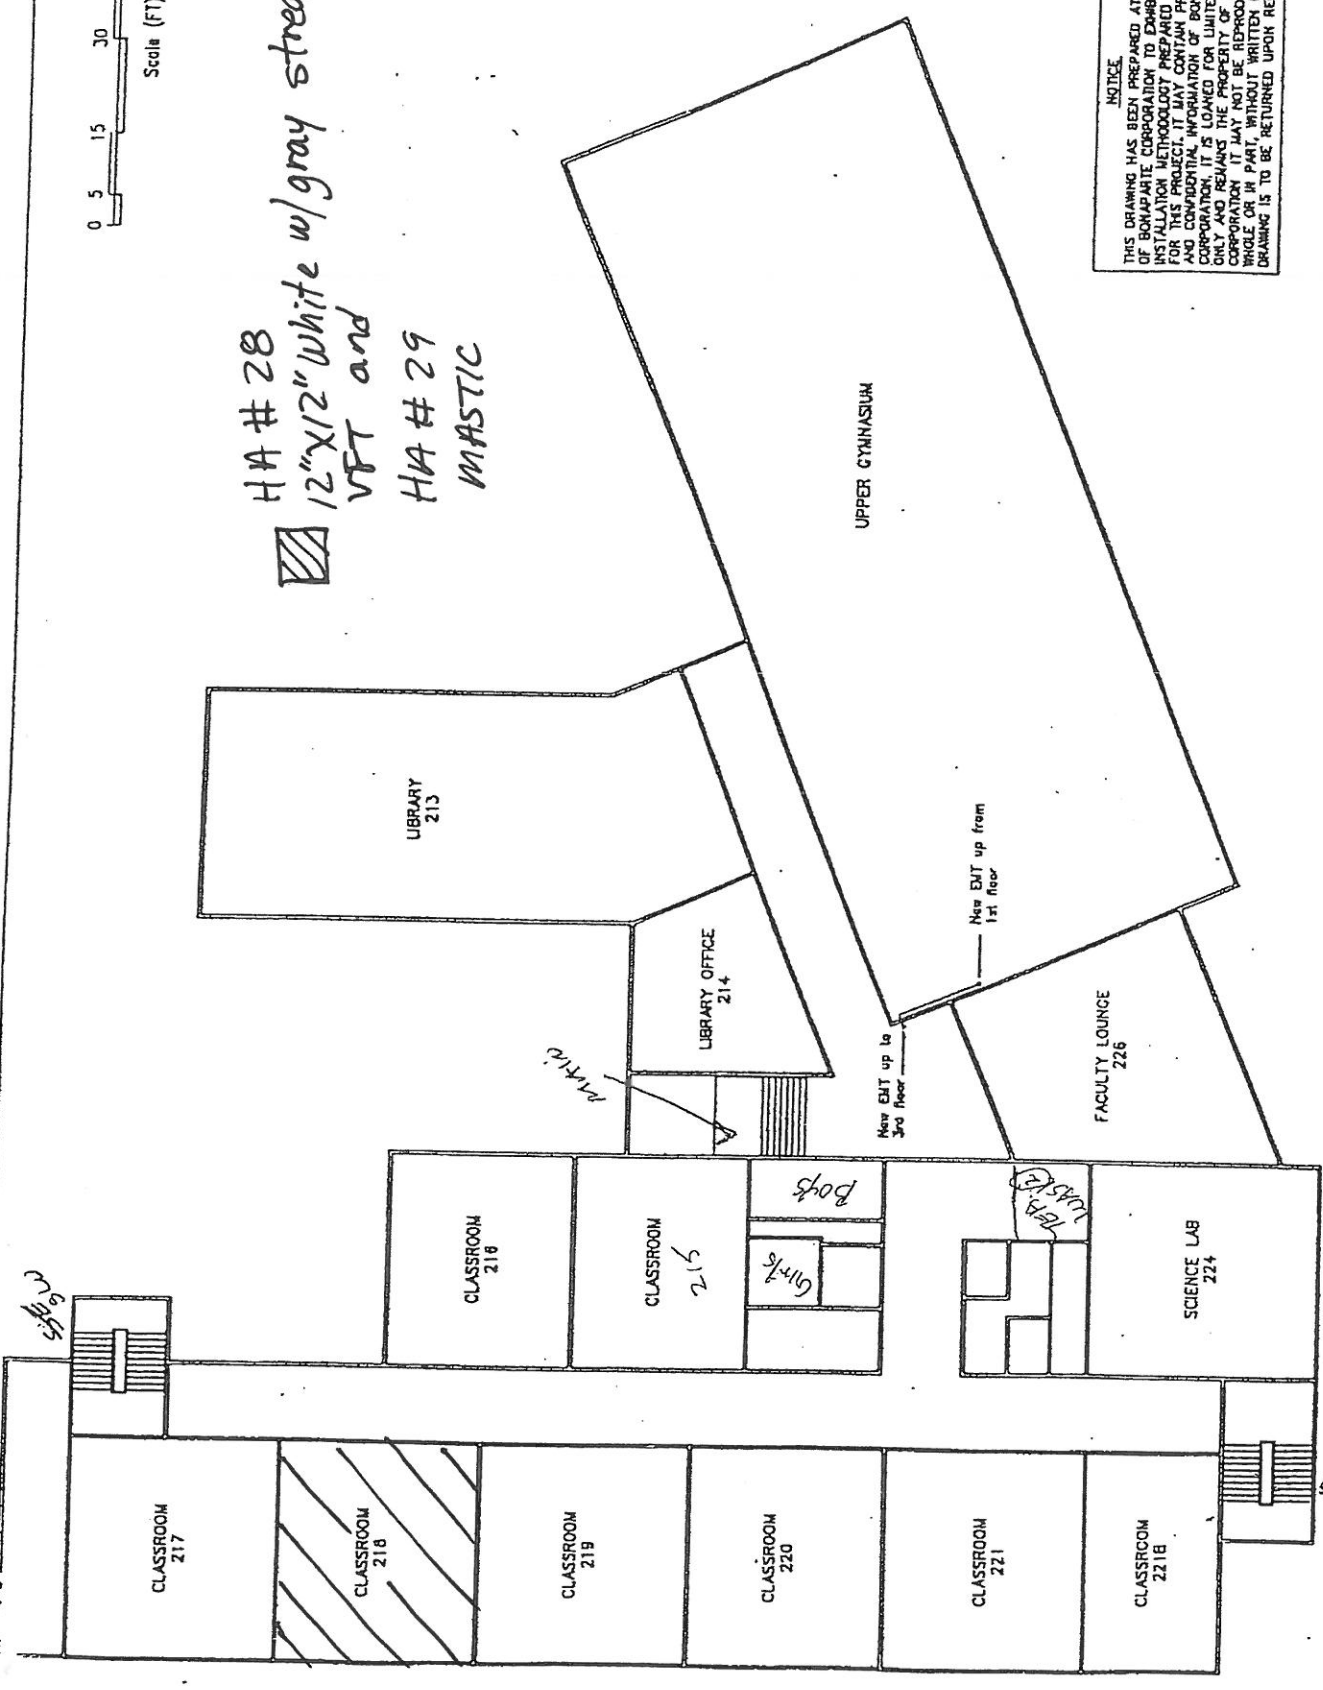
HA # 28  
 12" x 12" White w/ gray streaks  
 VFT and  
 HA # 29  
 MASTIC

28	12x12 White w/Gray Streaks VFT	700	SF	Room 218	ASSUMED	MISC	N	NONE	0		No	ACBM with the potential for damage		MODERATE
29	12x12 White w/Gray Streaks VFT Mastic	700	SF	Room 218	ASSUMED	MISC	N	NONE	0		No	ACBM with the potential for damage		LOW

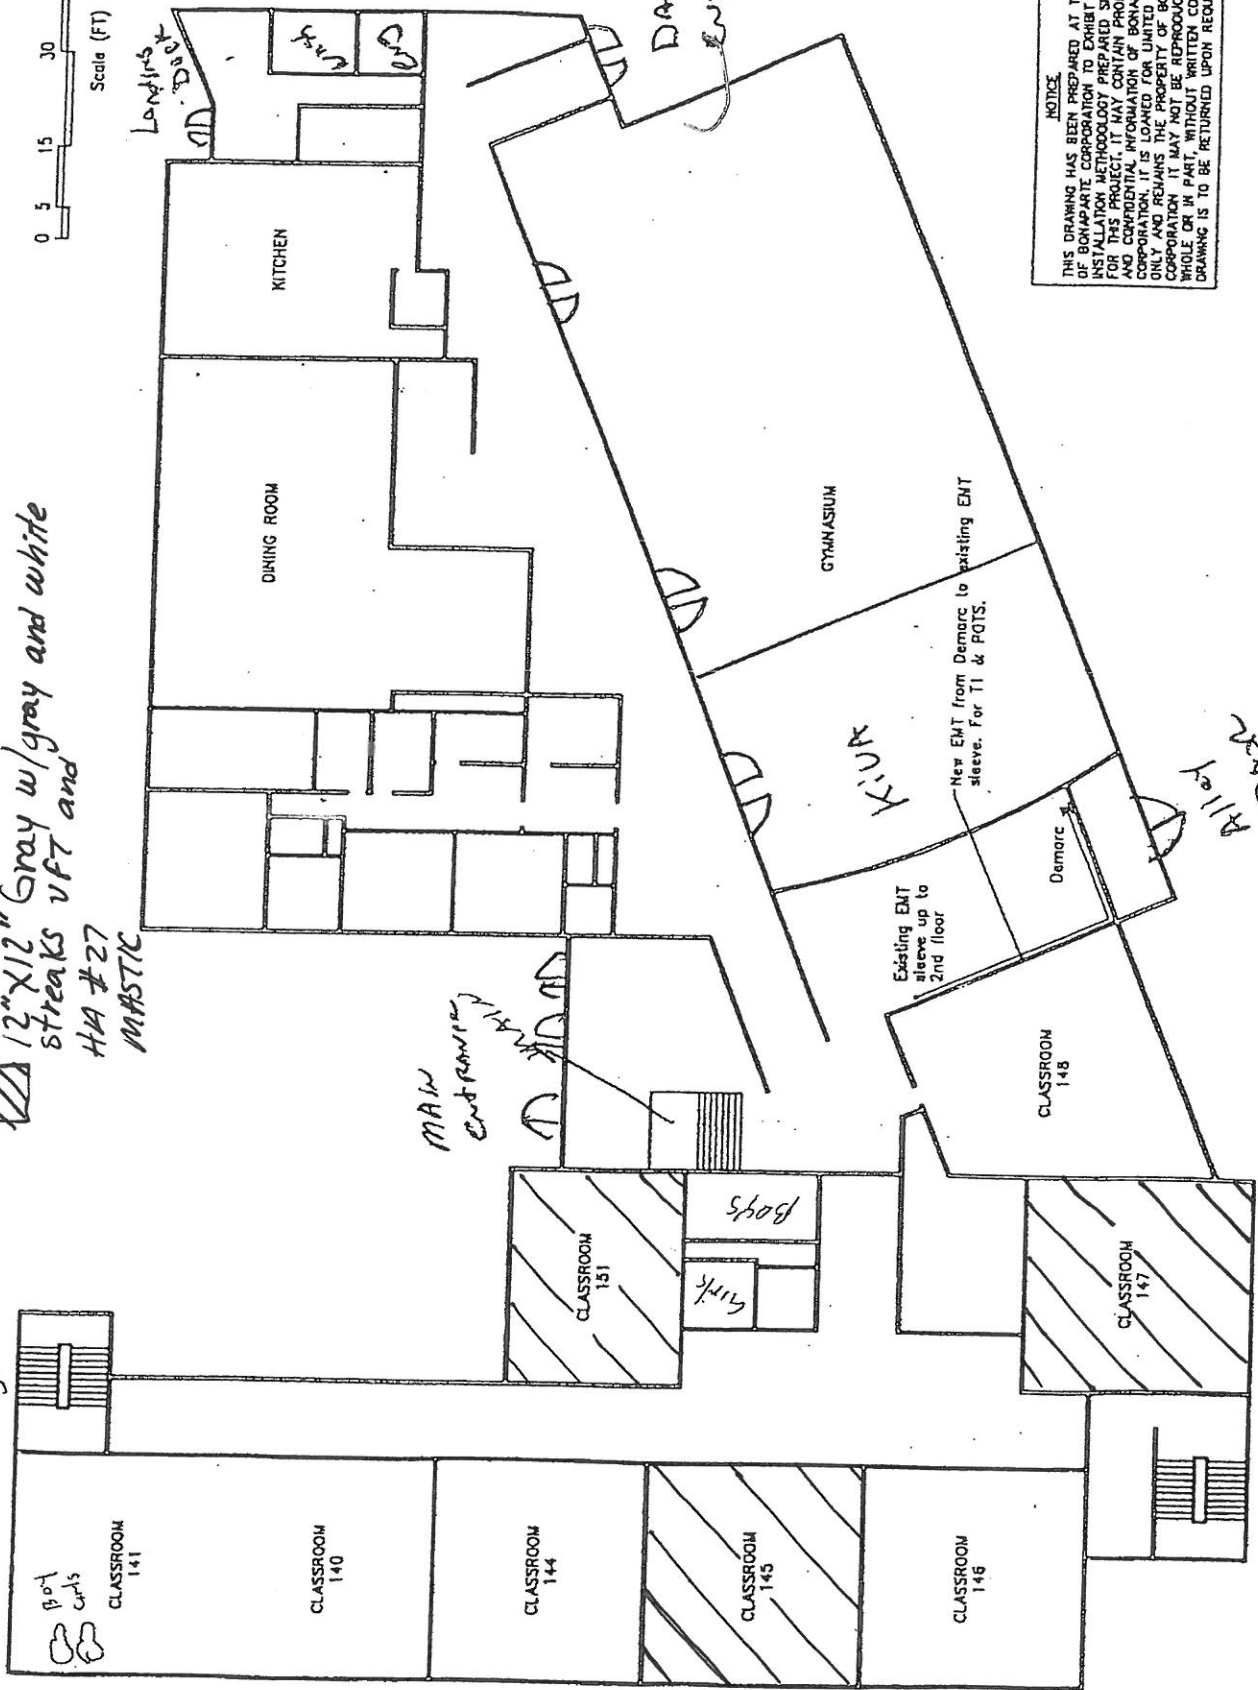
HA # 26  
12" X 12" Gray w/gray and white streaks VFT and HA # 27 MASTIC

26	12x12 Gray w/ gray and white streaks VFT	2,500	SF	Rooms 147,145,151	Assumed	MISC	No	0	SF	6 ACBM with the potential for damage	Operations and Maintenance
27	12x12 Gray w/ gray and white streaks VFT Mastic	2,500	SF	Rooms 147,145, 151	Assumed	MISC	No	0	SF	6 ACBM with the potential for damage	Operations and Maintenance
28	12x12 White w/Gray Streaks VFT	700	SF	Room 218	Assumed	MISC	No	0	SF	6 ACBM with the potential for damage	Operations and Maintenance
