ILLINOIS DEPARTMENT OF PUBLIC HEALTH
AHERA THREE YEAR REINSPECTION
ASBESTOS ABATEMENT PROGRAM
SCHOOL INFORMATION FORM

THREE-YEAR REINSPECTION

Edgebrook School

Tuesday, April 16, 2013

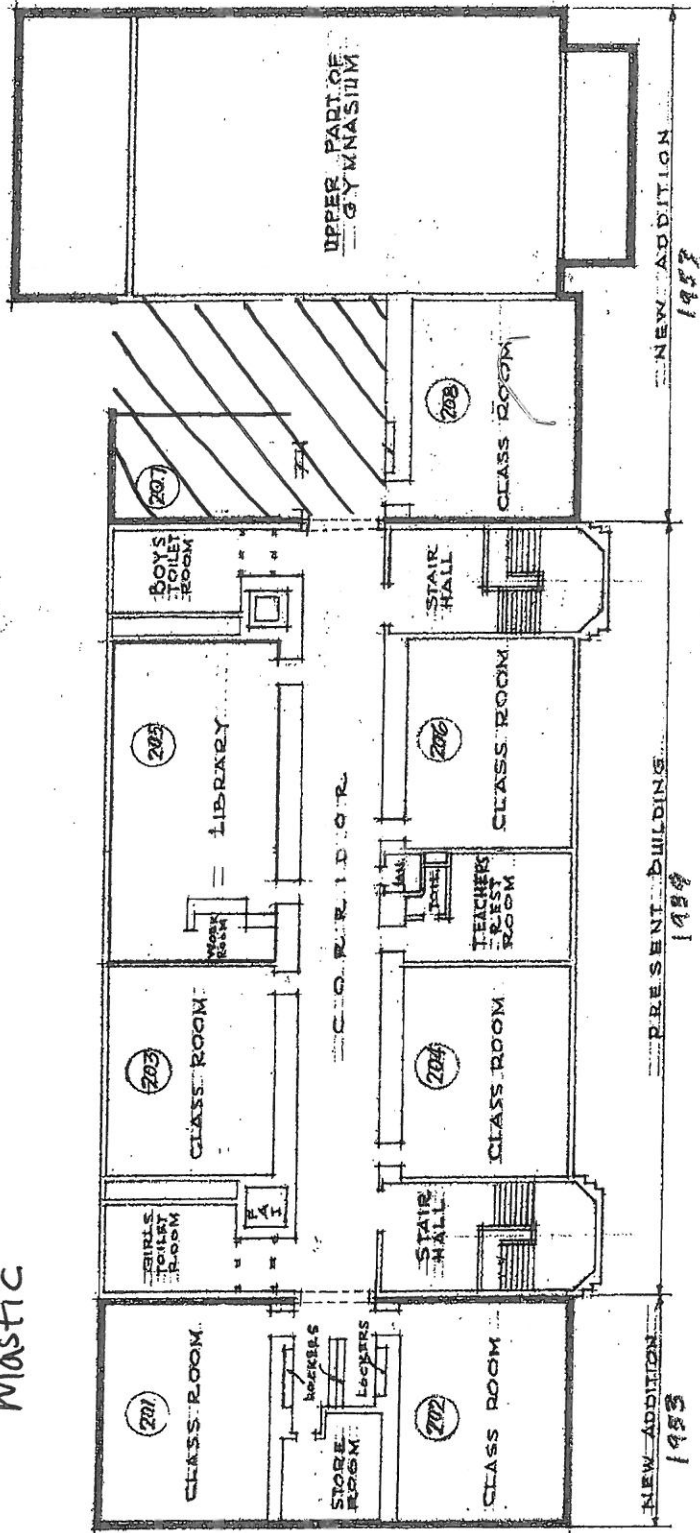
SECOND FLOOR PLAN
 SCALE 1" = 25'-0"

| HA No | Material Description | Material Quantity | Material Units | Material Location | Asbestos Type | Material Category | Friable | Damage Type | Damage Quantity | Damage Units | Change in Assessment Category | Damage Category | Damage Reason | Disturbance Potential |
|---|---|---|---|--|---|---|---|---|---|---|---|---|---|---|
| 53 | 12" X 12" white with gray specks VFT | 1,200 | SF | Rm 207, corridor by 207 (1953 Bldg) | ASSUMED | MISC | N | NONE | 0 | | No | ACBM with the potential for damage | | MODERATE |
| 54 | under 12" X 12" white with gray specks VFT MASTIC | 1,200 | SF | Rm 207, corridor by 207 (1953 Bldg) | ASSUMED | MISC | N | NONE | 0 | | No | ACBM with the potential for damage | | LOW |

HA #53
 12x12" white w/ gray specks VPT and
 HA #54
 Mastic

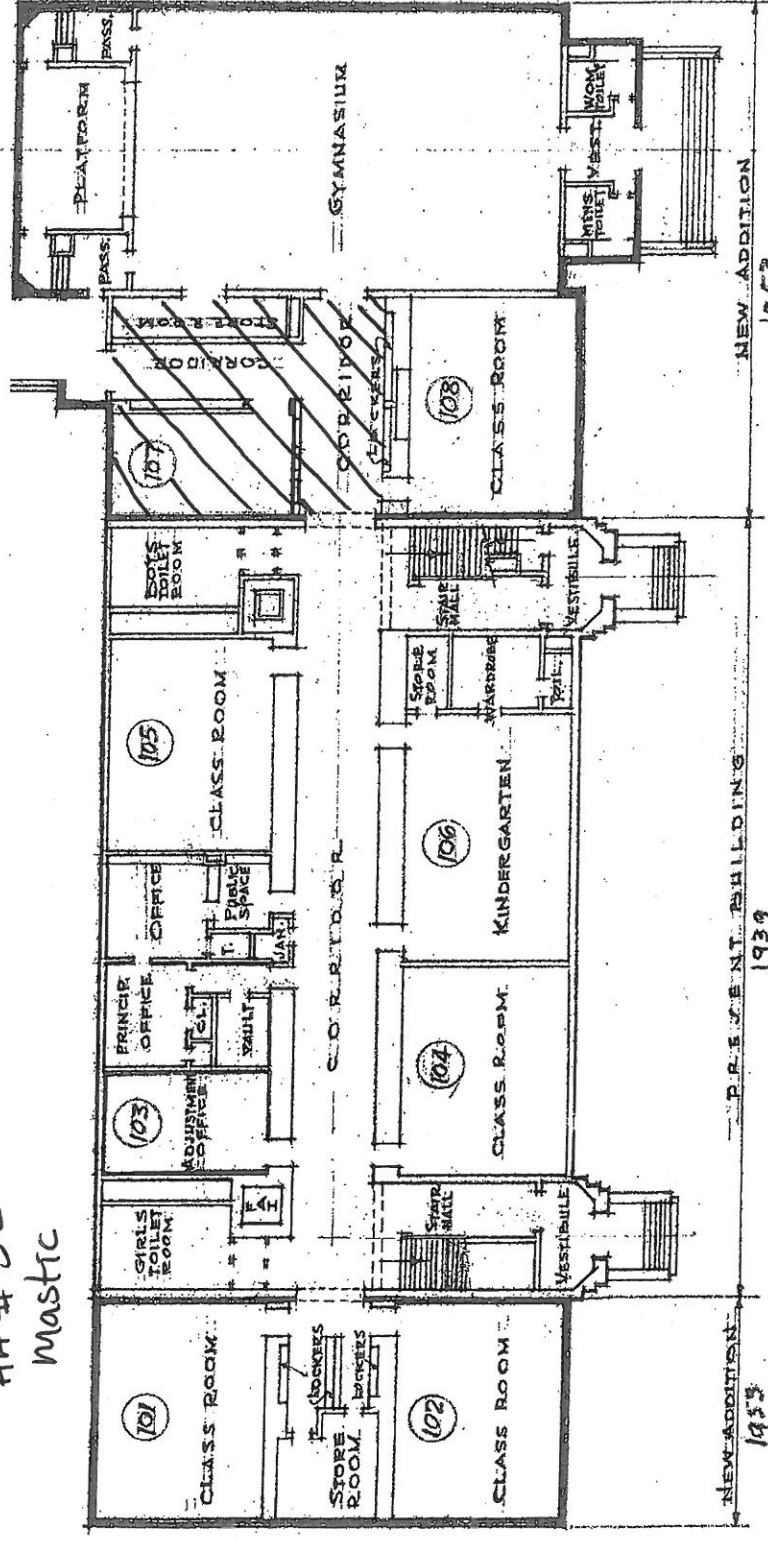
FIRST FLOOR PLAN
 SCALE 1/8" = 25'-0"

| HA No | Material Description | Material Quantity | Material Units | Material Location | Asbestos Type | Material Category | Friable | Damage Type | Damage Quantity | Damage Units | Change in Assessment Category | Damage Category | Damage Reason | Disturbance Potential |
|---|---|---|---|--|---|---|---|---|---|---|---|--|---|---|
| 51 | 12" X 12" light beige with tan streaks VFT | 1,250 | SF | Rm 107, NE Corridor by 107 Gym Storage (1953 Bldg) | ASSUMED | MISC | N | NONE | 0 | | No | ACBM with the potential for damage | | MODERATE |
| 52 | 12" X 12" light beige with tan streaks VFT MASTIC | 1,250 | SF | Rm 107, NE Corridor by 107 | ASSUMED | MISC | N | NONE | 0 | | No | ACBM with the potential for damage | | LOW |

HA # 51
 12x12" Light Beige w/ tan streaks
 VFT and
 HA # 52
 mastic

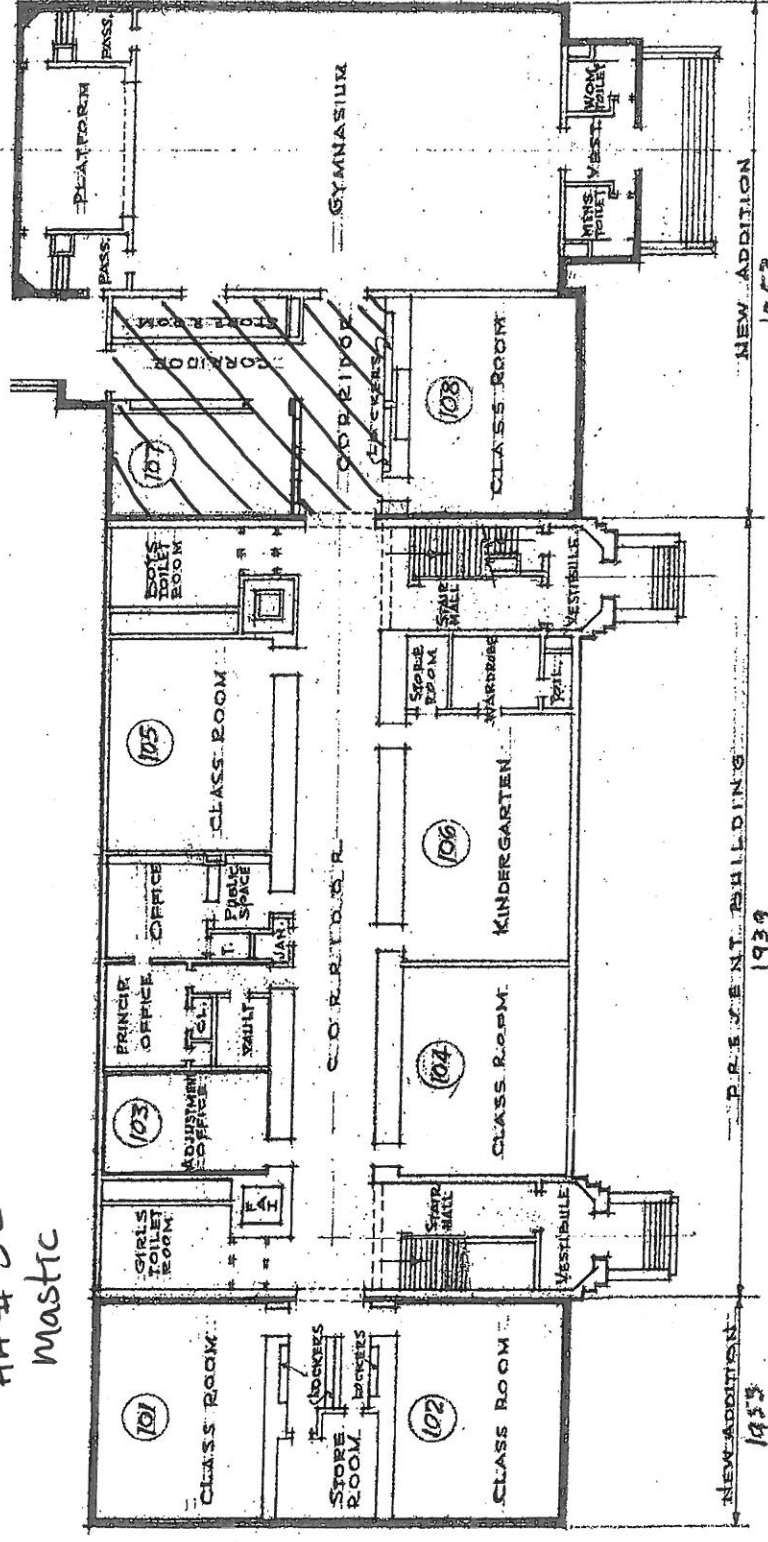
FIRST FLOOR PLAN
 SCALE 1/8" = 25'-0"

HA # 51
 12x12" Light Beige w/ tan streaks
 VFT and
 HA # 52
 mastic

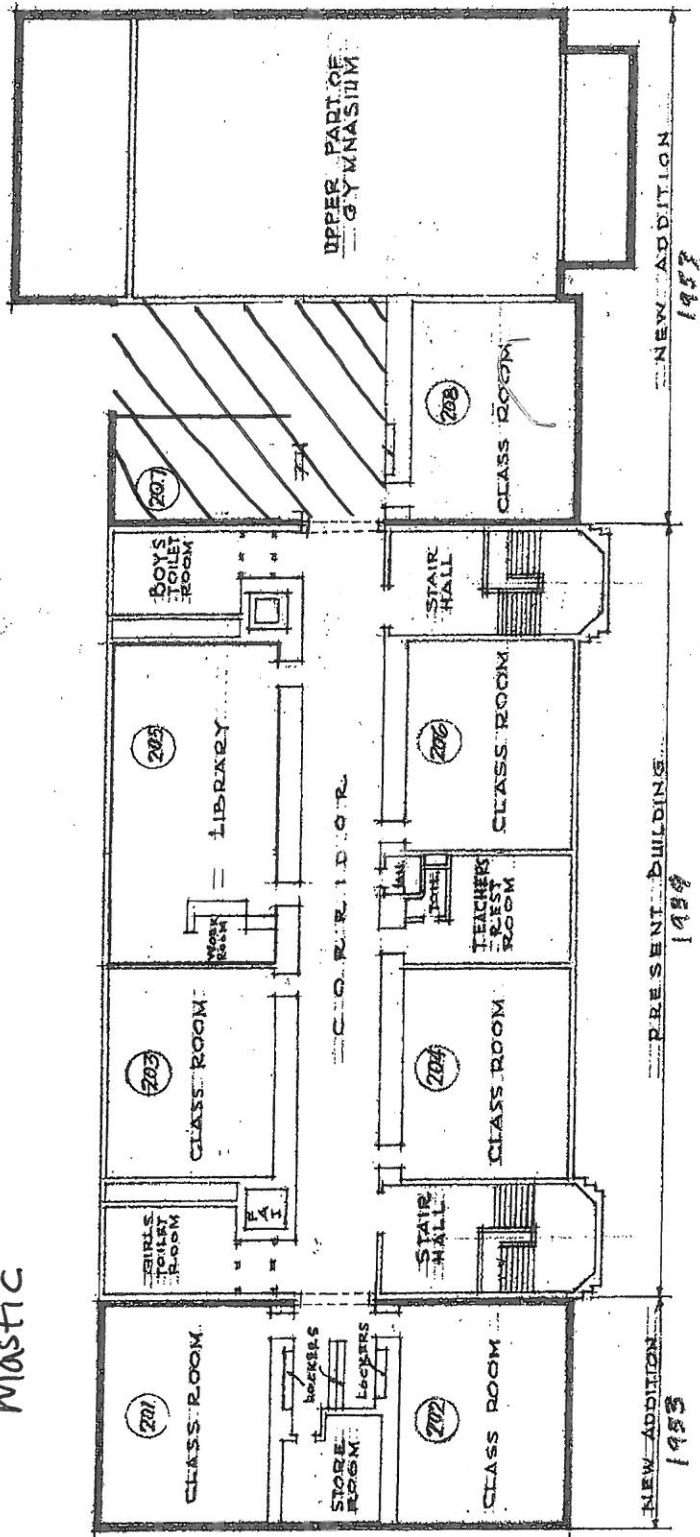
SECOND FLOOR PLAN
 SCALE 1" = 25'-0"

HA #53
 12x12" white w/ gray specks VPT and
 HA #54
 Mastic
