**ILLINOIS DEPARTMENT OF PUBLIC HEALTH  
AHERA THREE YEAR REINSPECTION  
ASBESTOS ABATEMENT PROGRAM  
SCHOOL INFORMATION FORM**

**THREE-YEAR REINSPECTION**

**Gray School**

3730 N Laramie Avenue  
Chicago, IL, 60641

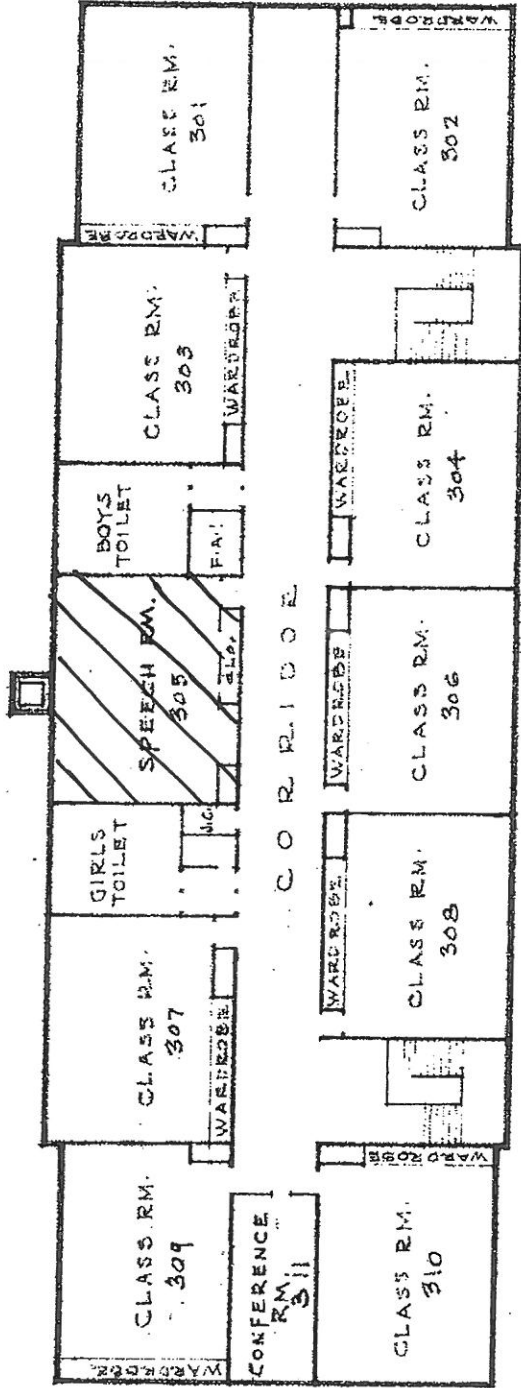
THIRD FLOOR PLAN

HA #37  
12"X12" Violet Streaked VFT and  
HA #37A  
MASTIC

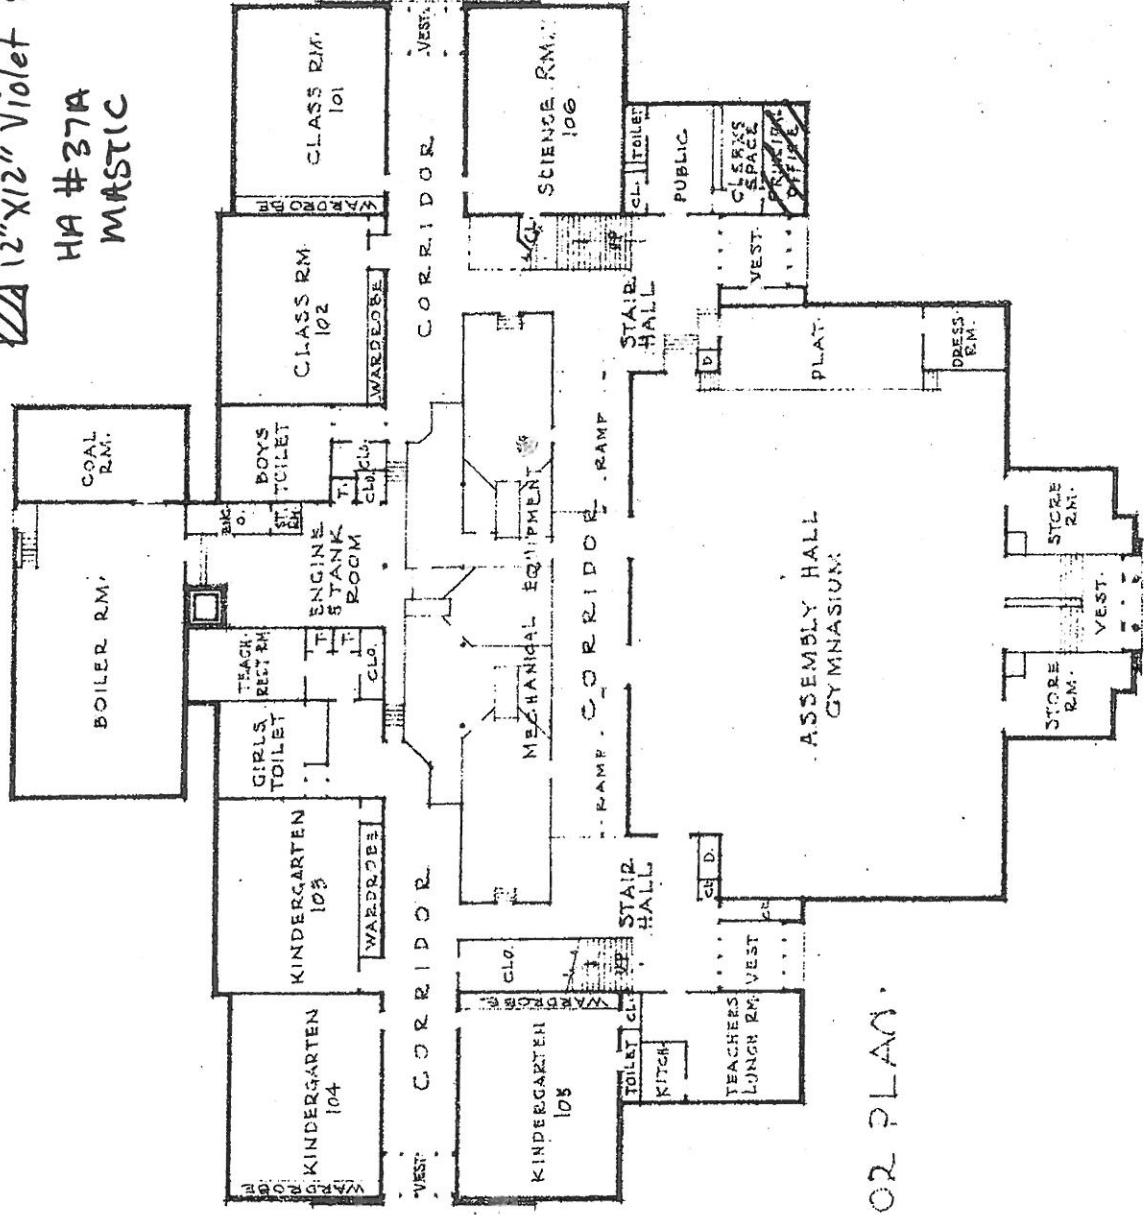
FIRST FLOOR PLAN.

HA # 39  
Fire Curtain

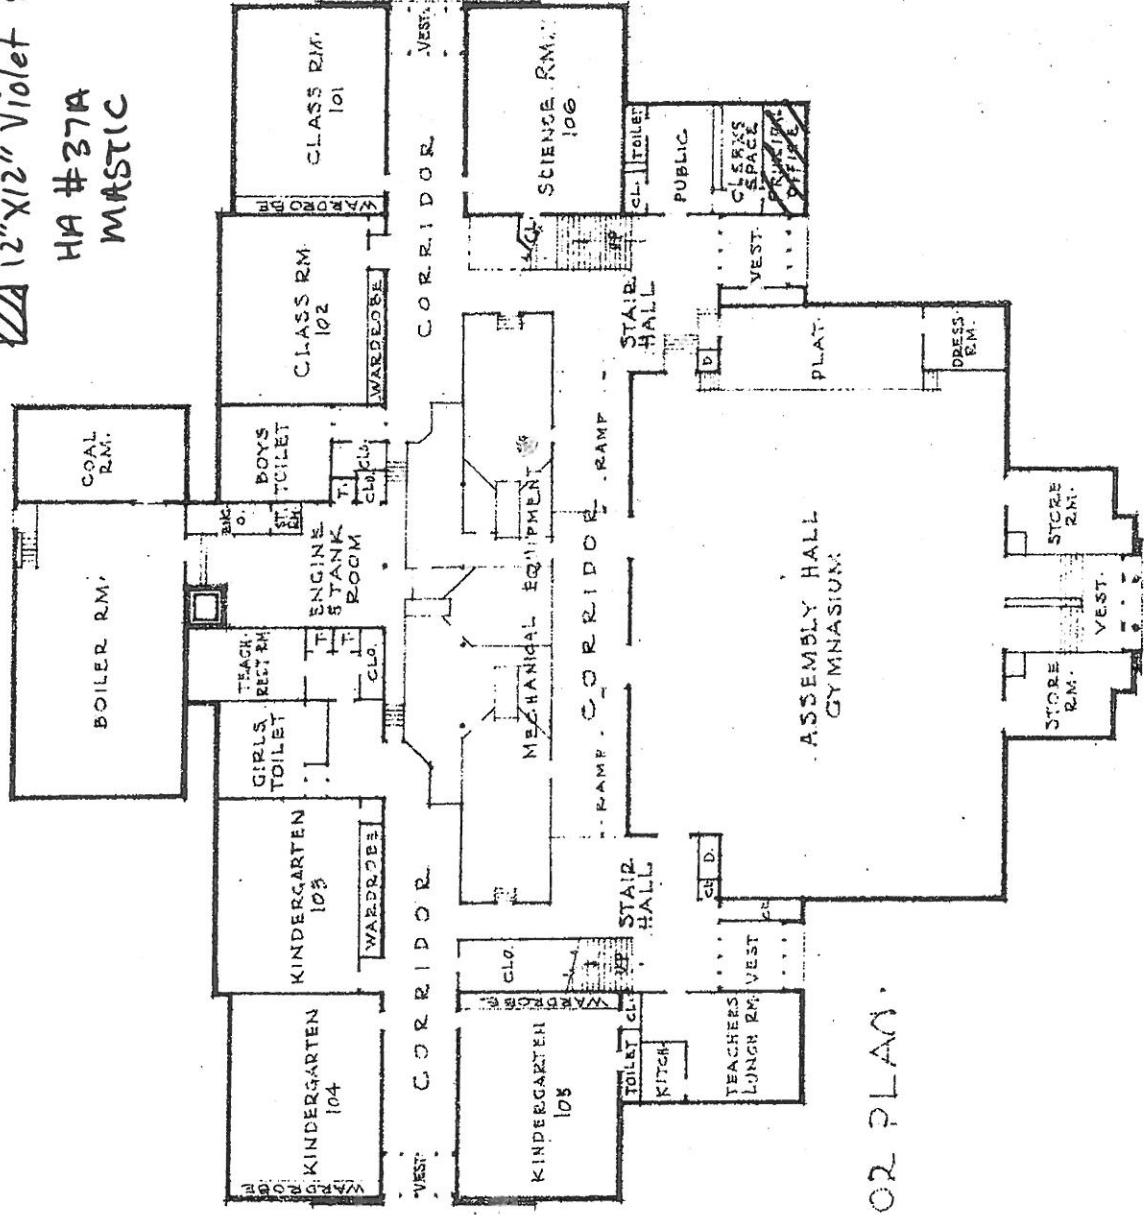
FIRST FLOOR PLAN.

HA #37  
12"X12" Violet Streaked VFT and  
HA #37A  
MASTIC
