ILLINOIS DEPARTMENT OF PUBLIC HEALTH
AHERA THREE YEAR REINSPECTION
ASBESTOS ABATEMENT PROGRAM
SCHOOL INFORMATION FORM

THREE-YEAR REINSPECTION

Hitch School

REPORT DATE:

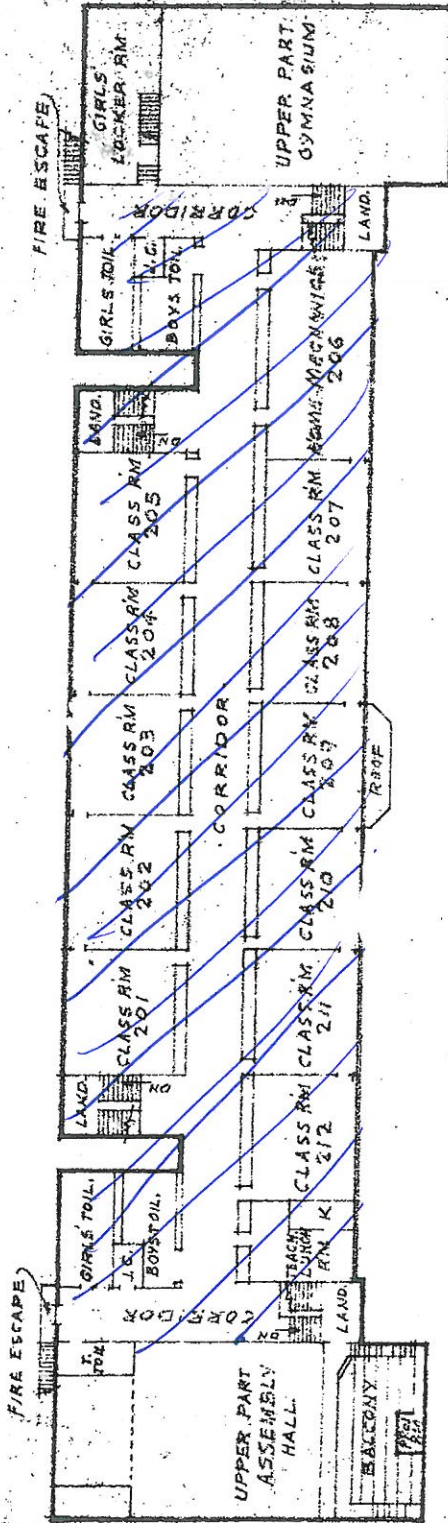
SECOND FLOOR PLAN

HA36 - Pink Insulation

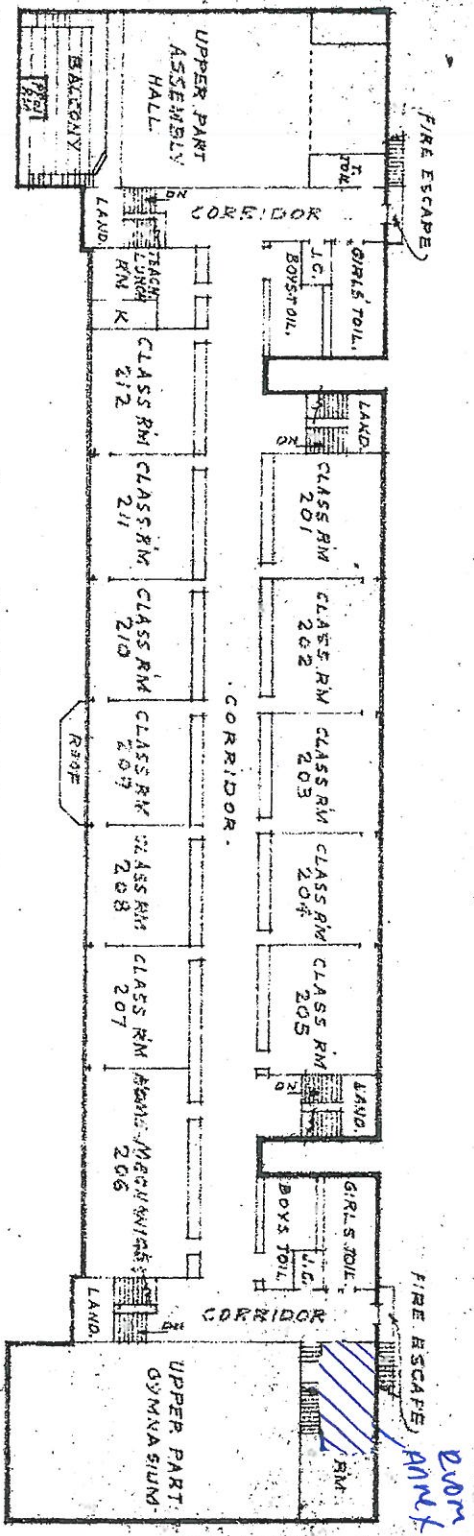
SECOND FLOOR PLAN

-7A35-12x12' ceiling w/ orange & brown speck VFT
 -7A35A
 MASTIC

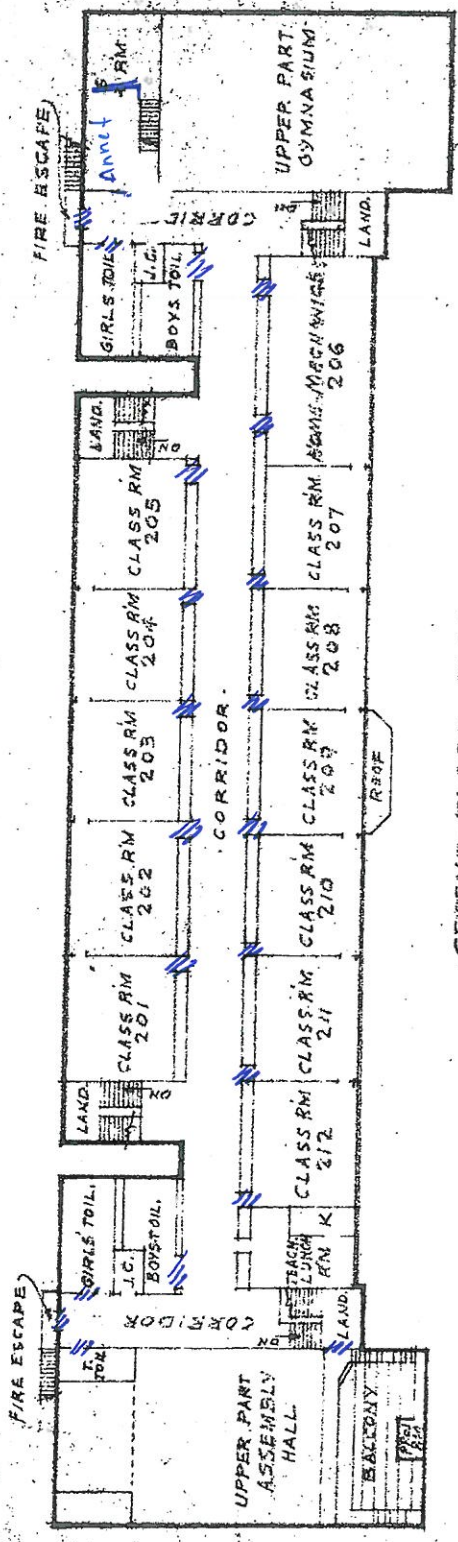
SECOND FLOOR PLAN

HA32 Fire doors

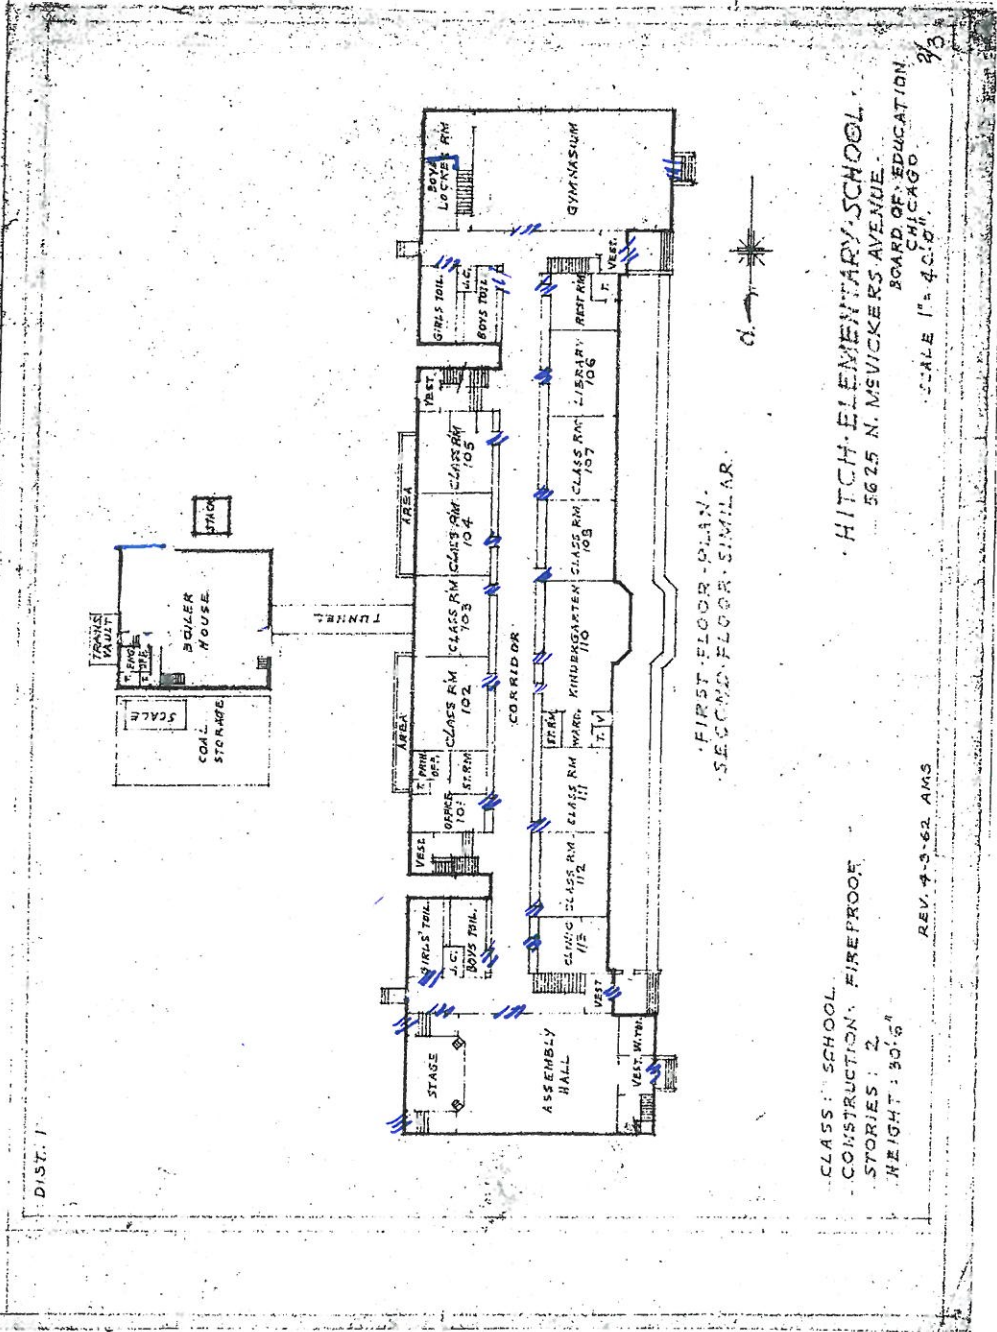
HA 32 Firedoors

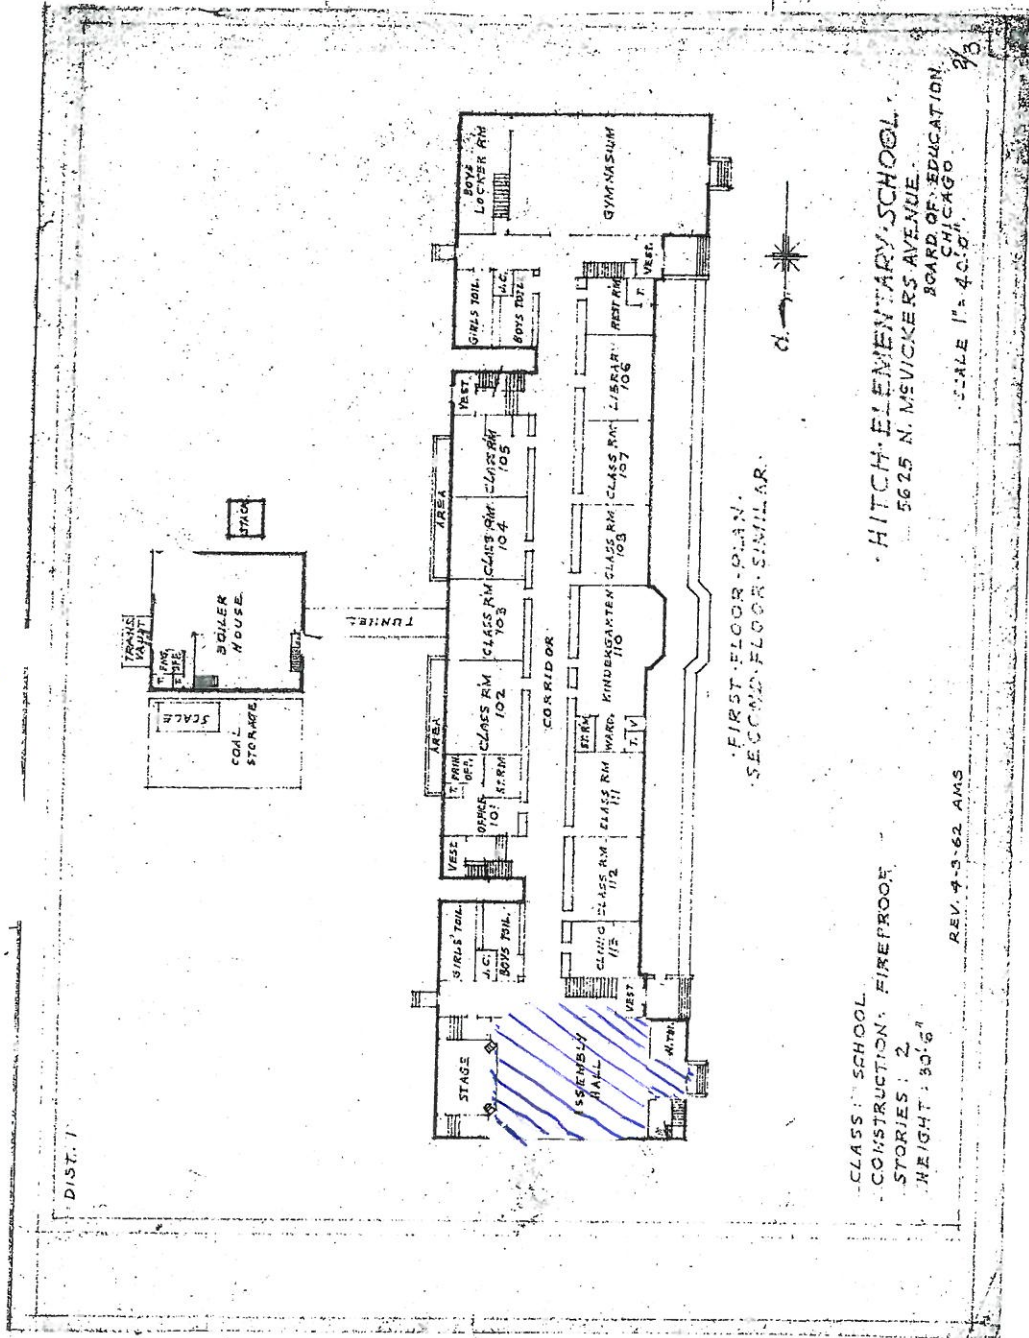
HIA 84 - ORNAMENTAL PLASTER
