**ILLINOIS DEPARTMENT OF PUBLIC HEALTH
AHERA THREE YEAR REINSPECTION
ASBESTOS ABATEMENT PROGRAM
SCHOOL INFORMATION FORM**

THREE-YEAR REINSPECTION

Mount Greenwood School

REPORT DATE:

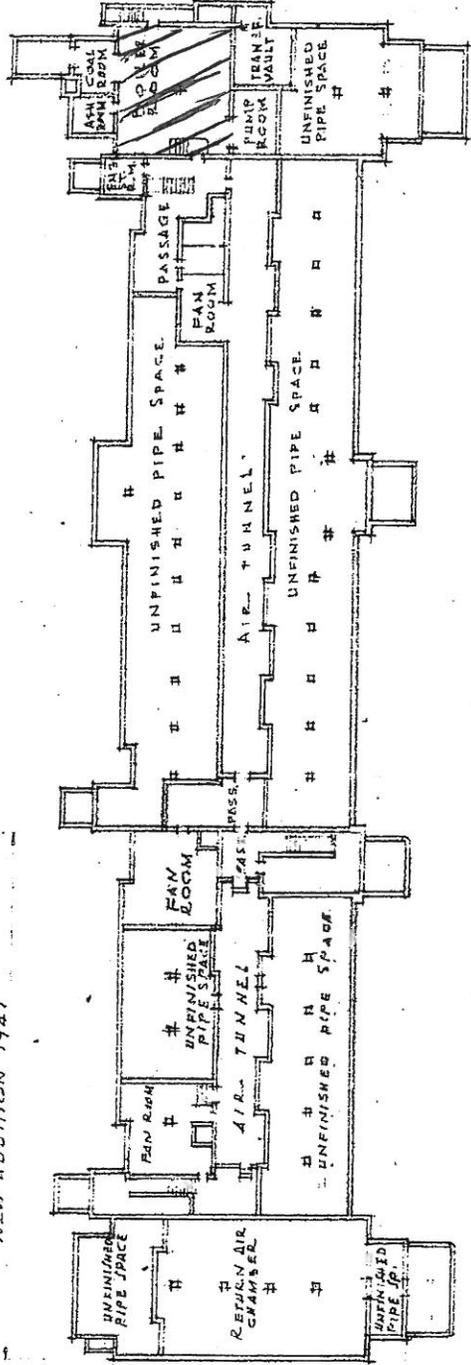
HA#18 Boiler Gaskets

| HA No | Material Description | Material Quantity | Material Units | Material Location | Asbestos Type | Material Category | Friable | Damage Type | Damage Quantity | Damage Units | Change in Assessment Category | Damage Category | Damage Reason | Disturbance Potential |
|---|---|---|---|---|---|---|---|---|---|---|---|---|---|---|
| 18 | Boiler Gaskets | 160 | LF | Boiler Room | ASSUMED | TSI | Y | NONE | | | | ACBM with the potential for damage | | LOW |

| HA Num | Material Description | Material Quantity | Material Units | Material Location | Asbestos Type | Material Category | Friable | Damage Quantity | Damage Units | Damage Category | Response |
|---|--|---|---|---|---|---|---|---|---|---|---|
| 18 | Boiler Gaskets | 160 | LF | Boiler Room | Assumed | TSI | Yes | 0 | LF | 6 ACBM with the potential for damage | Operations and Maintenance |

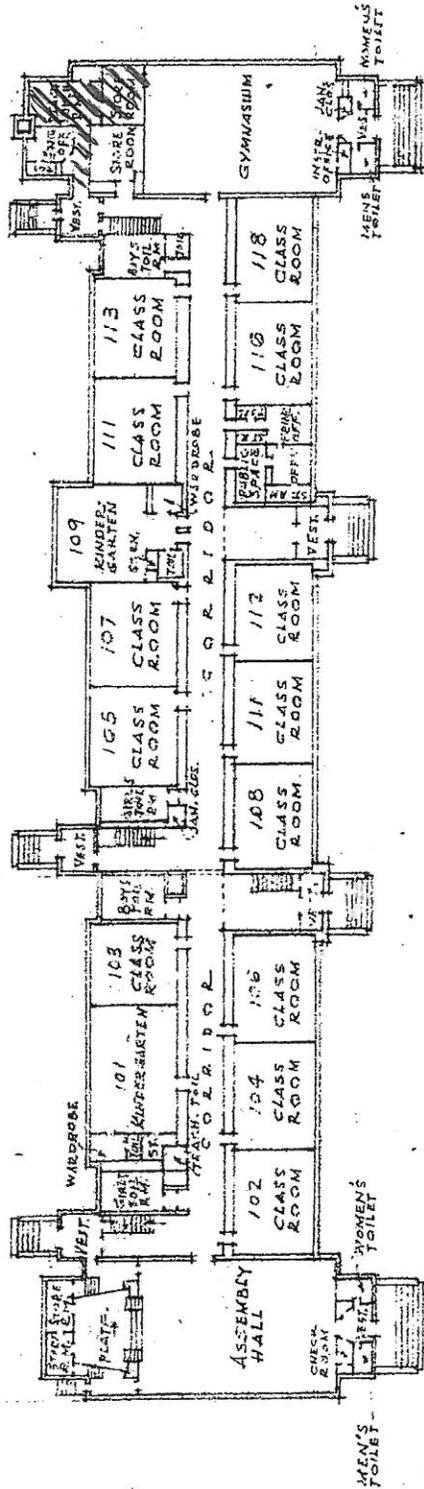
HA# 16+17 White w/Black Spec VFT + Mastic

| HA No | Material Description | Material Quantity | Material Units | Material Location | Asbestos Type | Material Category | Friable | Damage Type | Damage Quantity | Damage Units | Change in Assessment Category | Damage Category | Damage Reason | Disturbance Potential |
|---|---|---|---|---|---|---|---|---|---|---|---|---|---|---|
| 16 | 12" x 12" White with Black Speckles Floor Tile | 1,400 | SF | Book Room, Store Room and Hallway Outside Office | ASSUMED | MISC | N | NONE | 0 | | | ACBM with the potential for damage | | MODERATE |
| 17 | 12" x 12" White with Black Speckles Floor Tile Mastic | 1,400 | SF | Book Room, Store Room and Hallway Outside Engineer Office | ASSUMED | MISC | N | NONE | | | | ACBM with the potential for damage | | LOW |

| HA Num | Material Description | Material Quantity | Material Units | Material Location | Asbestos Type | Material Category | Friable | Damage Quantity | Damage Units | Damage Category | Response |
|---|--|---|---|---|---|---|---|---|---|---|---|
| 16 | 12" x 12" White with Black Speckles Floor Tile | 1,400 | SF | Book Room, Store Room and Hallway Outside Office | Assumed | MISC | No | 0 | SF | 6 ACBM with the potential for damage | Operations and Maintenance |
| 17 | 12" x 12" White with Black Speckles Floor Tile Mastic | 1,400 | SF | Book Room, Store Room and Hallway Outside Engineer Office | Assumed | MISC | No | 0 | SF | 6 ACBM with the potential for damage | Operations and Maintenance |

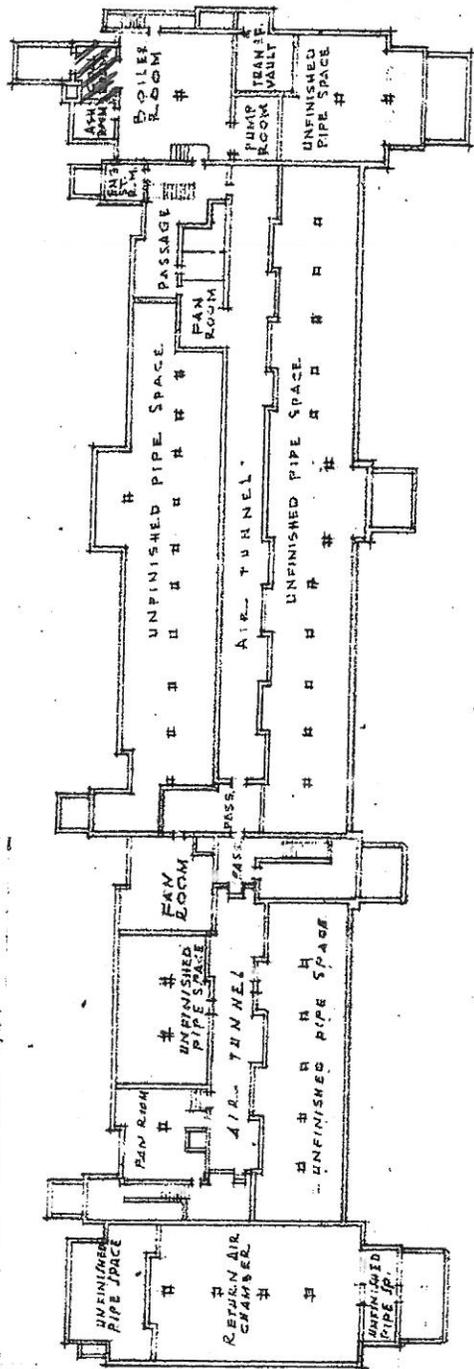
HA# 19 Incinerator Fire
Bricks

| HA No | Material Description | Material Quantity | Material Units | Material Location | Asbestos Type | Material Category | Friable | Damage Type | Damage Quantity | Damage Units | Change in Assessment Category | Damage Category | Damage Reason | Disturbance Potential |
|---|---|---|---|---|---|---|---|---|---|---|---|---|---|---|
| 19 | Incinerator Fire Birck | 400 | SF | Coal Room | ASSUMED | MISC | N | NONE | | | | ACBM with the potential for damage | | LOW |

| HA Num | Material Description | Material Quantity | Material Units | Material Location | Asbestos Type | Material Category | Friable | Damage Quantity | Damage Units | Damage Category | Response |
|---|--|---|---|---|---|---|---|---|---|---|---|
| 19 | Incinerator Fire Birck | 400 | SF | Coal Room | Assumed | MISC | No | 0 | SF | 6 ACBM with the potential for damage | Operations and Maintenance |
