**ILLINOIS DEPARTMENT OF PUBLIC HEALTH
AHERA THREE YEAR REINSPECTION
ASBESTOS ABATEMENT PROGRAM
SCHOOL INFORMATION FORM**

THREE-YEAR REINSPECTION

Carpenter School

1250 W. Erie Street
Chicago, IL, 60622

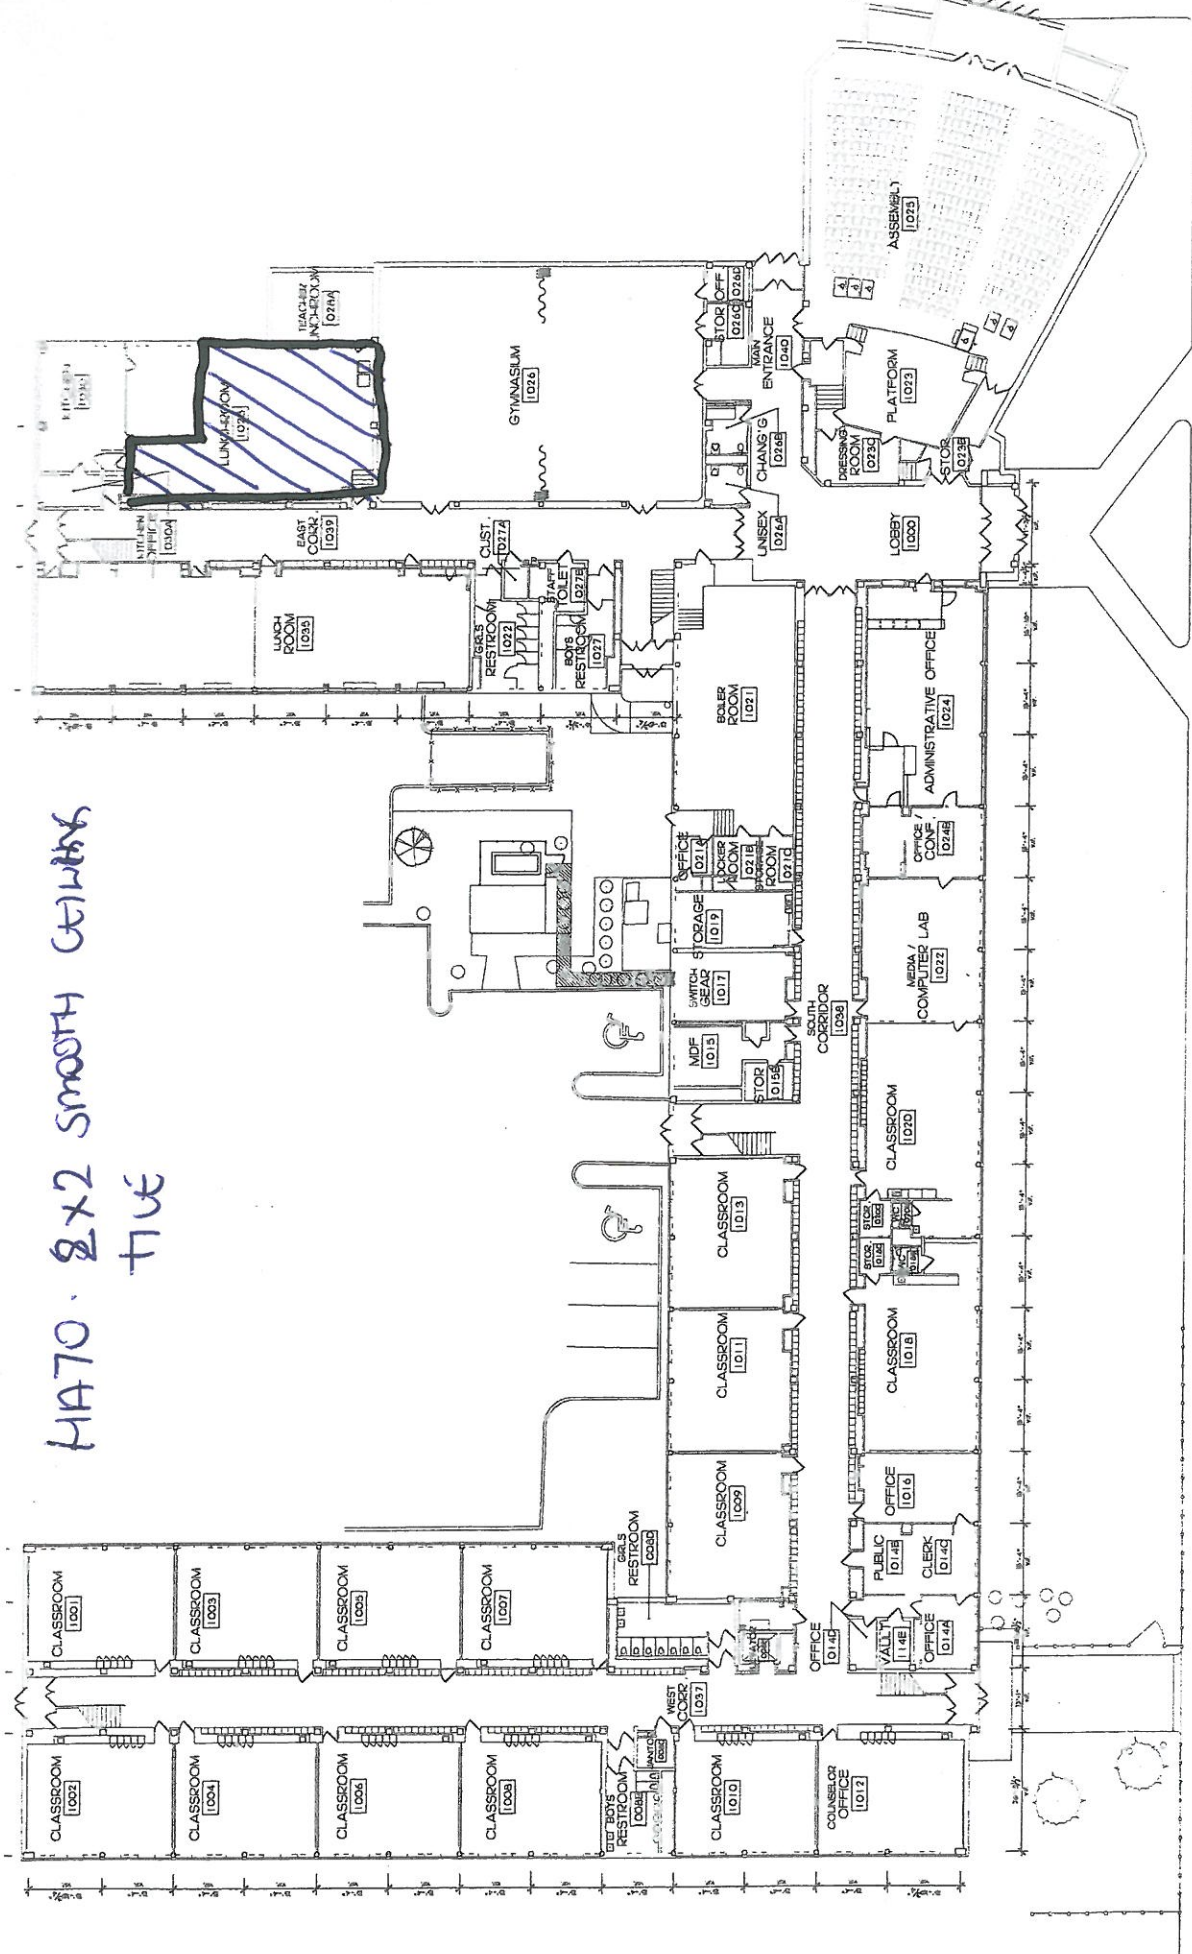
H1A70 - 2x2 SMOOTH CEILING
TUE

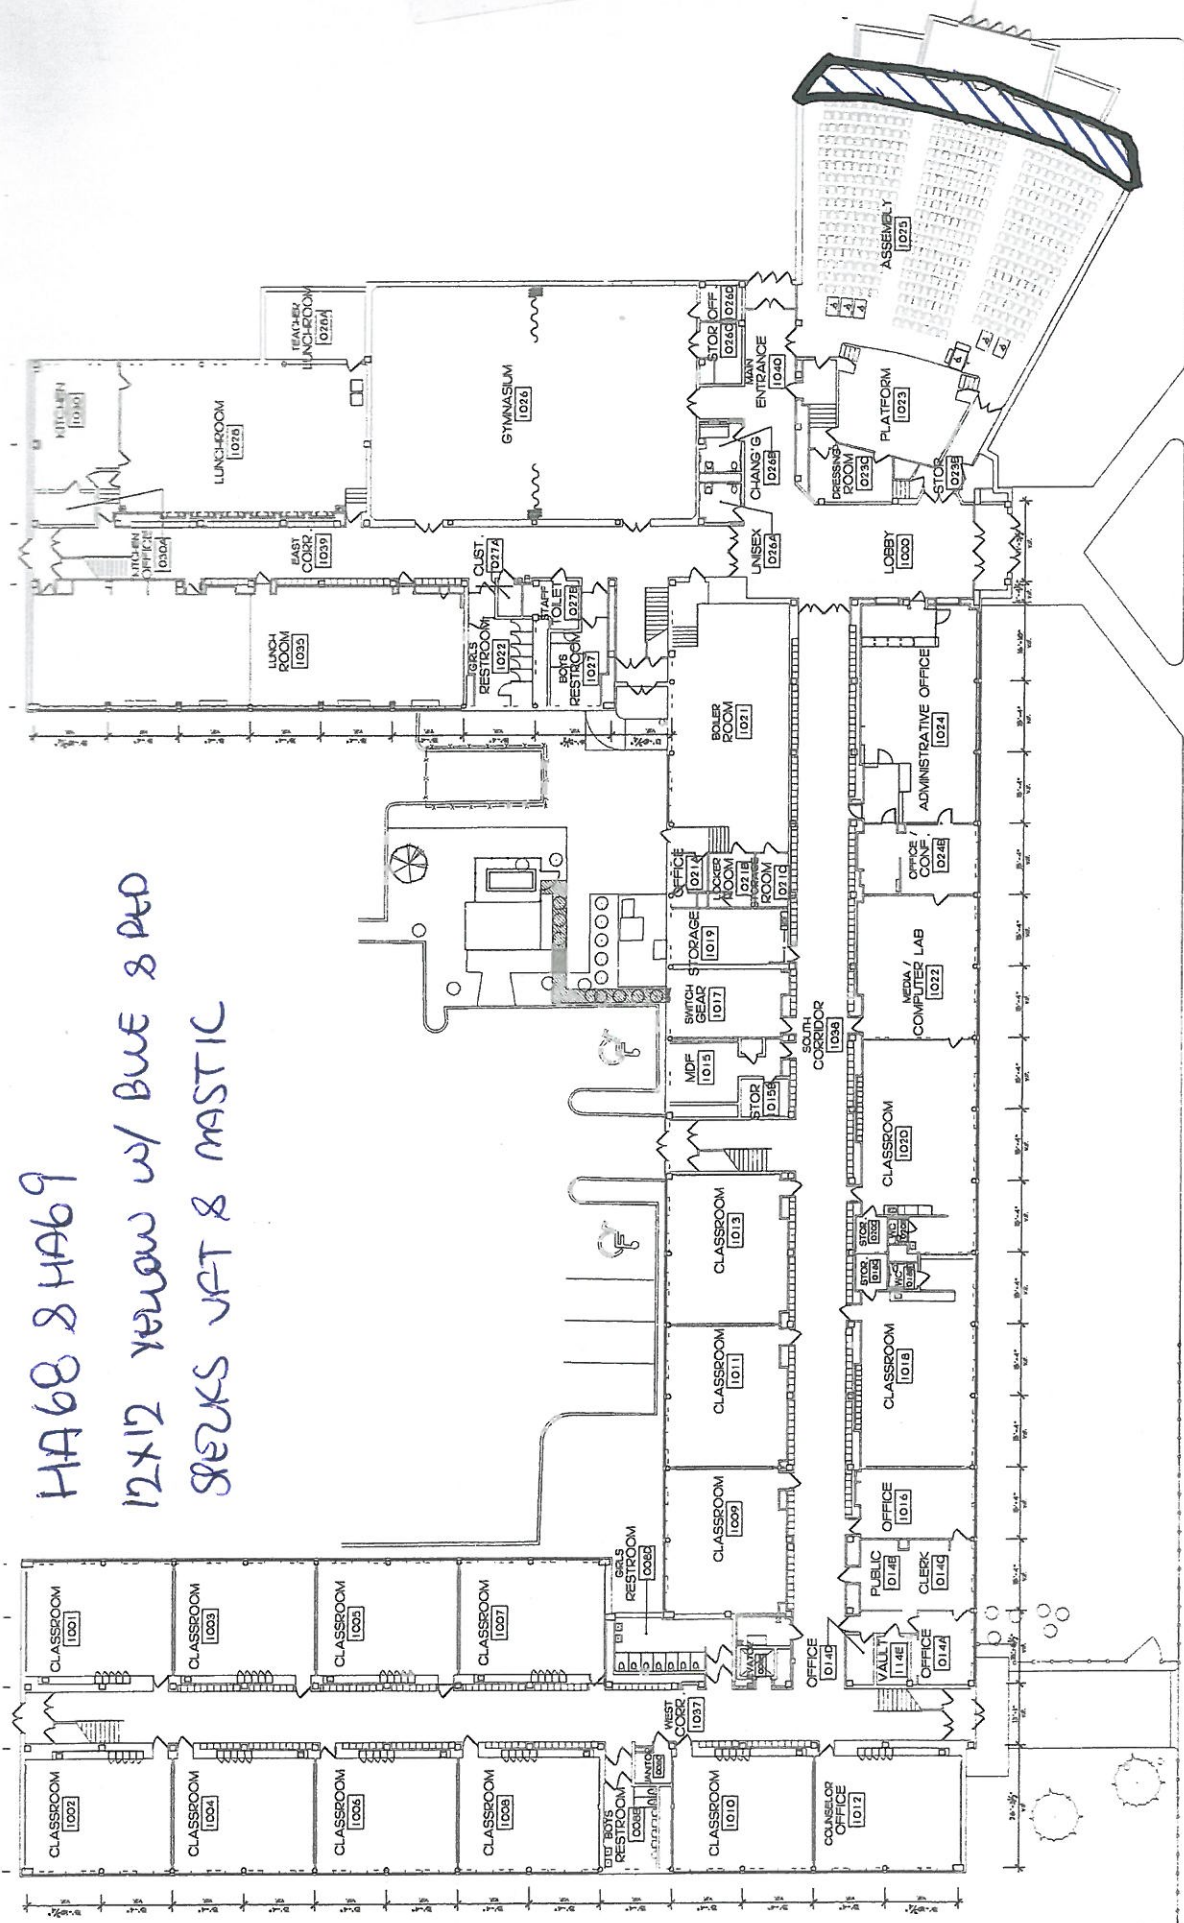
HA 68 & HA 69
 12x12 yellow w/ blue & red
 SLEKS VFT & MASTIC
