ILLINOIS DEPARTMENT OF PUBLIC HEALTH
AHERA THREE YEAR REINSPECTION
ASBESTOS ABATEMENT PROGRAM
SCHOOL INFORMATION FORM

THREE-YEAR REINSPECTION

Peterson School

REPORT DATE:

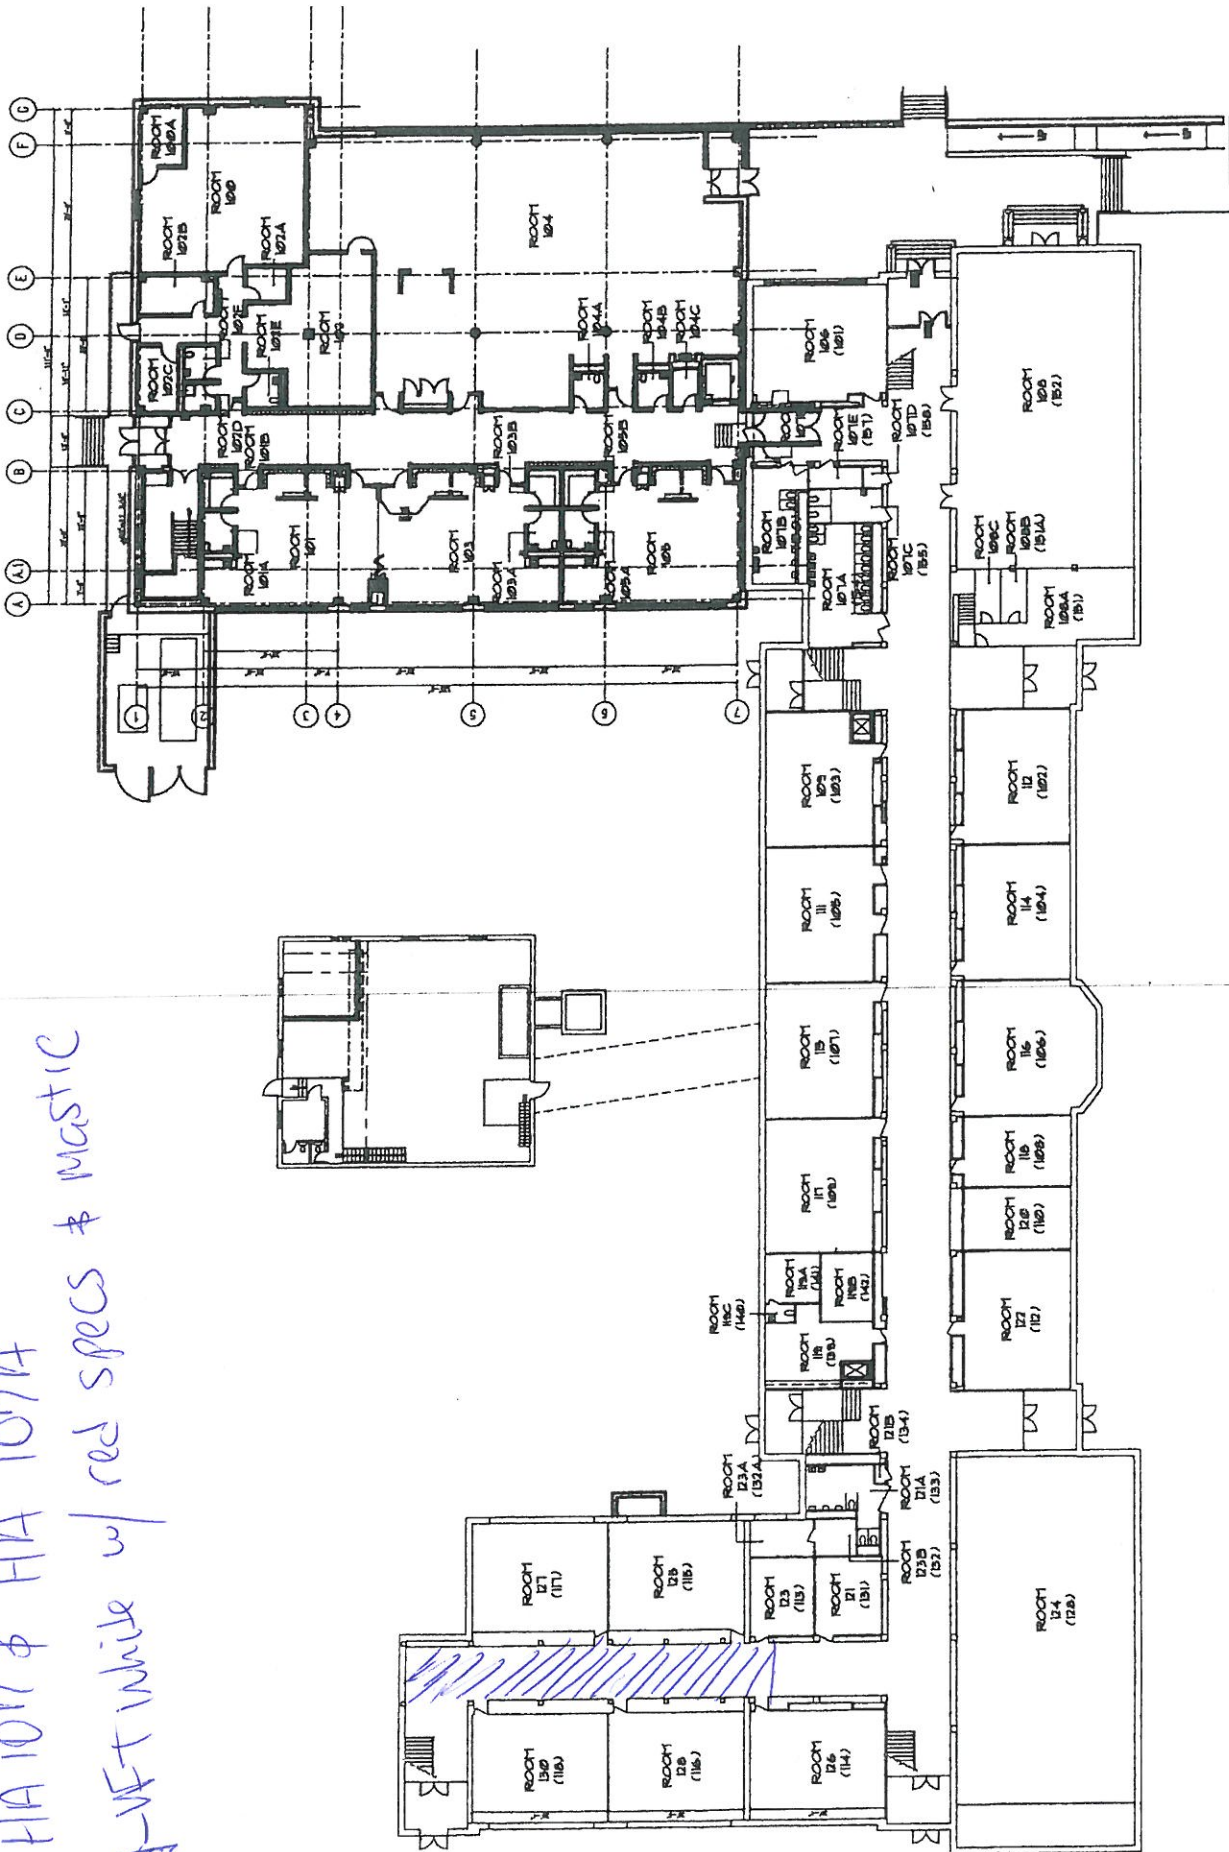
HA 107 & HA 107A
 VFT white w/ red specs & mastic

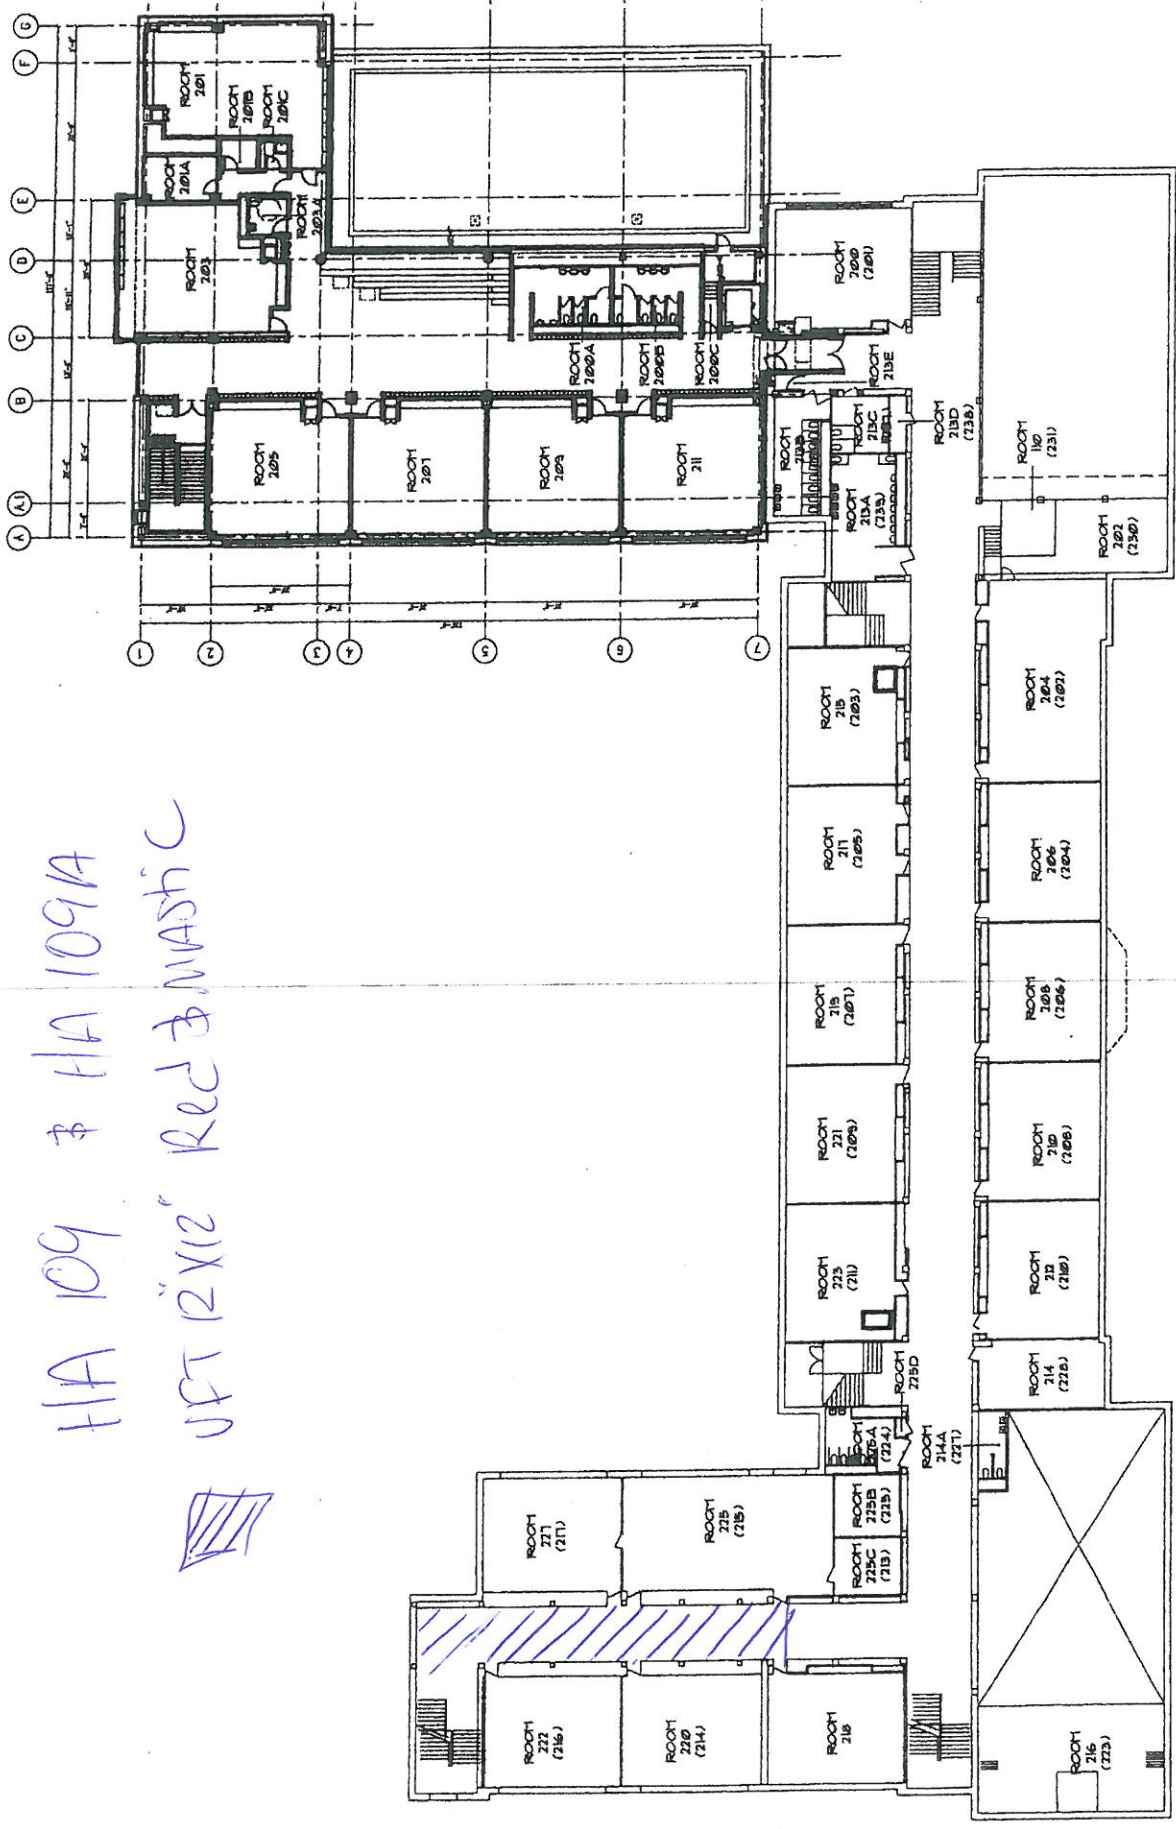
HA 109 & HA 109A
 UFT 12'x12' Red Mastic

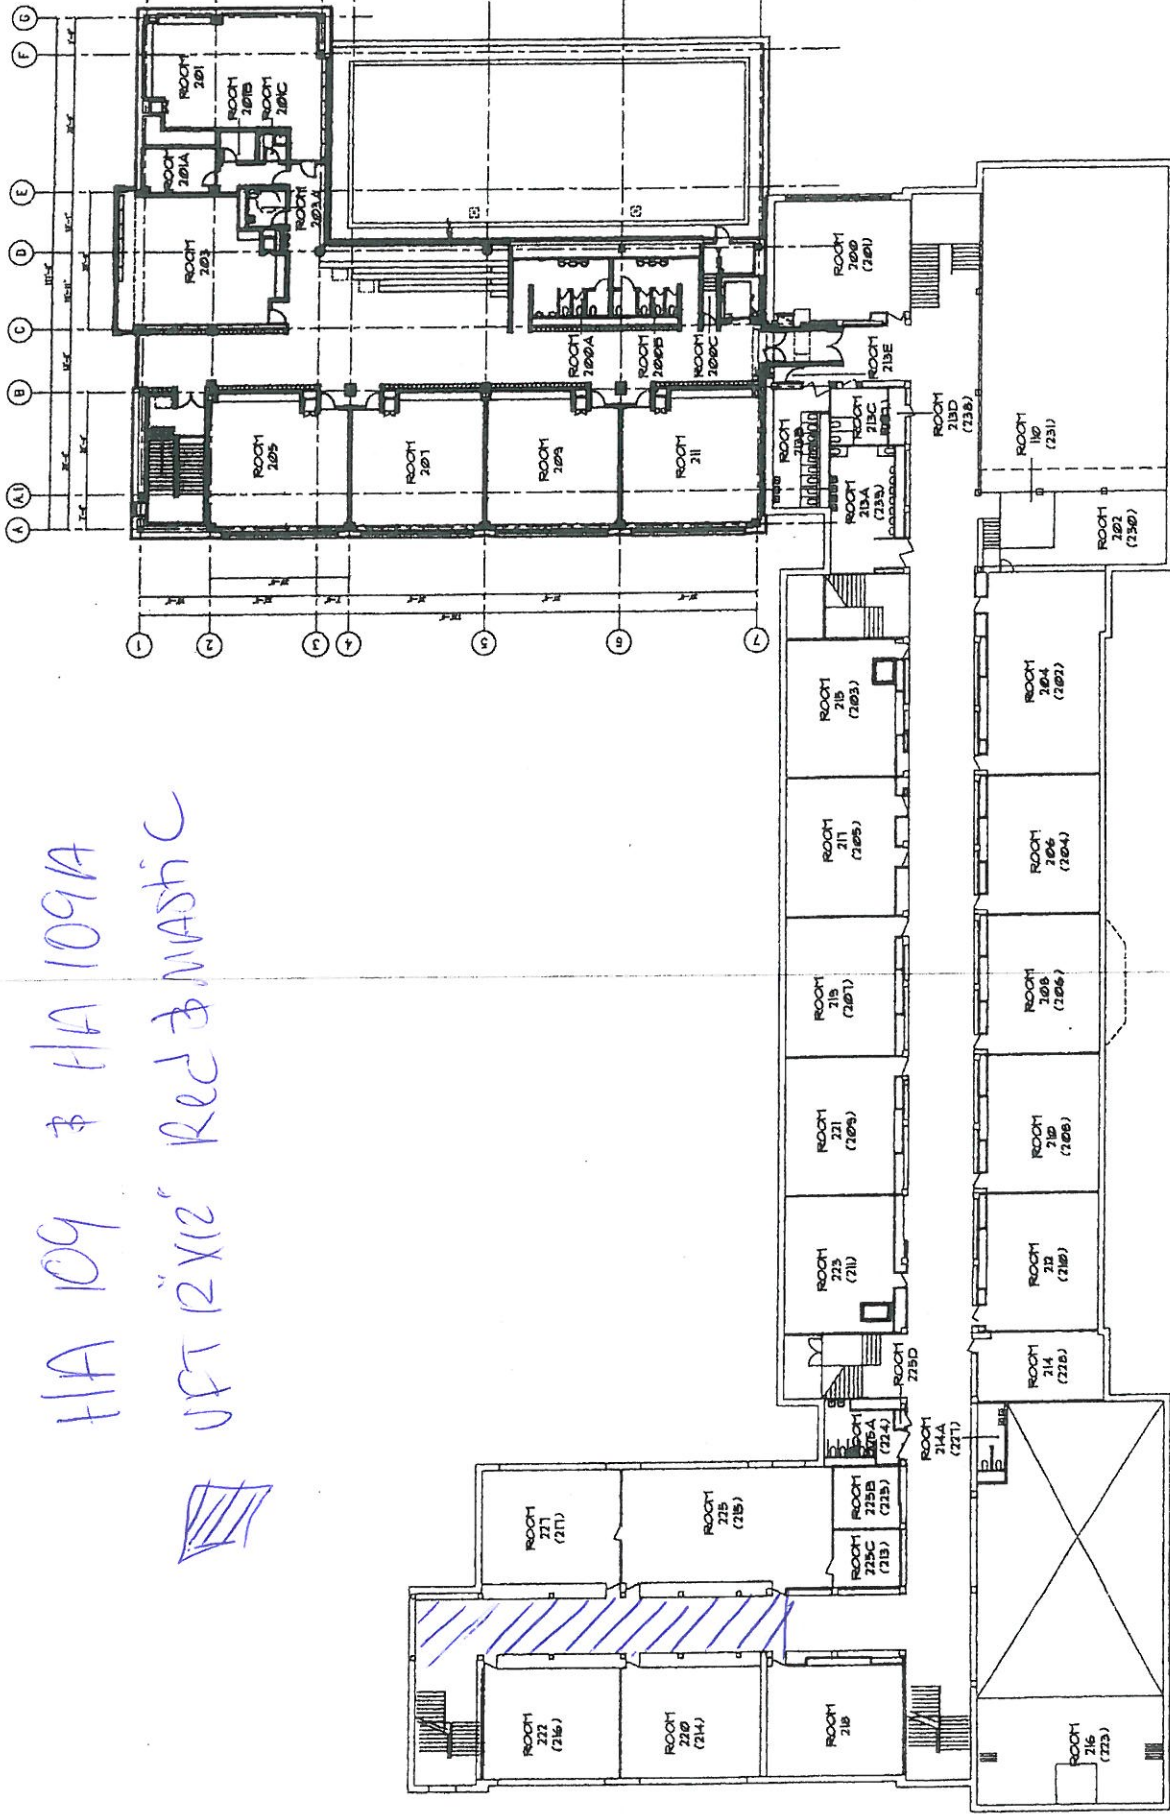
HA 109 & HA 109/A
 UFT 12'x12' Red Mastic

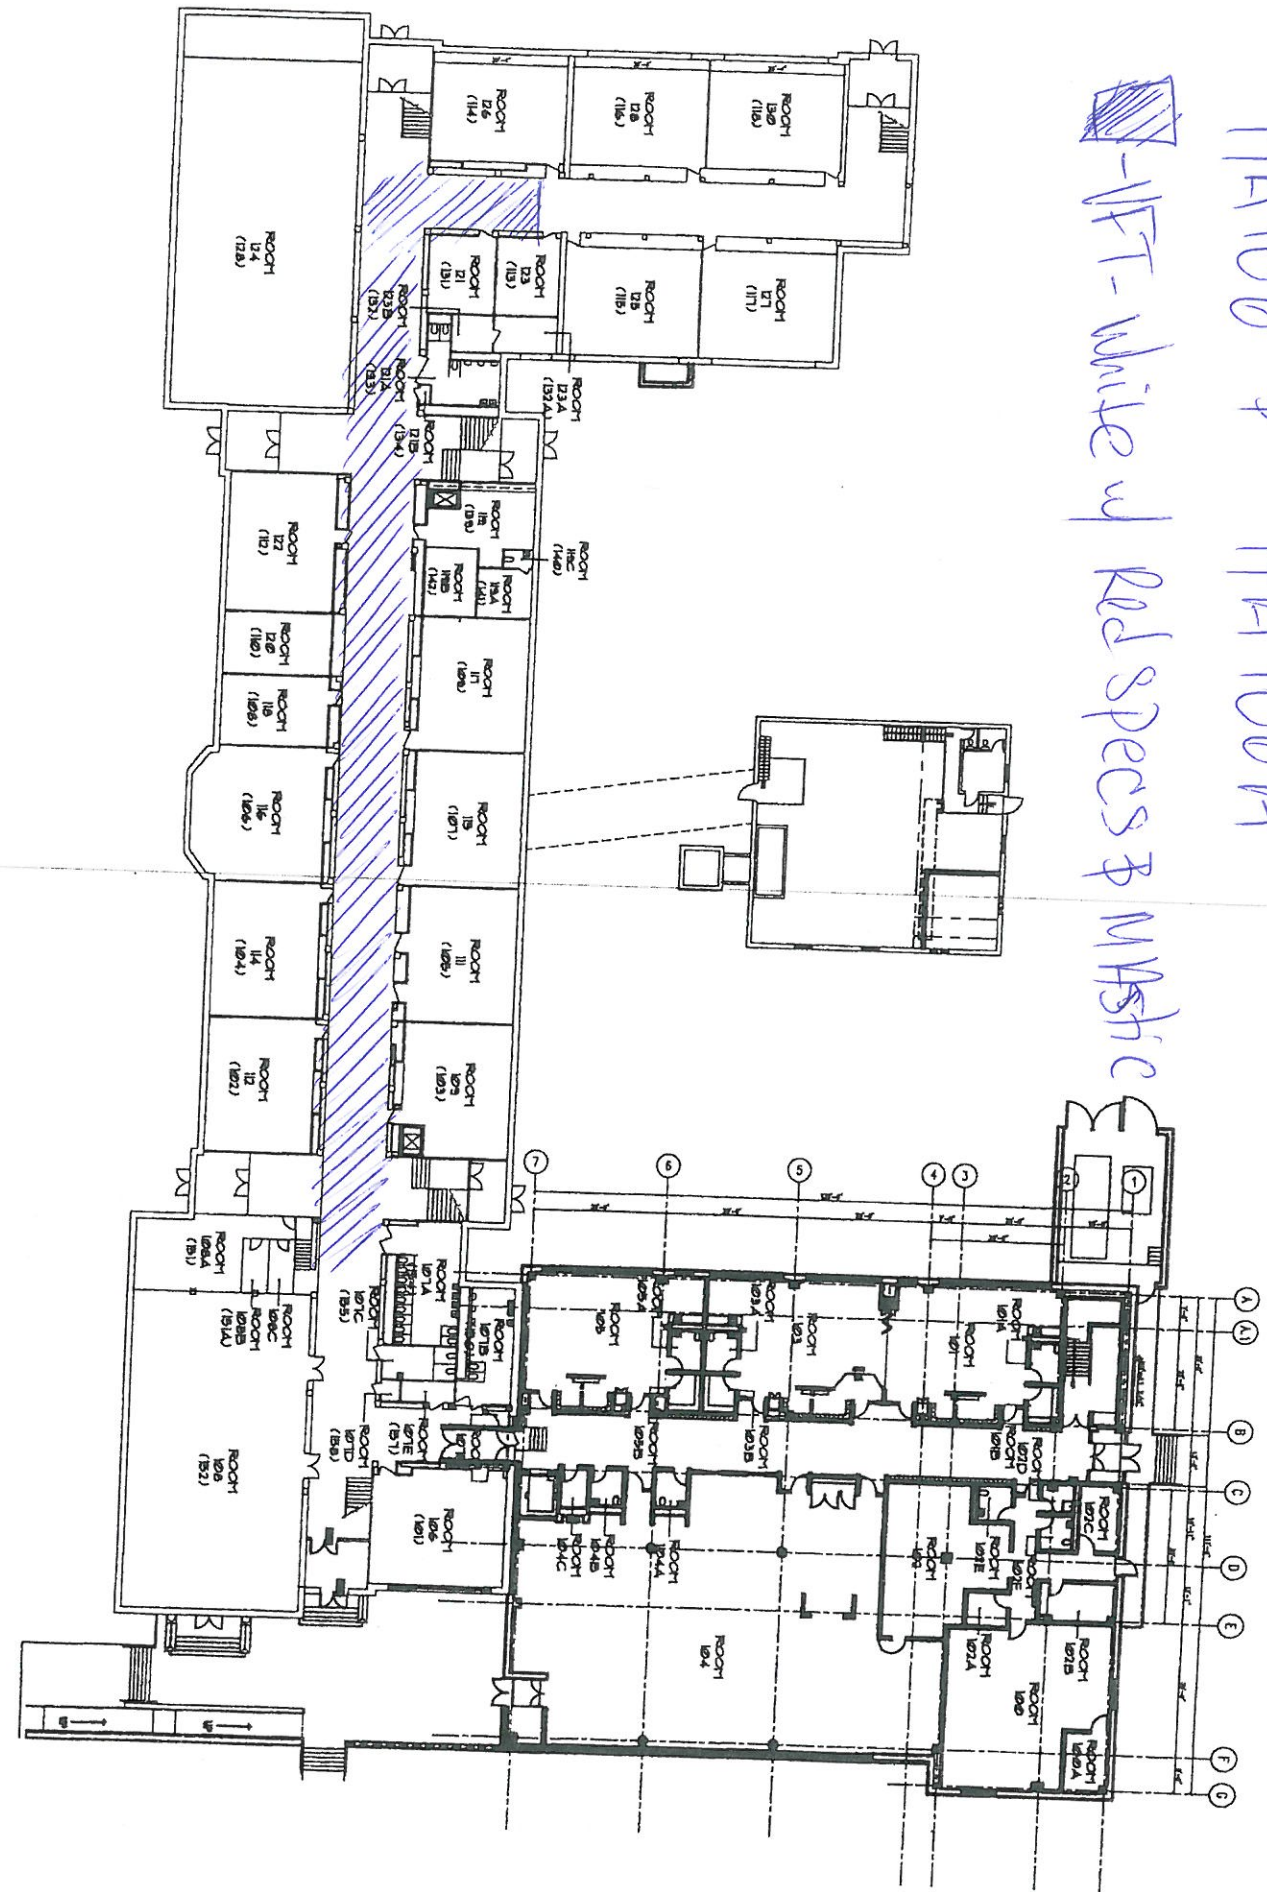
HA106 & HA106A

11FT-White w/ Red Specs & Mastic

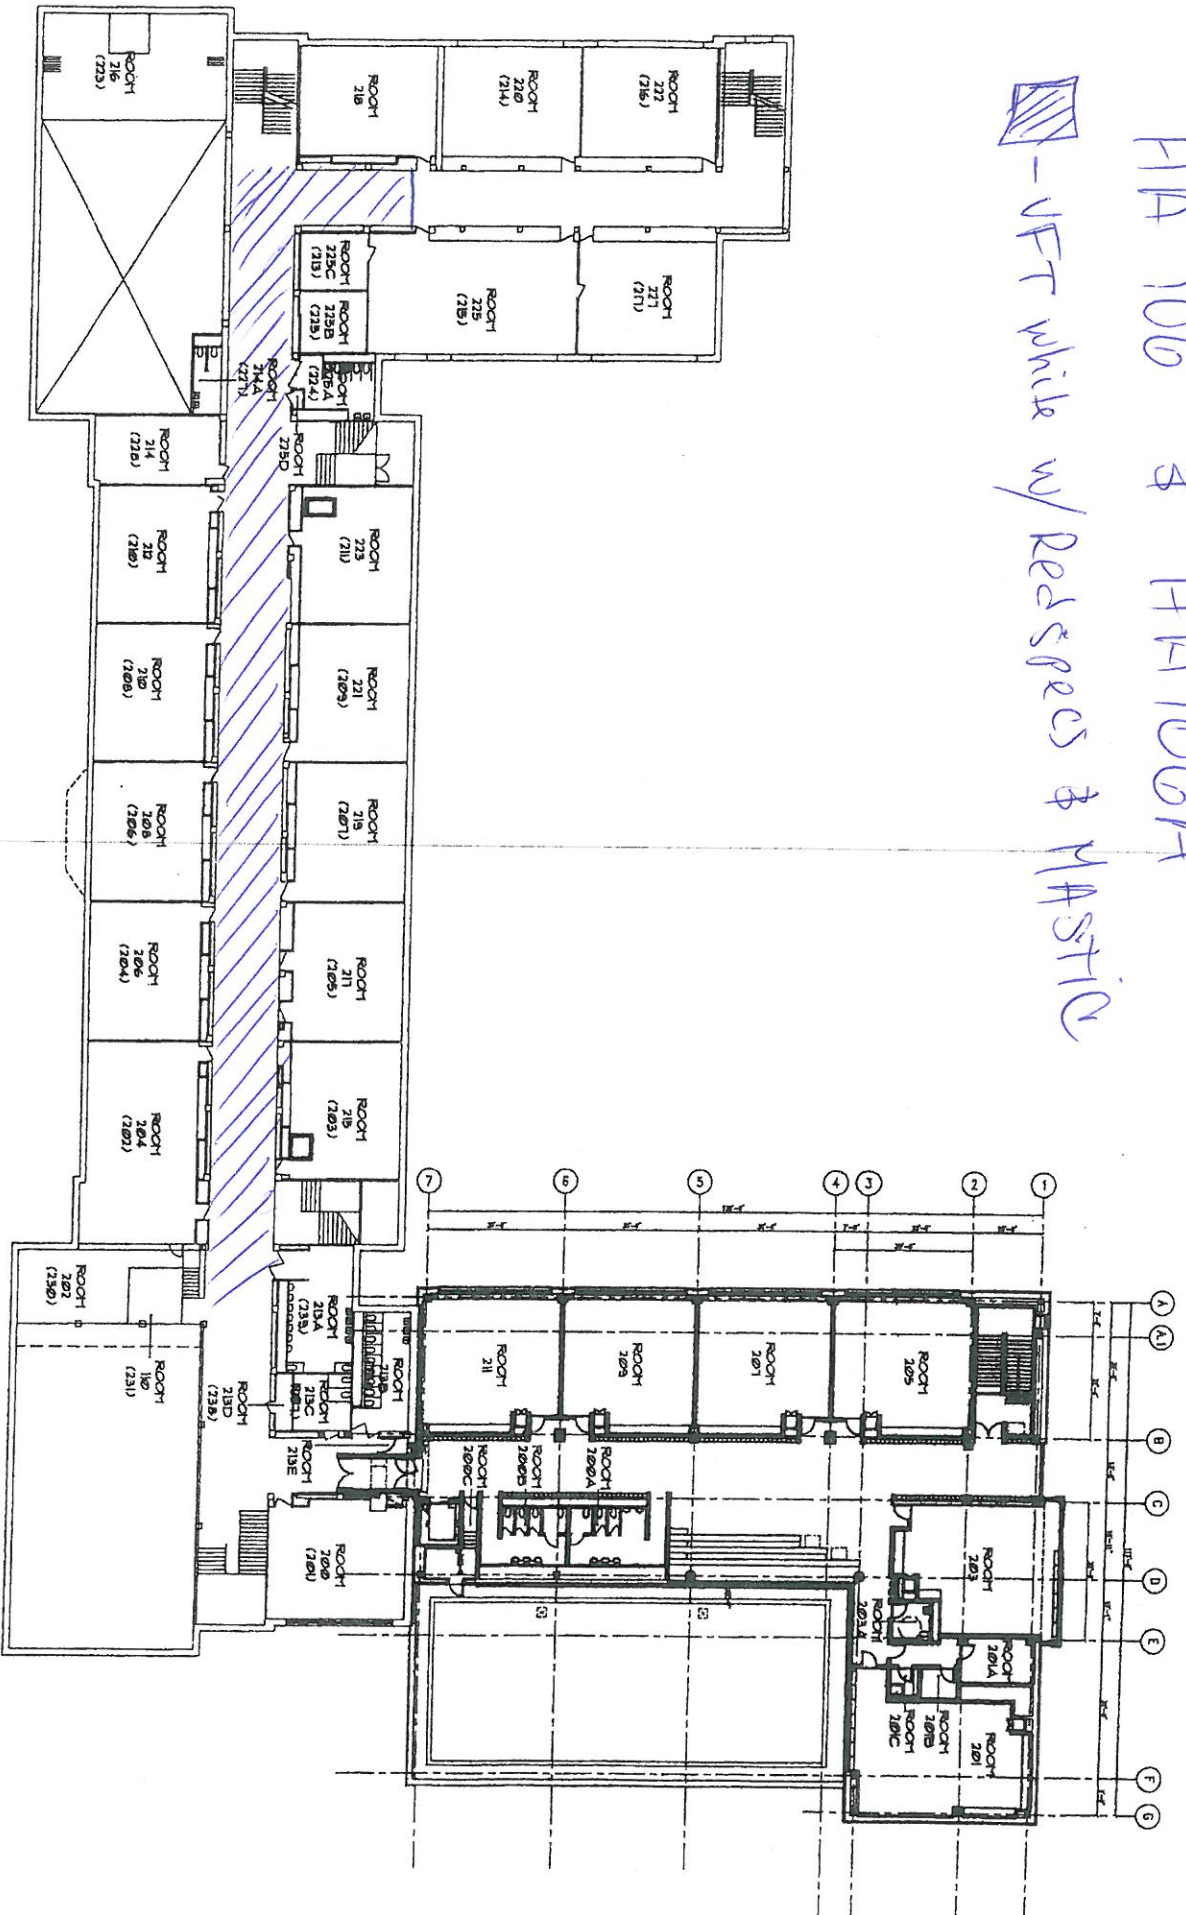
HA 106 & HA 106A
 - VET white w/ Red spec & Mastic

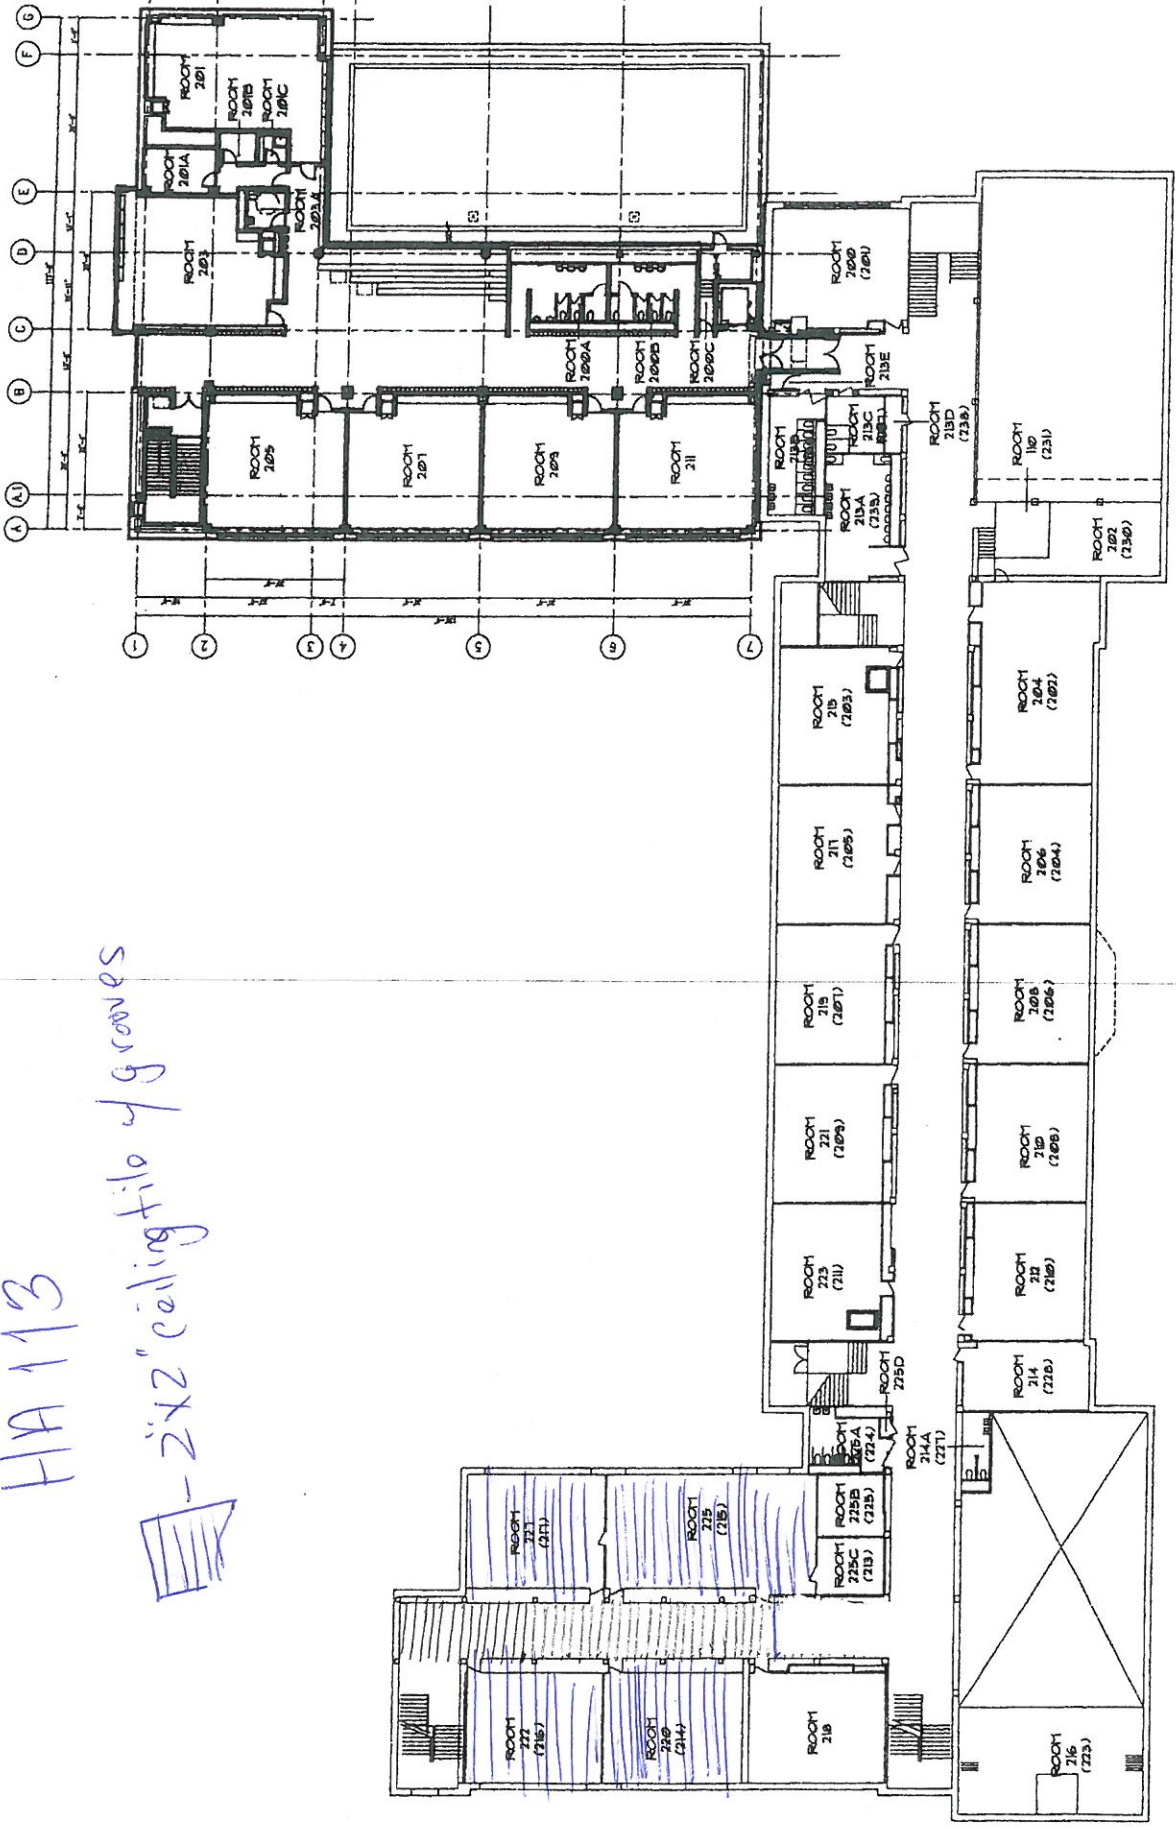
HA 113

2'x2' ceiling tile grooves

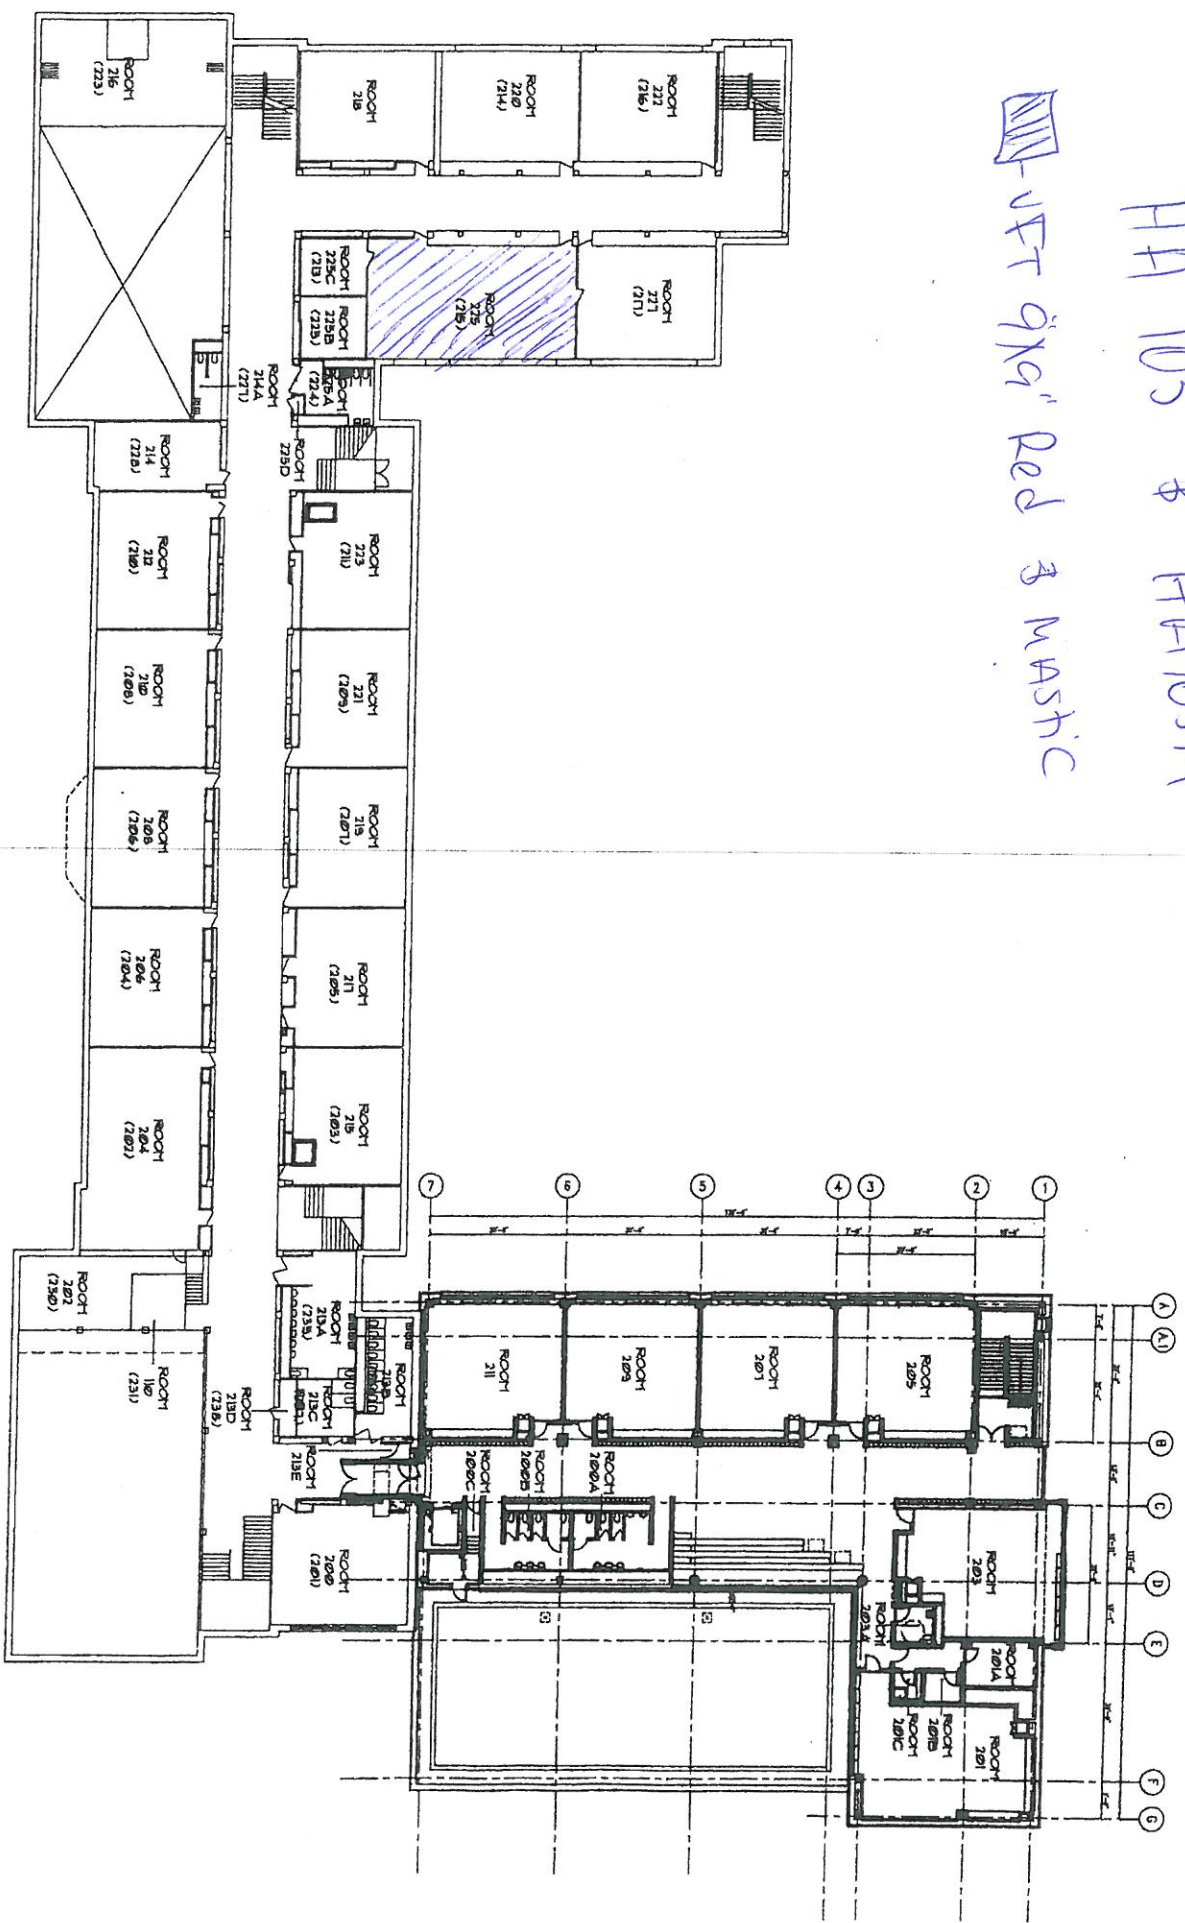
HA 105 & HA105A

11FT 9X9" Red & MASHIC

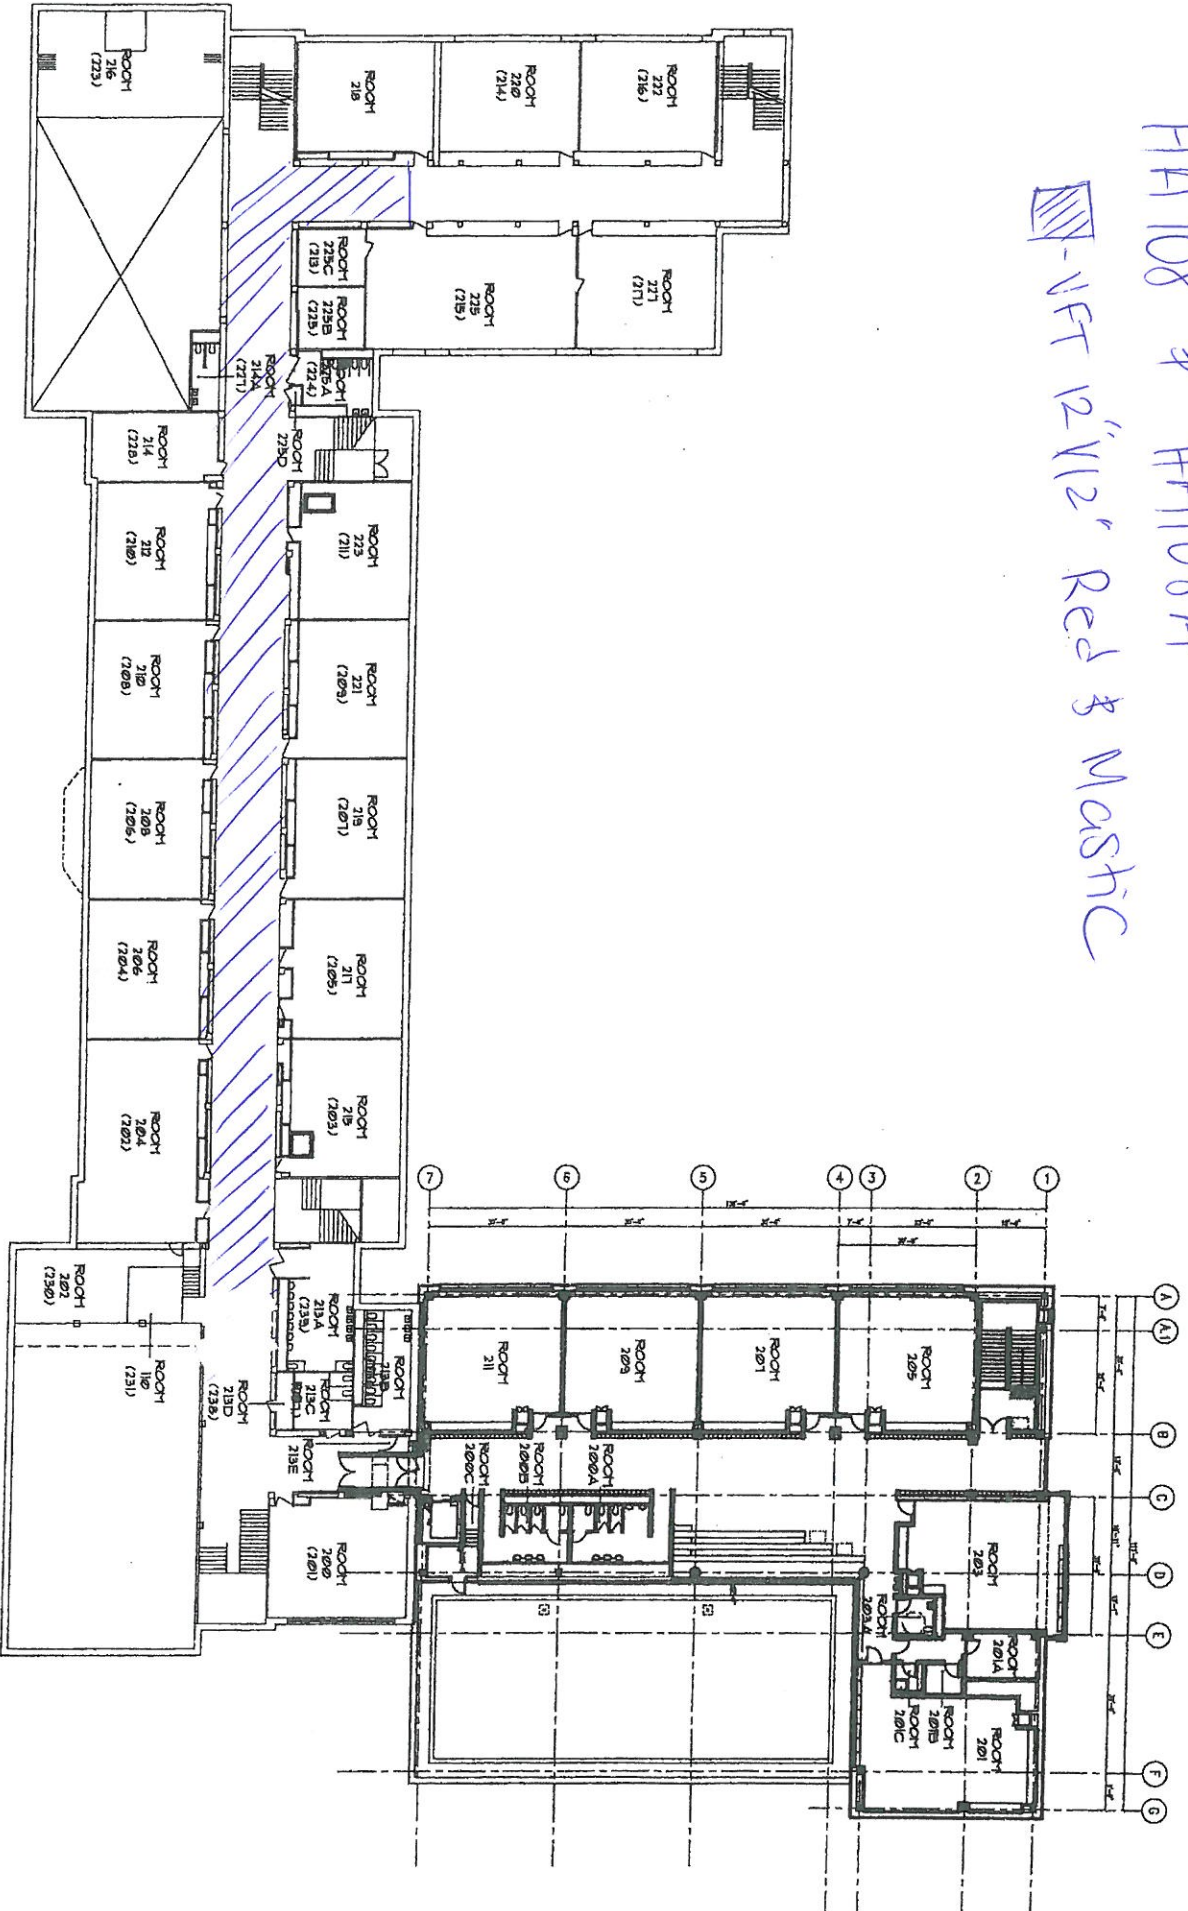
HA108 & HA108A
 -VFT 12"V12" Red & Mastic

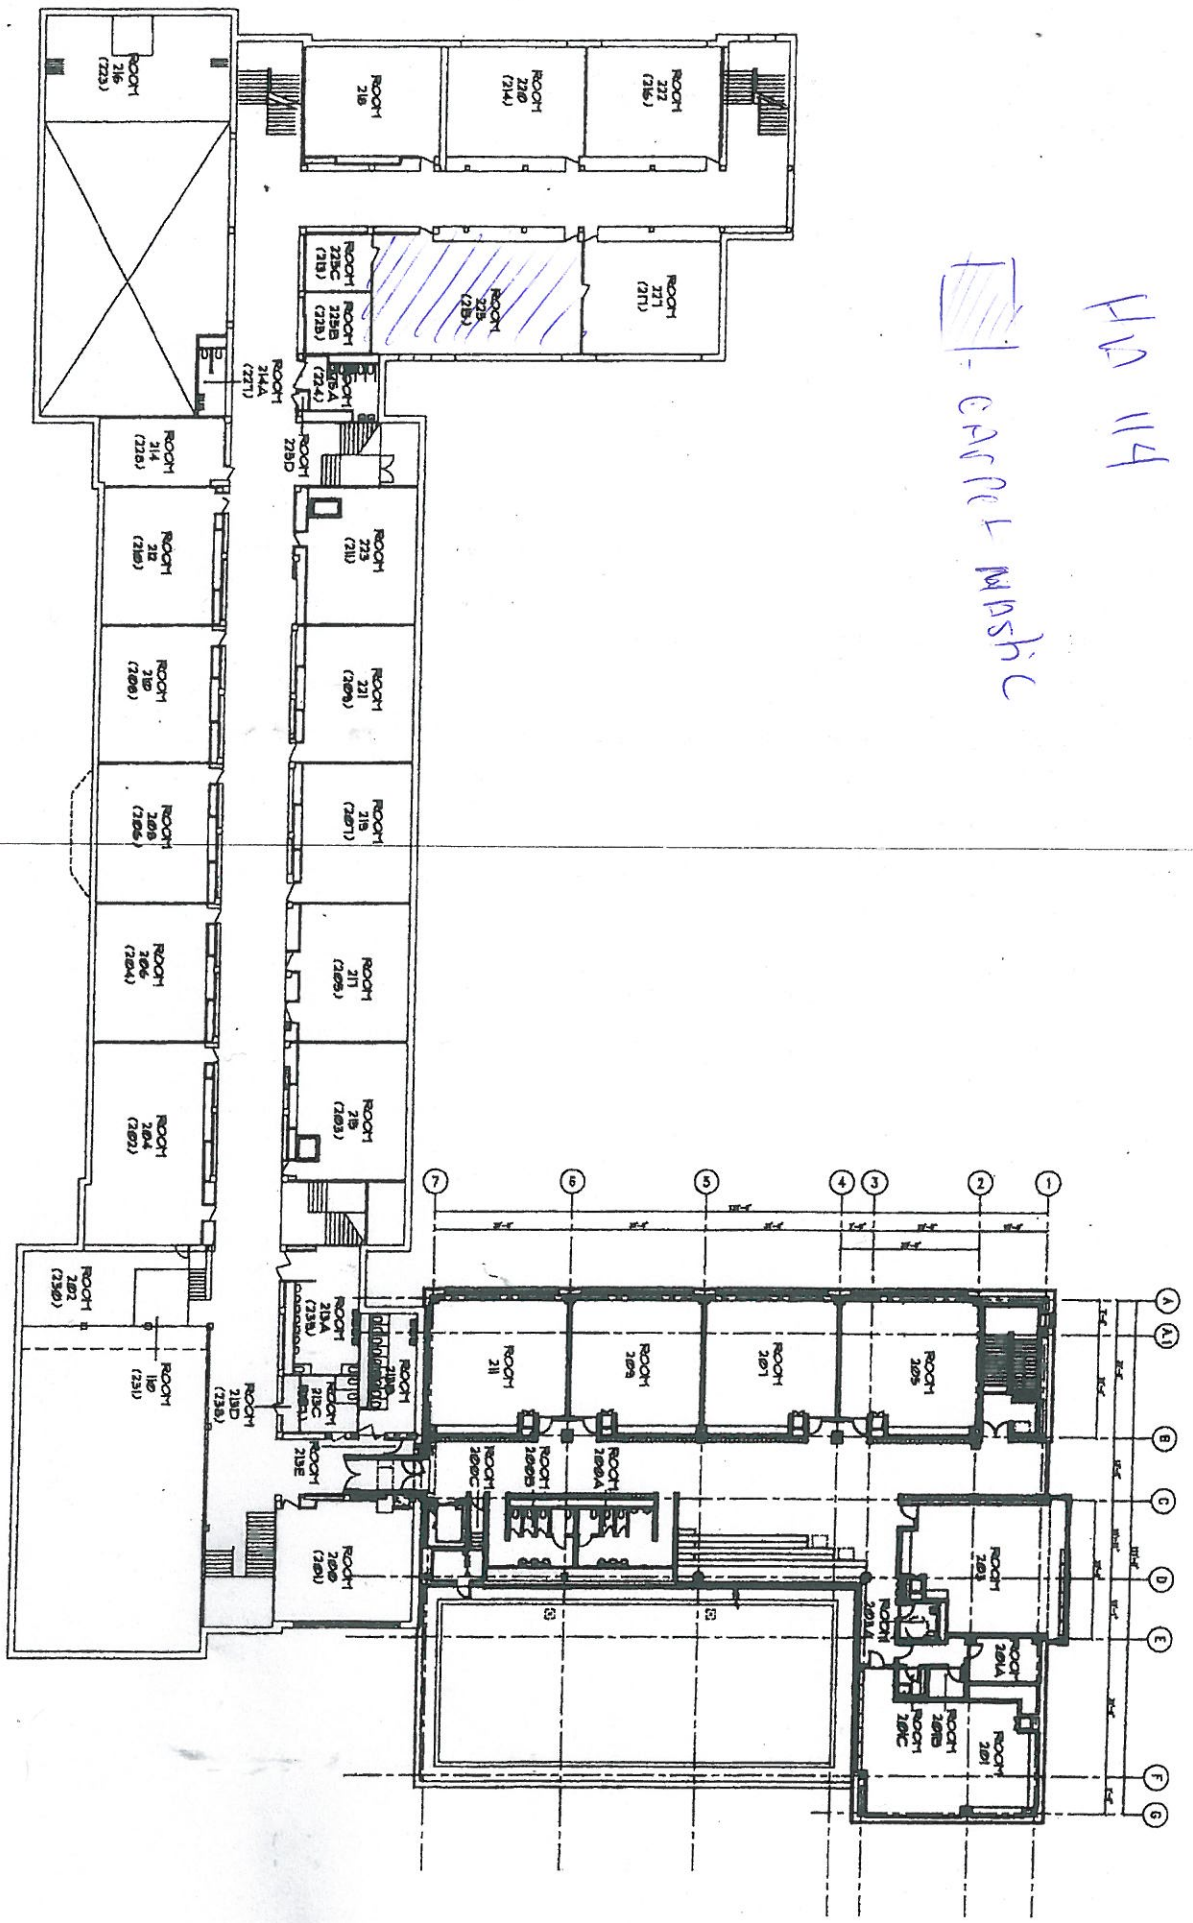
HD 114

Carpet Washic

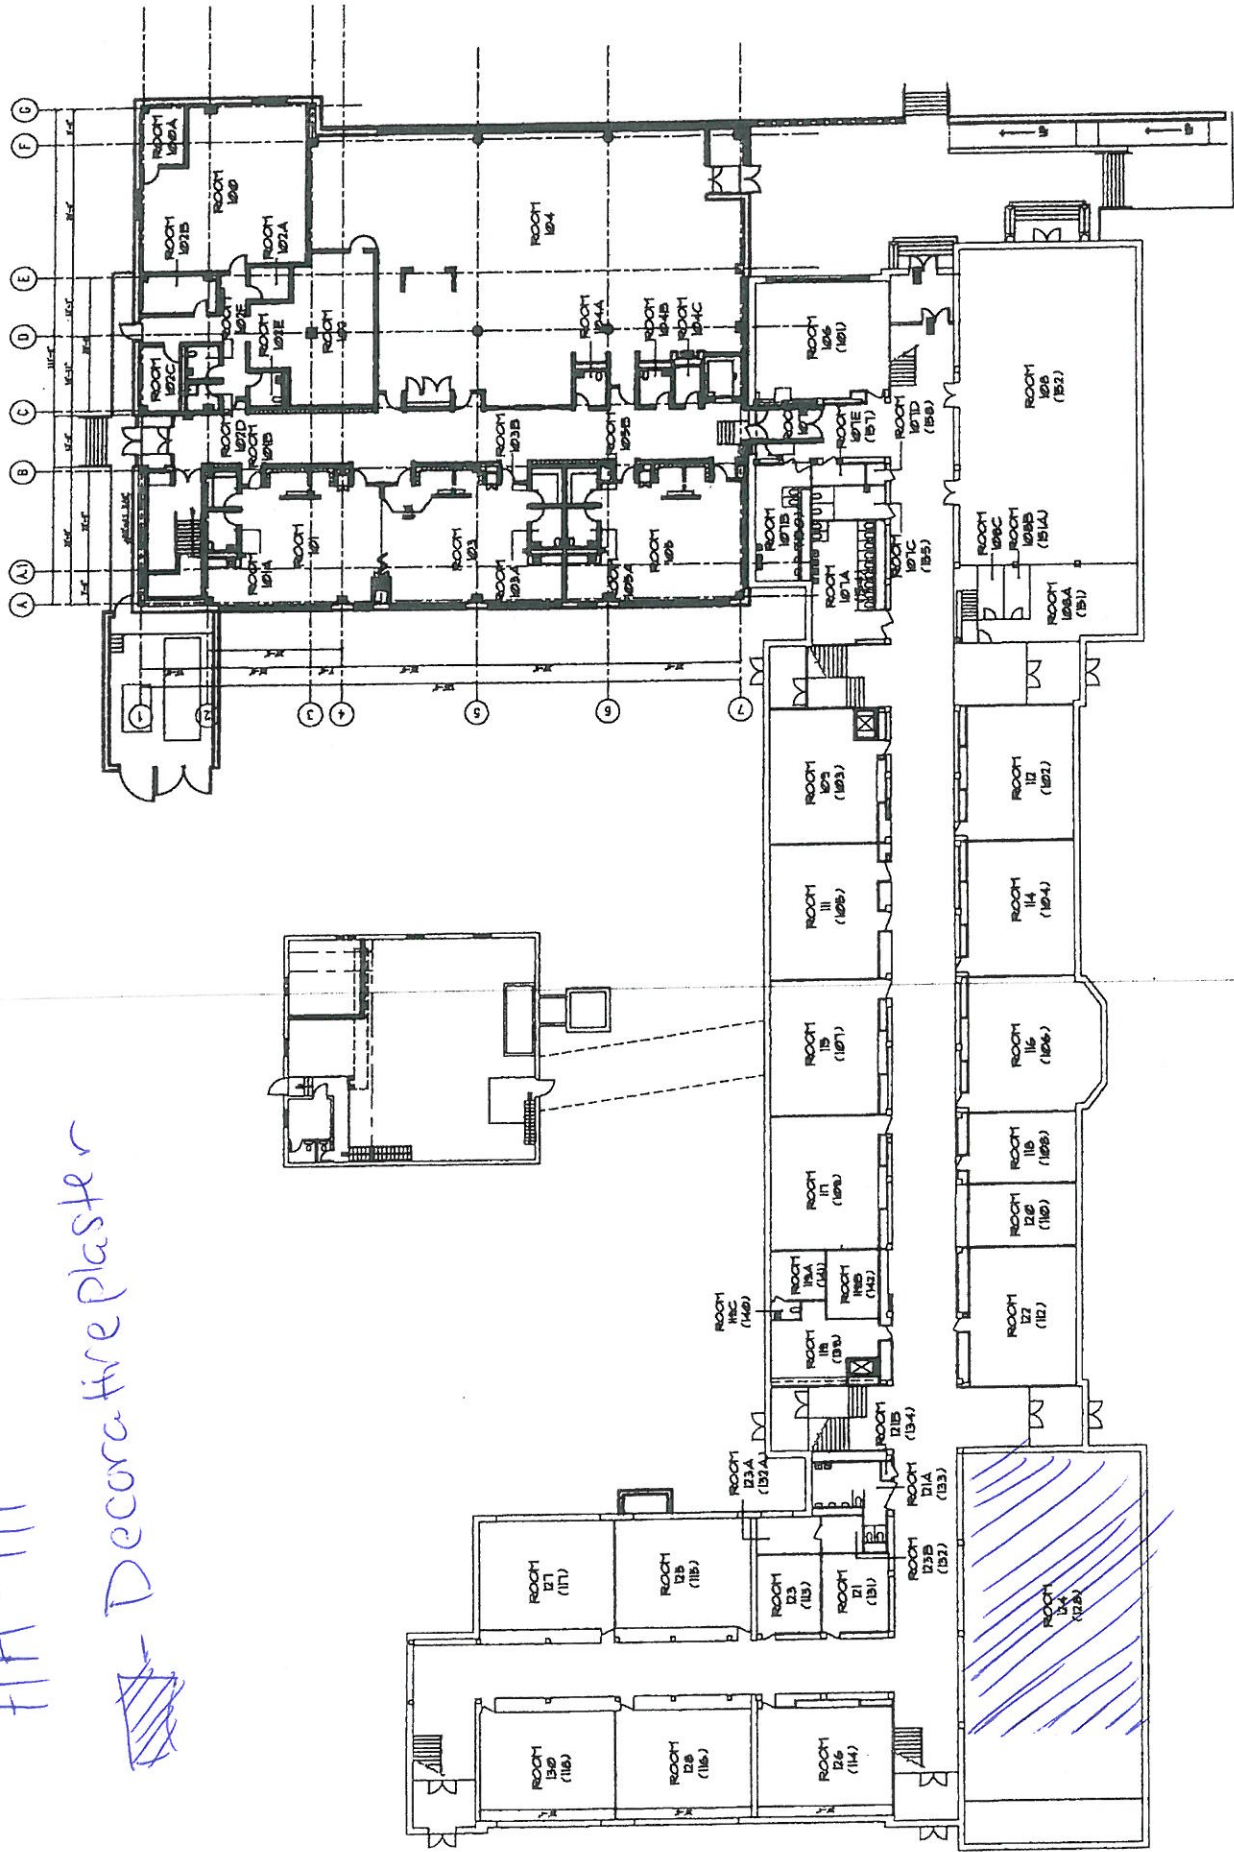
HA-111

Decorative plaster
