ILLINOIS DEPARTMENT OF PUBLIC HEALTH
AHERA THREE YEAR REINSPECTION
ASBESTOS ABATEMENT PROGRAM
SCHOOL INFORMATION FORM

THREE-YEAR REINSPECTION

Peterson School

REPORT DATE:

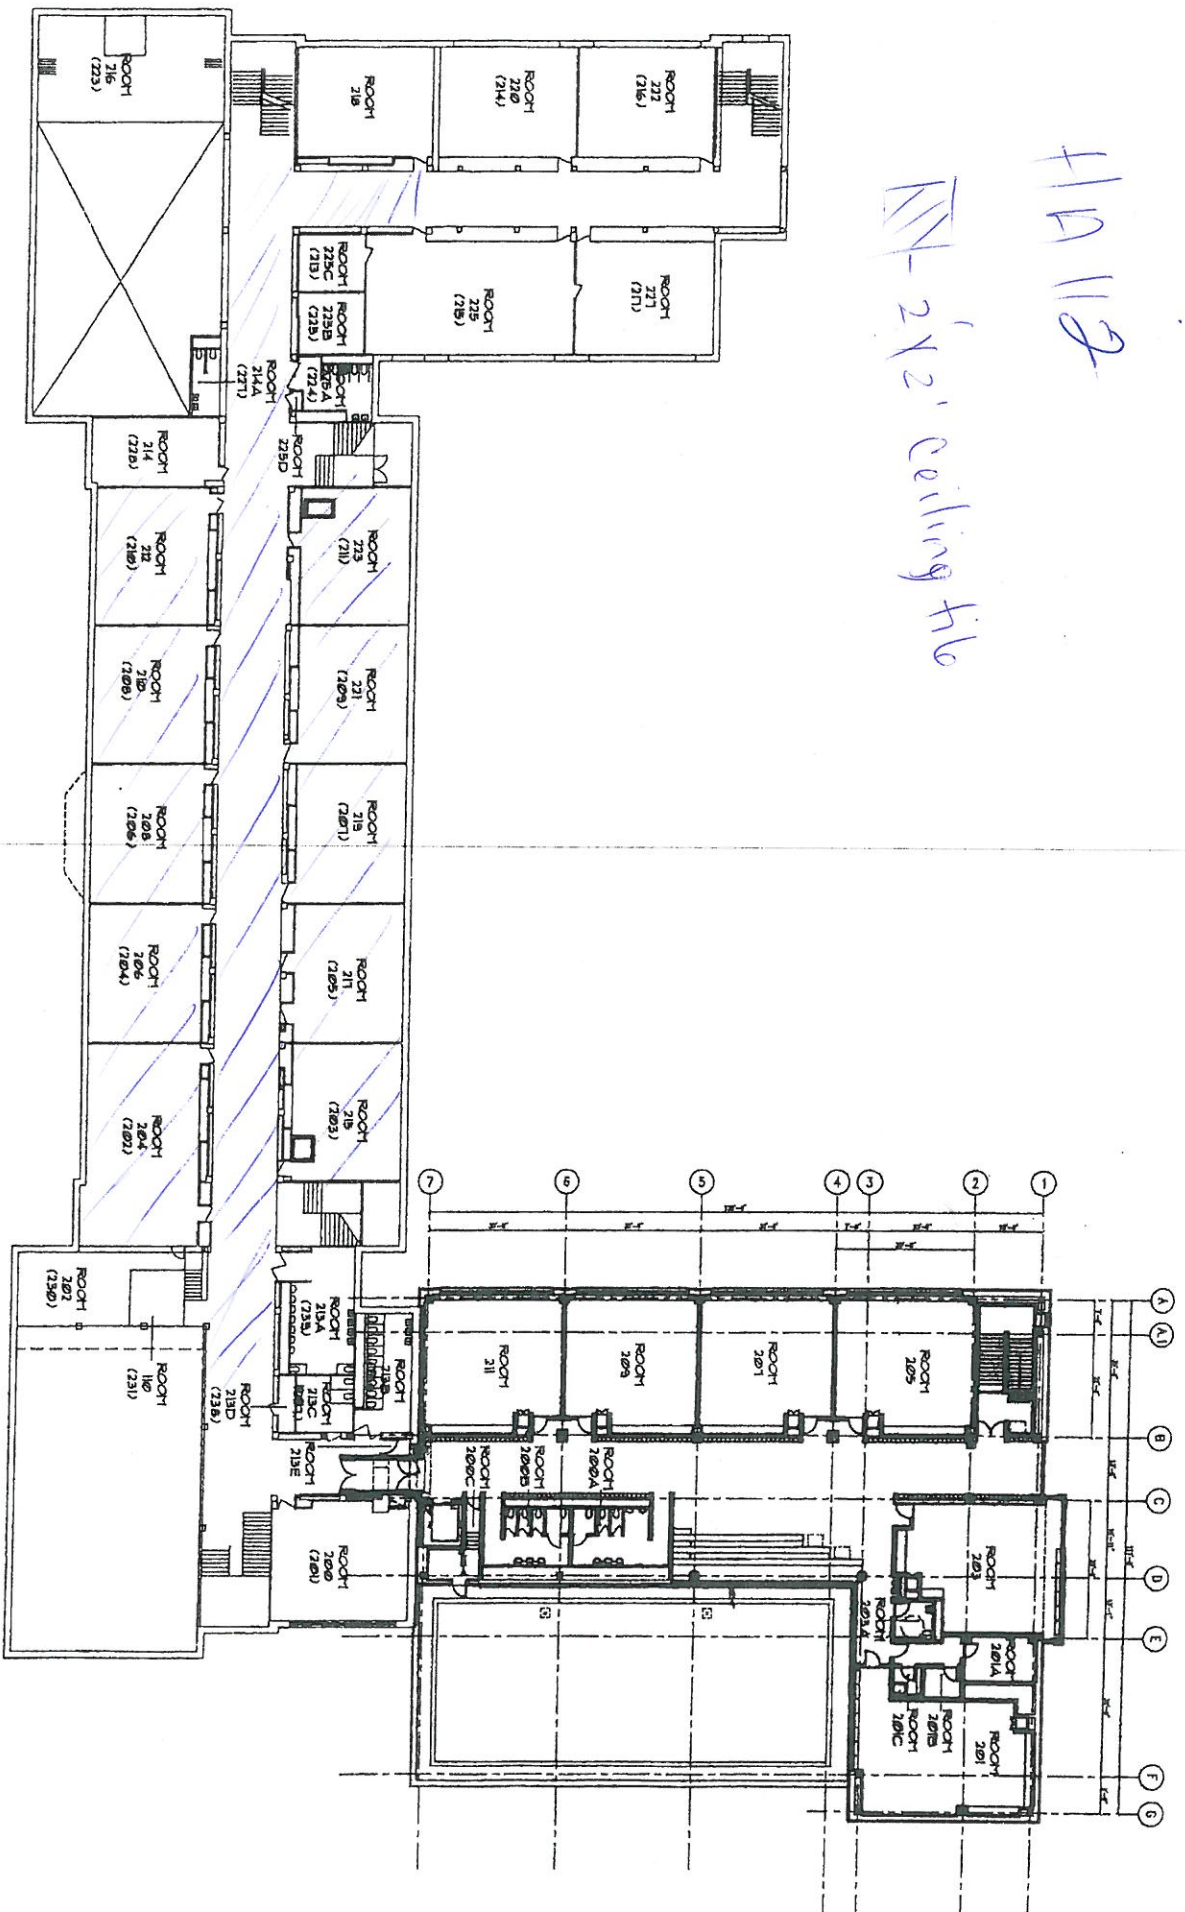
HA 112

2x2' ceiling tile

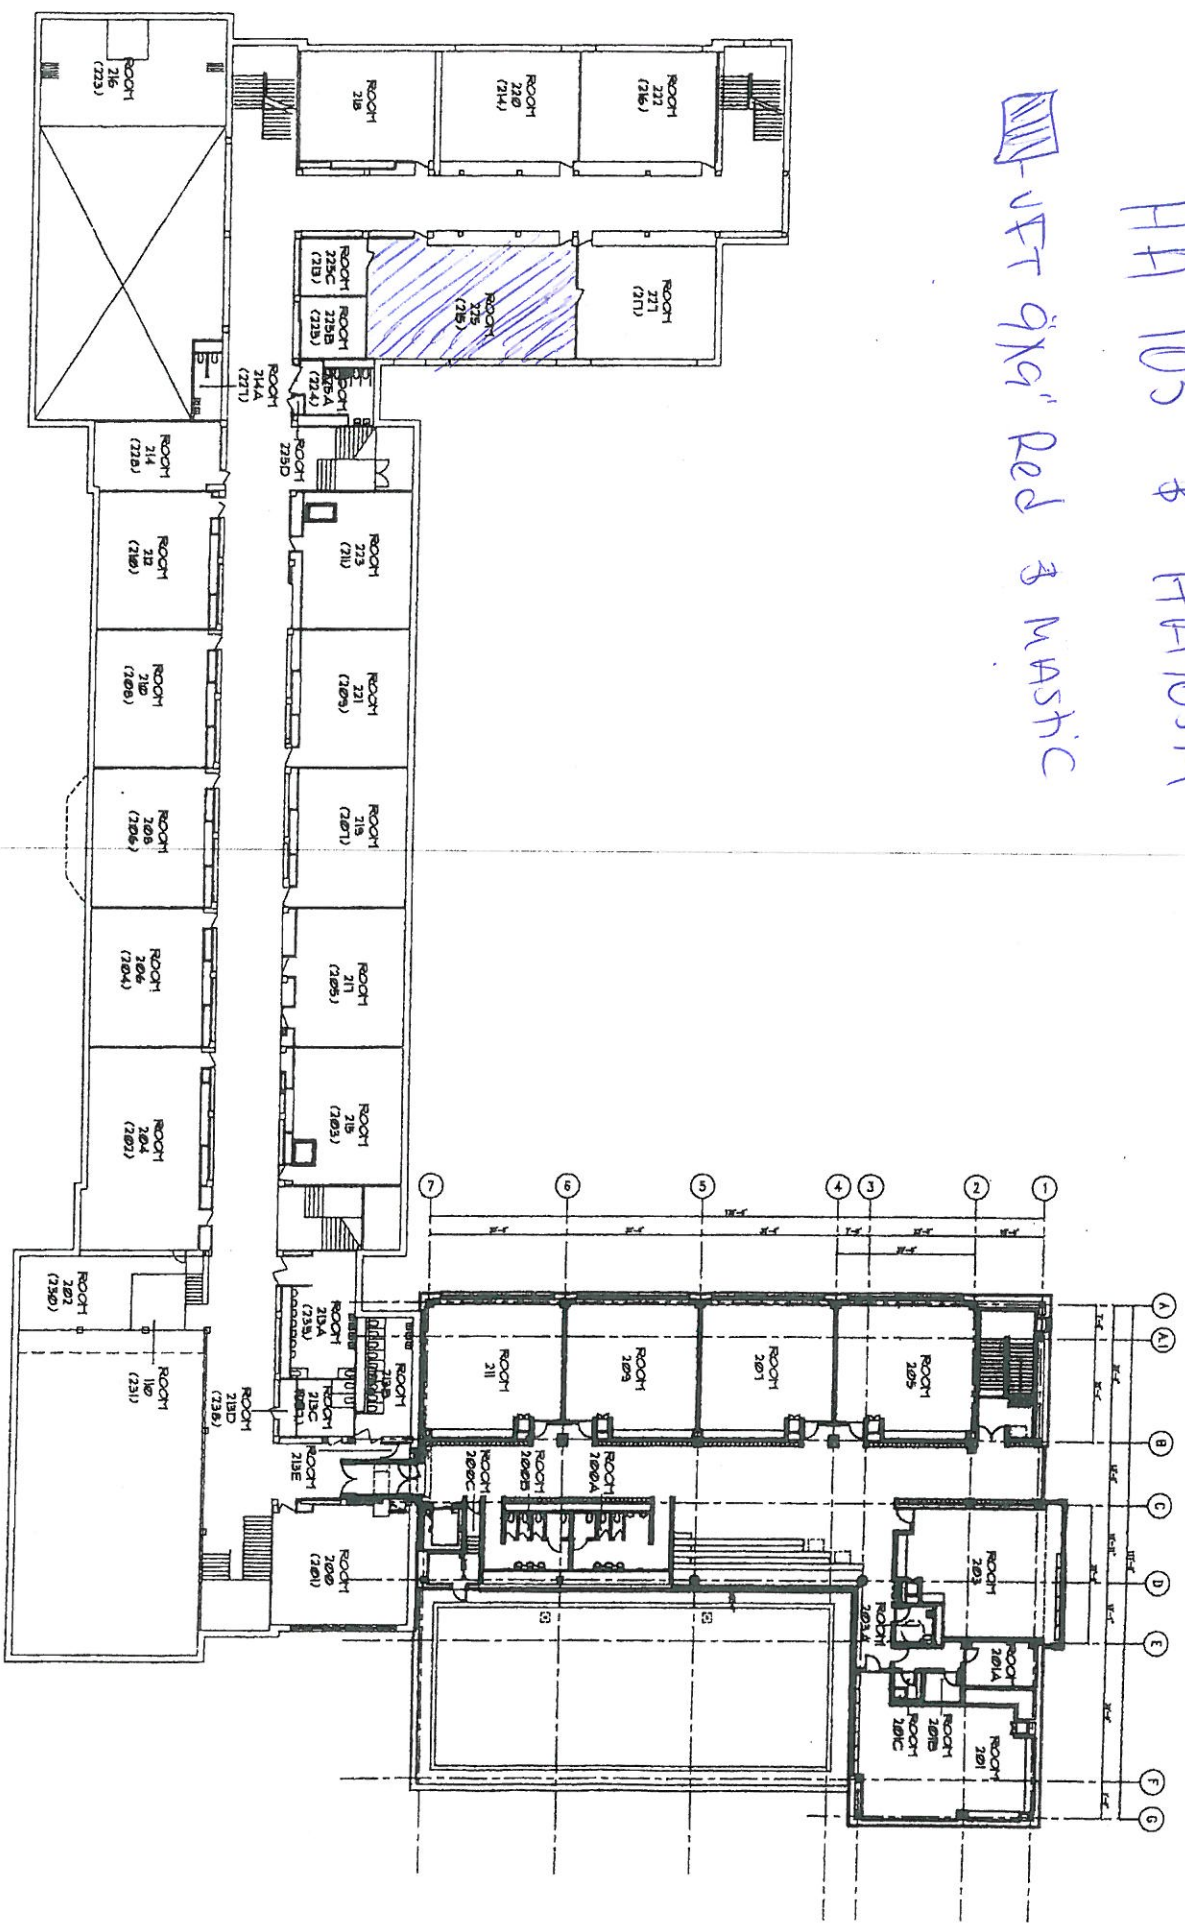
HA 105 & HA105A

11' x 9' Red & MASHIC

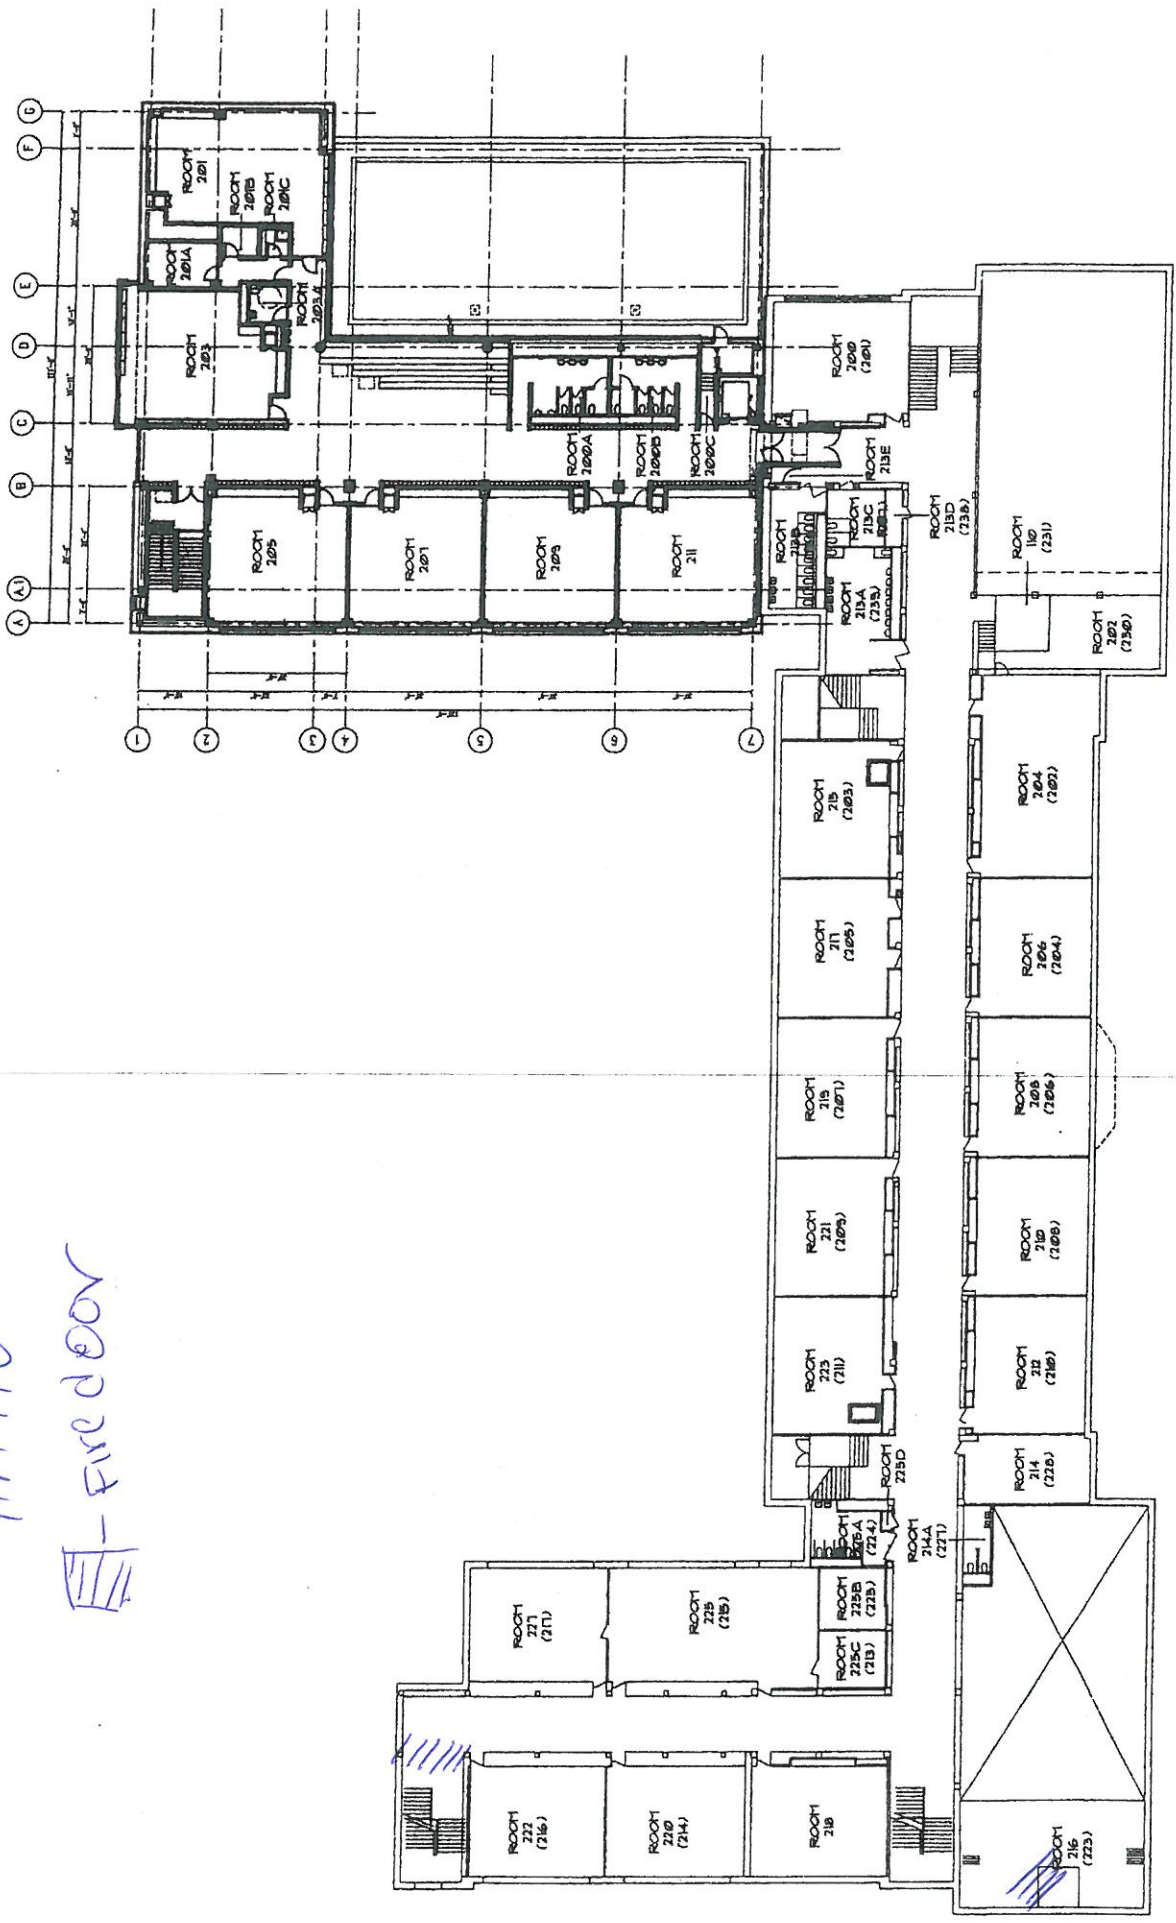
- fire door

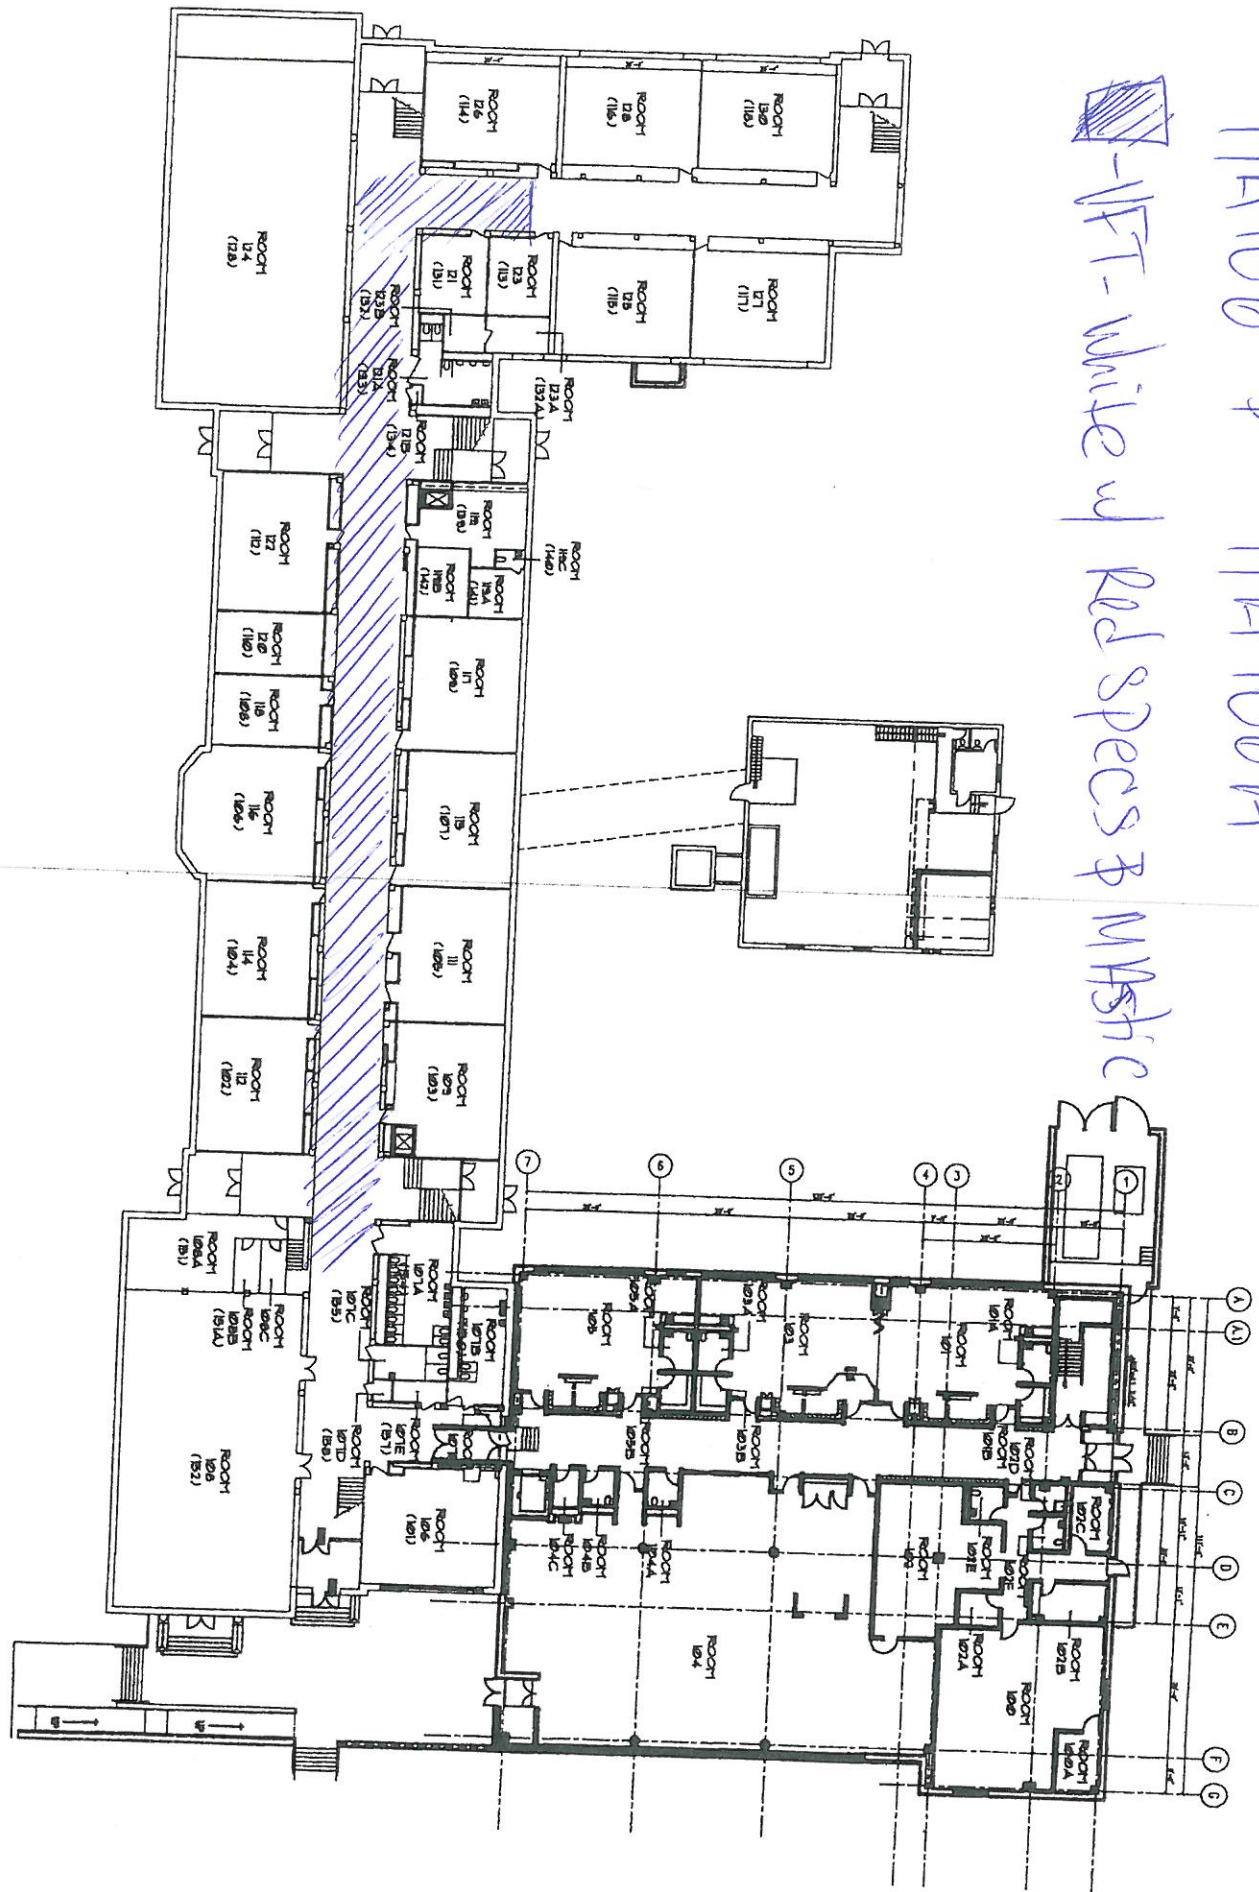
HA106 & HA106A

11FT-White w/ Red Specs & Mastic

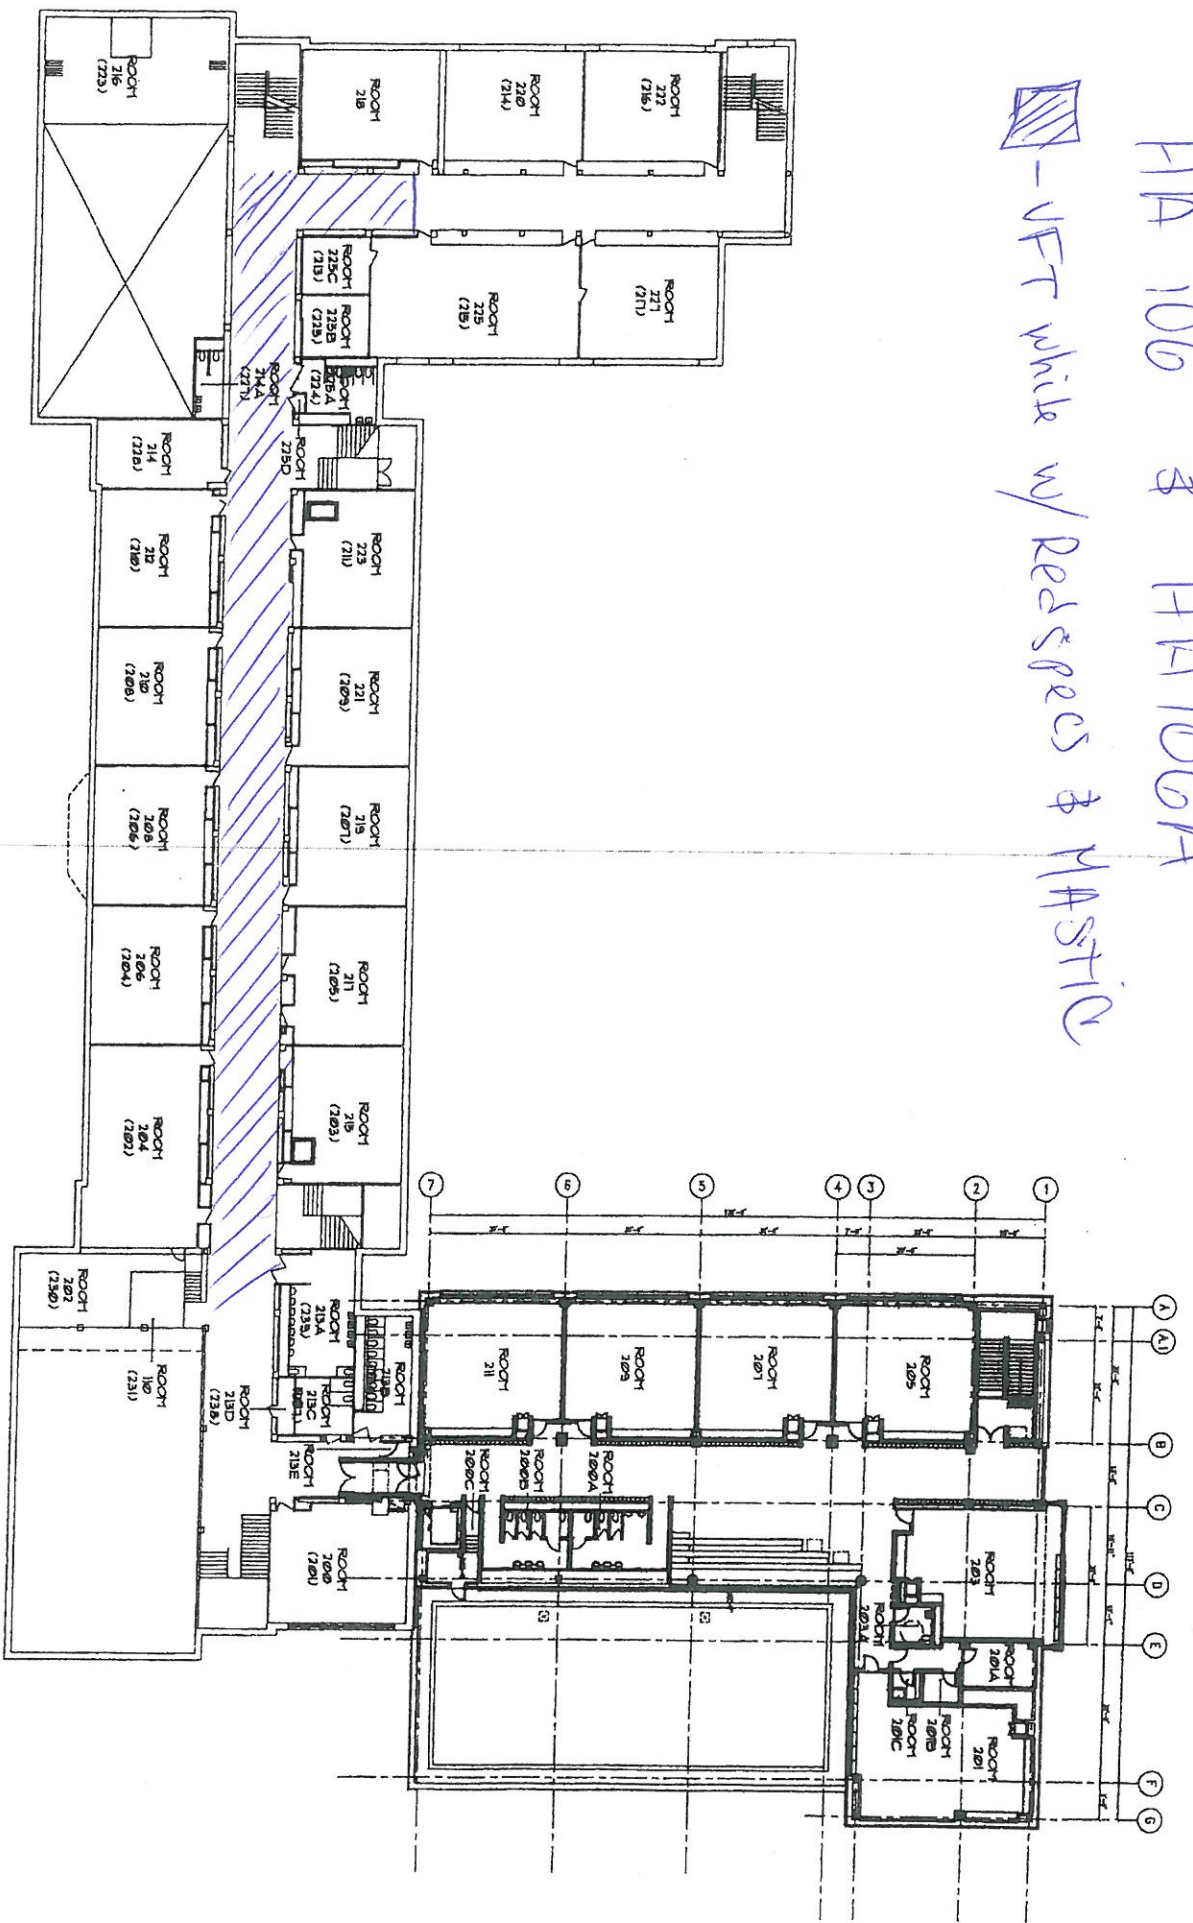
HA 106 & HA 106A

- VET white w/ Red spec & Mastic

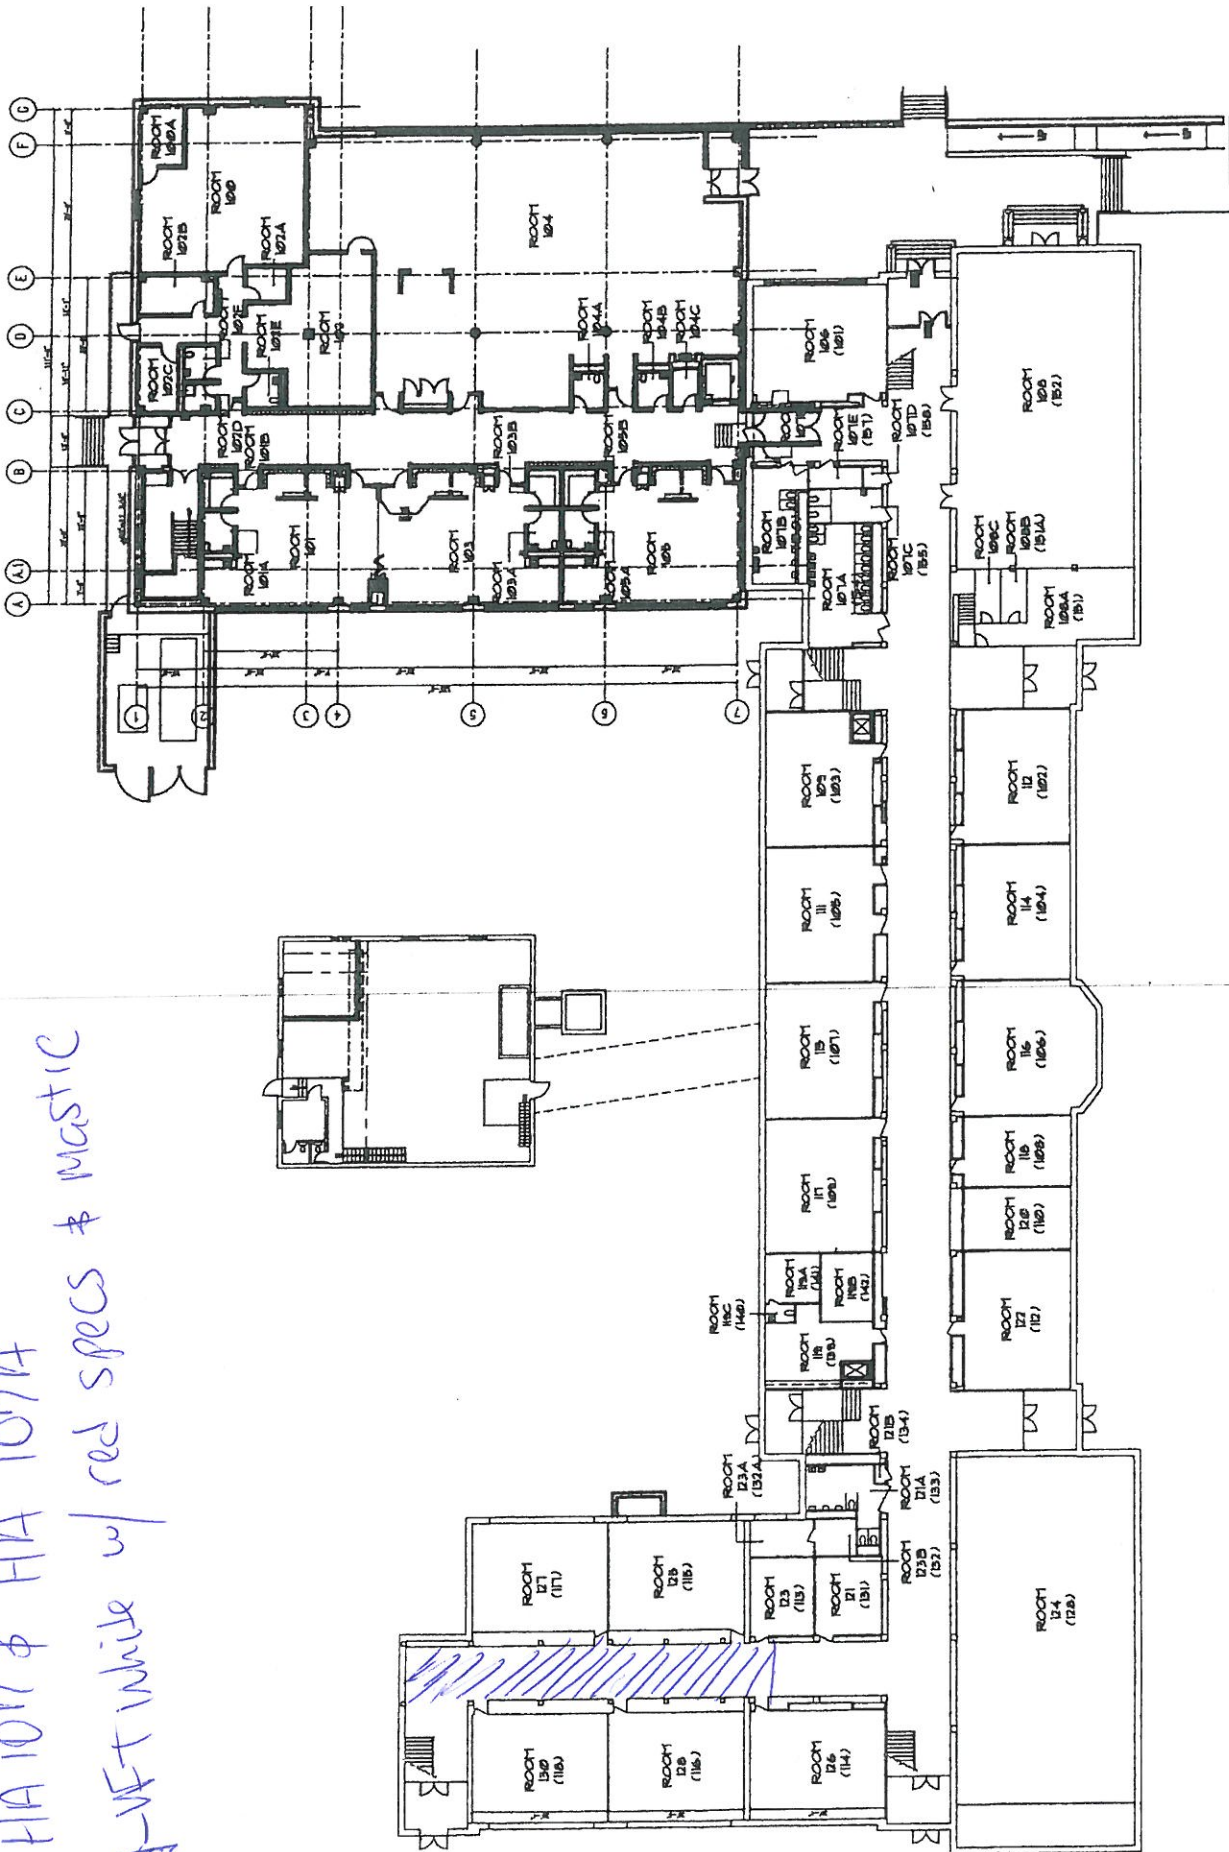
HA 107 & HA 107A
 VFT white w/ red specs & mastic
