**ILLINOIS DEPARTMENT OF PUBLIC HEALTH  
AHERA THREE YEAR REINSPECTION  
ASBESTOS ABATEMENT PROGRAM  
SCHOOL INFORMATION FORM**

**THREE-YEAR REINSPECTION**

**Pritzker School**

Unit: 25871  
Building ID: 6460

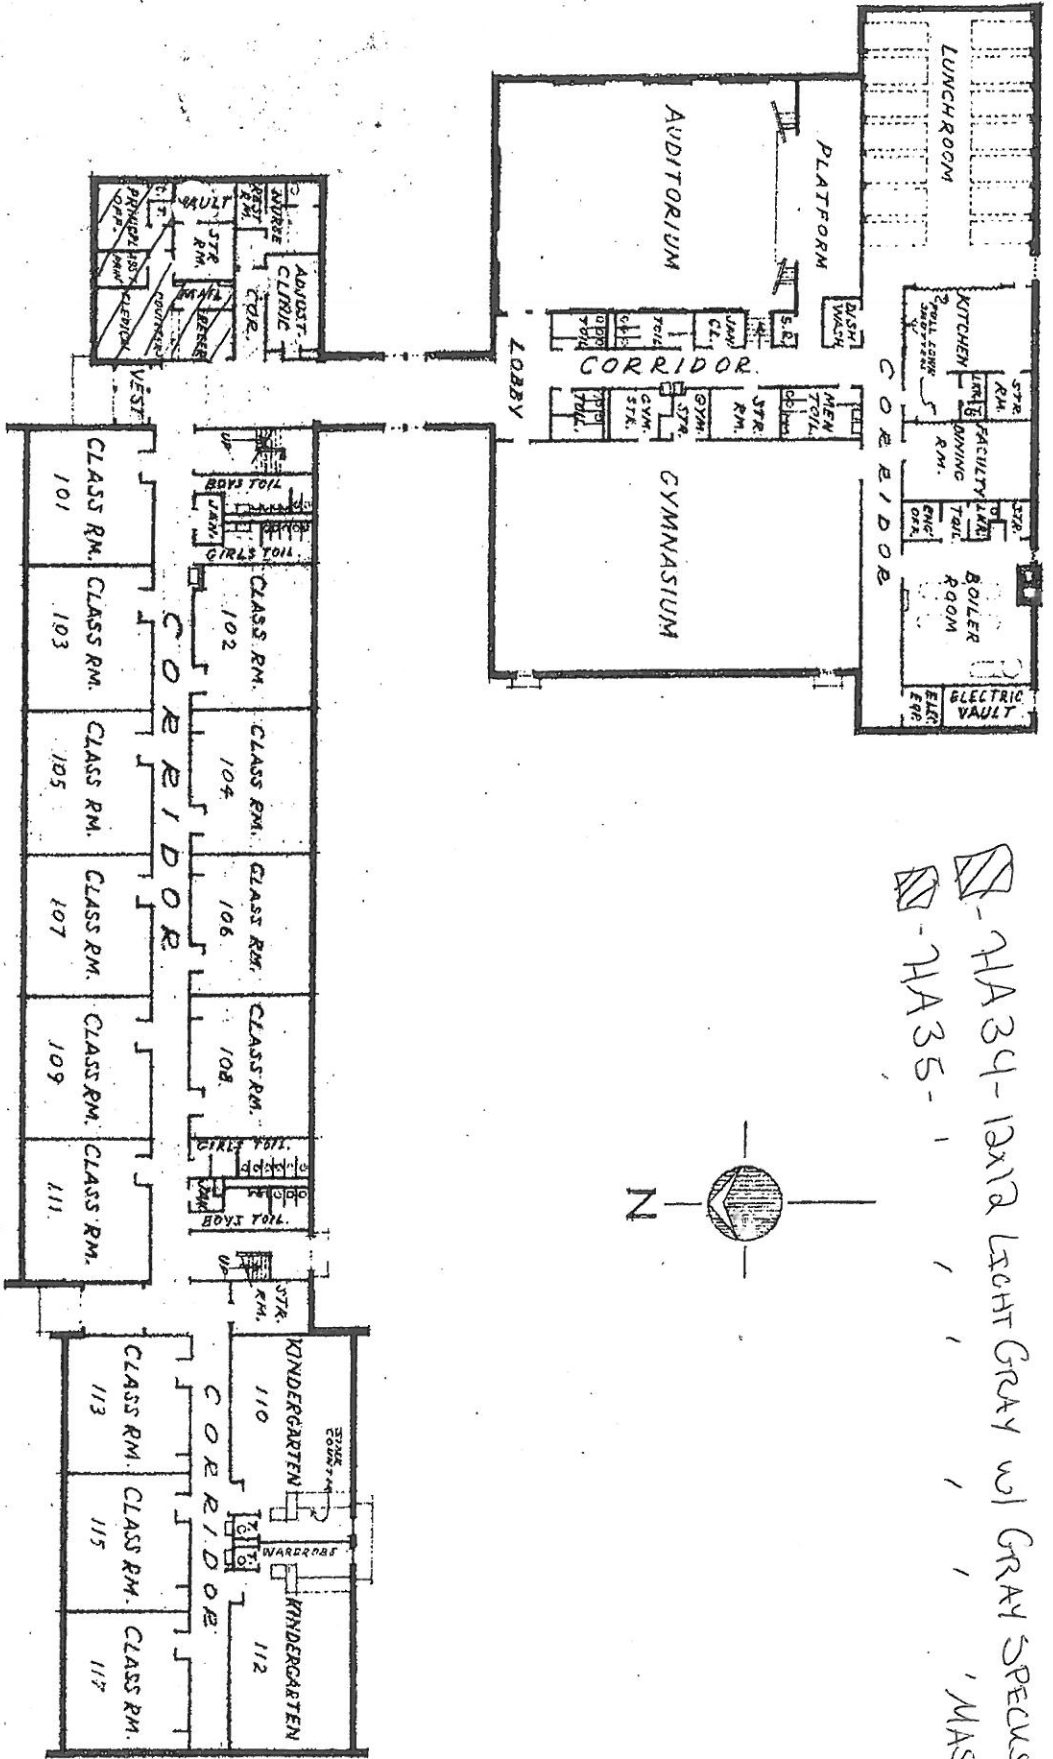
- HA 34-1212 LIGHT GRAY w/ GRAY SPECKS VHT  
 - HA 35-1 / / / / / MASTIC

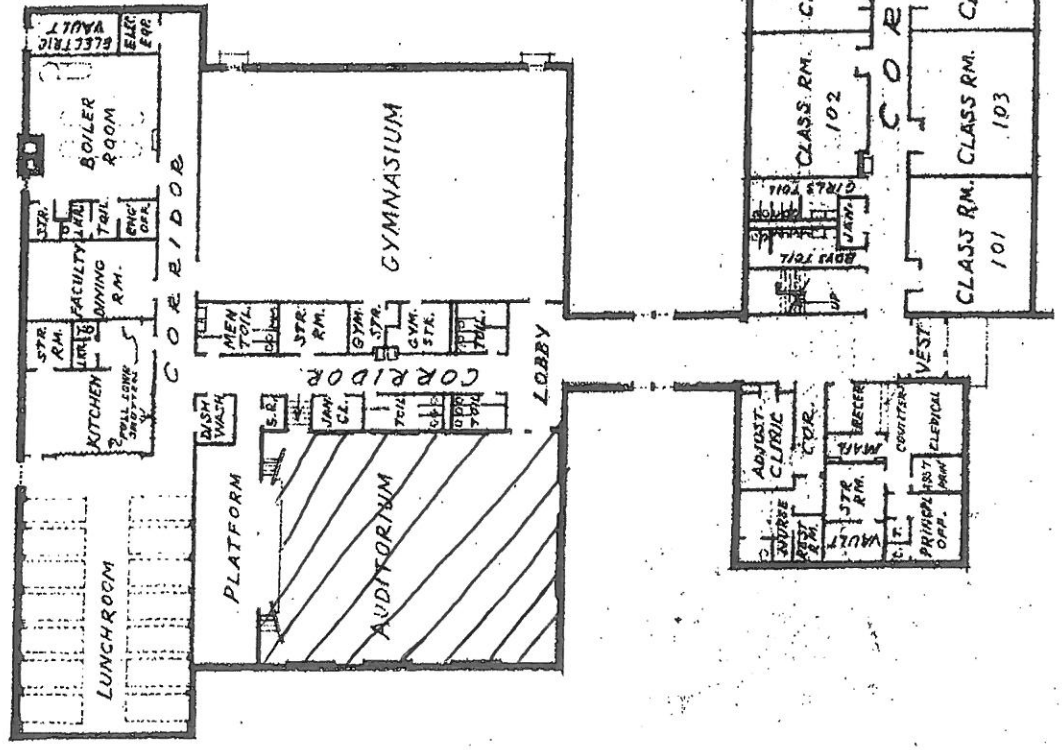
FIRST FLOOR PLAN  
 SCALE 1/8" = 1'-0"

- HA 32 - 12x12 LIGHT BLUE w/ BLUE SPECKS VFT  
 - HA 33 - ' ' ' ' ' ' MASTIC
