**ILLINOIS DEPARTMENT OF PUBLIC HEALTH
AHERA THREE YEAR REINSPECTION
ASBESTOS ABATEMENT PROGRAM
SCHOOL INFORMATION FORM**

THREE-YEAR REINSPECTION

Wildwood School

6950 N Hiawatha Avenue
Chicago, IL, 60646

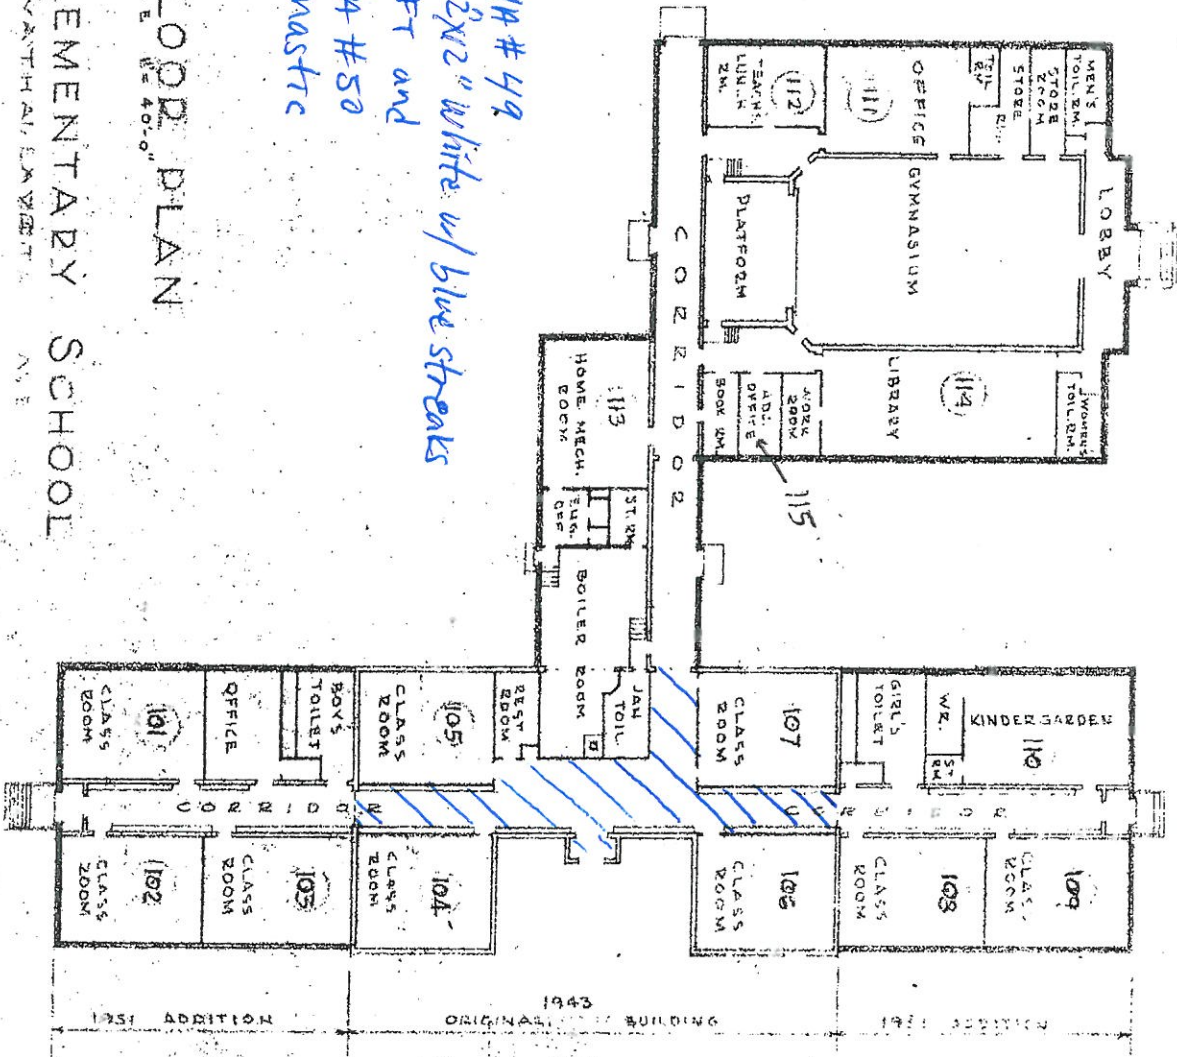
FIRST FLOOR PLAN

HA # 49
12x12 white w/ blue streaks
VFT and
HA # 50
mastic

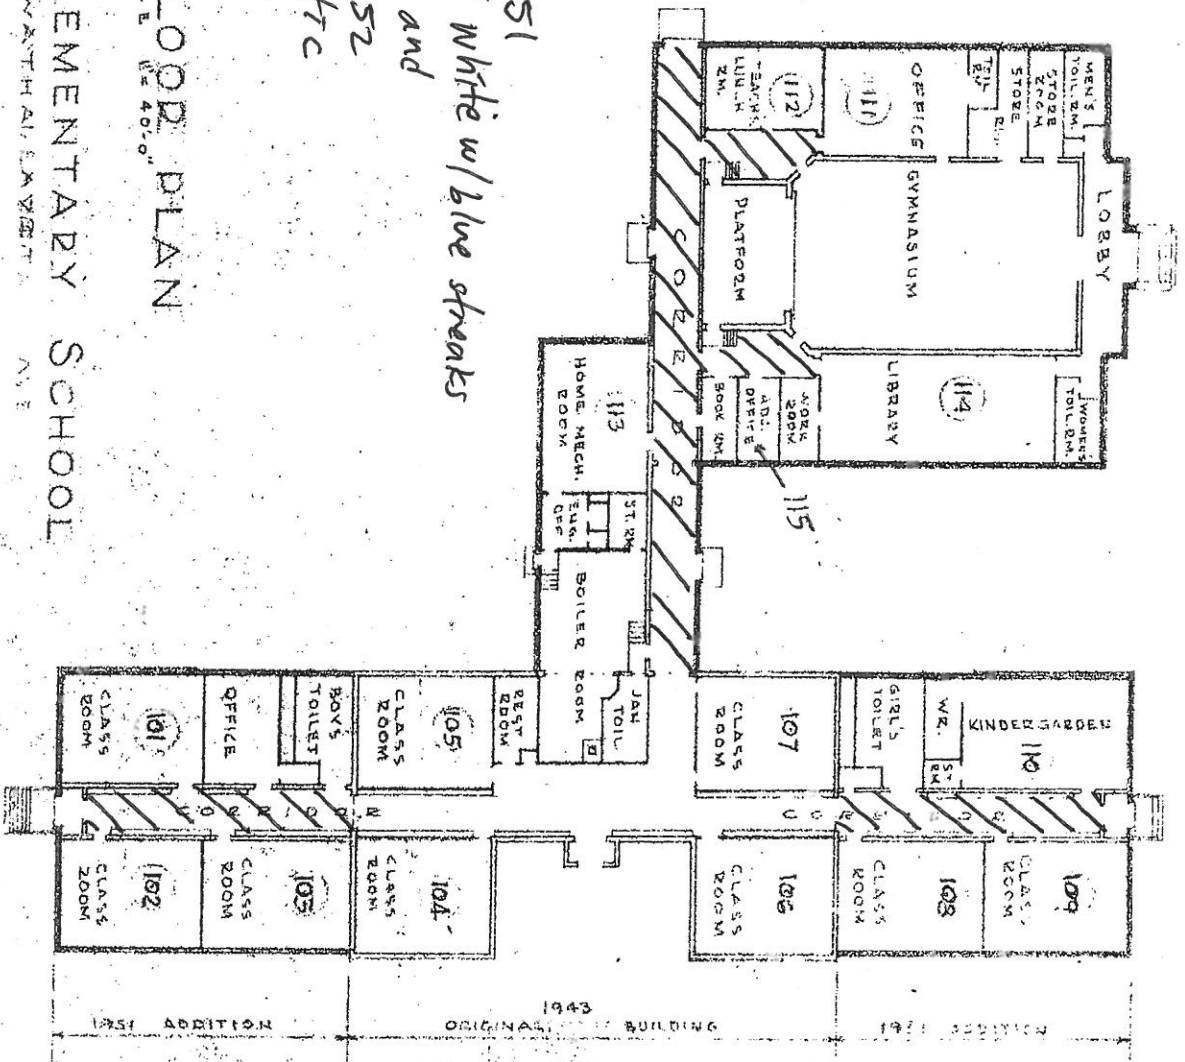
FIRST FLOOR PLAN
SCALE 1/4" = 40'-0"

HA #51
1/2" x 1/2" white w/blue streaks
VFT and
HA #52
mastic
