**ILLINOIS DEPARTMENT OF PUBLIC HEALTH
AHERA THREE YEAR REINSPECTION
ASBESTOS ABATEMENT PROGRAM
SCHOOL INFORMATION FORM**

THREE-YEAR REINSPECTION

Stone Academy

6239 N Leavitt Street
Chicago, IL, 60659

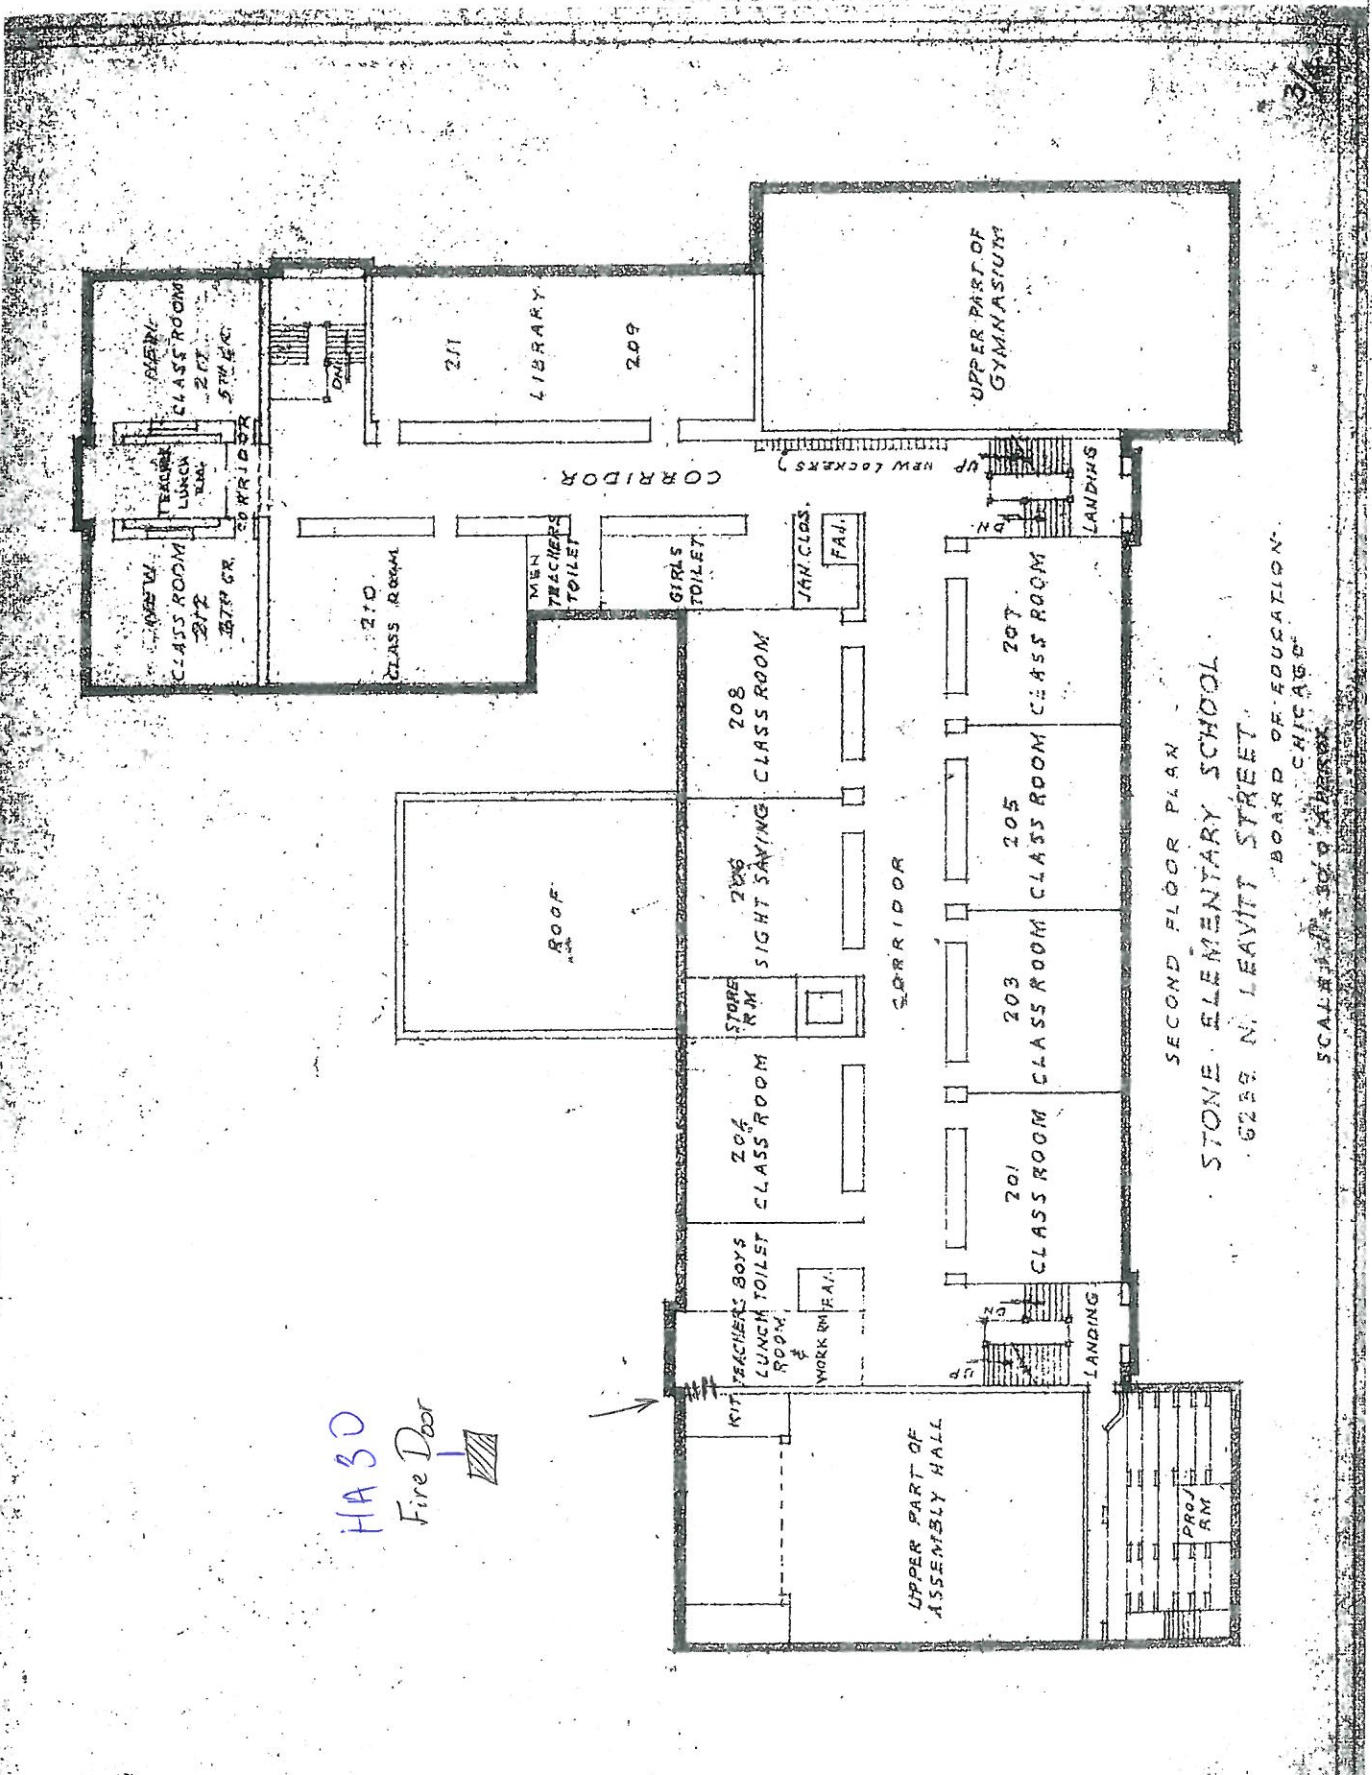
SECOND FLOOR PLAN
STONE ELEMENTARY SCHOOL
6239 N. LEAVITT STREET
BOARD OF EDUCATION
CHICAGO
SCALE 1/8" = 1'-0"

HASD
Fire Door

HA-30
- five doors

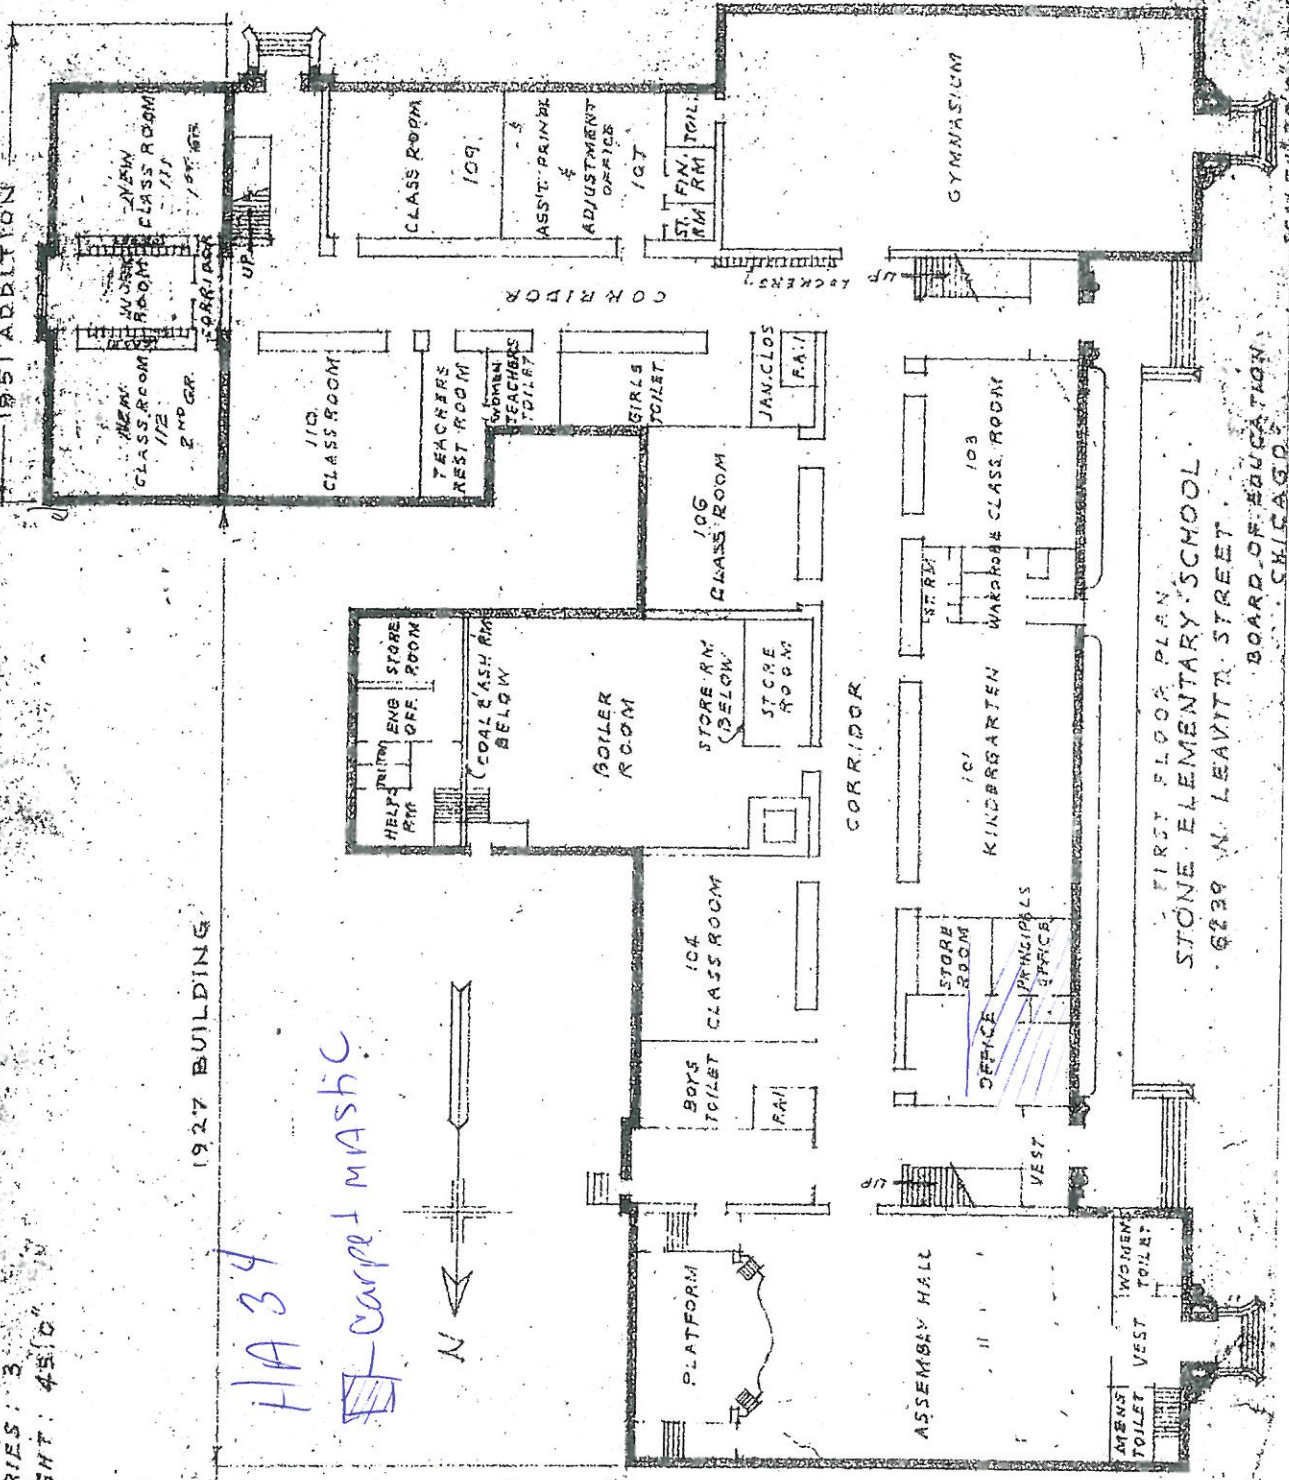
FIRST FLOOR PLAN
STONE ELEMENTARY SCHOOL
629 N. LEAVITT STREET
BOARD OF EDUCATION
CHICAGO

HA 34
Carpet + mastic

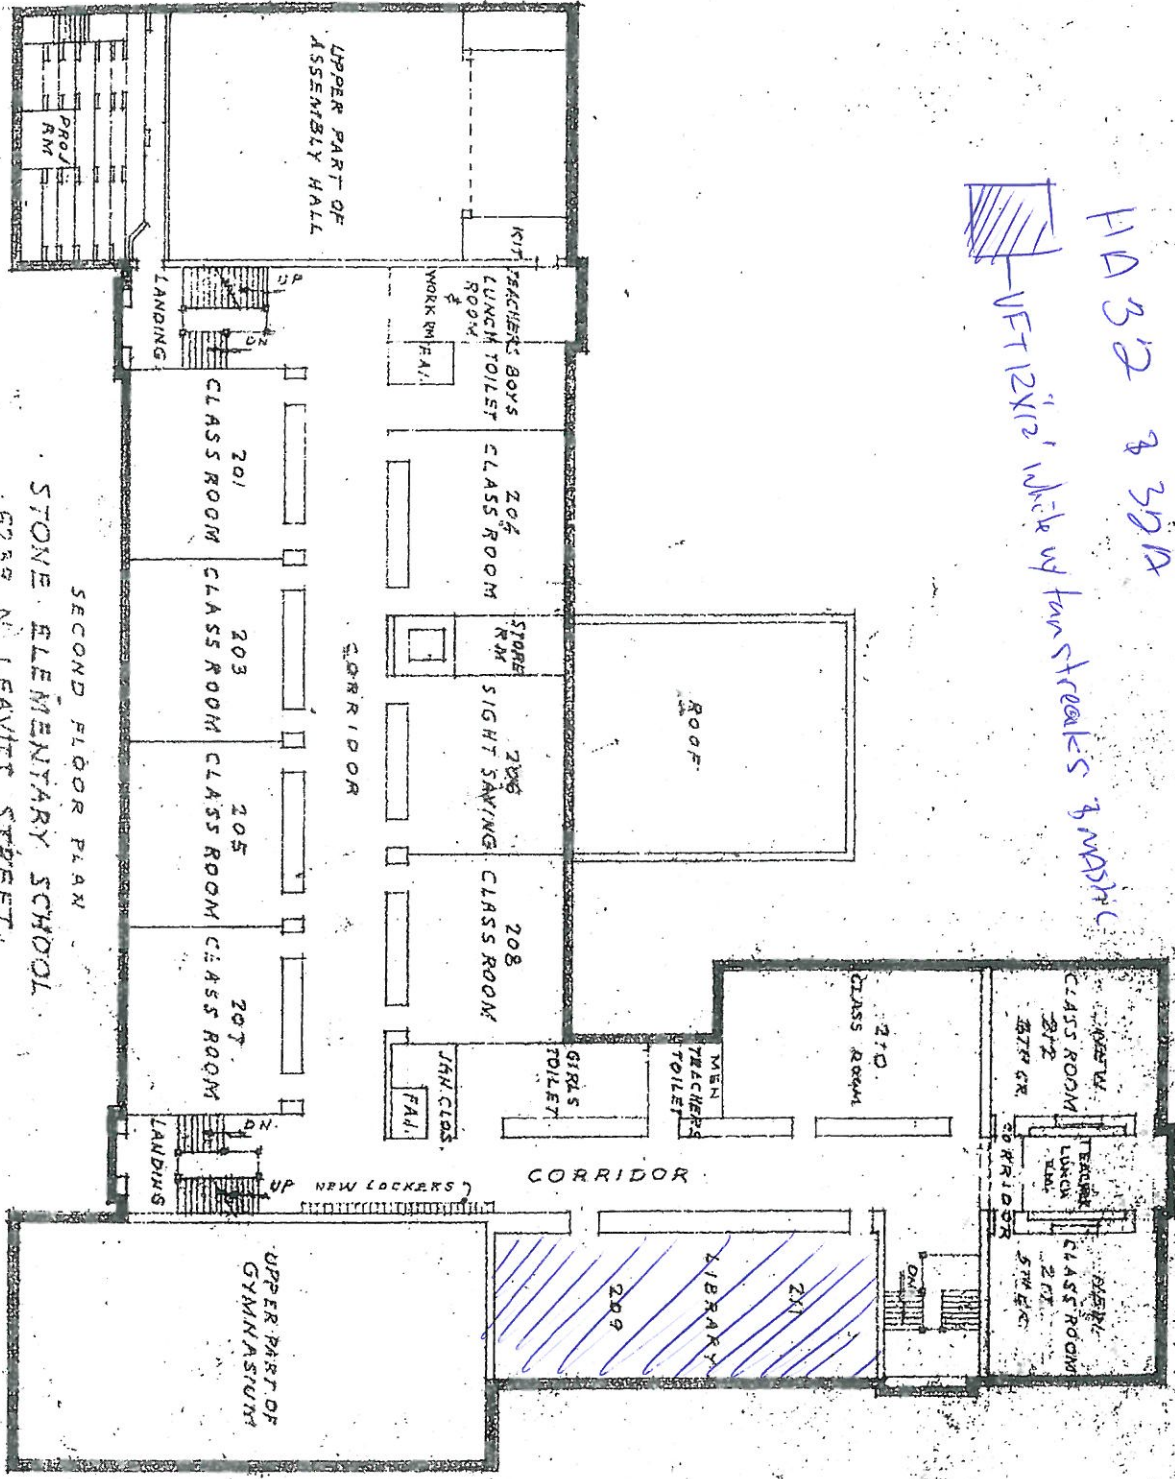
SECOND FLOOR PLAN
 STONE ELEMENTARY SCHOOL
 6239 N LEAVITT STREET

H1A 32 & 32A
 11'-12" x 12" width of fan streaks & wash

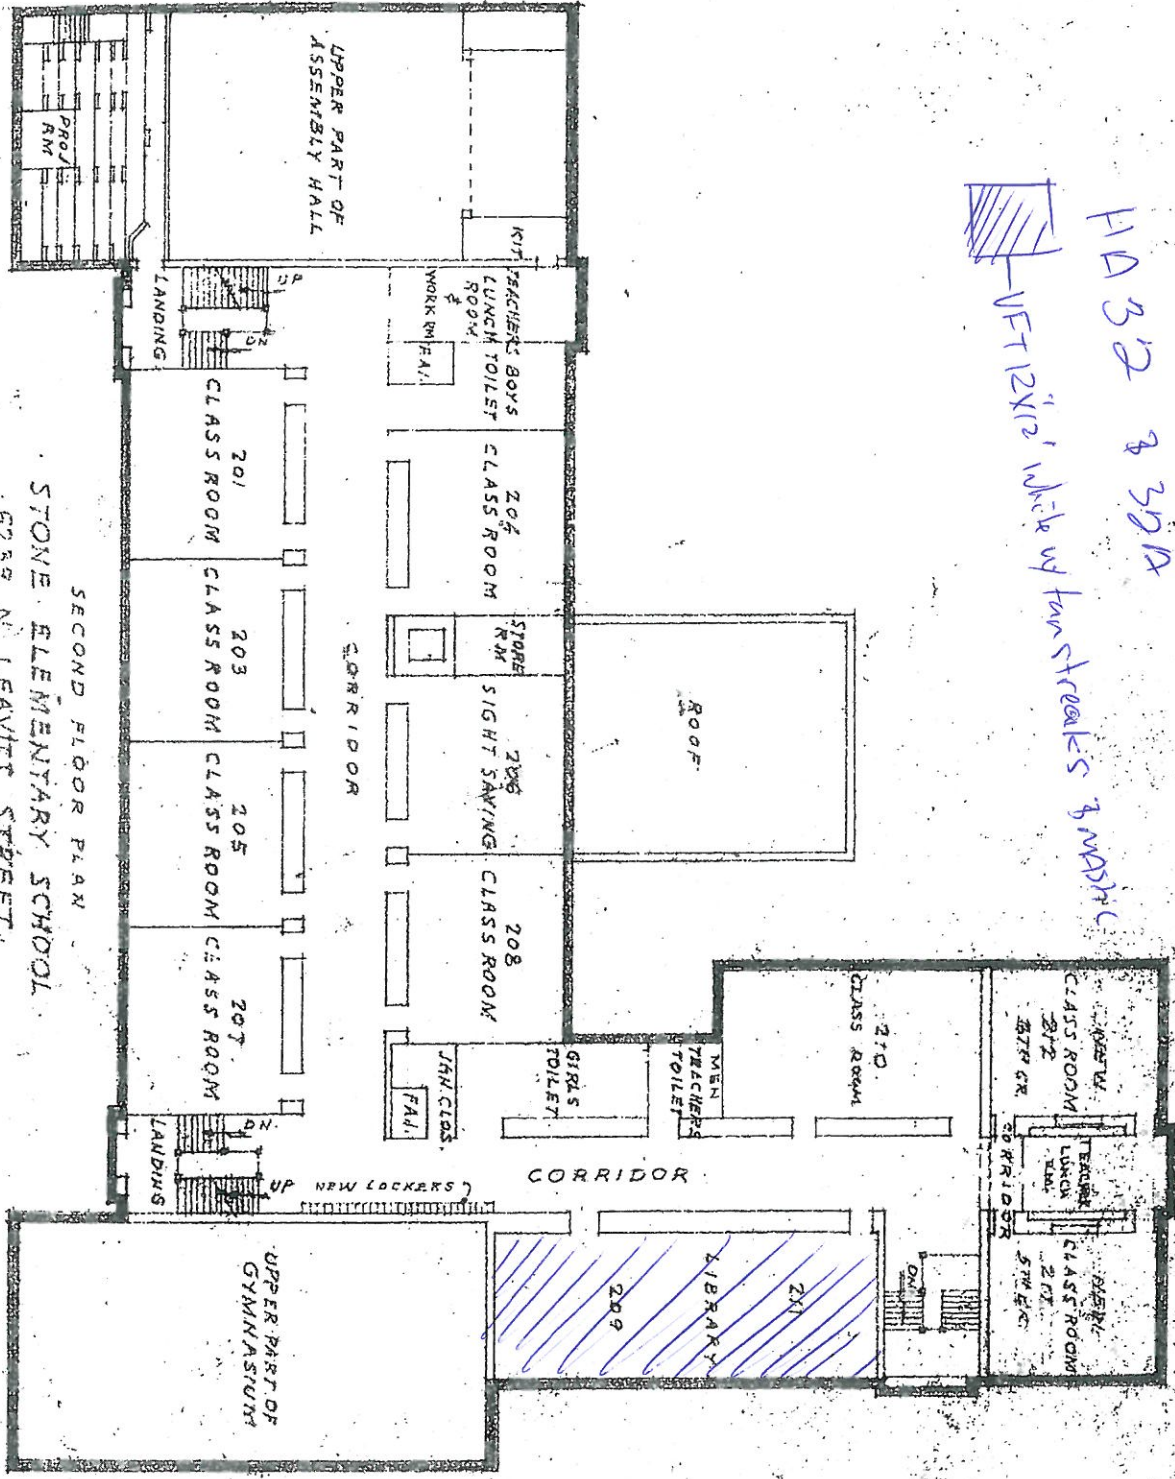
SECOND FLOOR PLAN
 STONE ELEMENTARY SCHOOL
 6239 N LEAVITT STREET
 BOARD OF EDUCATION
 CHICAGO

H1A 32 & 32A
 11'-12" x 12" width of fan streaks & mesh
