ILLINOIS DEPARTMENT OF PUBLIC HEALTH  
AHERA THREE YEAR REINSPECTION  
ASBESTOS ABATEMENT PROGRAM  
SCHOOL INFORMATION FORM

**THREE-YEAR REINSPECTION**

**Hay Community Academy**

Monday, April 29, 2013

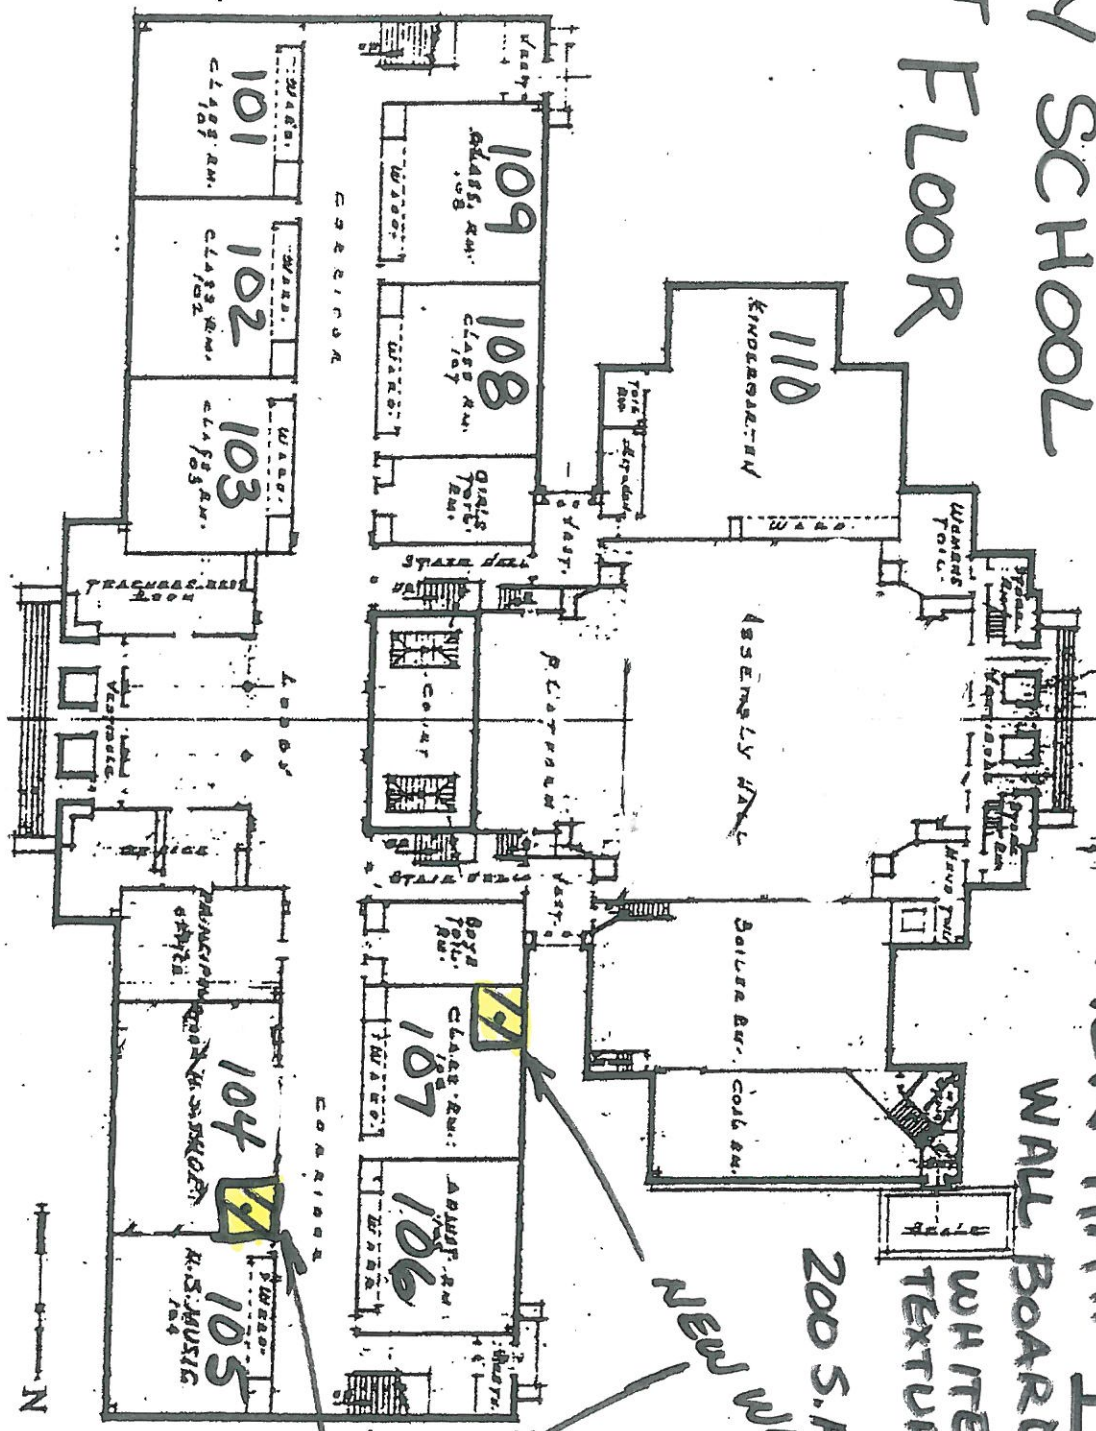
# HAY SCHOOL 1ST FLOOR

NEW HA# I  
WALL BOARD

WHITE -  
TEXTURED

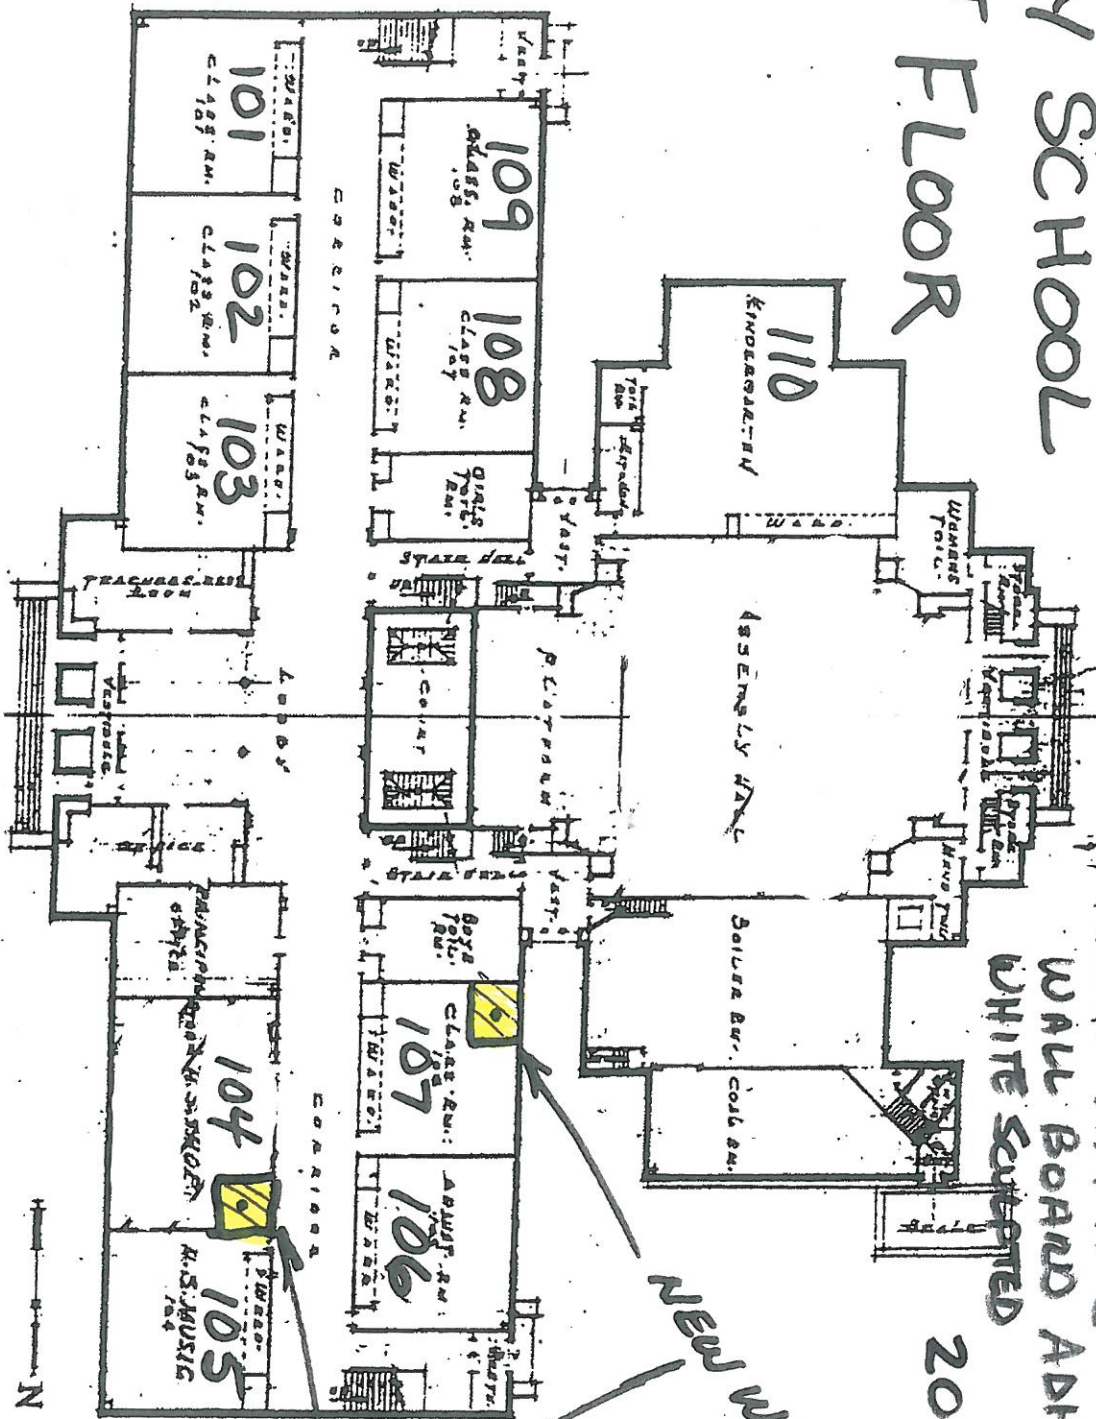
# HAY SCHOOL 1ST FLOOR

NEW HA # 3

WALL BOARD ADHESIVE  
WHITE SCUMPTED

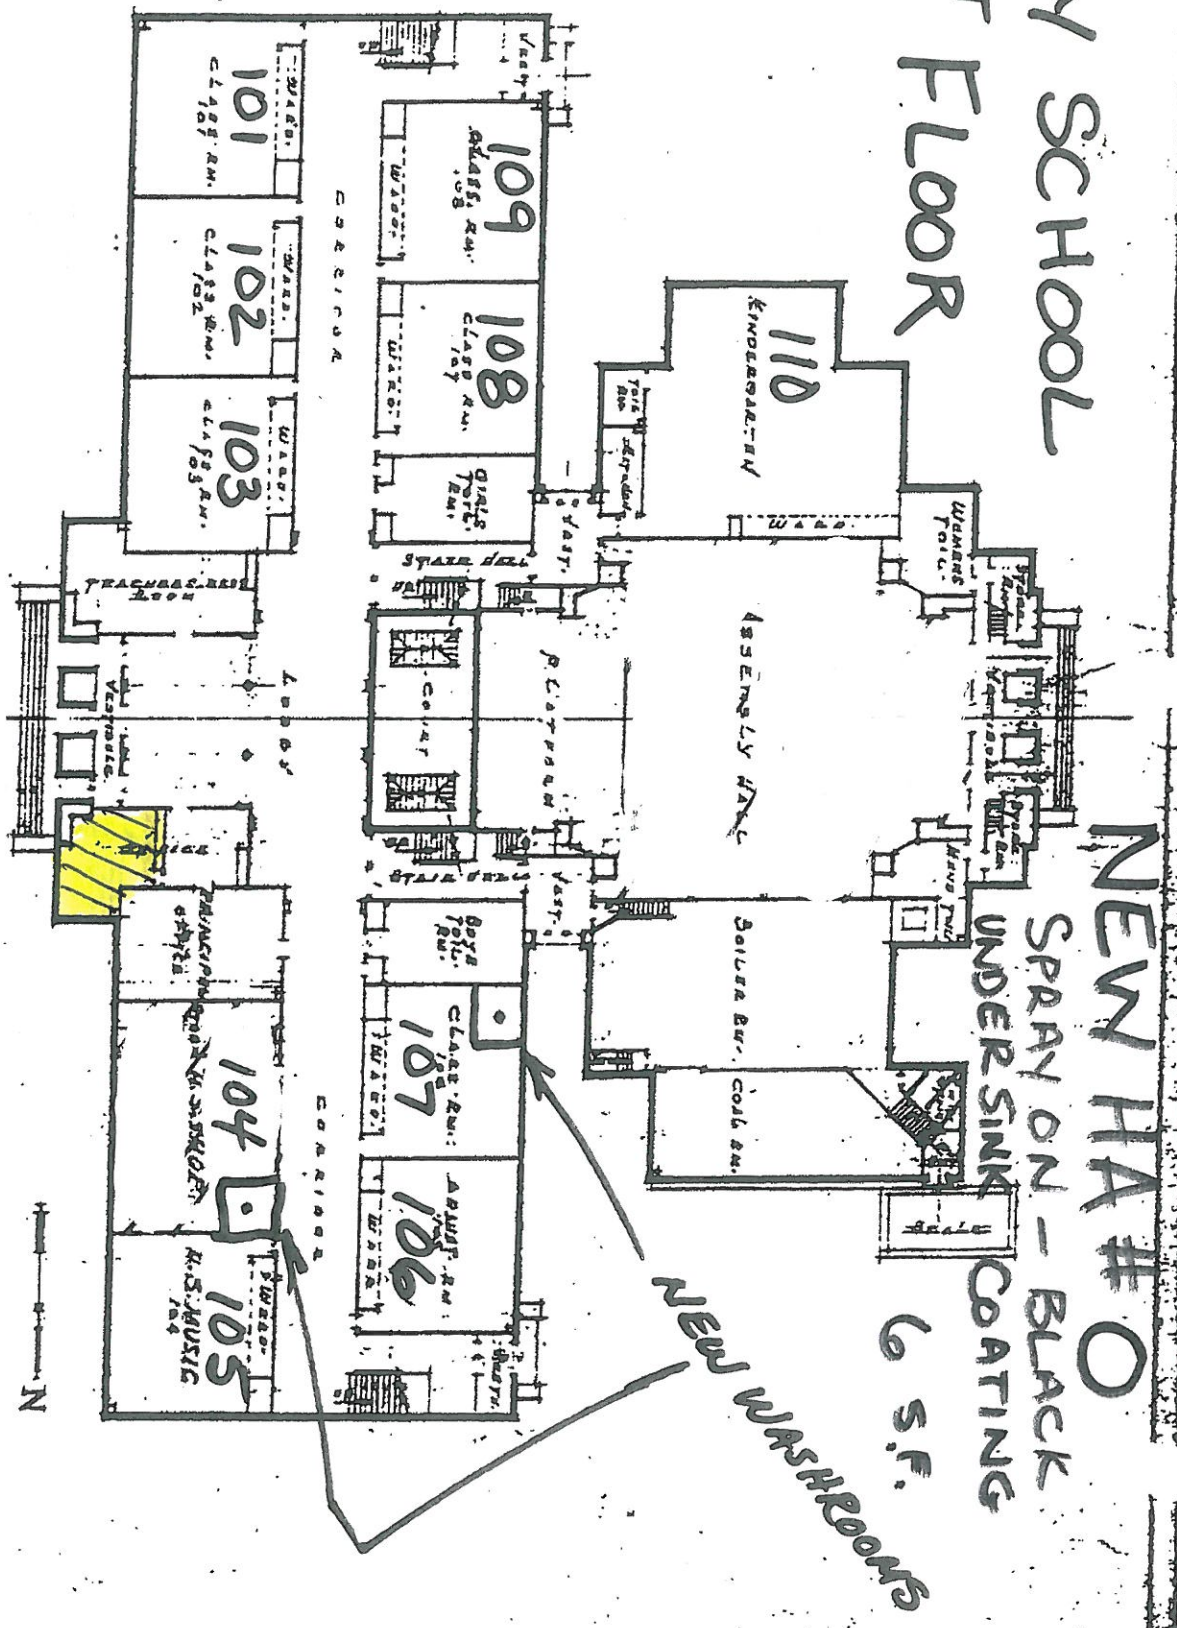
# HAY SCHOOL 1ST FLOOR

NEW HA # O

SPRAY ON - BLACK  
UNDER SINK  
COATING

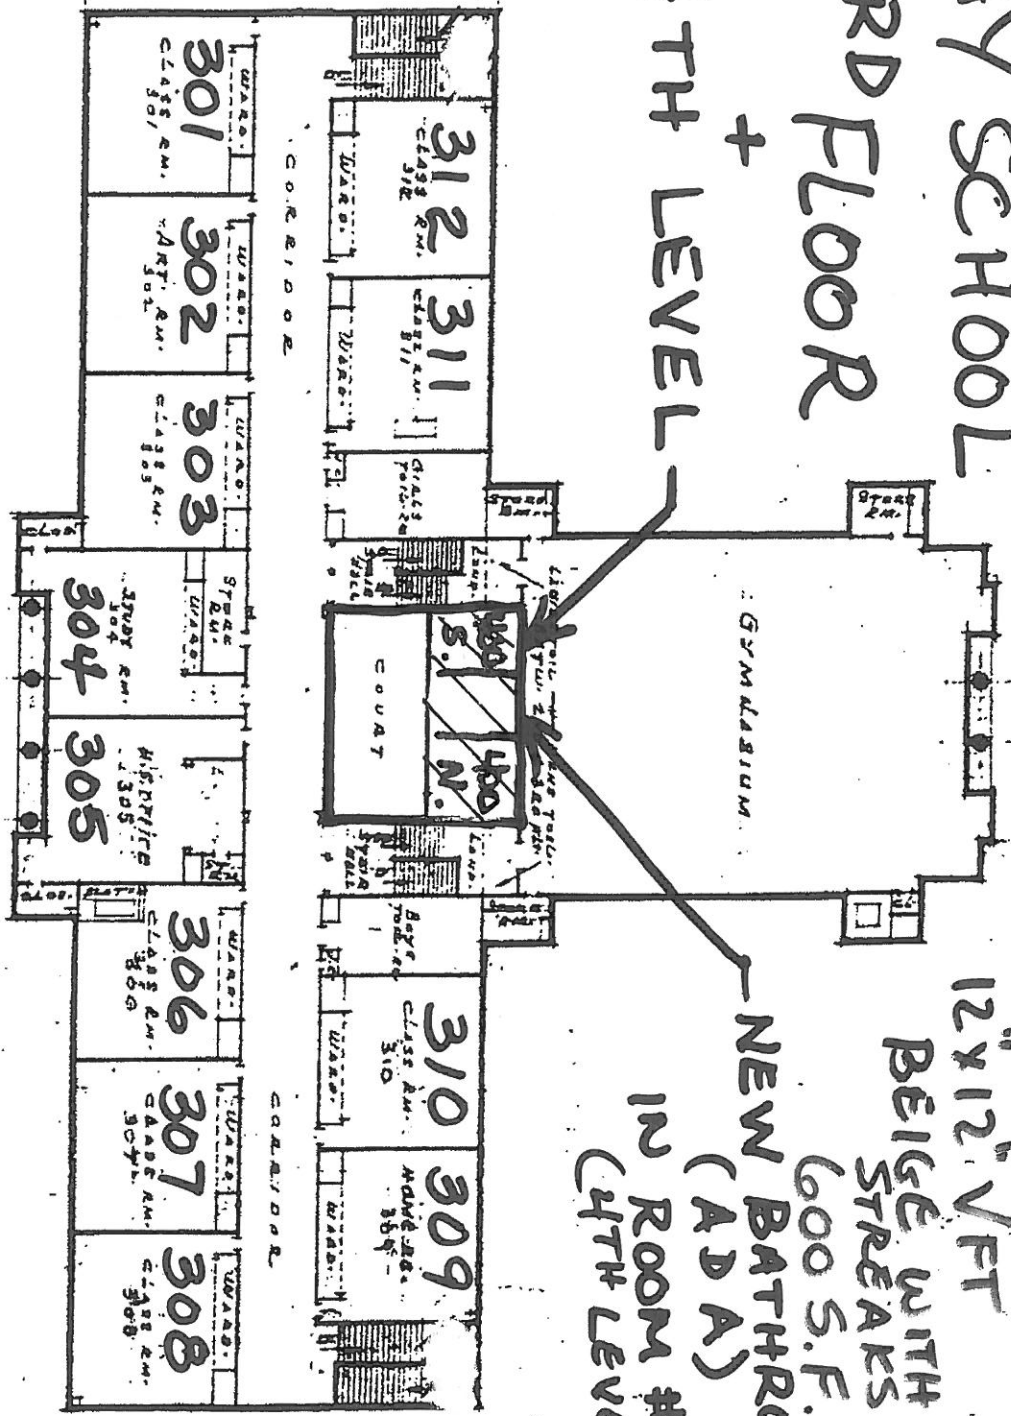
# HAY SCHOOL 3RD FLOOR + 4TH LEVEL

NEW HA# C  
12'x12' VFT  
BEIGE WITH TAN  
STREAKS  
600 S.F.  
NEW BATHROOM  
(ADA)  
NEW ROOM #400  
IN ROOM #400  
(4TH LEVEL)

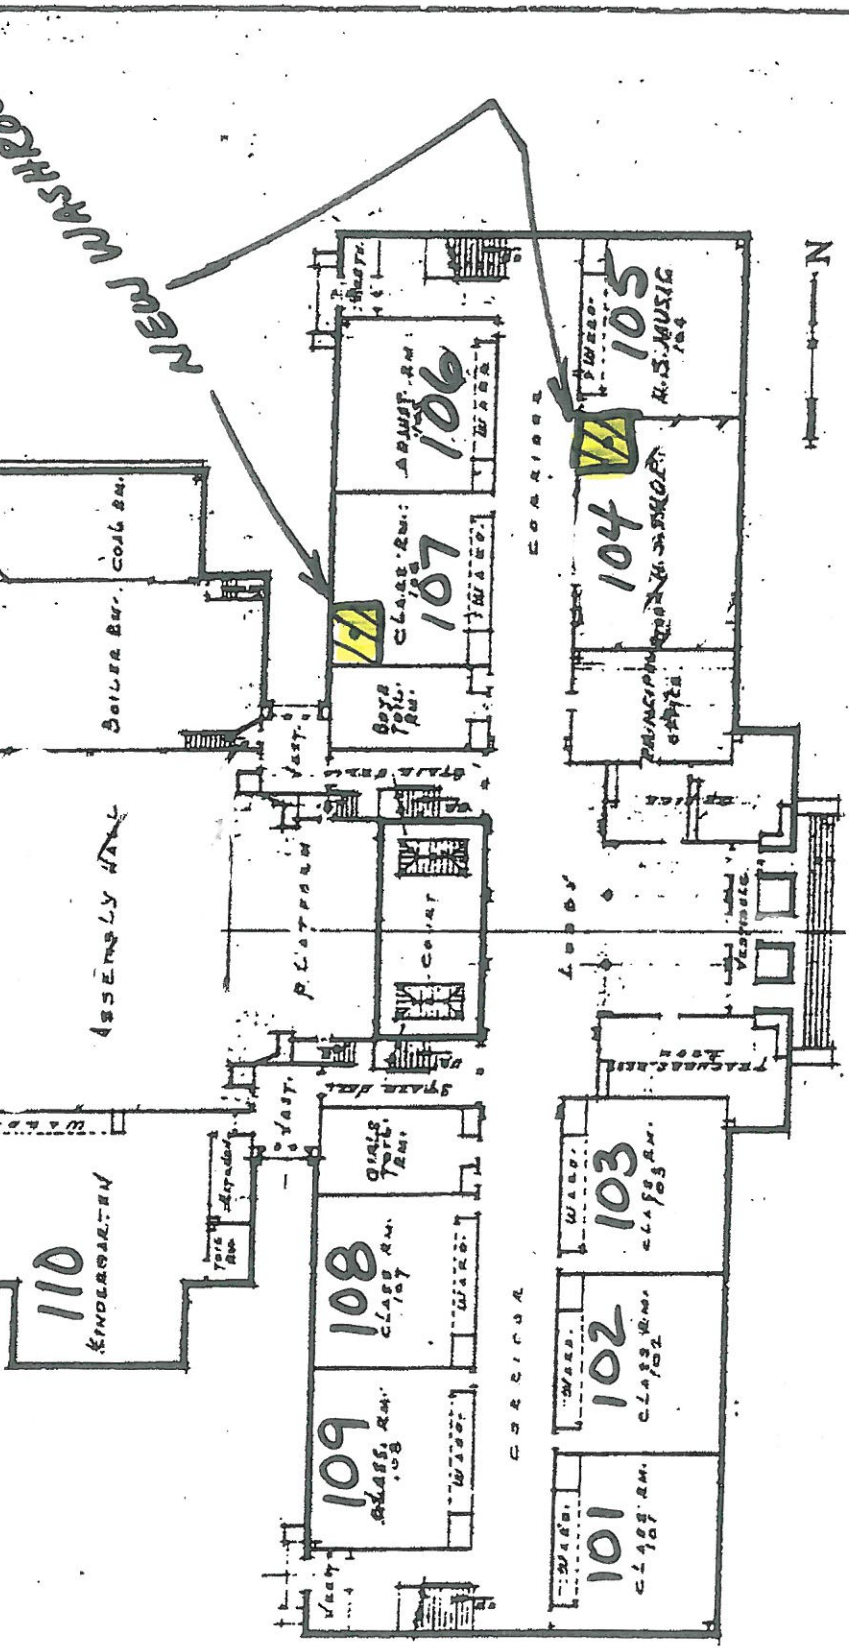
**HAY SCHOOL**  
**1ST FLOOR**  
**NEW HA# - L**  
**2' x 4' WHITE C.T**  
**SUSPENDED**  
**80 S.F.**  
**NEW WASHROOMS**

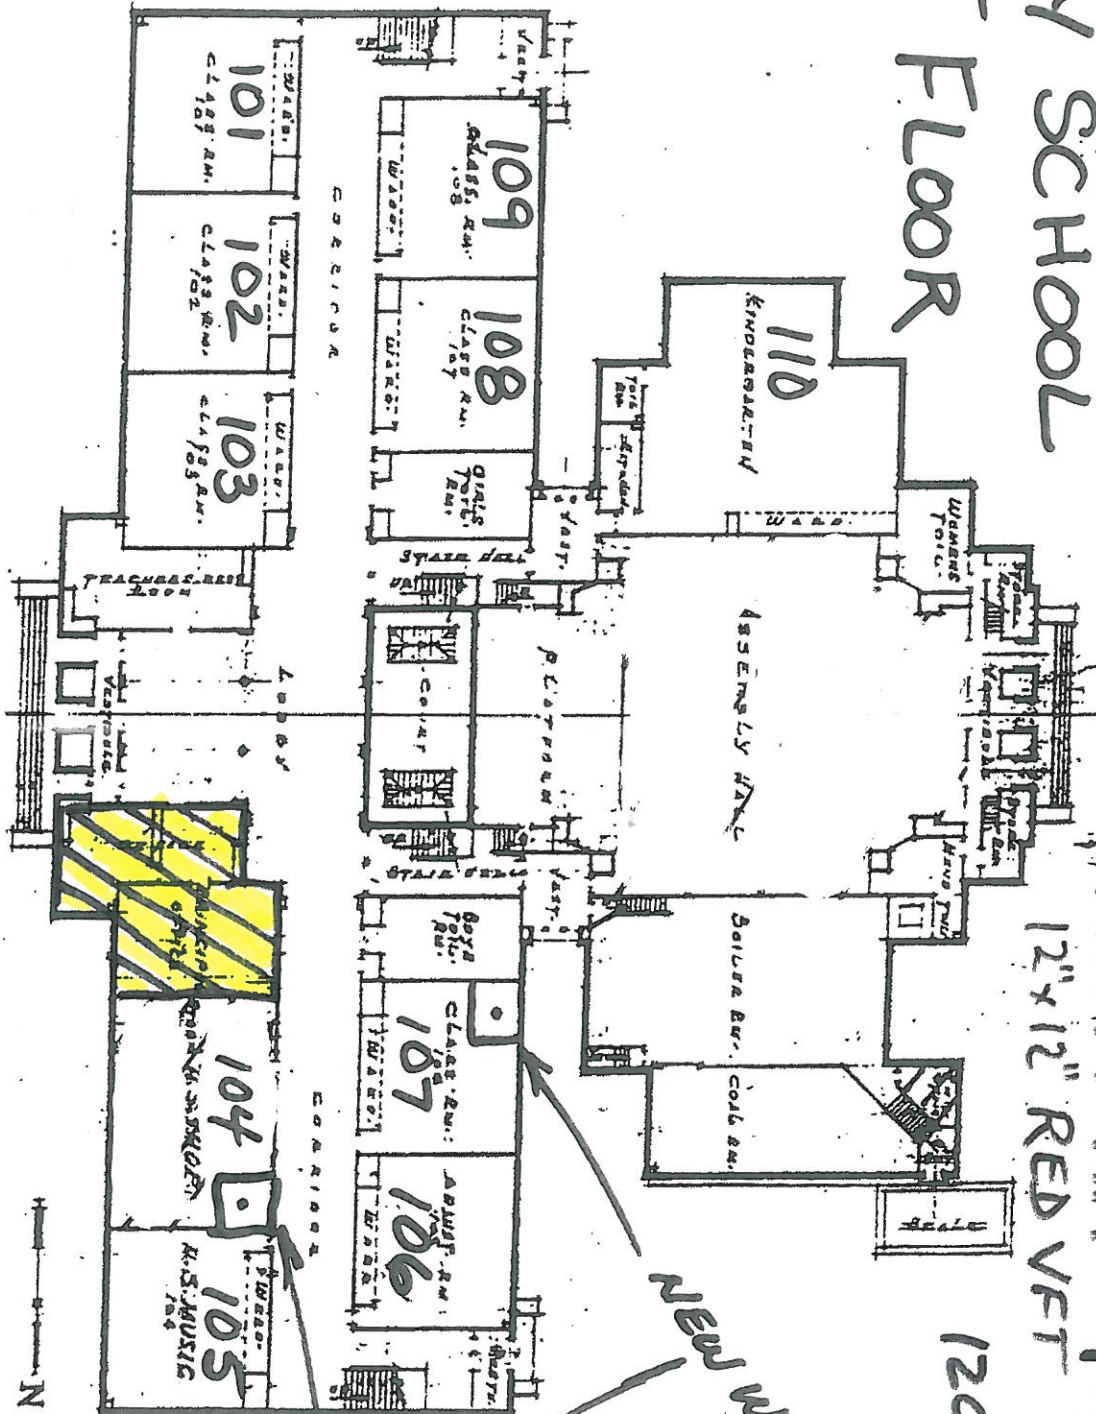
# HAY SCHOOL 1ST FLOOR

NEW HA # M  
12'x12' RED VFT

1200 S.F.
