ILLINOIS DEPARTMENT OF PUBLIC HEALTH
AHERA THREE YEAR REINSPECTION
ASBESTOS ABATEMENT PROGRAM
SCHOOL INFORMATION FORM

THREE-YEAR REINSPECTION

Hendricks Academy

4316 S. Princeton
Chicago, IL, 60609

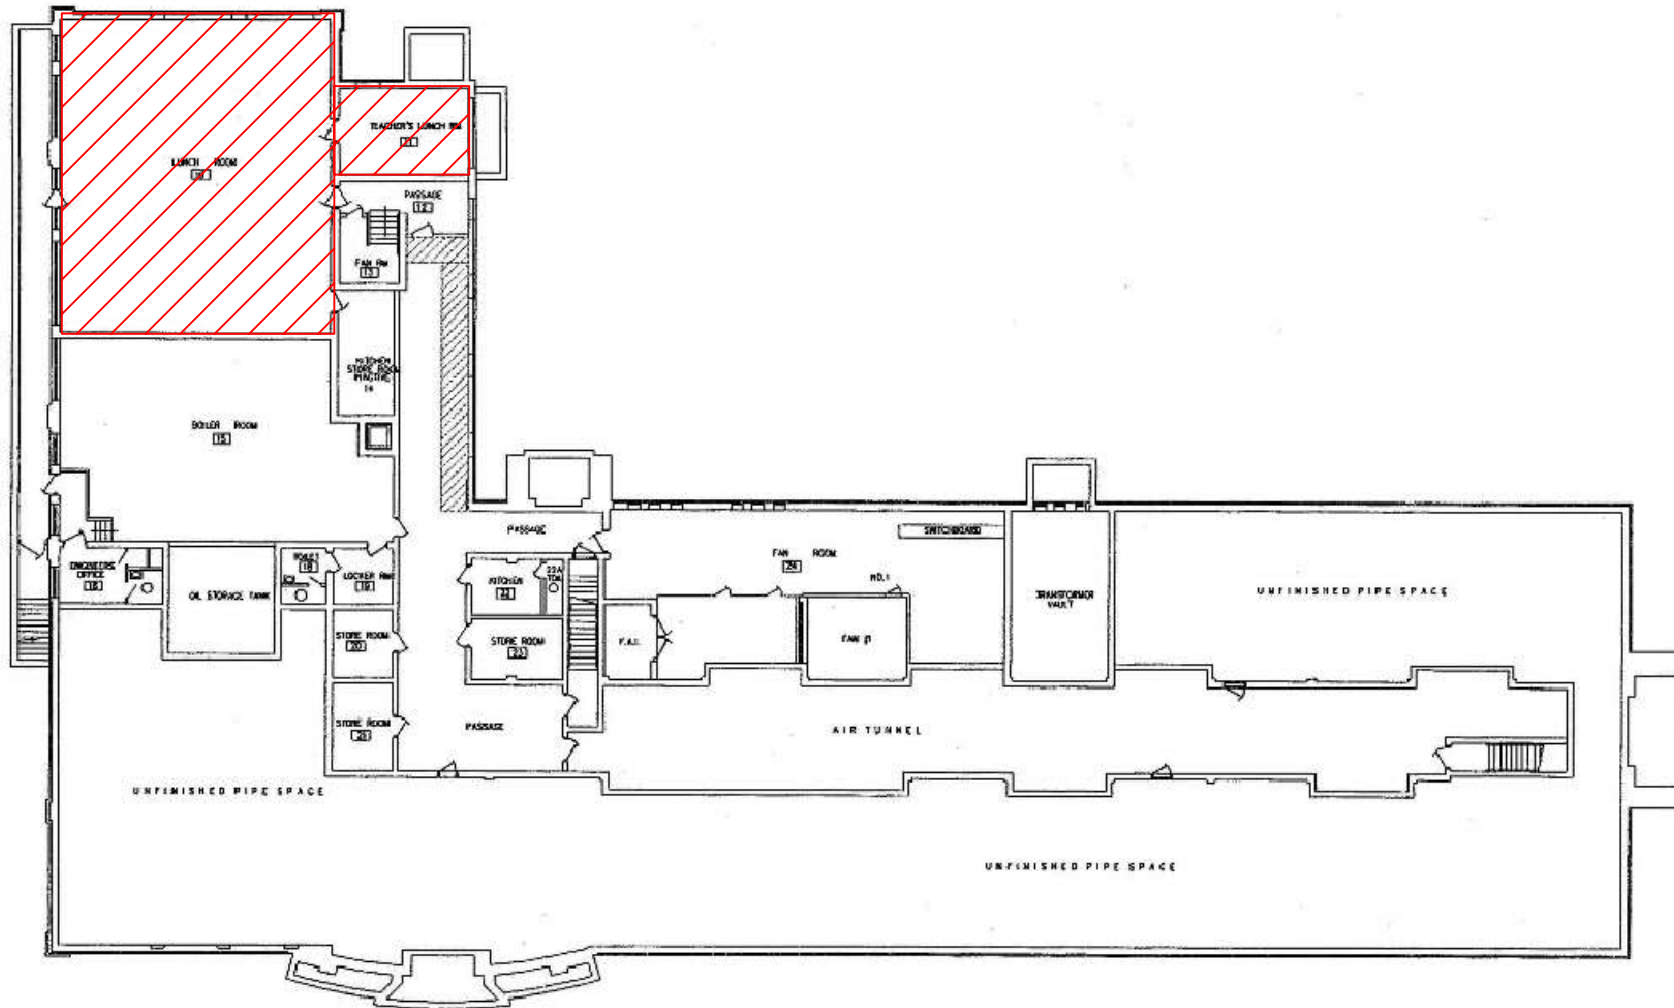
HA-51 White with Black 3' x 3' Rubber Floor Tiles
