ILLINOIS DEPARTMENT OF PUBLIC HEALTH  
AHERA THREE YEAR REINSPECTION  
ASBESTOS ABATEMENT PROGRAM  
SCHOOL INFORMATION FORM

**THREE-YEAR REINSPECTION**

**Pulaski Academy**

Wednesday, May 15, 2013

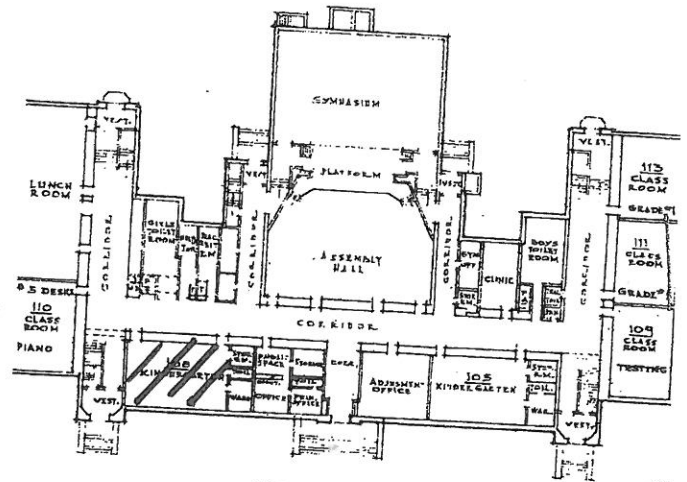
FIRST FLOOR PLAN  
SCALE 1/4" = 1'-0"

PULASKI SCHOOL  
NEW H A # 112 VET + # 113 ASSOCIATED  
MASTIC

Description: 12" x 12" BLUE WITH GRAY STREAKS  
Location: # 108  
Quantity: 800 S.F.

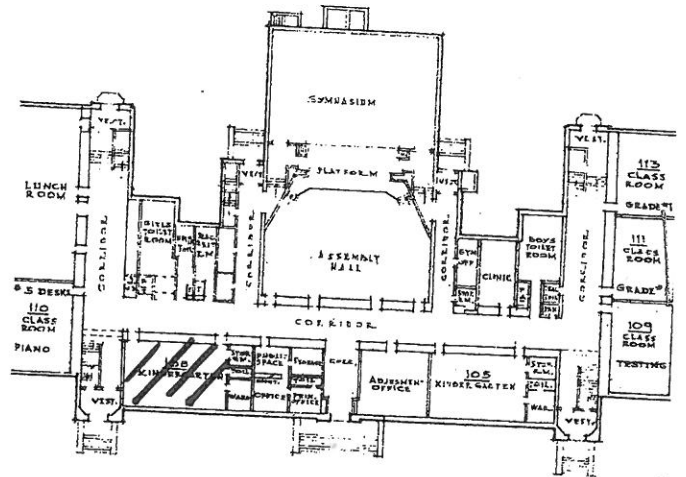
FIRST FLOOR PLAN  
SCALE 1/4" = 1'-0"

## NEW H A #112 VFT + #113 ASSOCIATED MASTIC

Description: 12" x 12" BLUE WITH GRAY STREAKS  
Location: #108  
Quantity: 800 S.F.

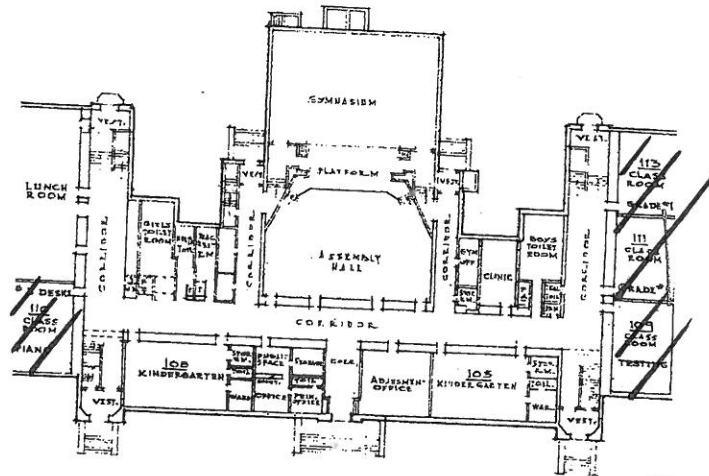
FIRST FLOOR PLAN  
SCALE 1/4" = 1'-0"

Location: NEW LUNCHROOM (OLD CLASSROOMS) # 110

Quantity: 3800 S.F.

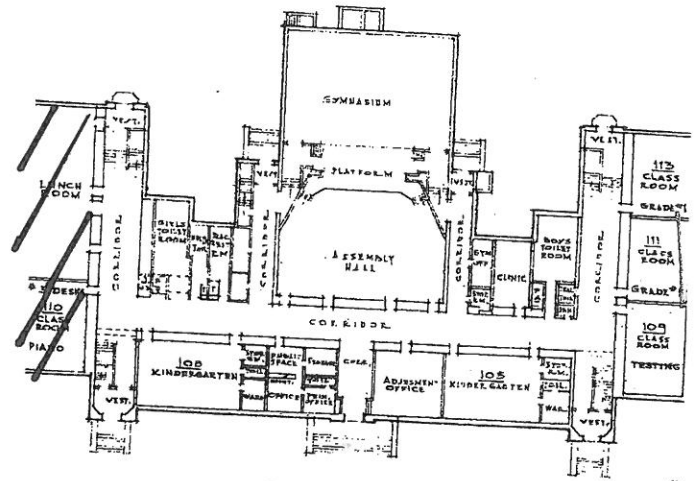
FIRST FLOOR PLAN  
SCALE 1/8" = 1'-0"

Description: 12" x 12" GREEN WITH LIGHT GREEN STREAKS  
Location: MUSIC ROOM, + # 110  
Quantity: 800 S.F.

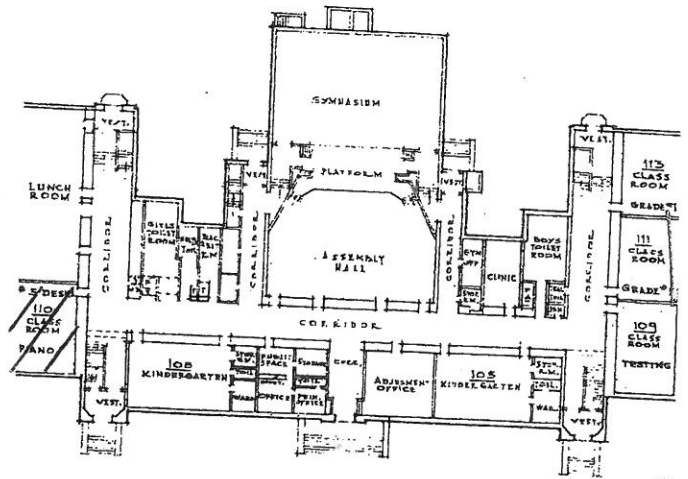
FIRST FLOOR PLAN  
SCALE 1/8"=1'-0"

# PULASKI SCHOOL NEW H A # 122

Description: DRYWALL SYSTEM  
Location: #110 MUSIC ROOM  
Quantity: 200 S.F.

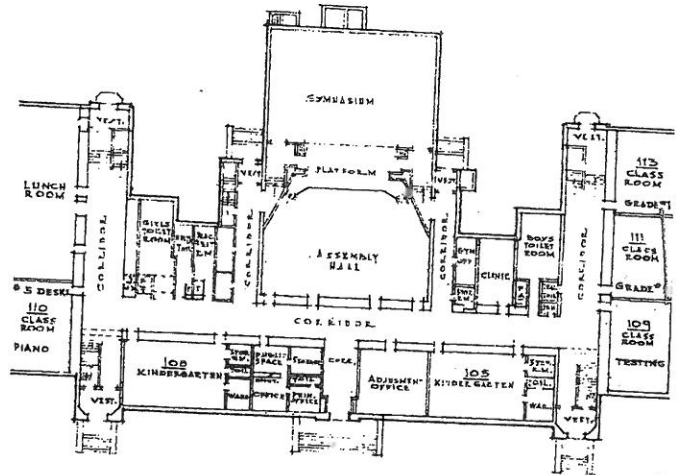
FIRST FLOOR PLAN  
 SCALE: 1/8" = 1'-0"

Location: ASSEMBLY HALL - AISLES

Quantity: 1500 S.F.

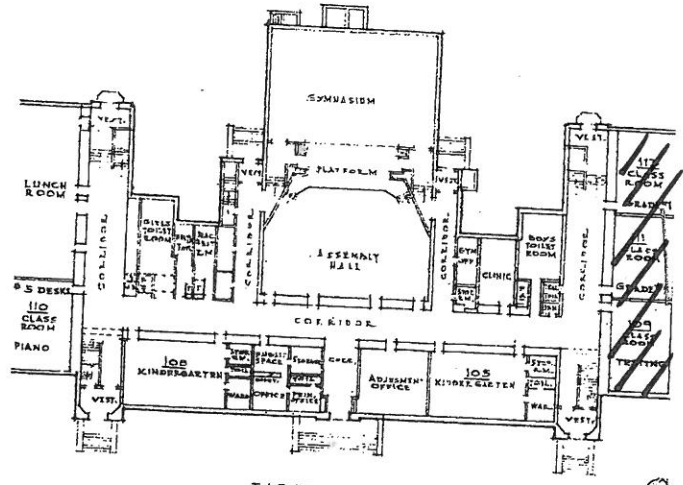
FIRST FLOOR PLAN  
SCALE 1/8" = 1'-0"

Description: ASSOCIATED WITH NEW H A # 118 -  
Location: LUNCH ROOM  
Quantity: 3000 S.F.

12" x 12"  
GRAY WITH DARK  
GRAY VFT

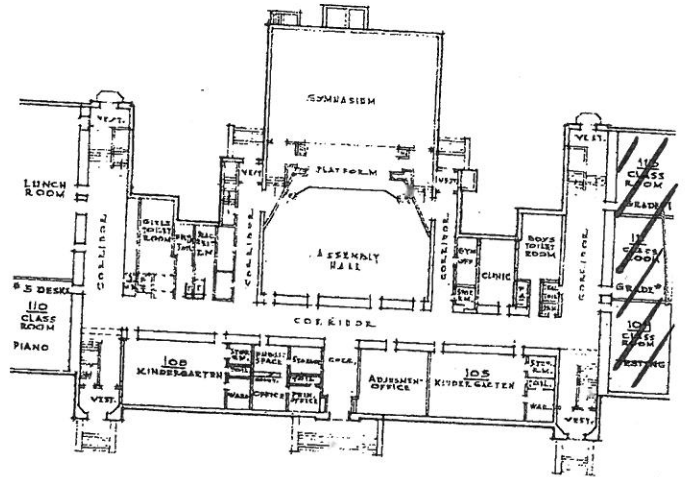
FIRST FLOOR PLAN  
SCALE 1/4" = 1'-0"

# PULASKI SCHOOL NEW H A # 118 VFT

Description: **12" x 12" GRAY W/ DARK GRAY STREAKS**  
Location: **NEW LUNCH ROOM**  
Quantity: **3000 S.F.**

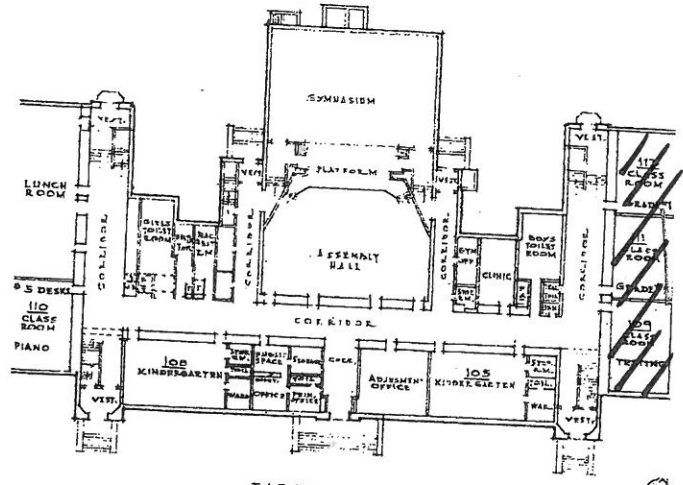
FIRST FLOOR PLAN  
SCALE 1/8" = 1'-0"

Description: ASSOCIATED WITH NEW HA # 118 -  
Location: LUNCH ROOM  
Quantity: 3000 S.F.

12" x 12"  
GRAY WITH DARK  
GRAY VFT

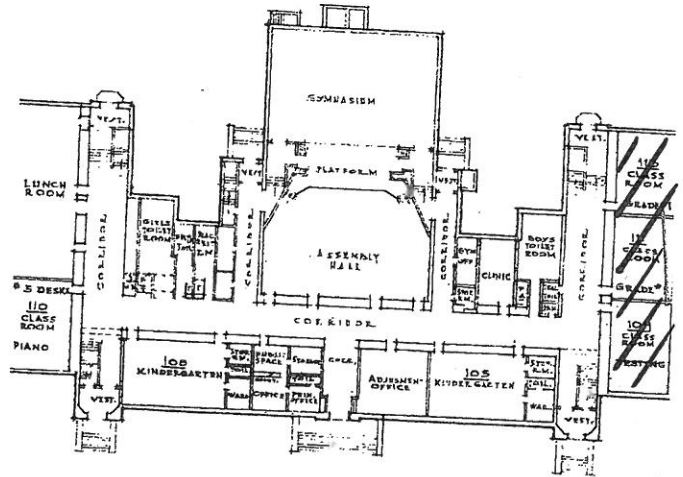
FIRST FLOOR PLAN  
SCALE 1/4" = 1'-0"

# PULASKI SCHOOL NEW H A # 118 VFT

Description: *12" x 12" GRAY W/ DARK GRAY STREAKS*  
Location: *NEW LUNCH ROOM*  
Quantity: *3000 S.F.*
