**ILLINOIS DEPARTMENT OF PUBLIC HEALTH
AHERA THREE YEAR REINSPECTION
ASBESTOS ABATEMENT PROGRAM
SCHOOL INFORMATION FORM**

THREE-YEAR REINSPECTION

De Diego Academy

Unit: 31261
Building ID: 7420

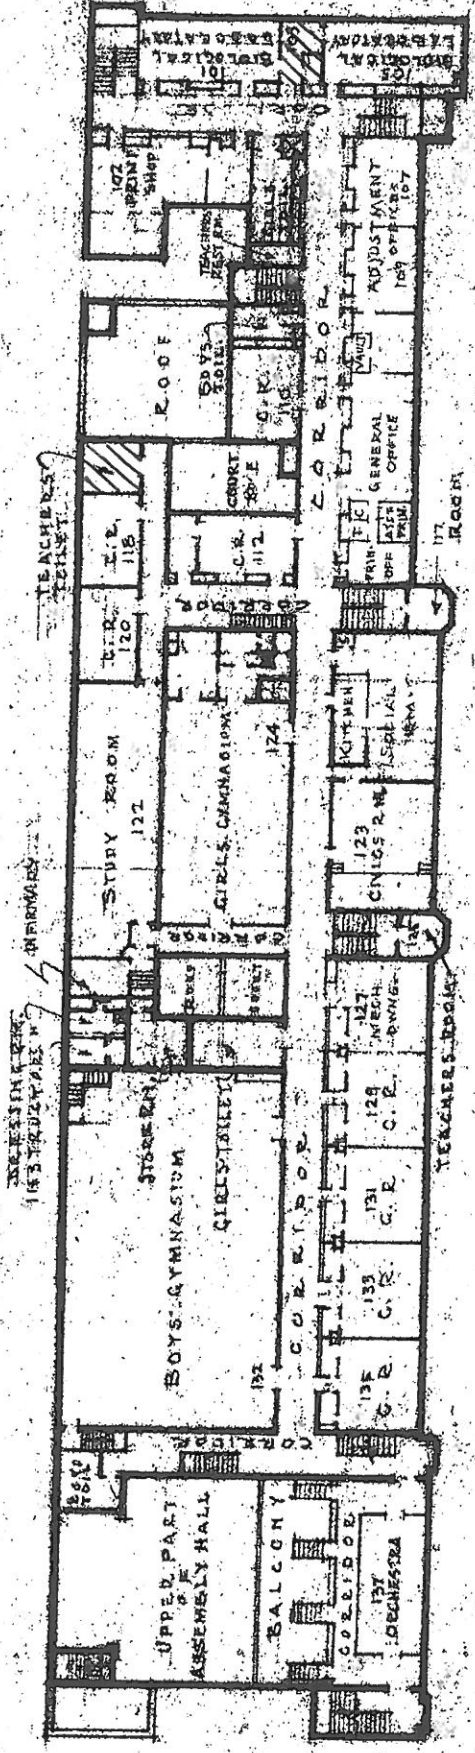
FIRST FLOOR PLAN
SCALE: 1/8" = 1'-0"

HA # 73

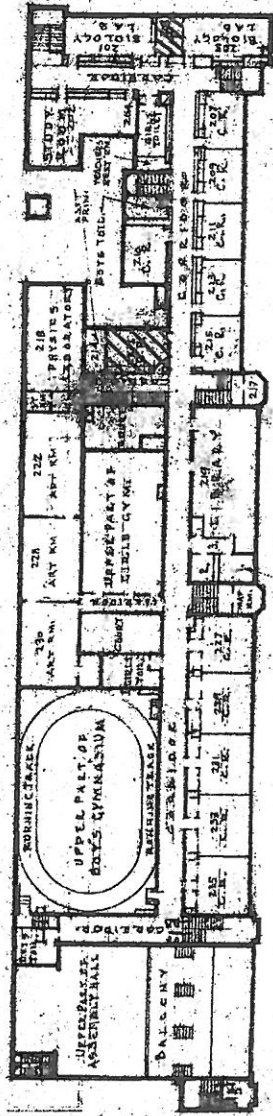
SECOND FLOOR PLAN

HA#73
 OFF WHITE w/ ORANGE SPECS VFT

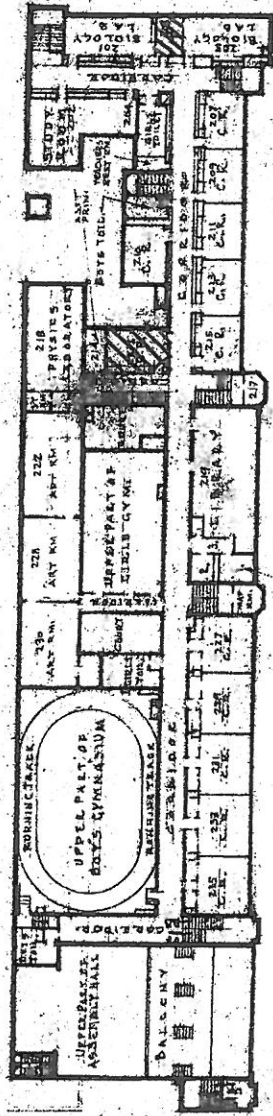
SECOND FLOOR PLAN

HA#73 OFF WHITE w/ ORANGE SPECS VFT
