**ILLINOIS DEPARTMENT OF PUBLIC HEALTH  
AHERA THREE YEAR REINSPECTION  
ASBESTOS ABATEMENT PROGRAM  
SCHOOL INFORMATION FORM**

**THREE-YEAR REINSPECTION**

**CHICAGO SCHOOL DIST 299**

**Lane Tech High School**

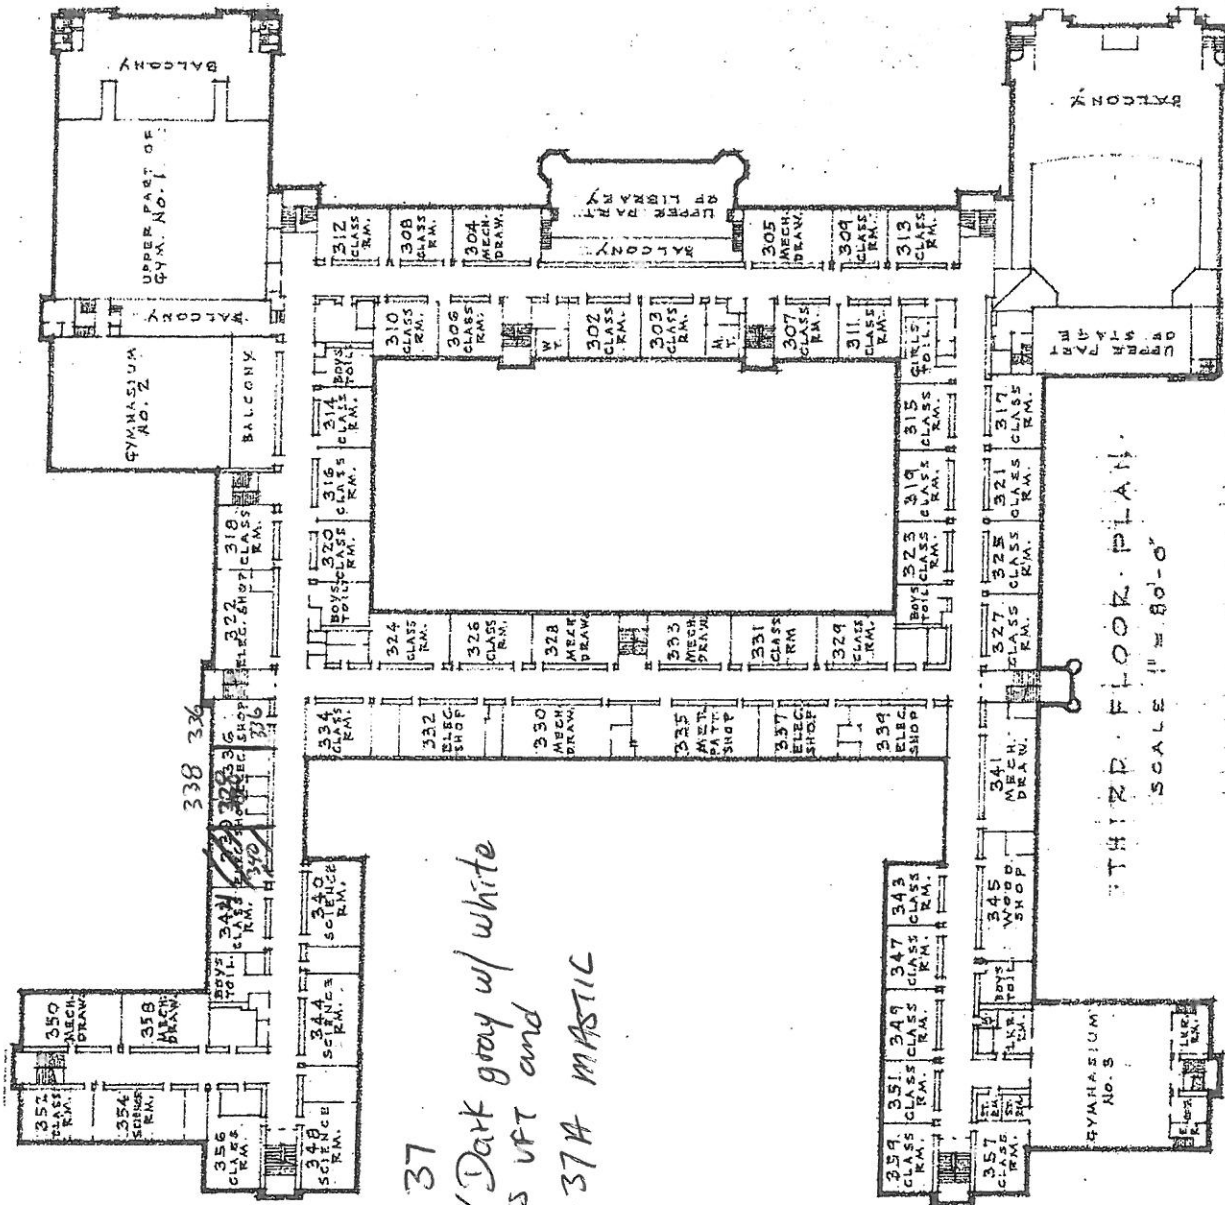
#4 # 37  
 12"x12" Dark gray w/ white  
 streaks vft and  
 #1A # 37A MASTIC

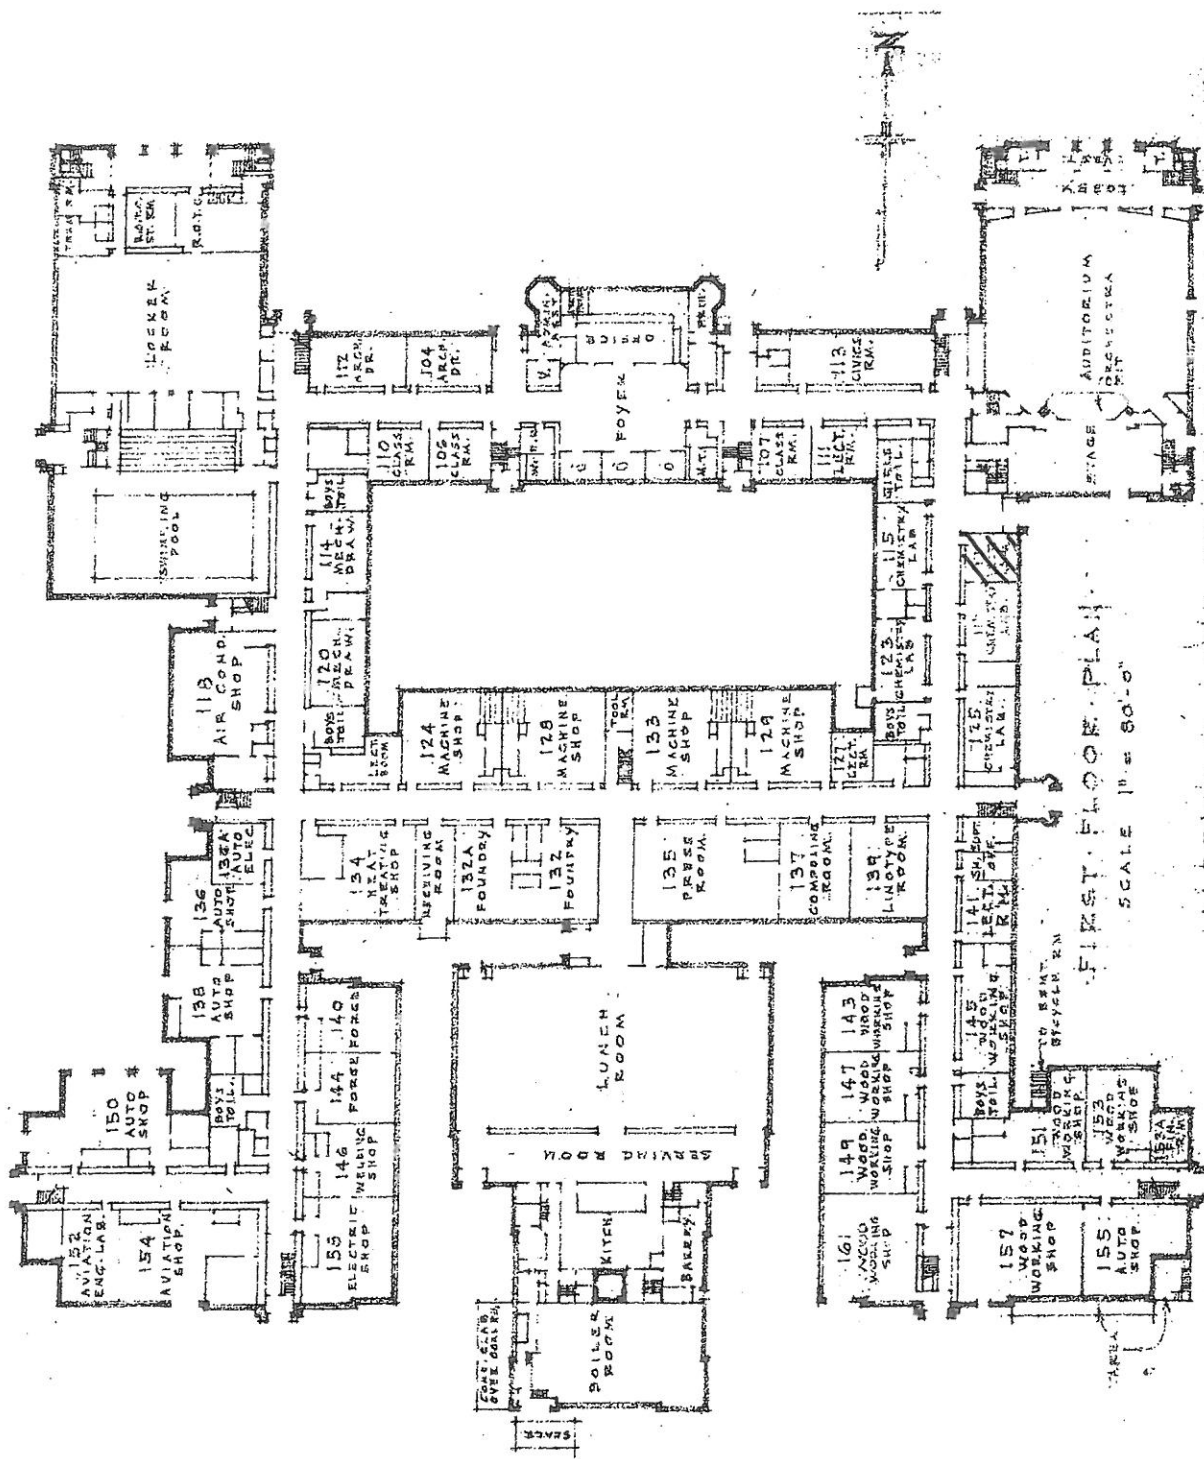
HA #41  
 12" X 12" Green w/ white & black streaks VFT and  
 HA #41A MASTIC

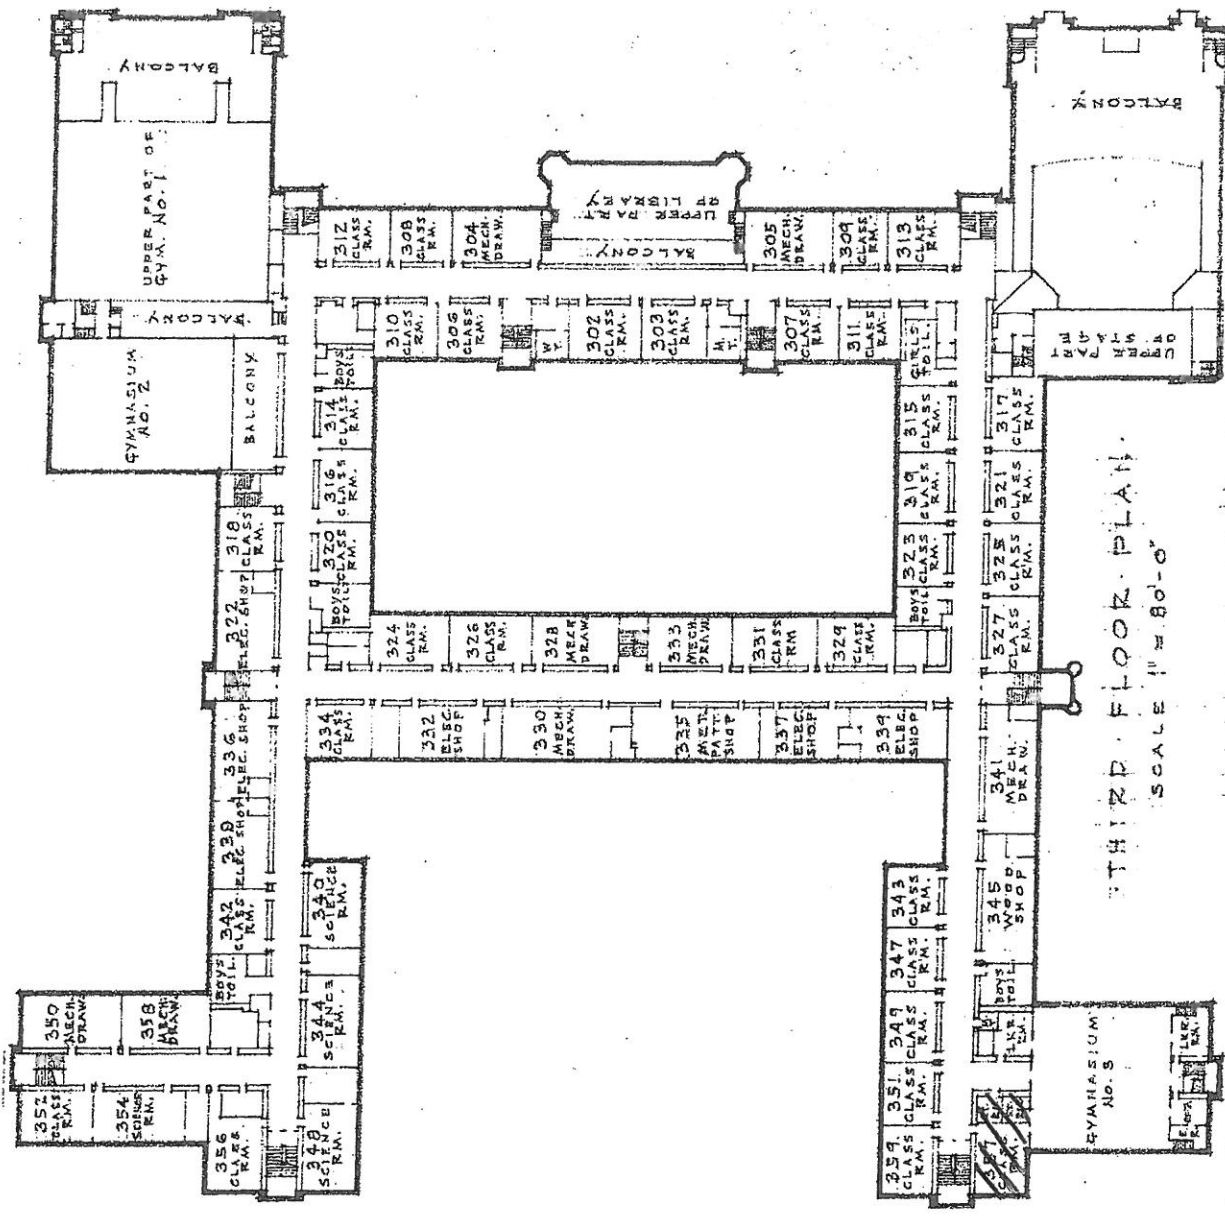
HA # 36  
 12"X12" light beige w/ white &  
 brown streaks vt and  
 HA #36A MASTIC

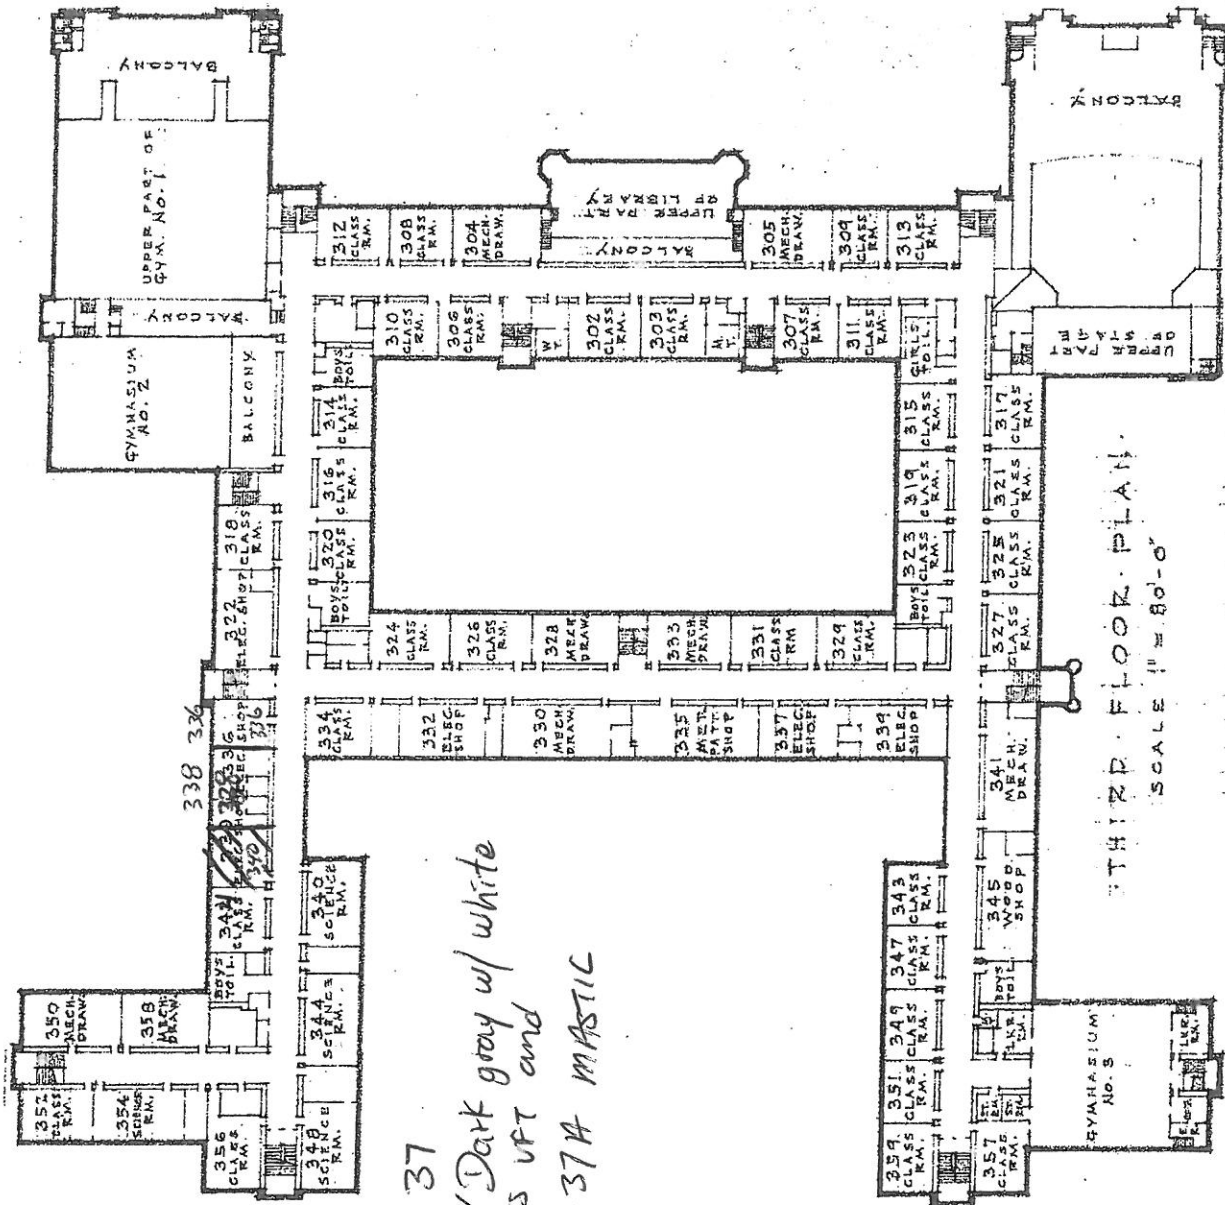
#4 # 37  
 12"X12" Dark gray w/ white  
 streaks vft and  
 #1A # 37A MASTIC

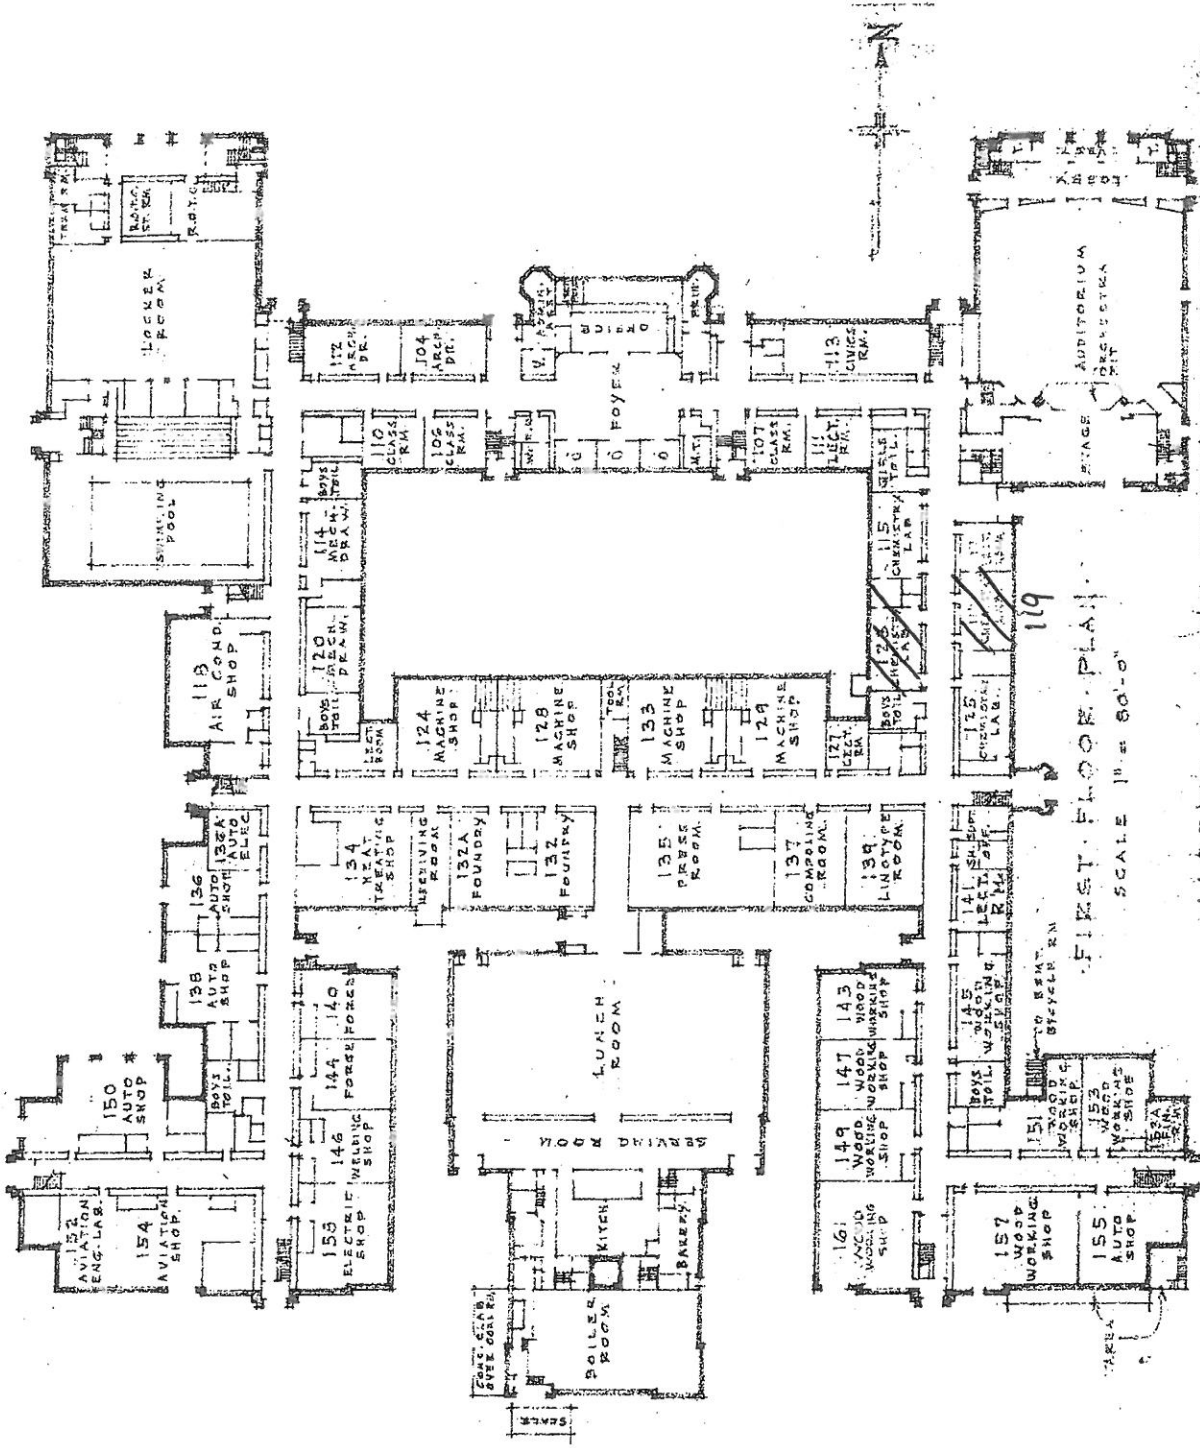
HA # 42

Black/gray lab center tops

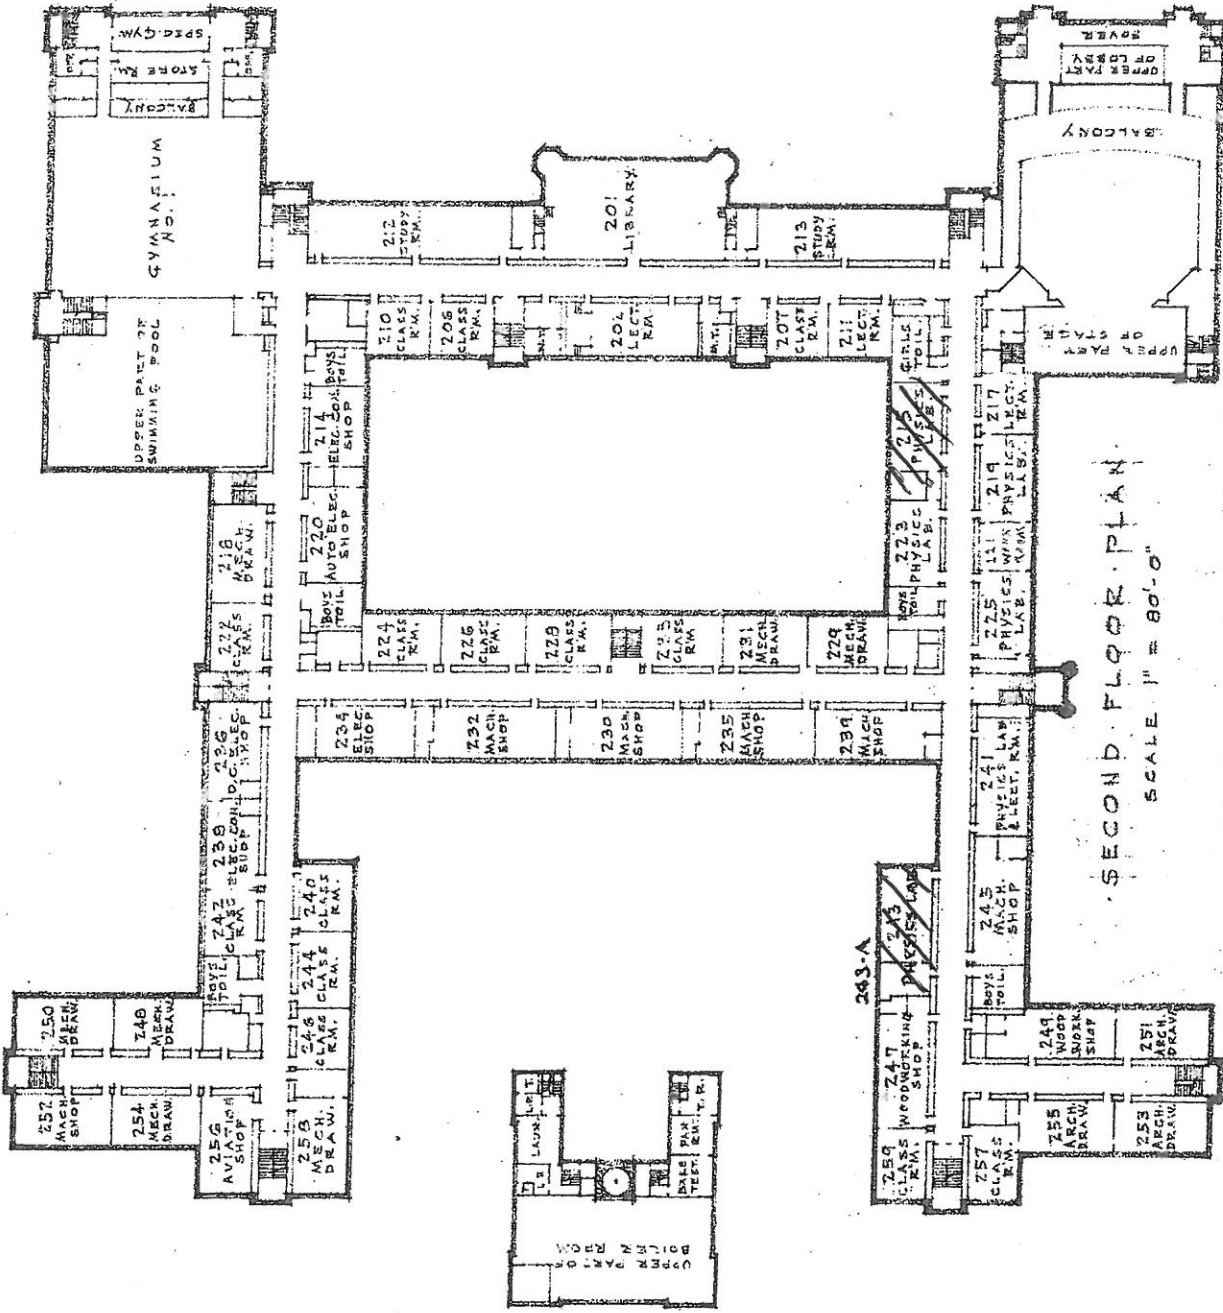
HA # 42  
Black/gray counter tops

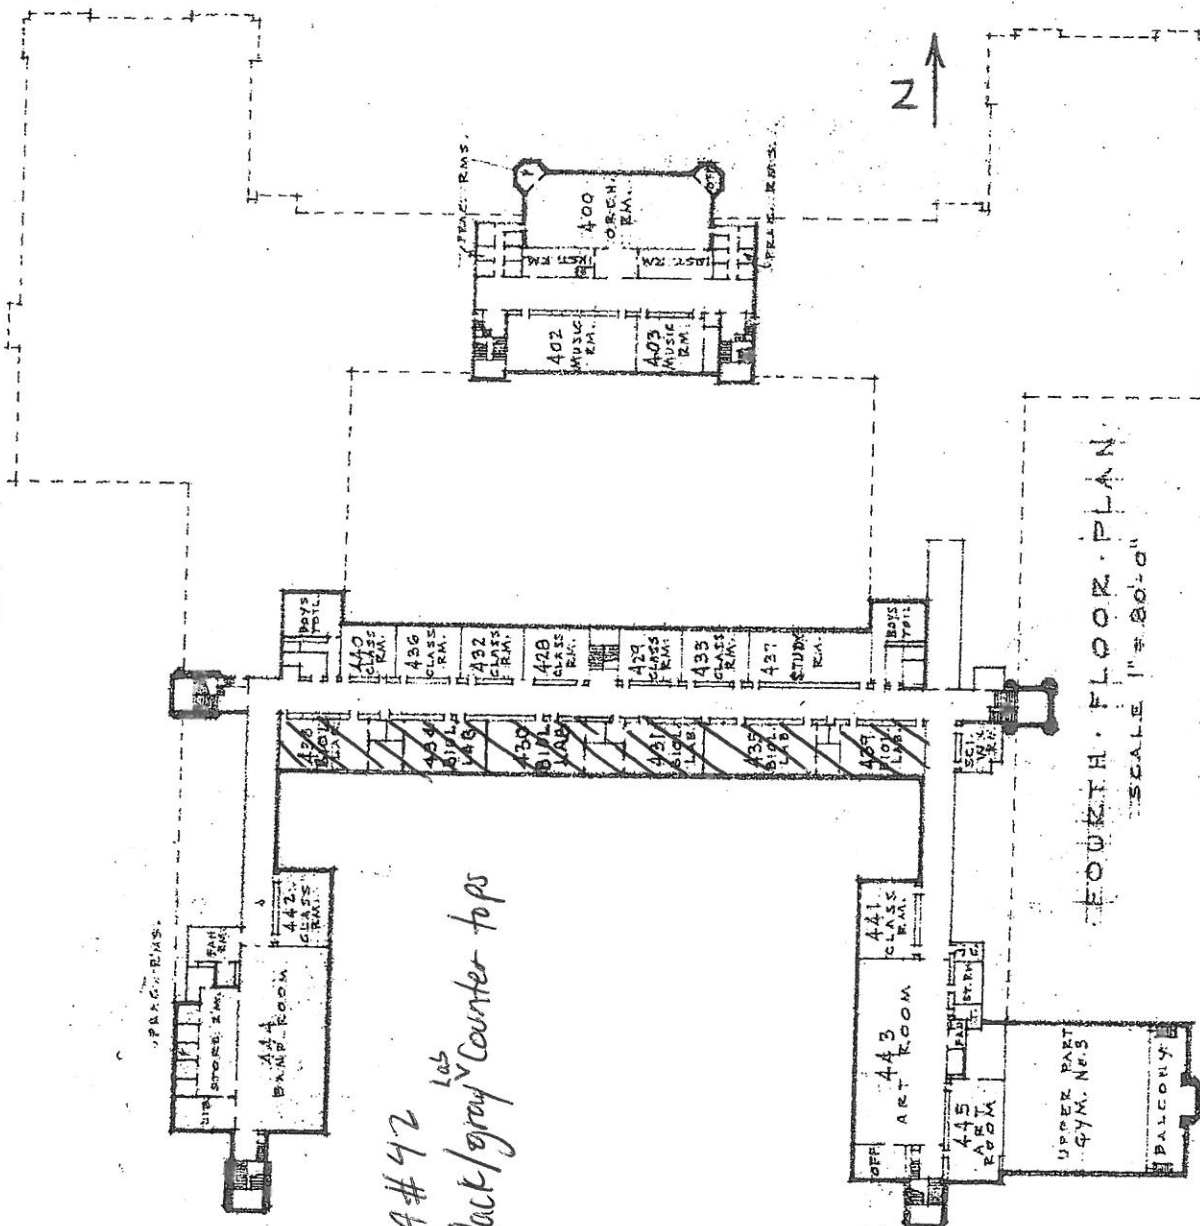
44# 42  
 105  
 Black/gray Counter tops  
 ▨

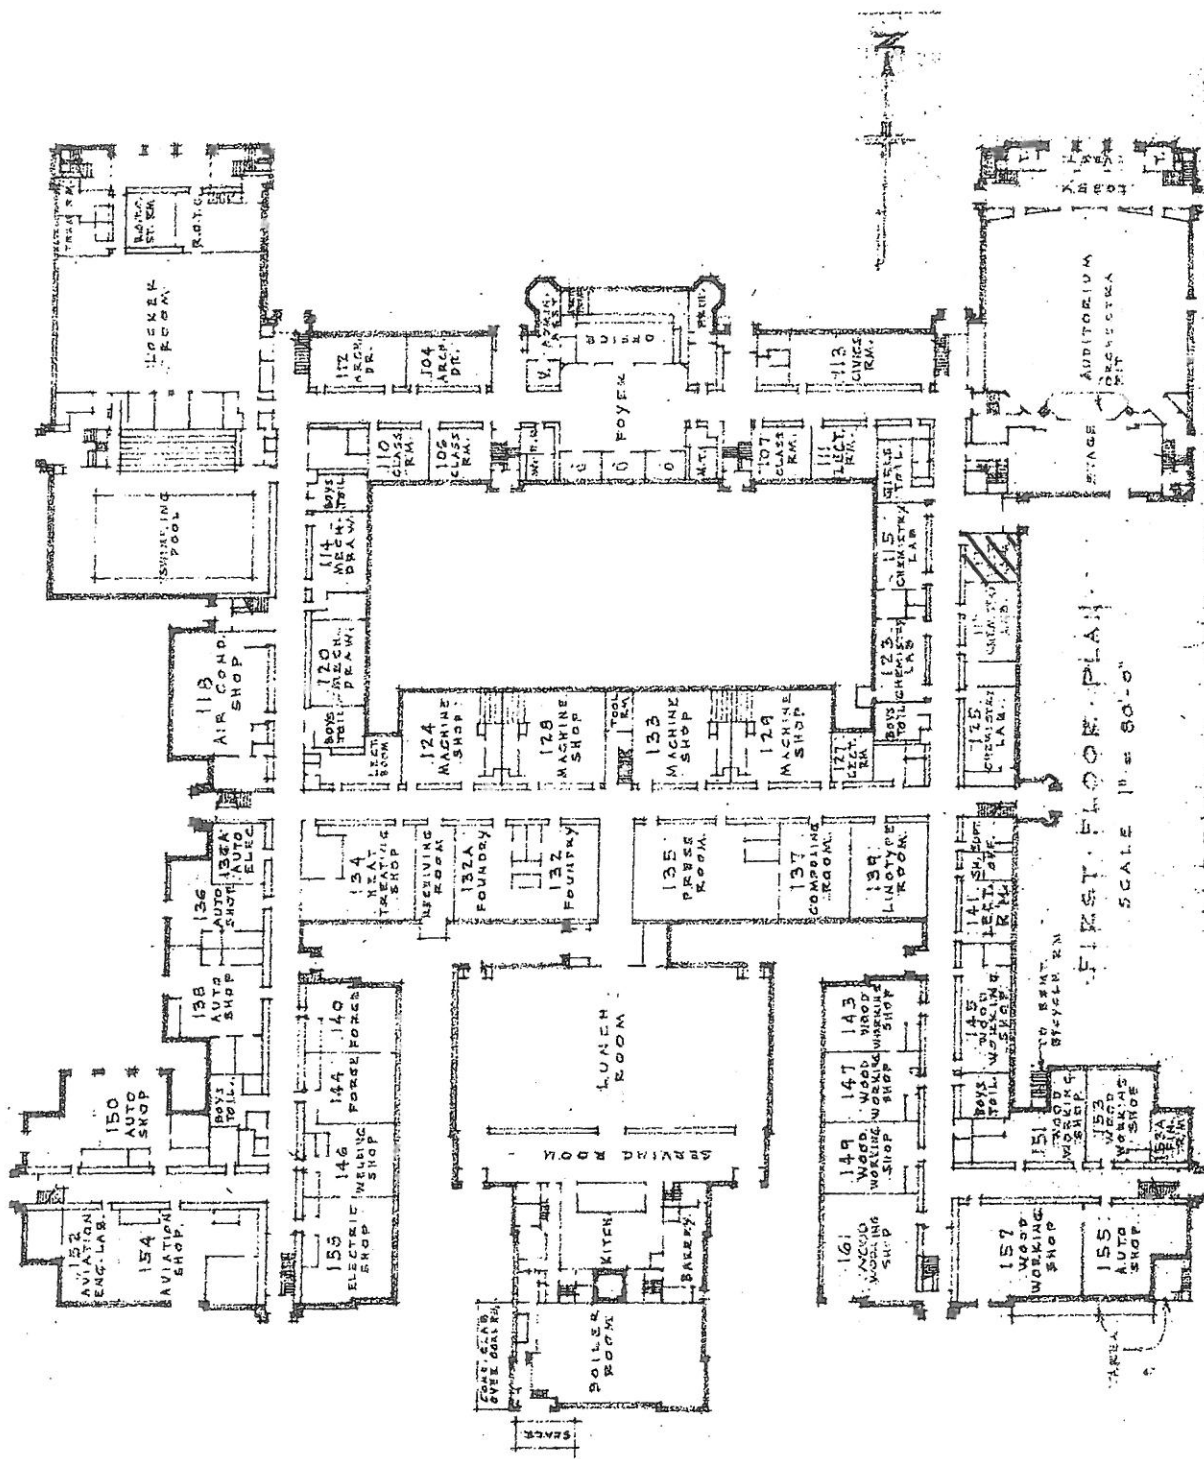
HA #41  
 12" X 12" Green w/ white & black streaks VFT and  
 HA #41A MASTIC
