**ILLINOIS DEPARTMENT OF PUBLIC HEALTH
AHERA THREE YEAR REINSPECTION
ASBESTOS ABATEMENT PROGRAM
SCHOOL INFORMATION FORM**

THREE-YEAR REINSPECTION

Brooks College Prep (Southside College Prep)

Unit: 47051
Building ID: 1500

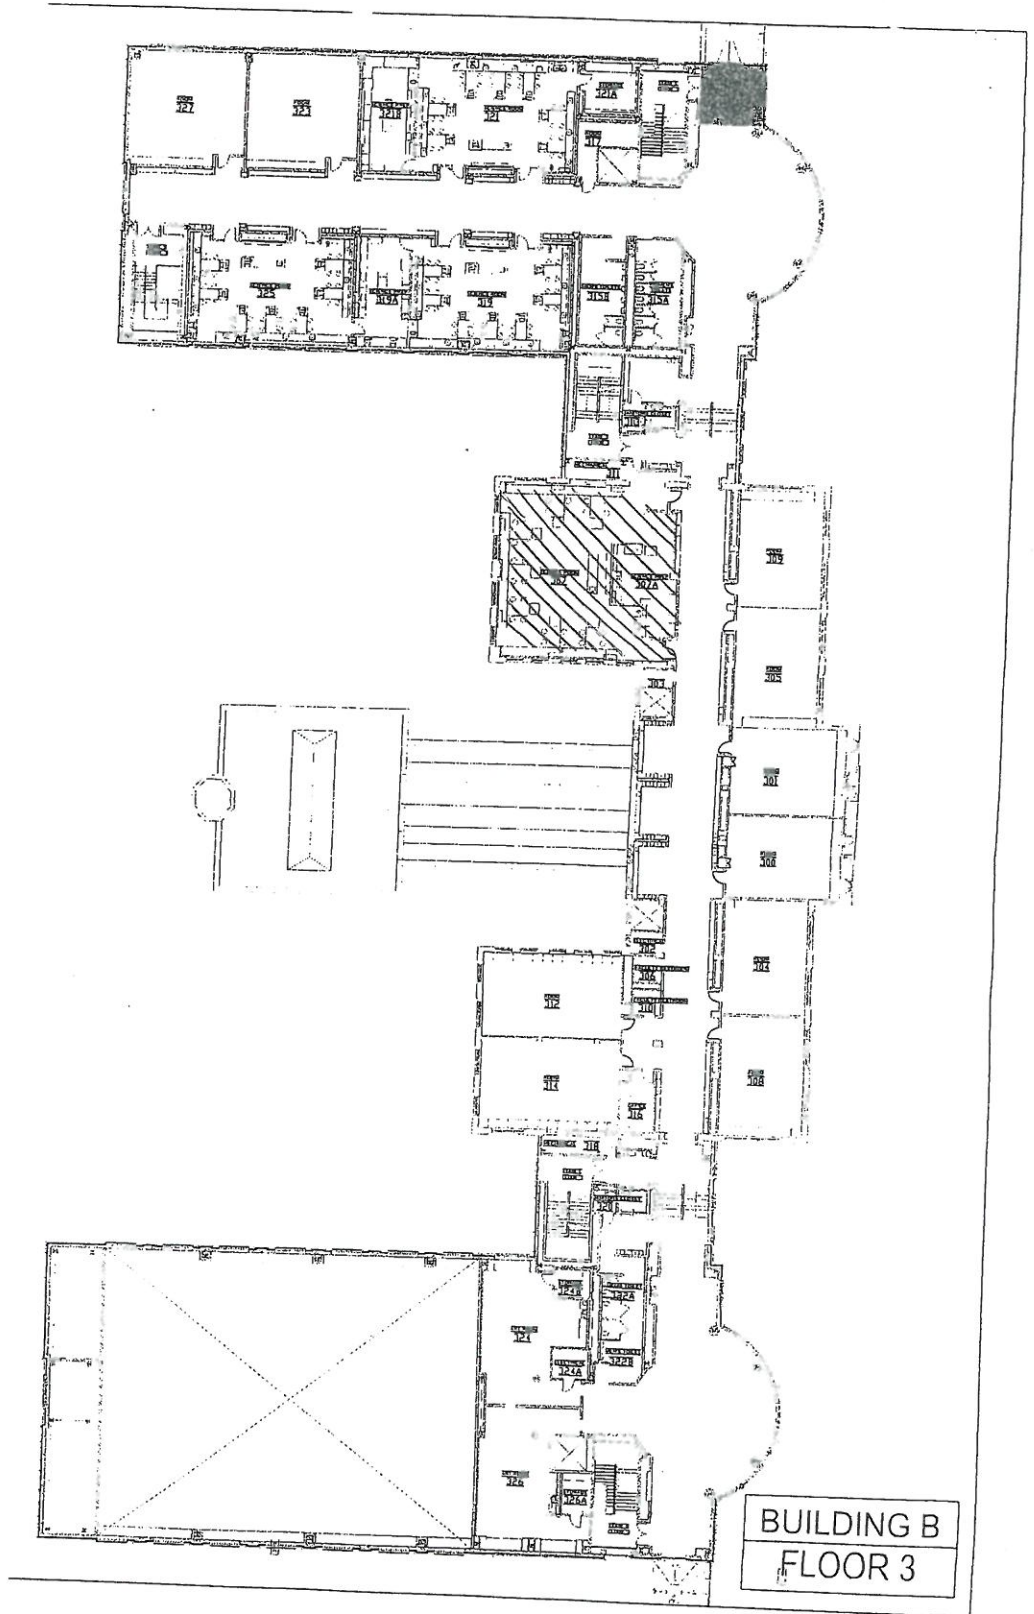
HA-30

BUILDING B
FLOOR 3

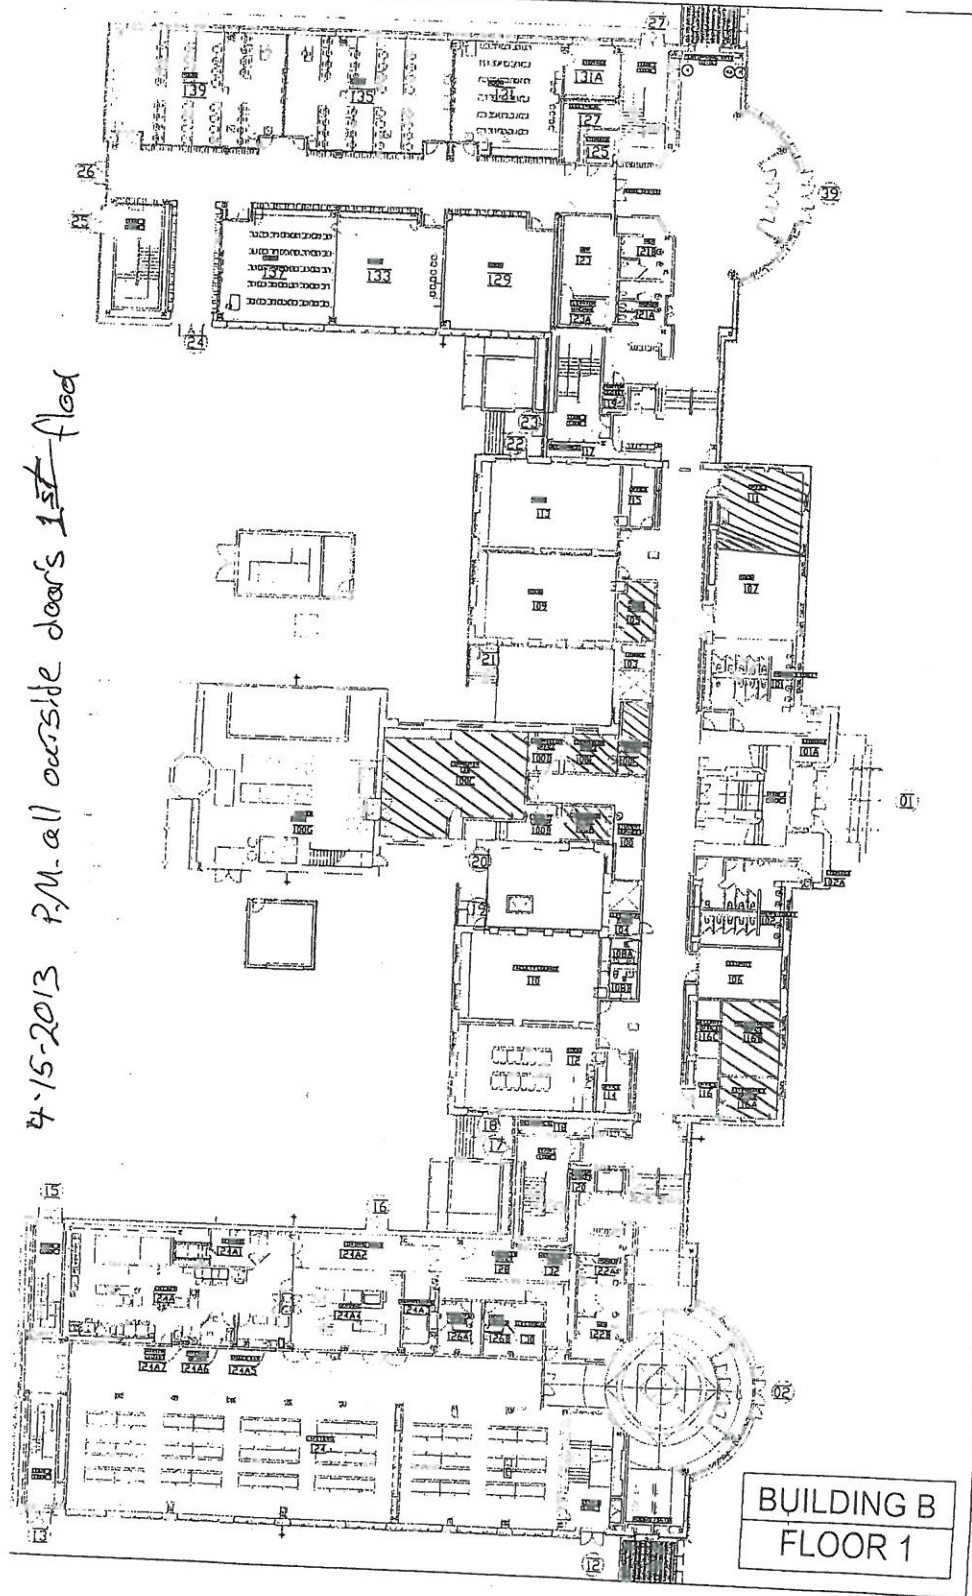
HA170

4-15-2013 P.M. all outside doors 1st floor

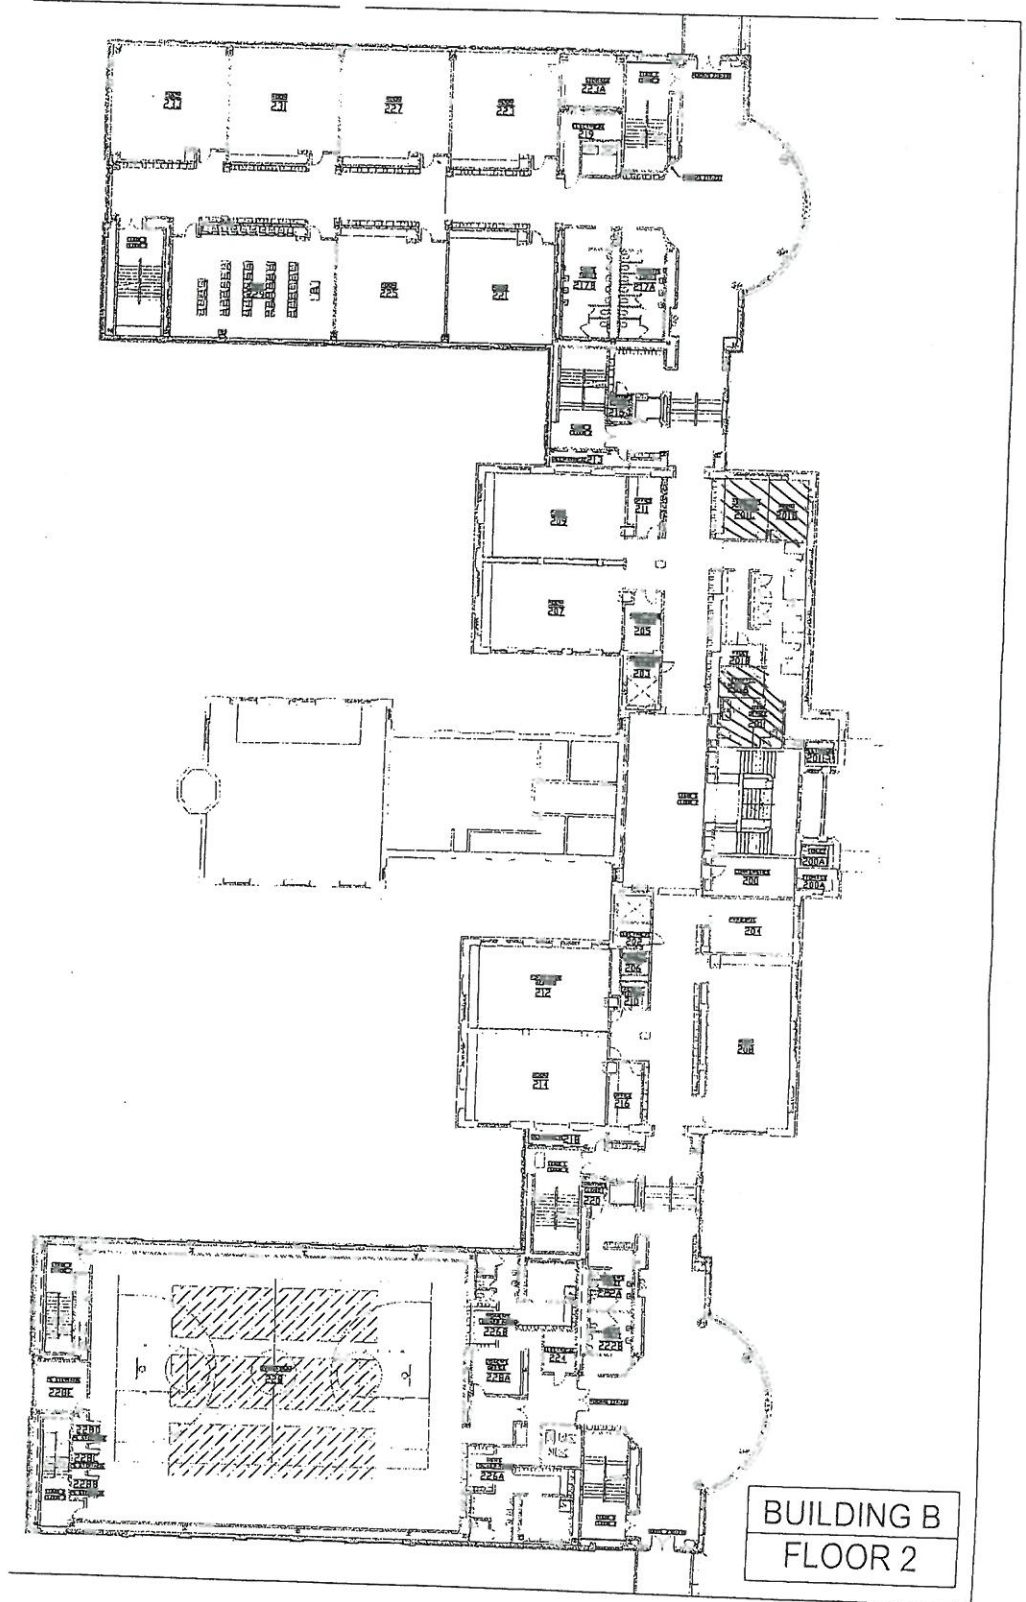
HA-171

BUILDING B
FLOOR 2
