ILLINOIS DEPARTMENT OF PUBLIC HEALTH
AHERA THREE YEAR REINSPECTION
ASBESTOS ABATEMENT PROGRAM
SCHOOL INFORMATION FORM

THREE-YEAR REINSPECTION

Whitney Young Magnet High School

REPORT DATE:

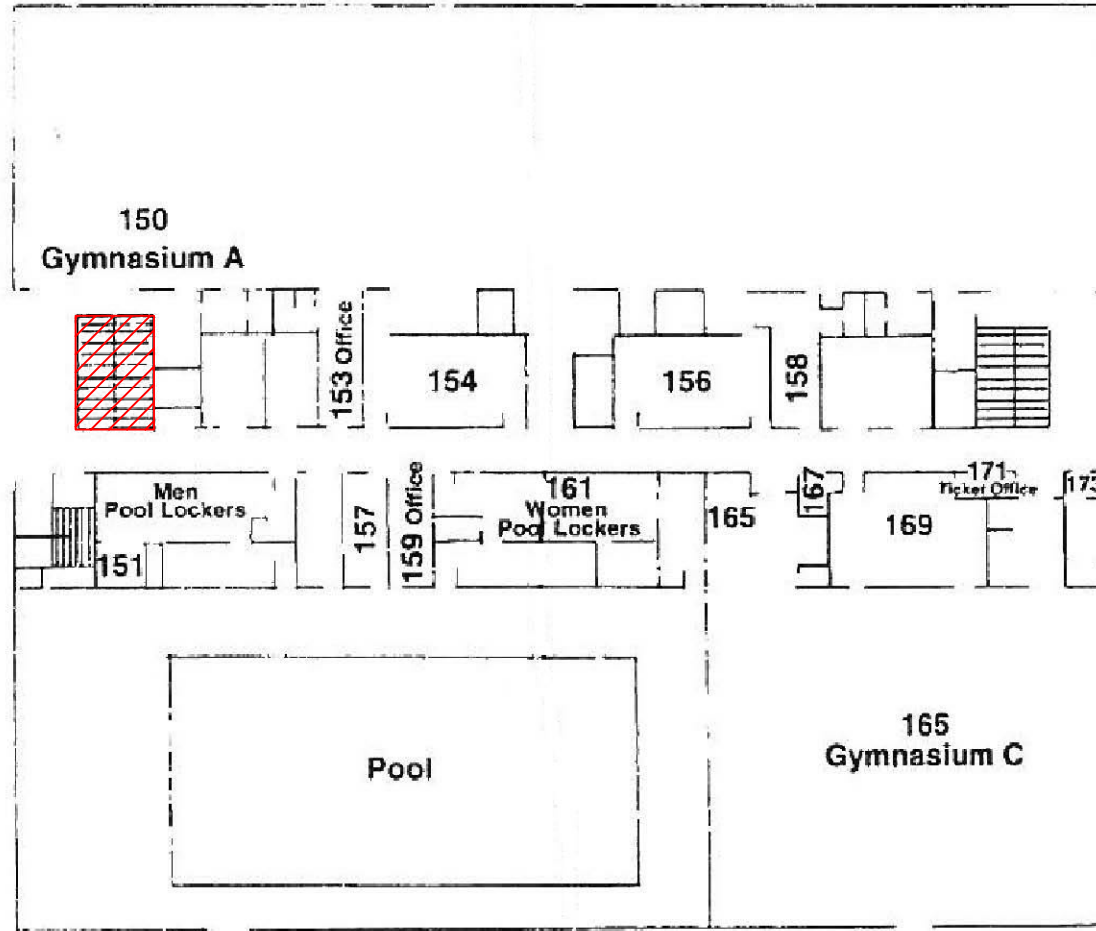
PHYSICAL EDUCATION BUILDING 1ST FLOOR

HA-172 Stair Tread Covering
