**ILLINOIS DEPARTMENT OF PUBLIC HEALTH
AHERA THREE YEAR REINSPECTION
ASBESTOS ABATEMENT PROGRAM
SCHOOL INFORMATION FORM**

NAME OF SCHOOL DISTRICT: CHICAGO SCHOOL DIST 299
SCHOOL ID NUMBER: 14-016-2990-0018
SCHOOL NAME: St. George Branch (New Armour Annex)
ADDRESS OF SCHOOL: 911 West 32nd Place
CITY: Chicago, IL, 60608

THREE-YEAR REINSPECTION

St. George Branch (New Armour Annex)

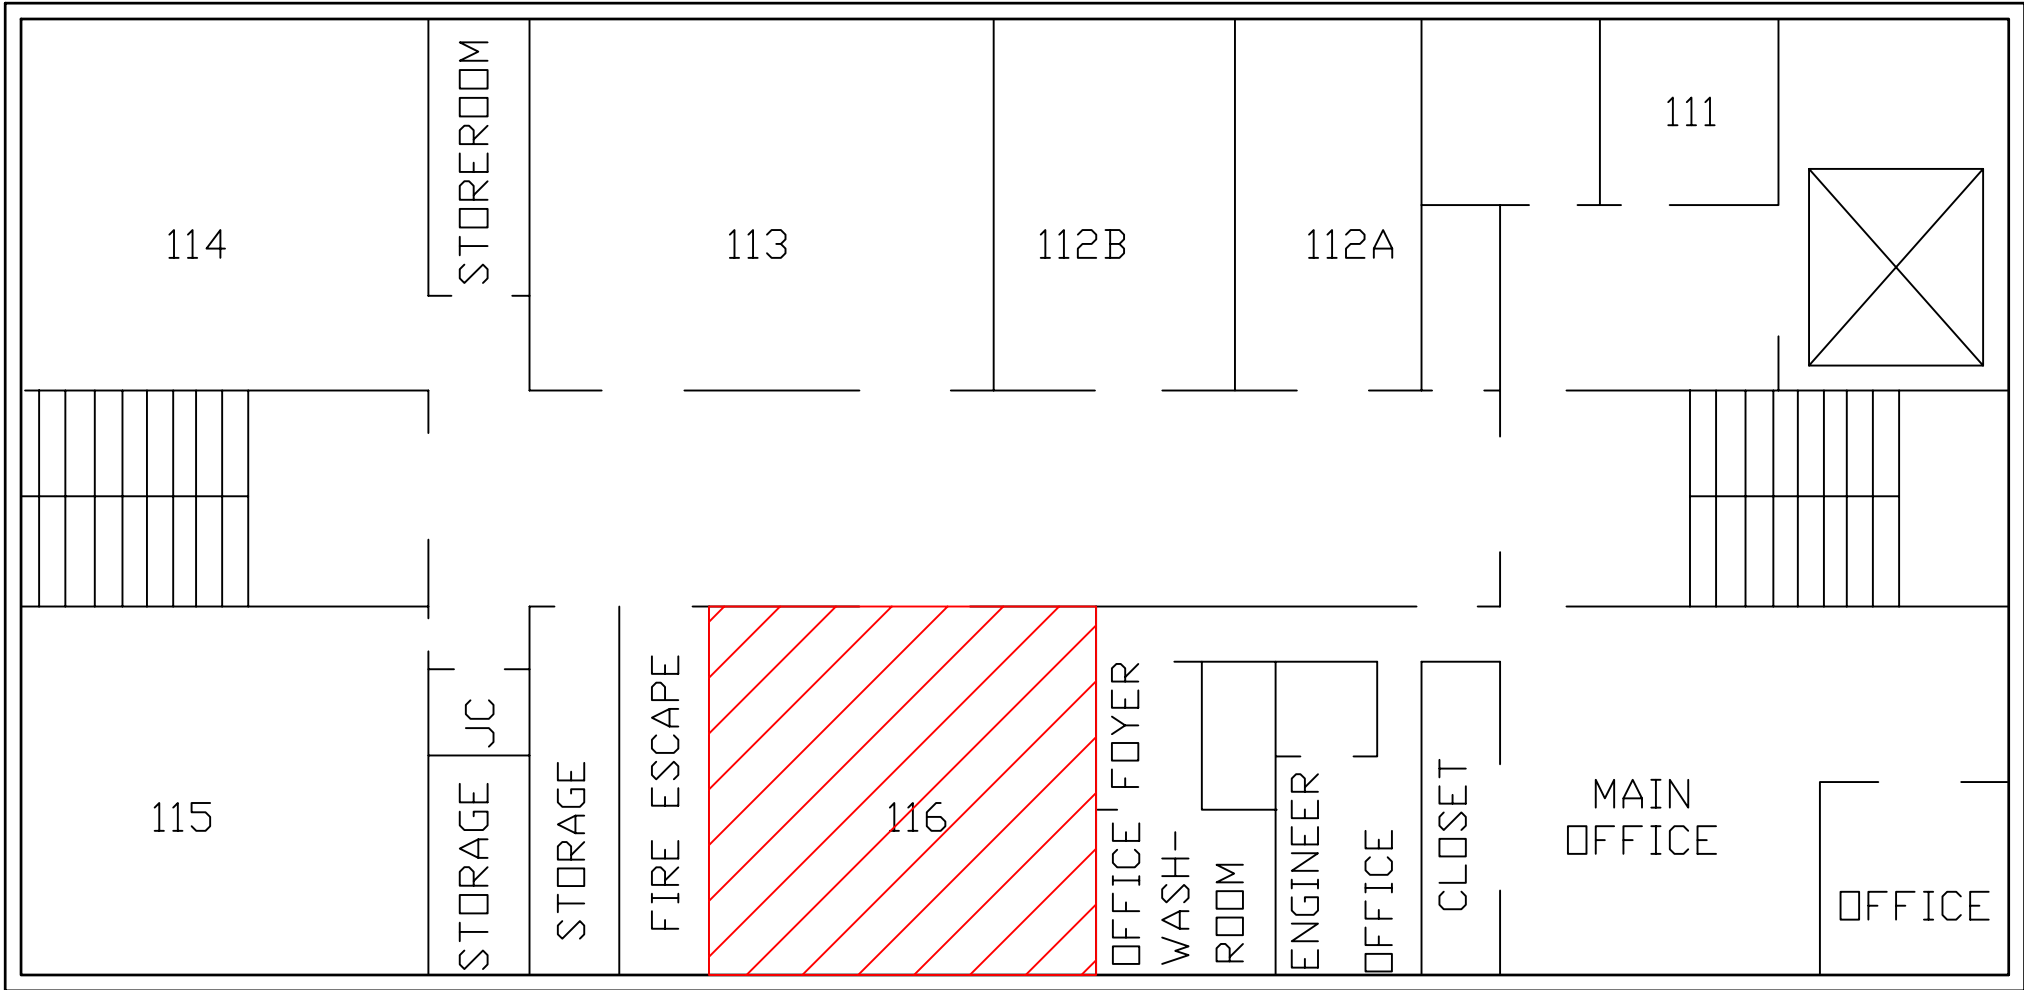
HA-79 12"x 12" Blue Mottled Floor Tile
