**ILLINOIS DEPARTMENT OF PUBLIC HEALTH
AHERA THREE YEAR REINSPECTION
ASBESTOS ABATEMENT PROGRAM
SCHOOL INFORMATION FORM**

THREE-YEAR REINSPECTION

Hearst School

REPORT DATE:

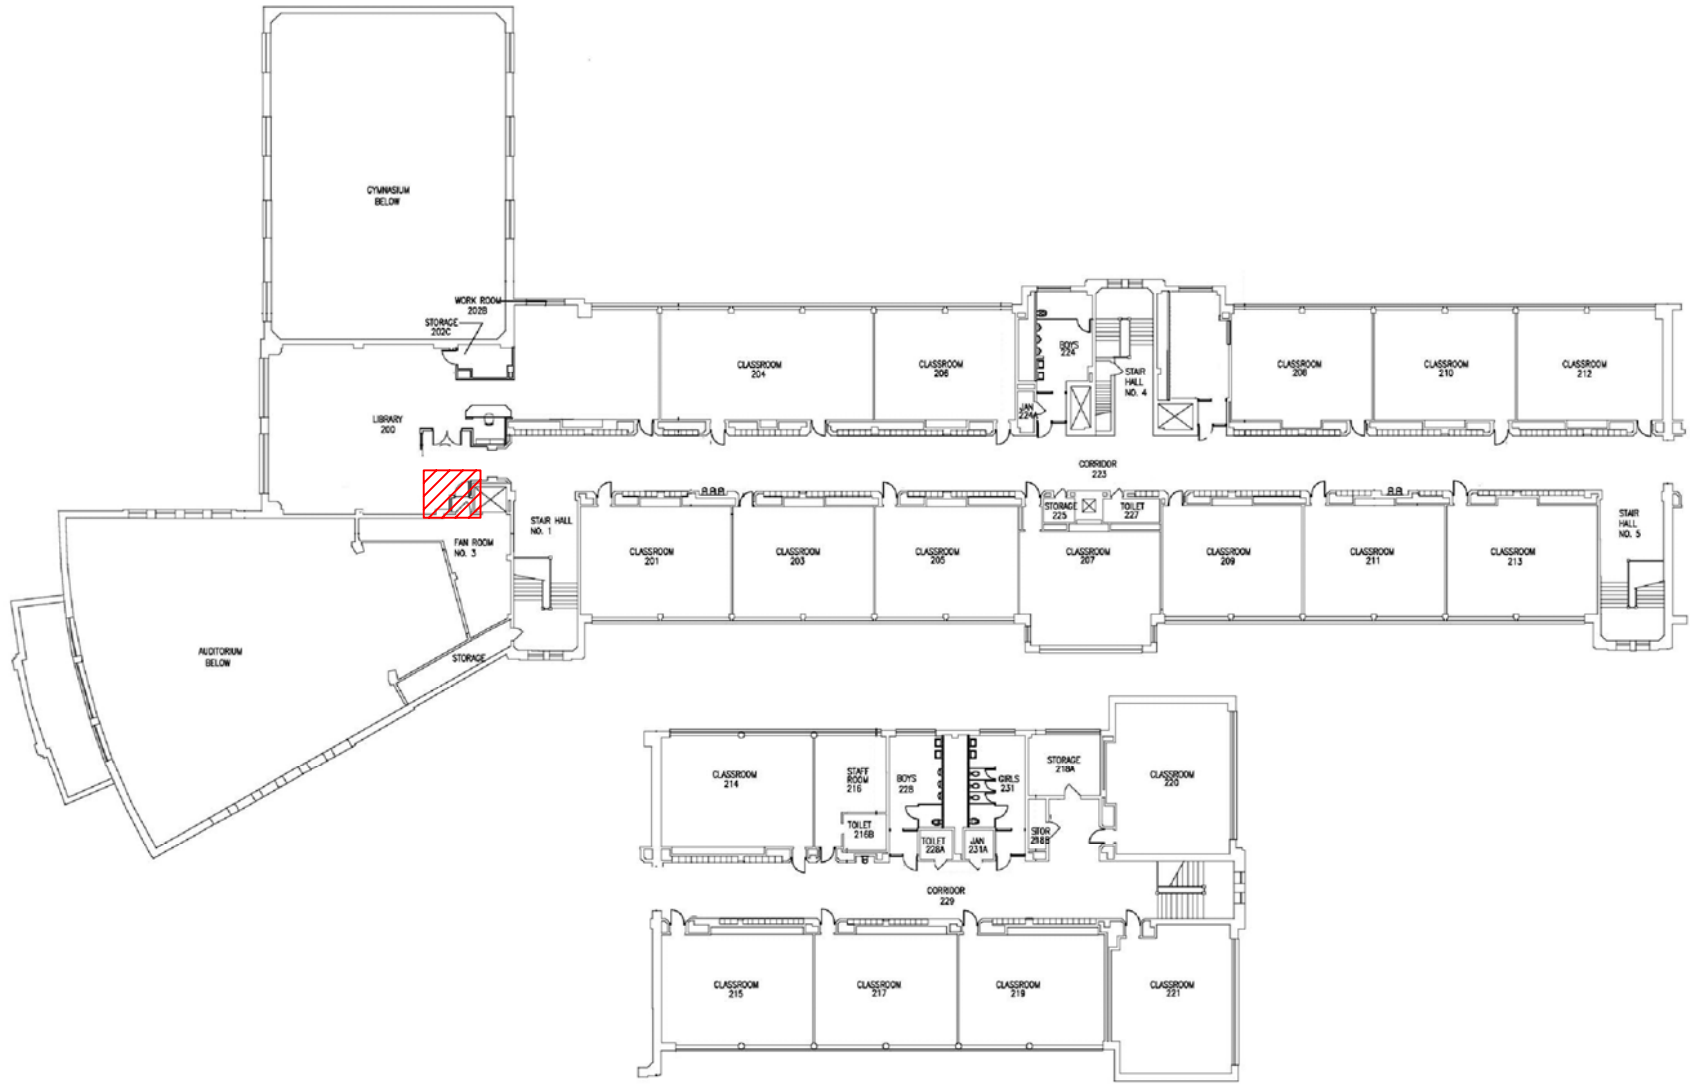
**CARNOW
CONIBEAR** HA-187

HA-187 Drywall System

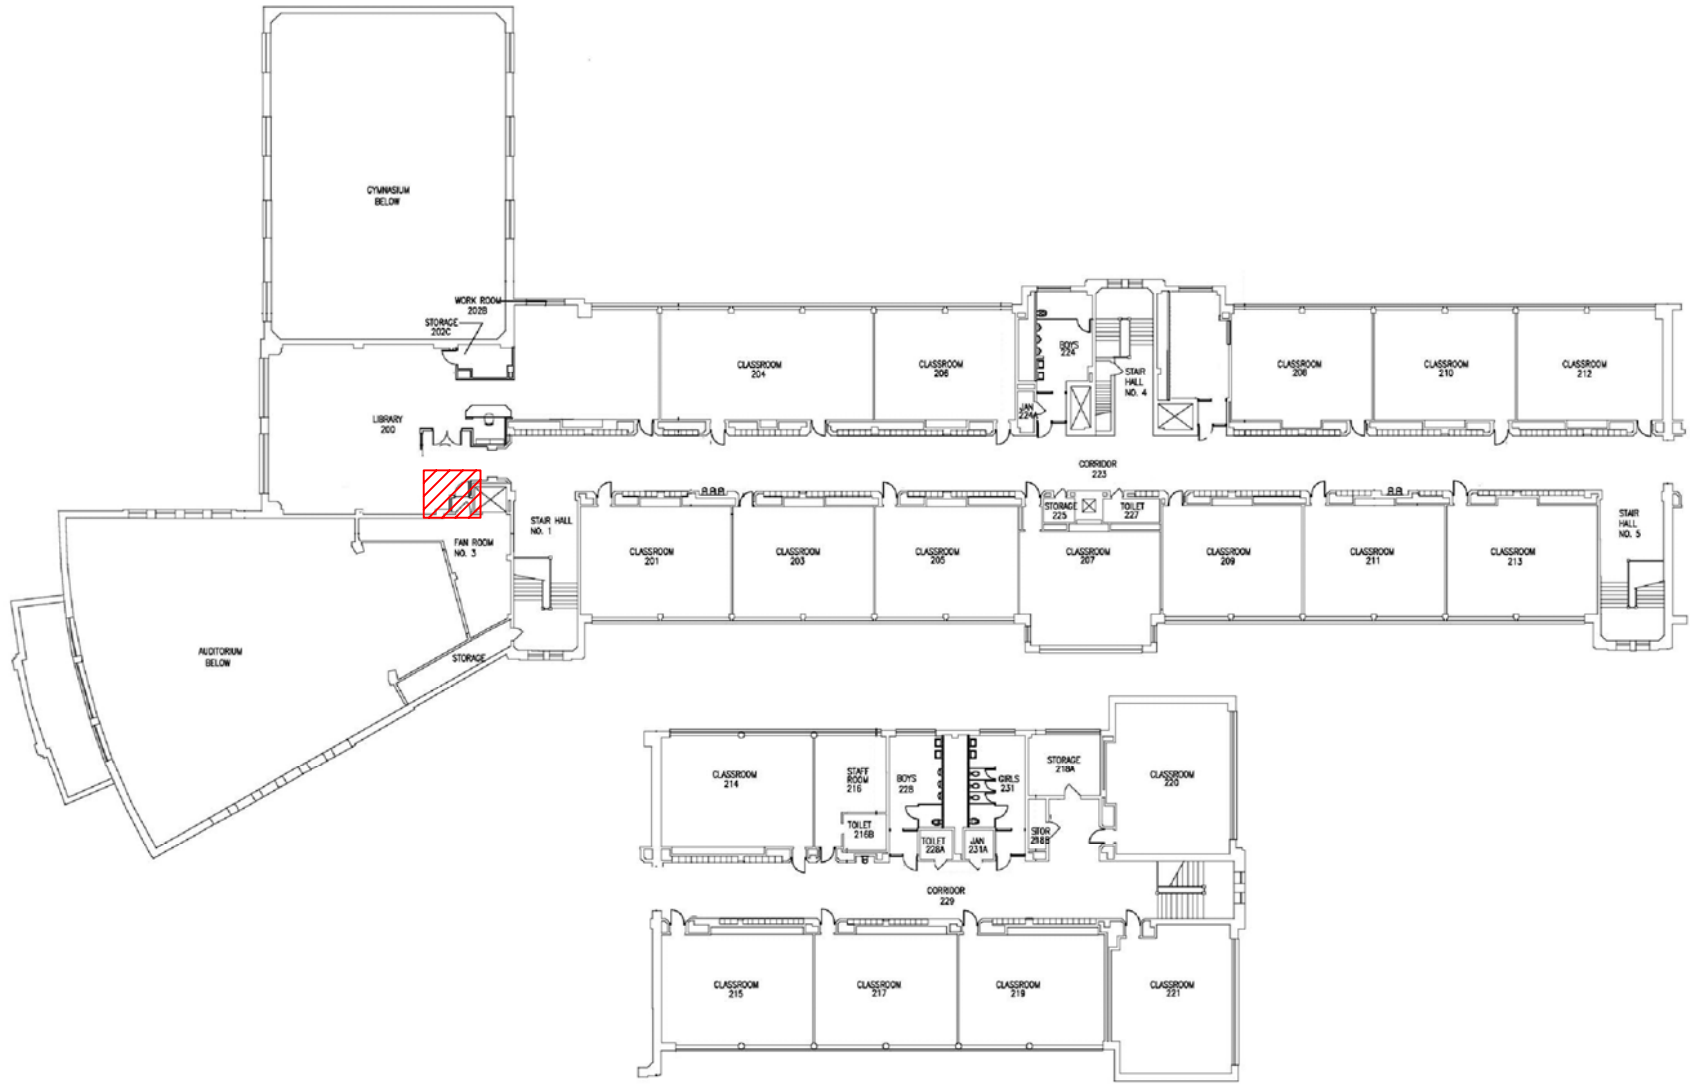
CCA PROJECT NUMBER
A320130001-194
DATE
2/25/2013
SHEET NUMBER
HA-181

HA-181 Mastic Associated with Black Vinyl Baseboard
