ILLINOIS DEPARTMENT OF PUBLIC HEALTH  
AHERA THREE YEAR REINSPECTION  
ASBESTOS ABATEMENT PROGRAM  
SCHOOL INFORMATION FORM

**THREE-YEAR REINSPECTION**

**Dunne School**

Wednesday, May 01, 2013

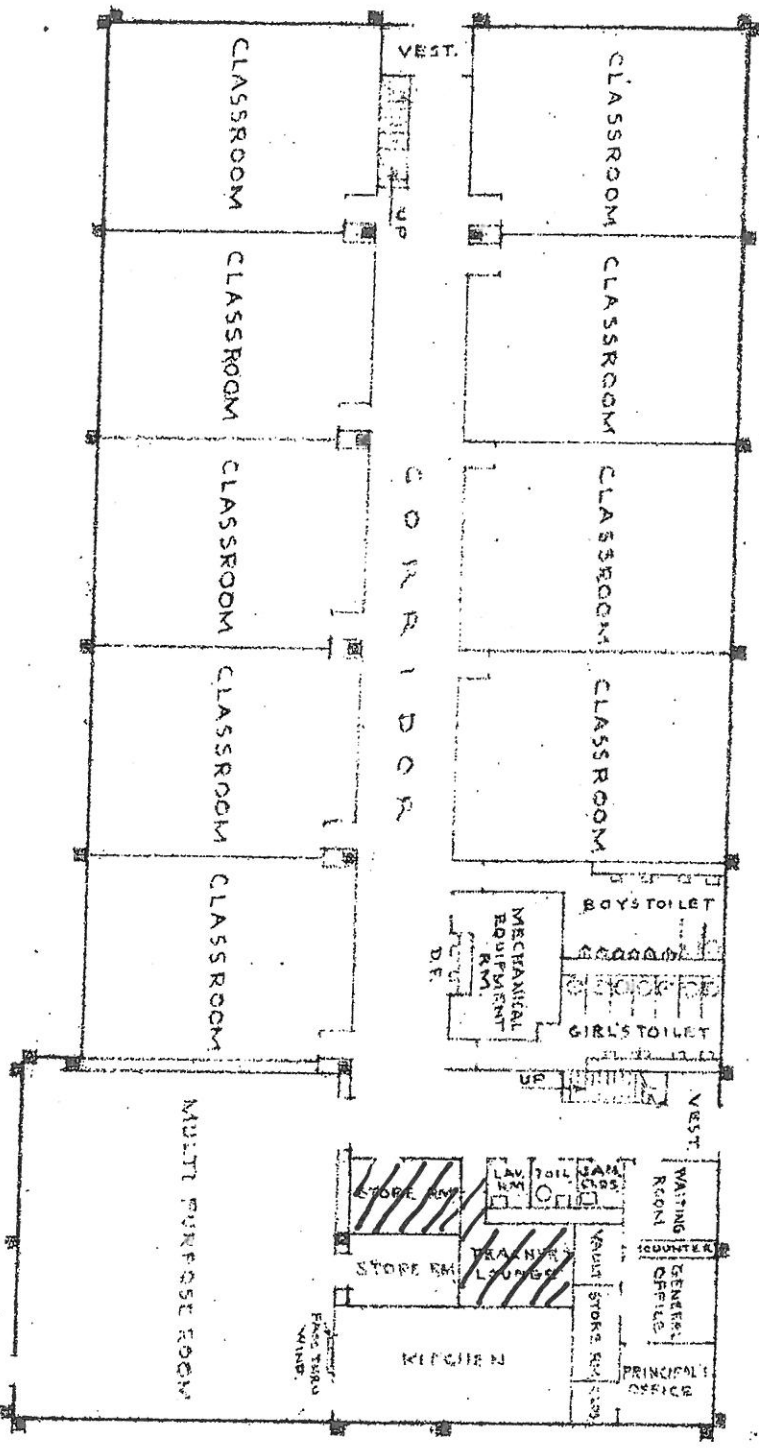
FIRST FLOOR PLAN  
SCALE 1/8" = 2'-0"

HA # 43  
 HA # 44  
 18x12 white w/ Red + Blue Specs  
 Floor tile + Hastic

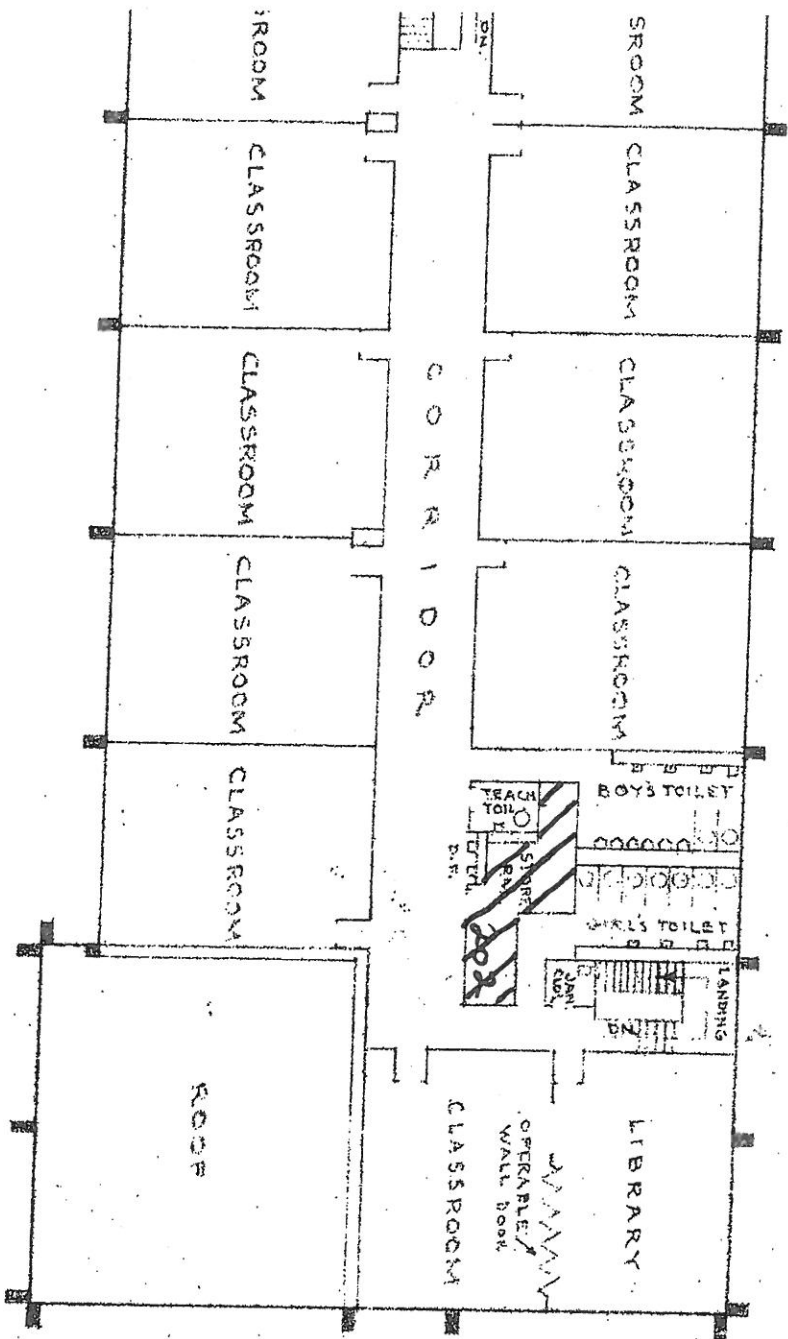
SECOND FLOOR PLAN  
 SCALE: 1" = 20'-0"

[Hatched Box] - HA # 43 49X12 white w/ Red + Blue  
 HA # 44 Specs Floor Tile + Washic

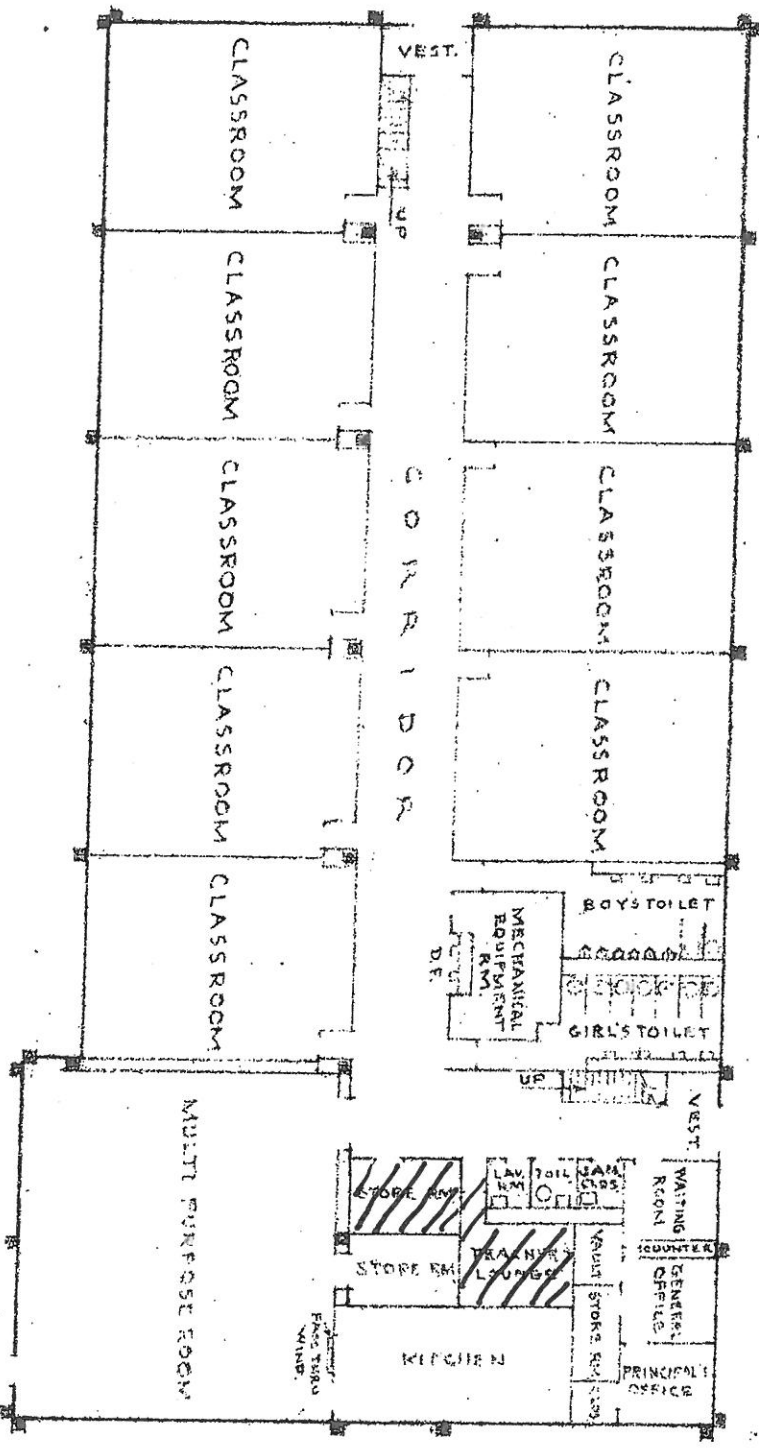
FIRST FLOOR PLAN  
SCALE 1/8" = 20'-0"

- HA # 43 18x12 white w/ Red + Blue Specs  
 HA # 44 Floor tile + Hastic

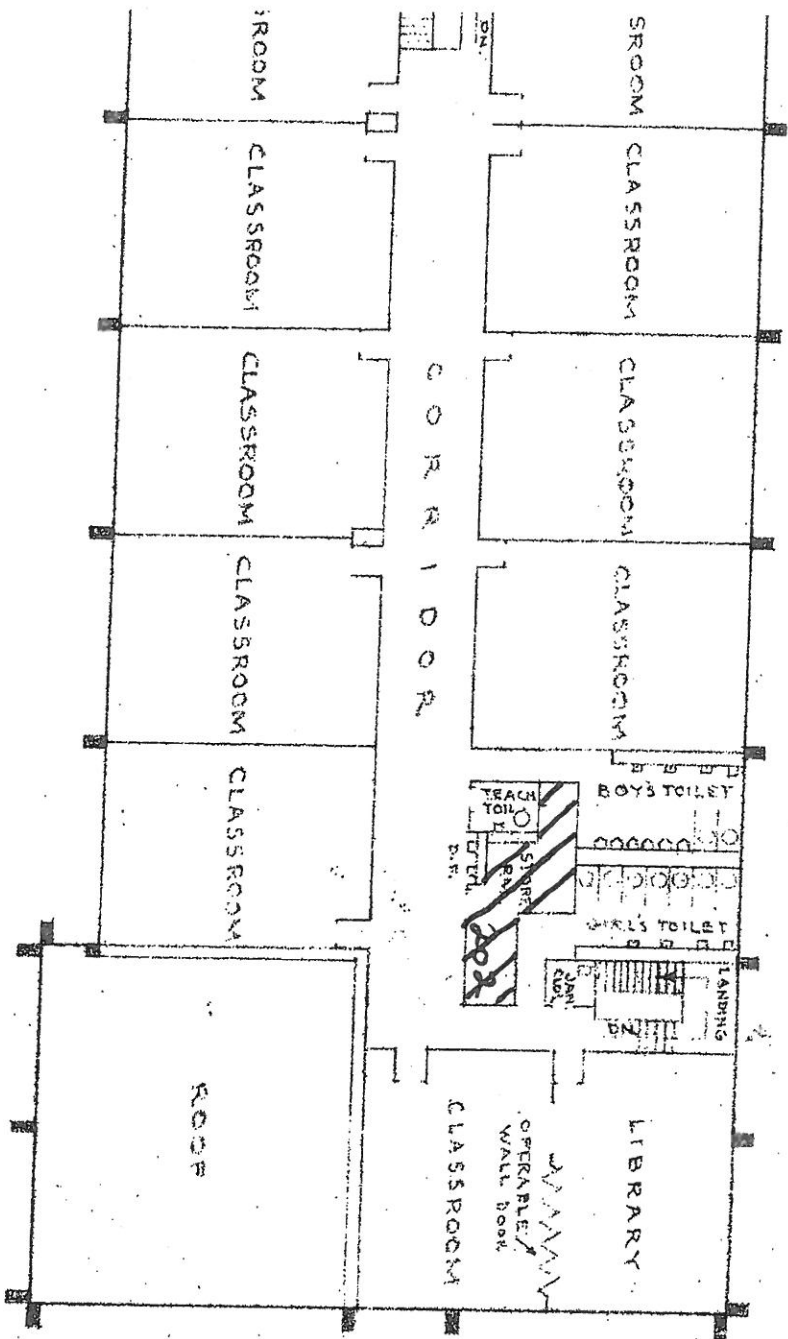
SECOND FLOOR PLAN  
 SCALE: 1" = 20'-0"

[Hatched Box] - HA # 43 49X12 white w/ Red + Blue  
 HA # 44 Specs Floor Tile + Washic

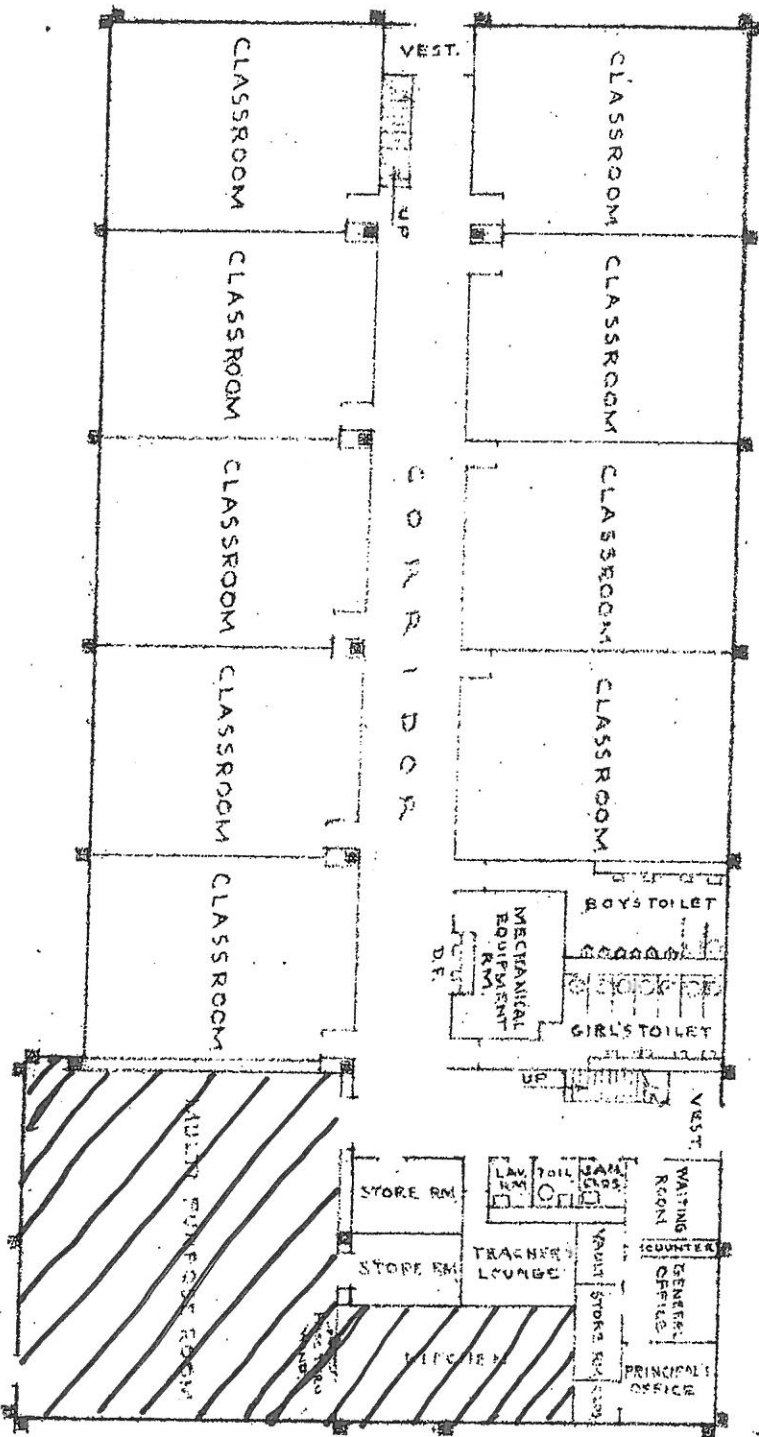
FIRST FLOOR PLAN  
 SCALE 1/8" = 20'-0"

HA #45  
 HA #46  
 yellow Floor tile + Mastic

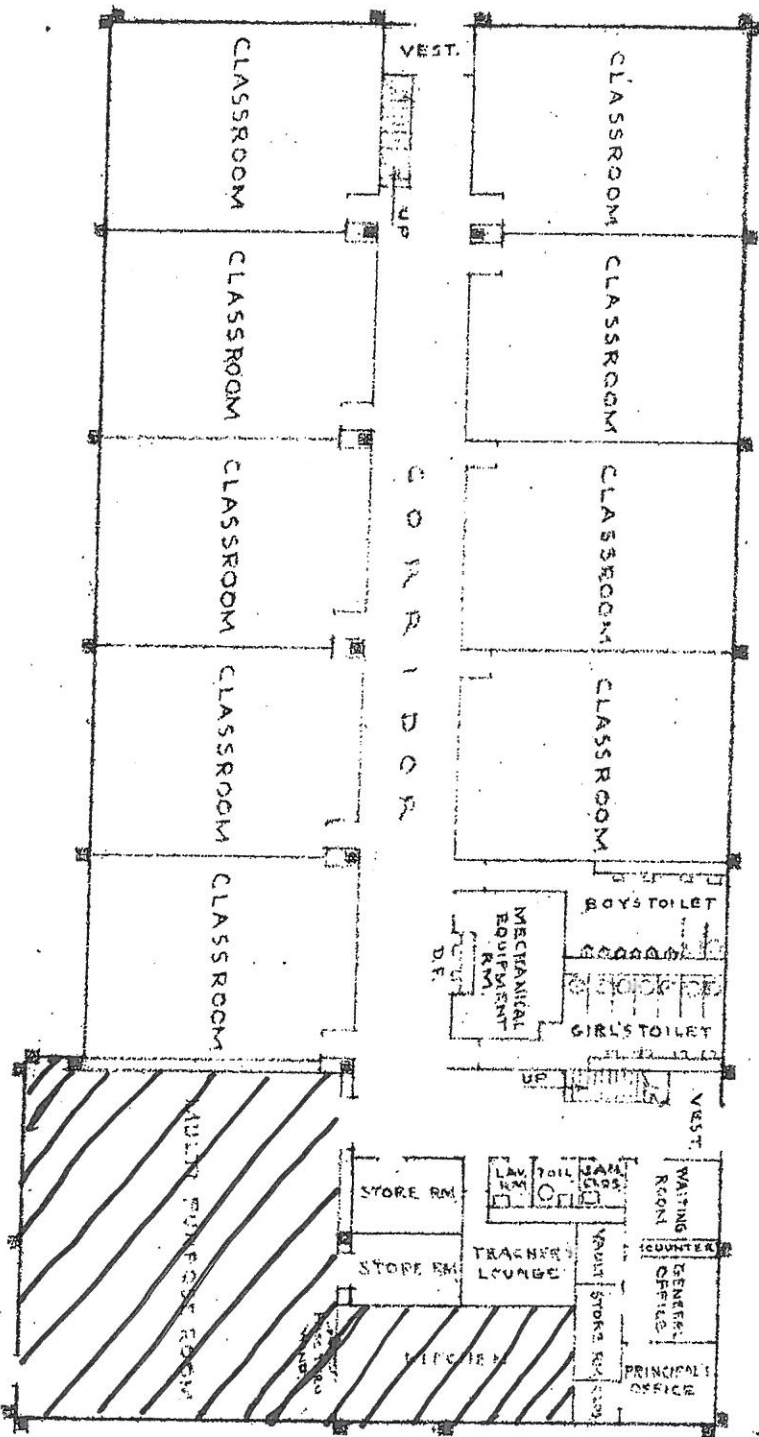
FIRST FLOOR PLAN  
 SCALE 1/8" = 20'-0"

HA #45  
 HA #46  
 yellow Floor tile + Mastic

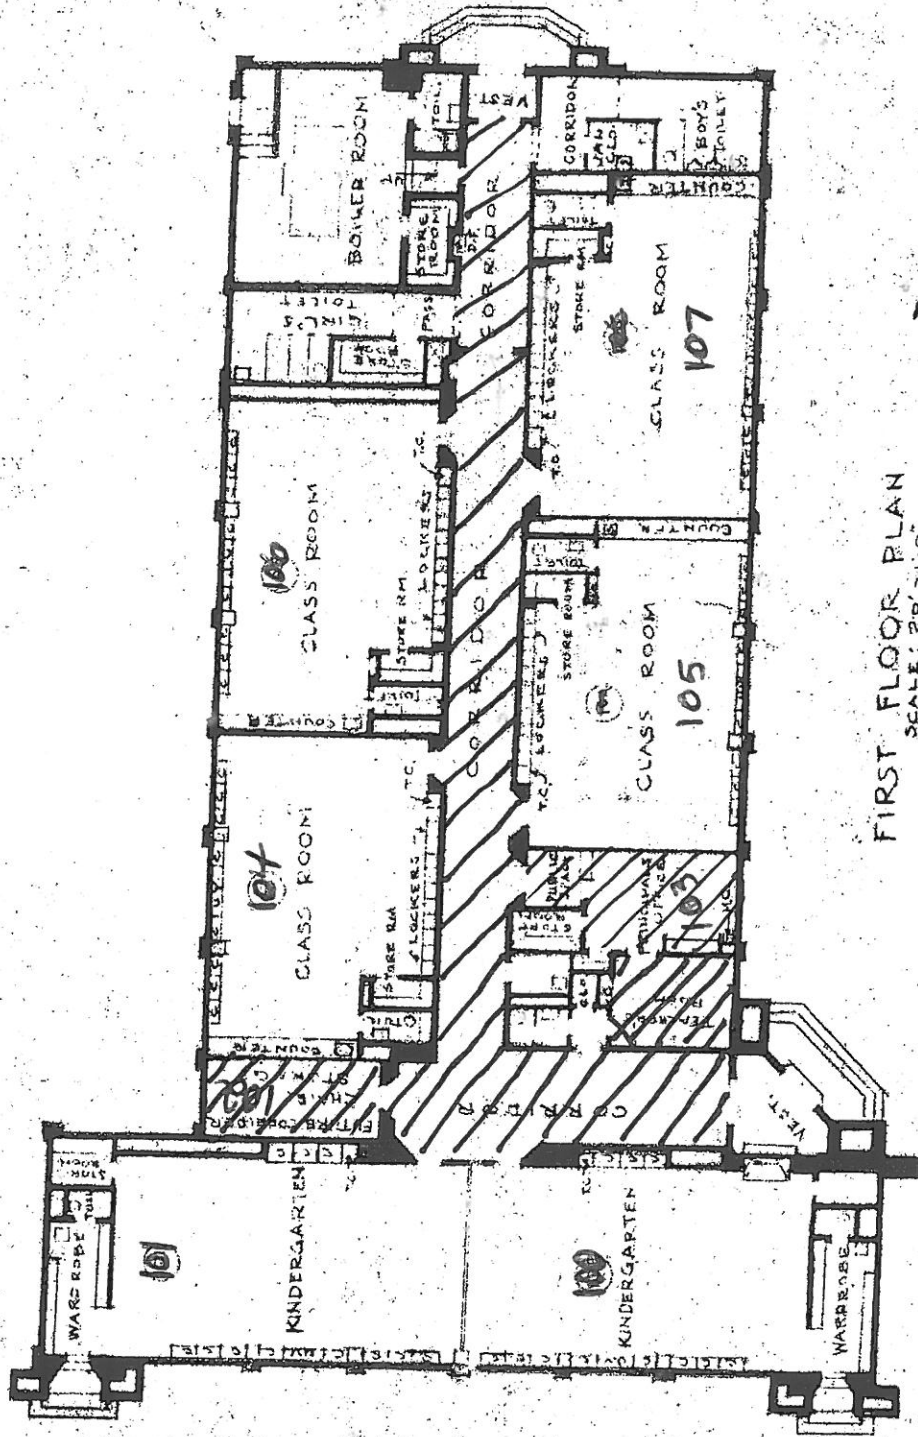
FIRST FLOOR PLAN  
SCALE: 20' = 1" 0"

HA #47

2x4 Ceiling Tile - 1953 Bldg.
