**ILLINOIS DEPARTMENT OF PUBLIC HEALTH  
AHERA THREE YEAR REINSPECTION  
ASBESTOS ABATEMENT PROGRAM  
SCHOOL INFORMATION FORM**

**THREE-YEAR REINSPECTION**

**Orr Community Academy HS**

Unit: 51081  
Building ID: 1830

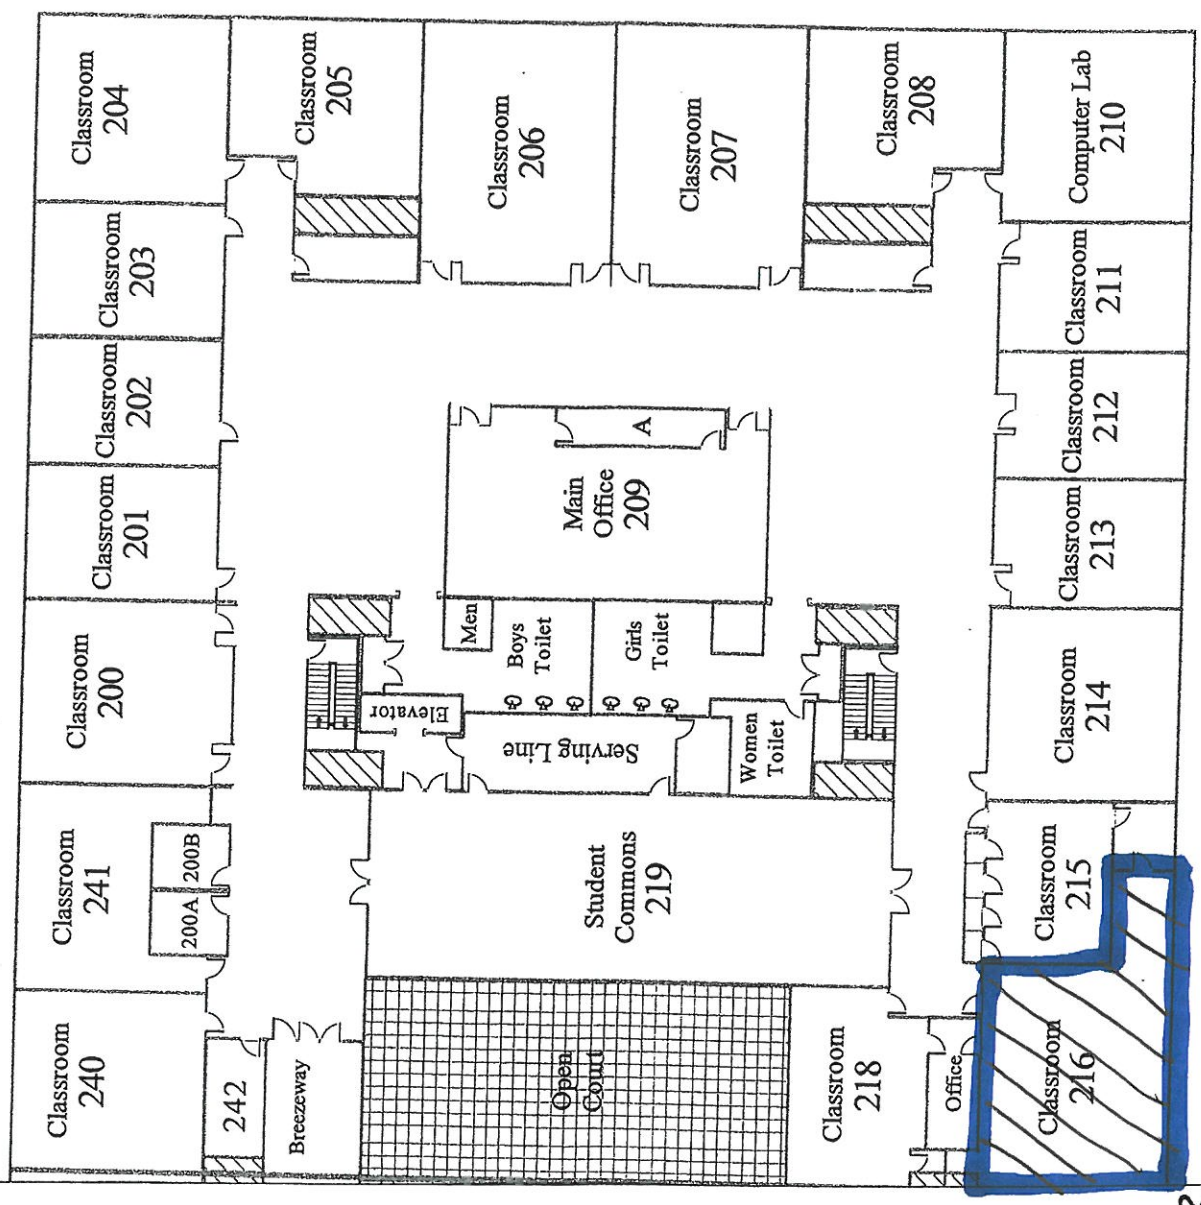
ORR Campus  
2<sup>ND</sup> Floor

HAY1 = fume HOODS:

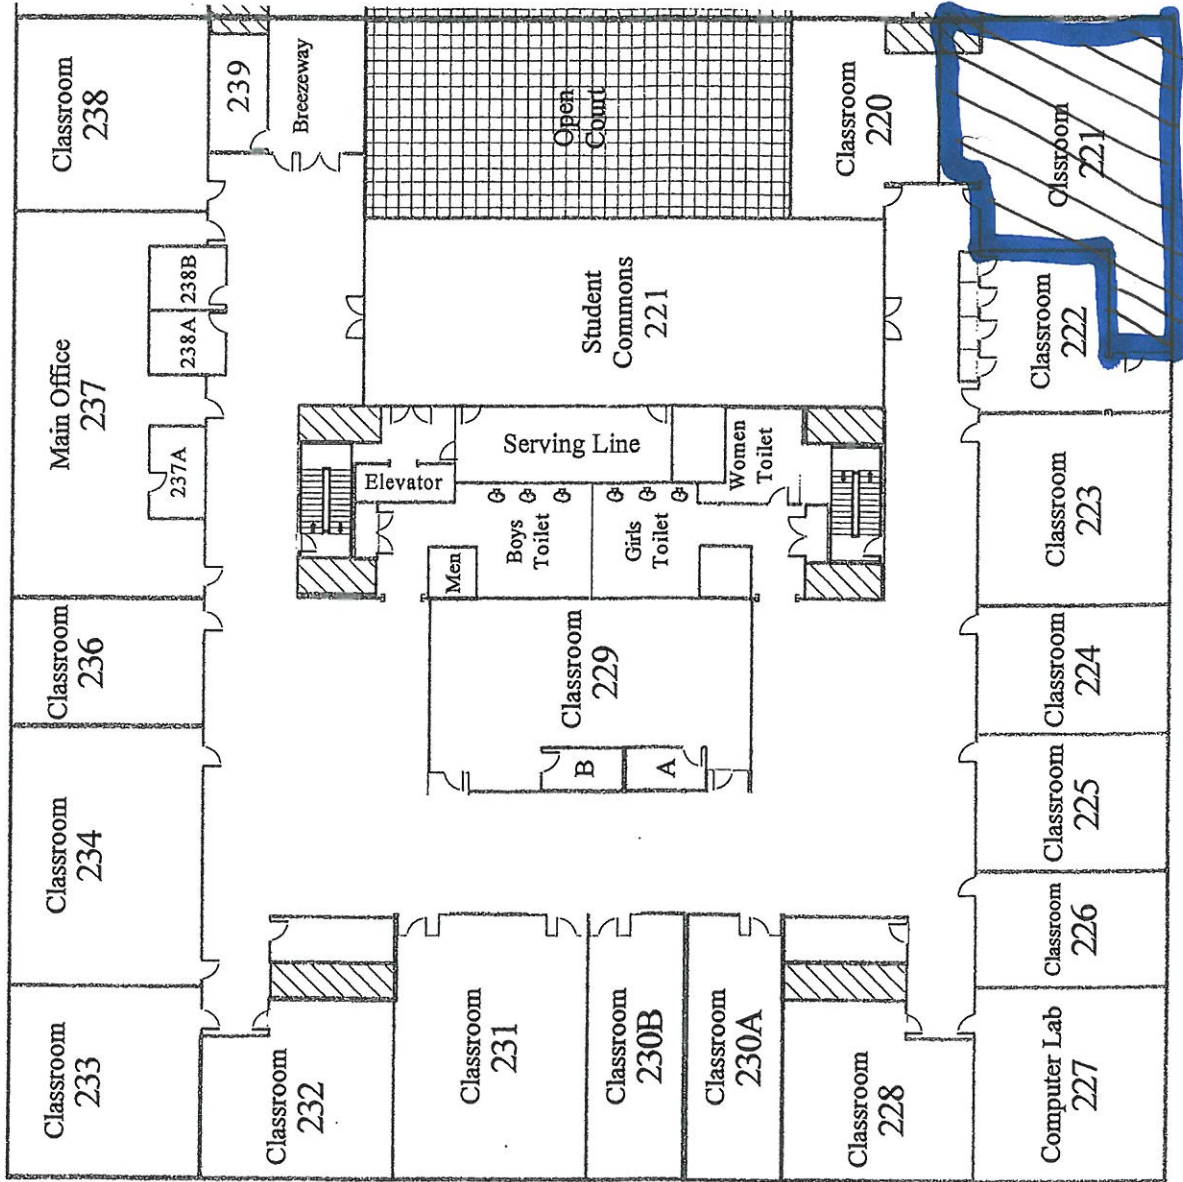
Off C:  
2nd Floor

HAY1 = fume HOODS

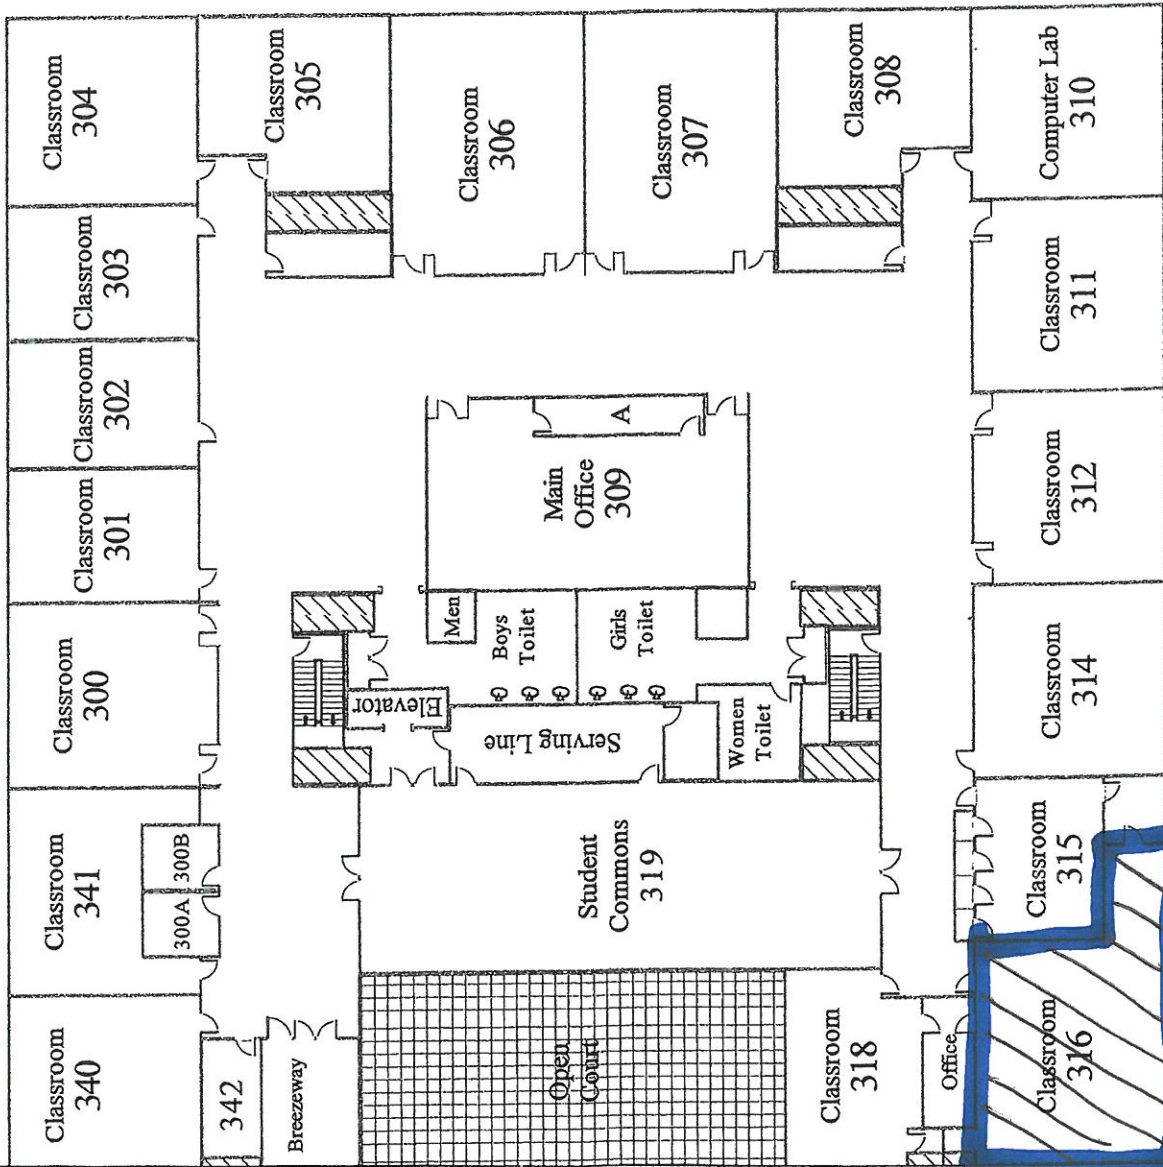
ORR  
Campus  
3rd floor

HAY 1 = FUME HOODS

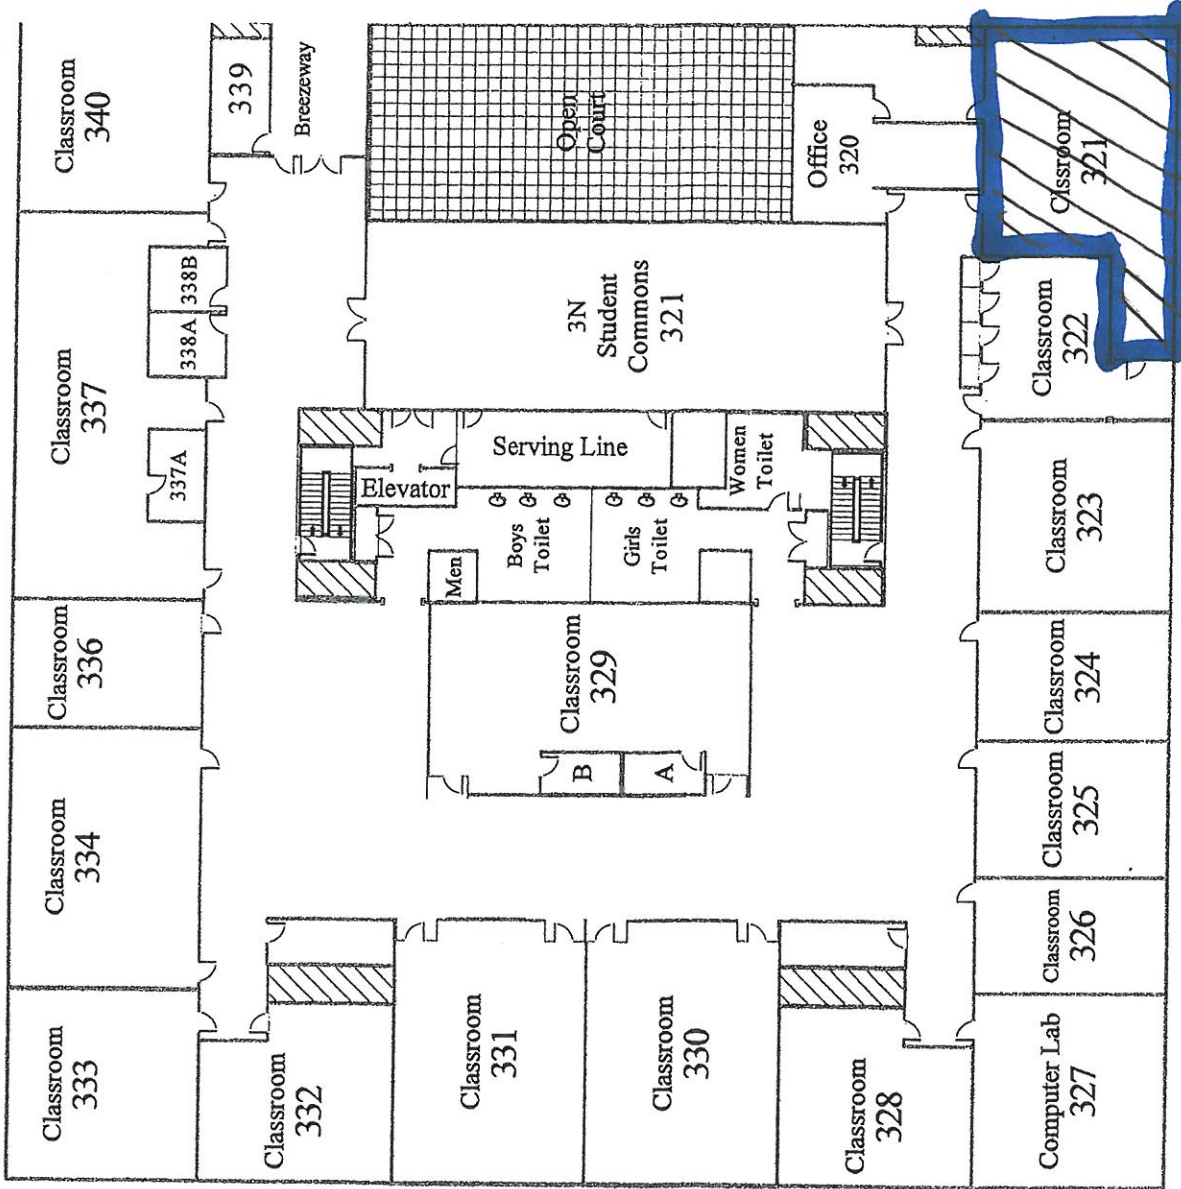
Orr Campus  
3rd Floor

HA41 = Fume HOODS.

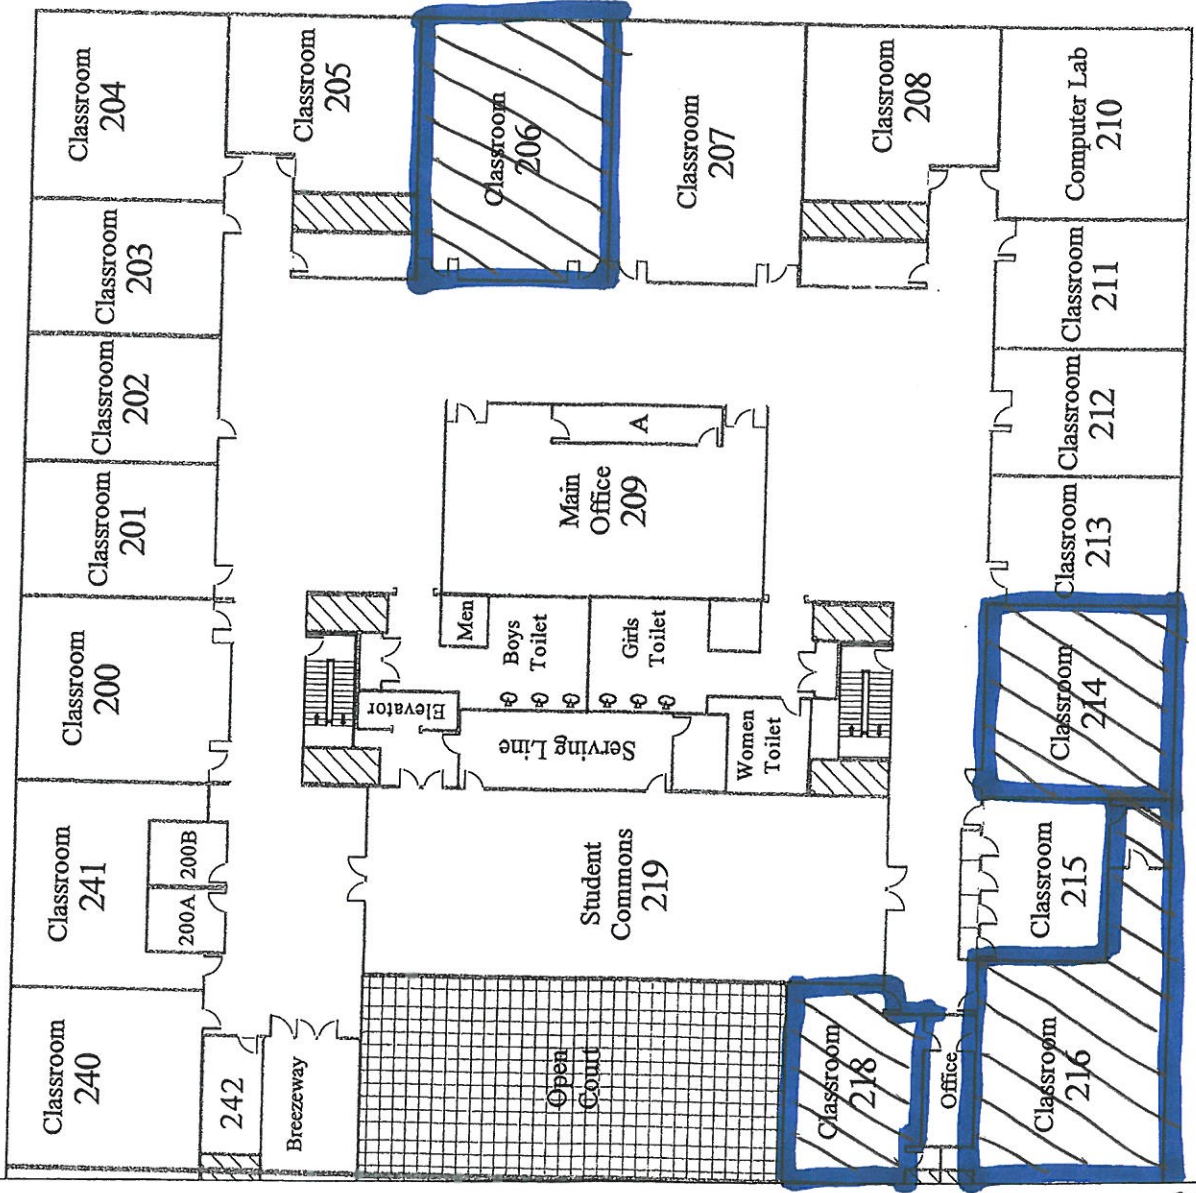
ORR Campus  
2<sup>ND</sup> Floor

HAYY = BELTE UNOLEUM &  
HAYS MASTIC

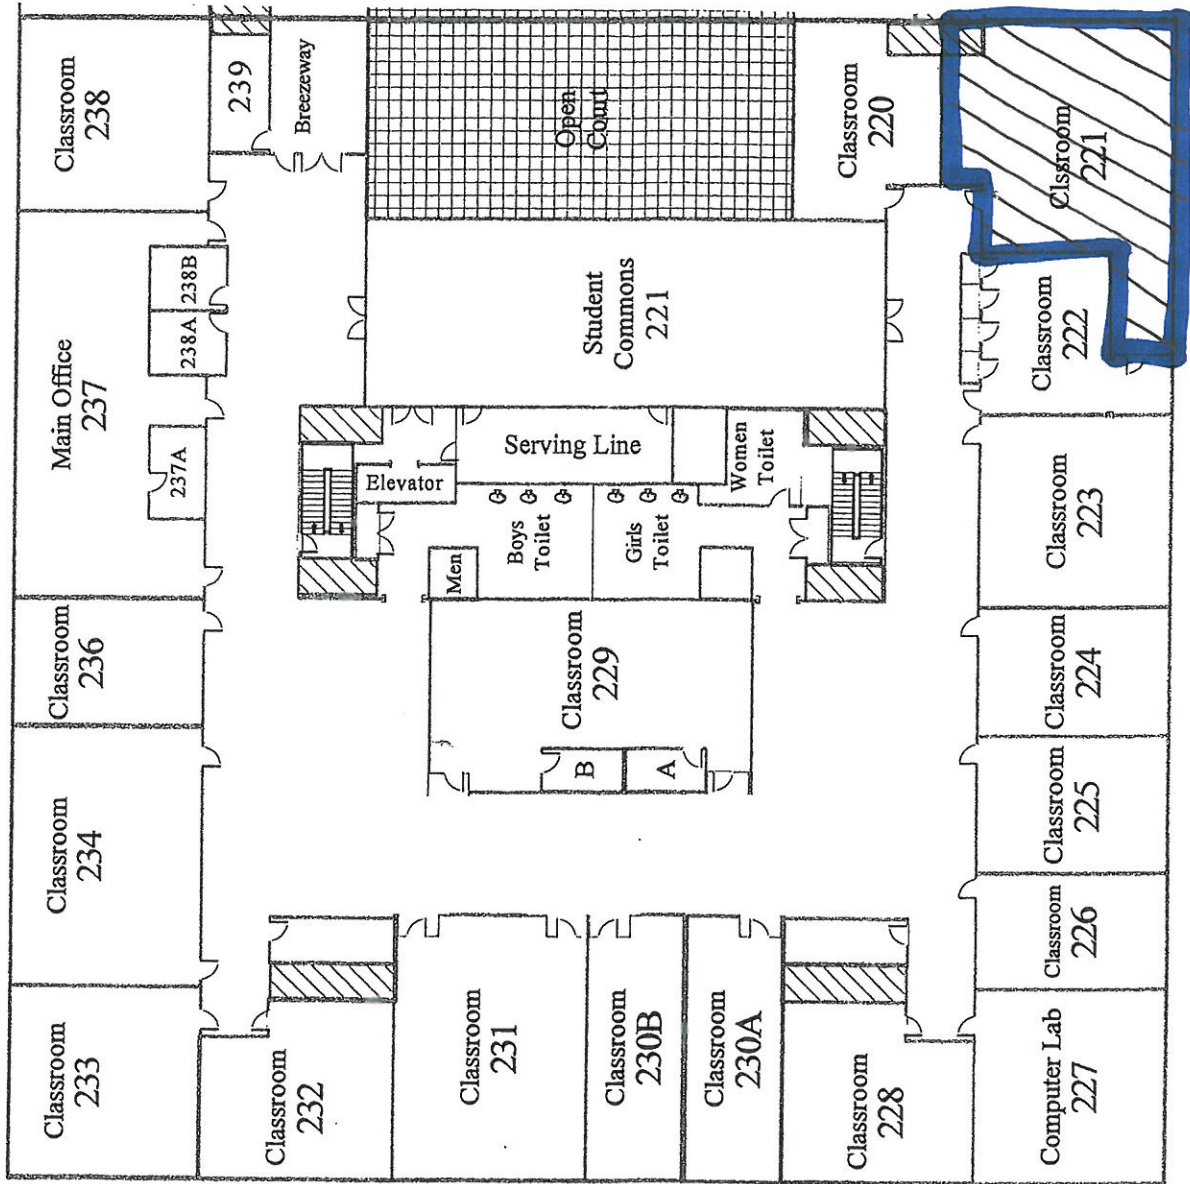
Off C:  
2nd Floor

HAY4 = BERGE LINOLEUM &  
HAY5 = MASTIC

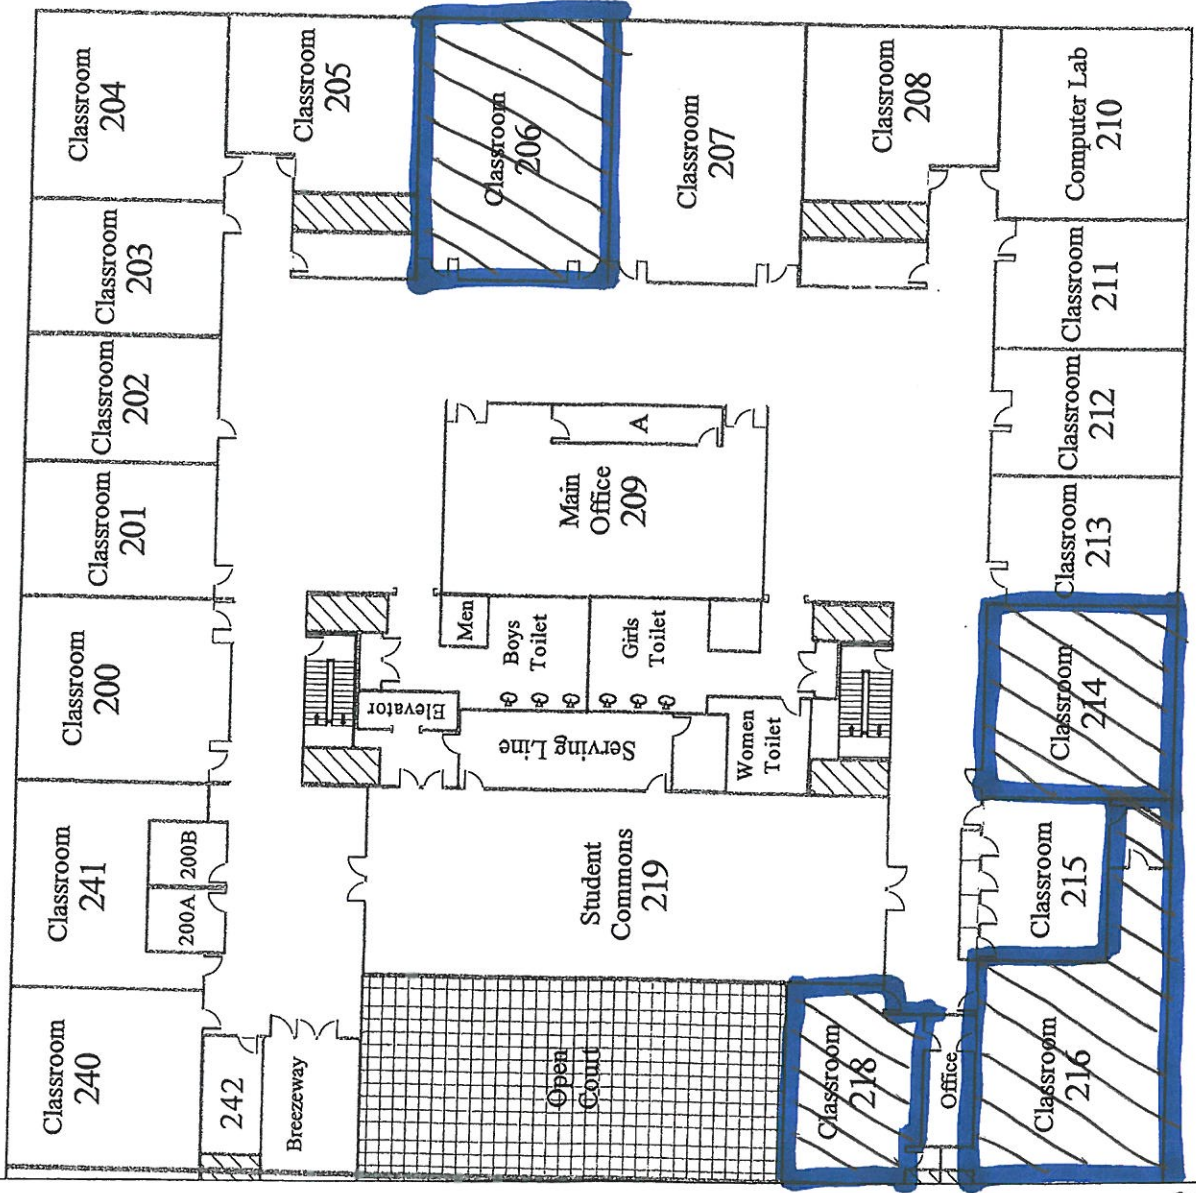
ORR Campus  
2<sup>ND</sup> Floor

HAYY = BELTE UNOLEUM &  
HAYS MASTIC

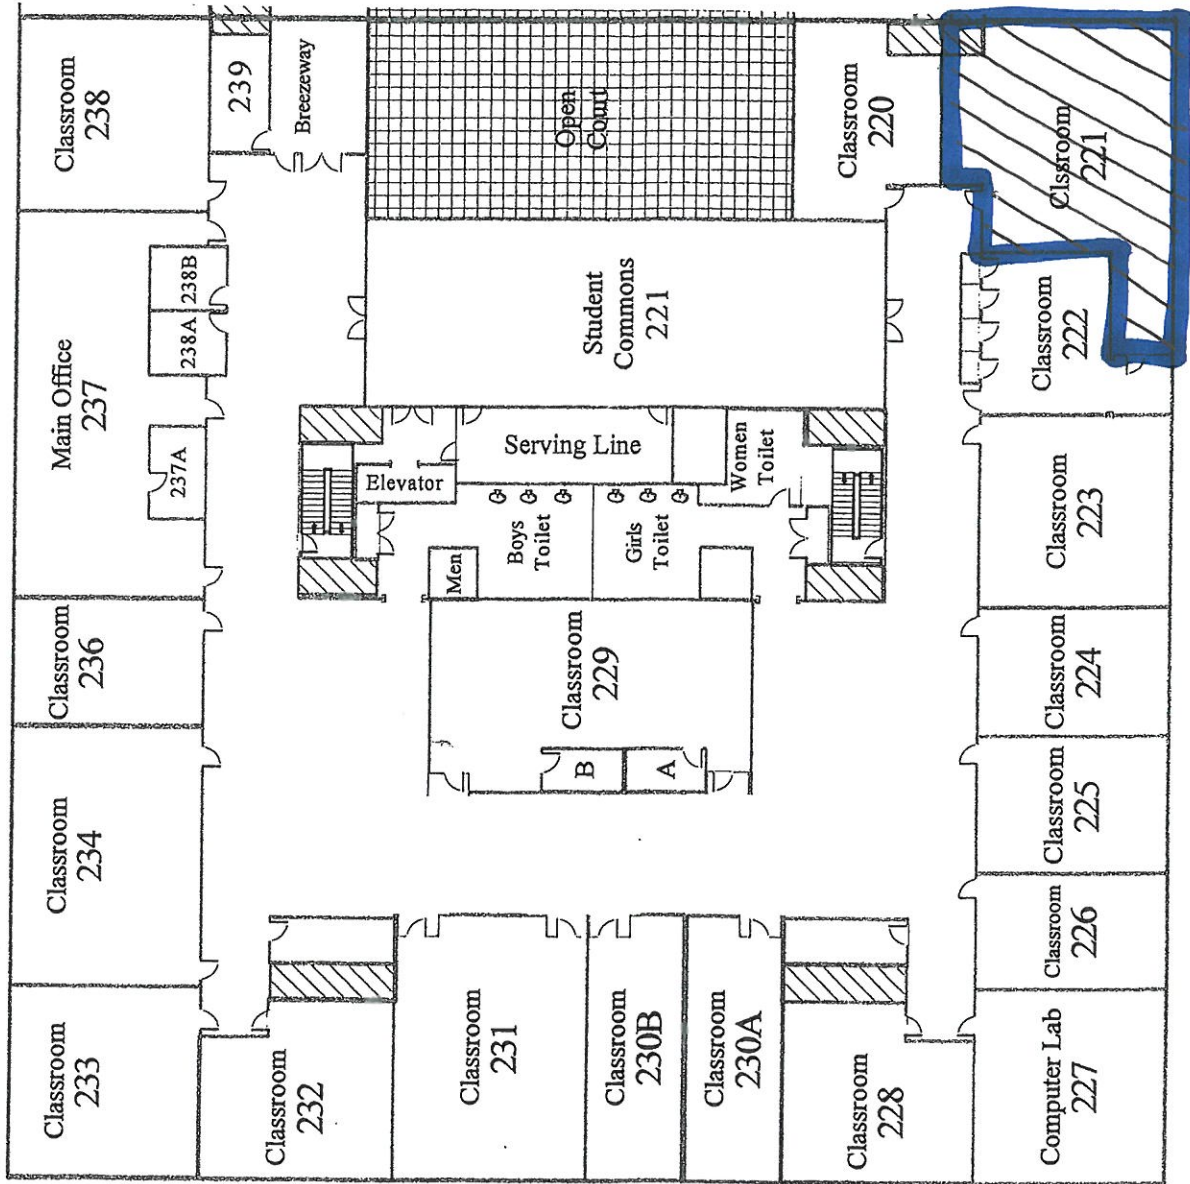
Off C:  
2nd Floor

HAY4 = BERGE LINOLEUM &  
HAY5 = MASTIC

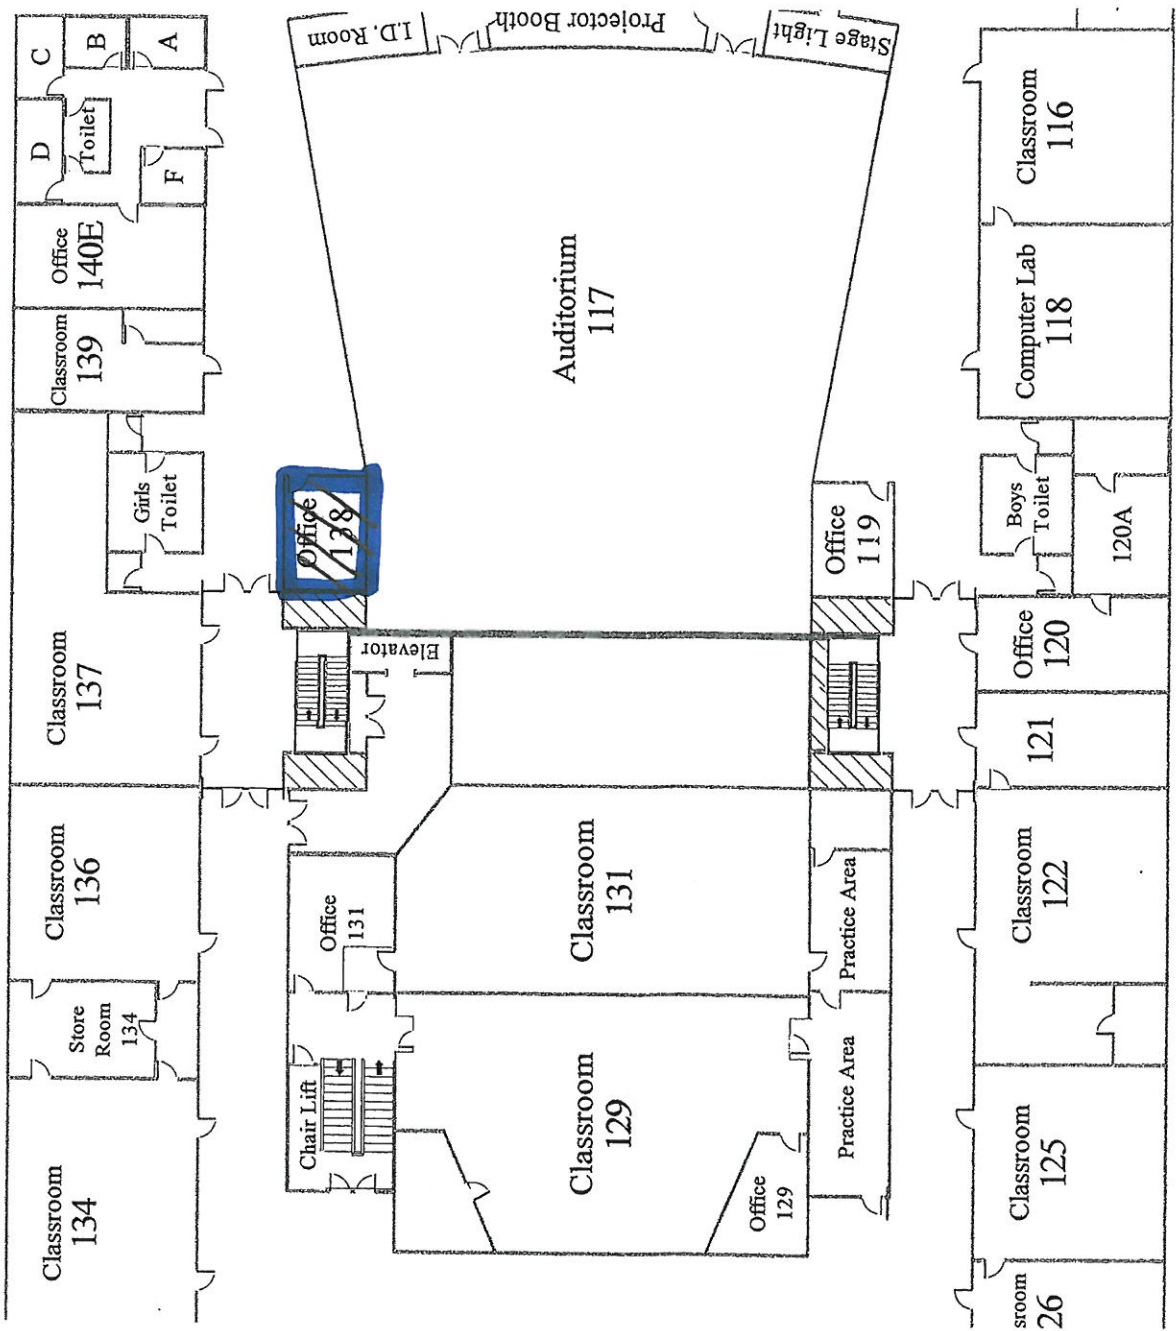
Orr Campus  
 1st Floor

H1416 = 12x12 WHITE w/  
 H1417 GREEN SPEKKS UFT  
 & MASTIC

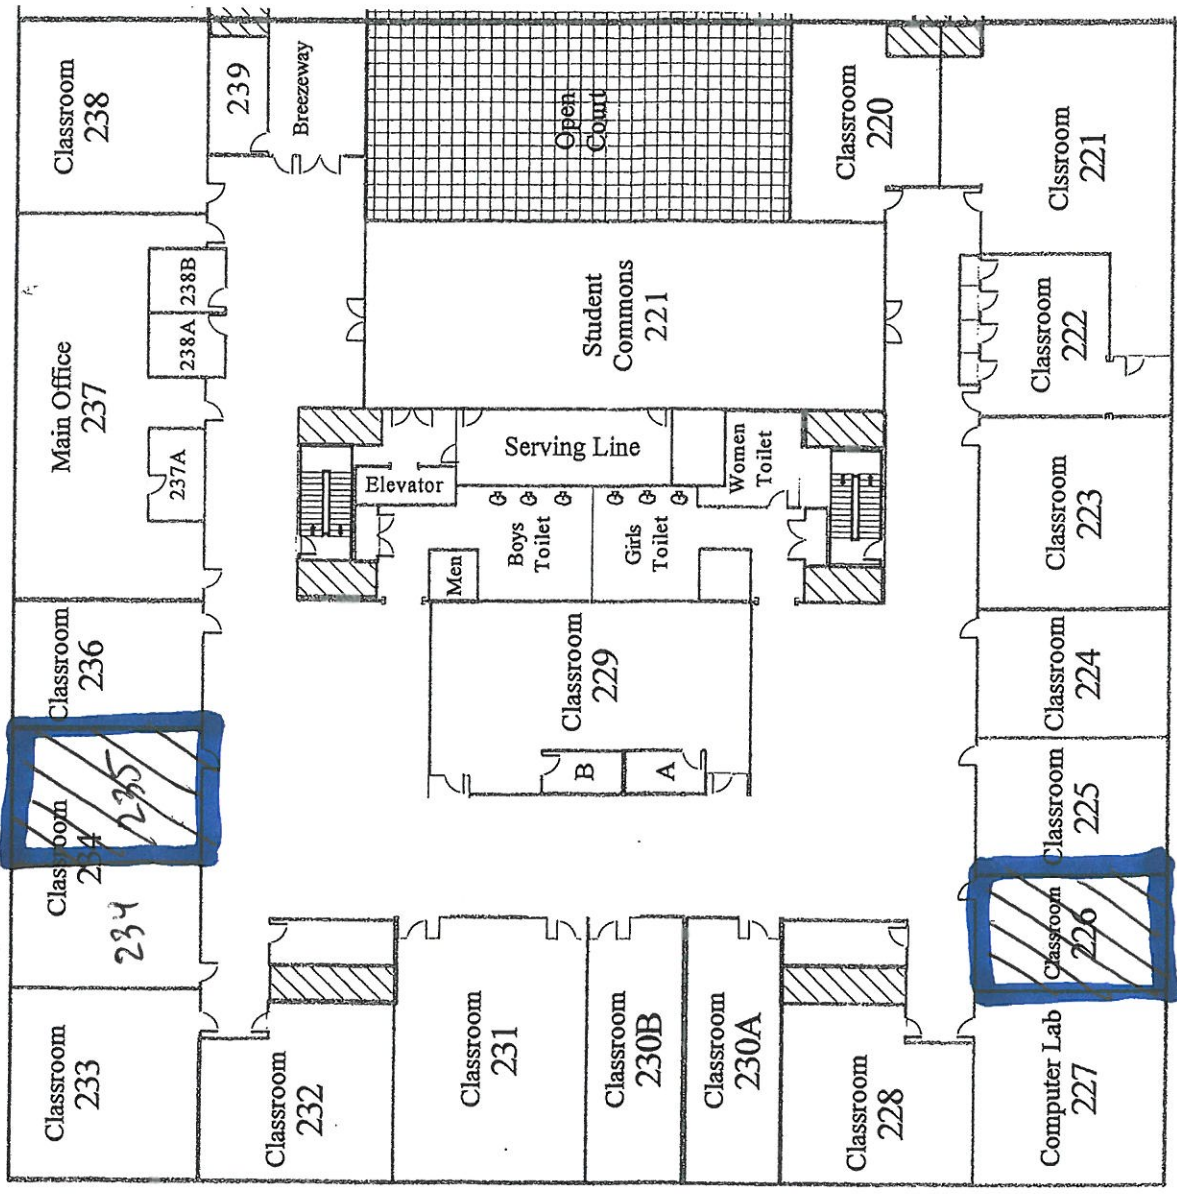
Off C:  
2nd Floor

HAY6 = 12x12 WHITE w/ GREEN  
HAY7 SPECKS VFT 8  
MASTIC

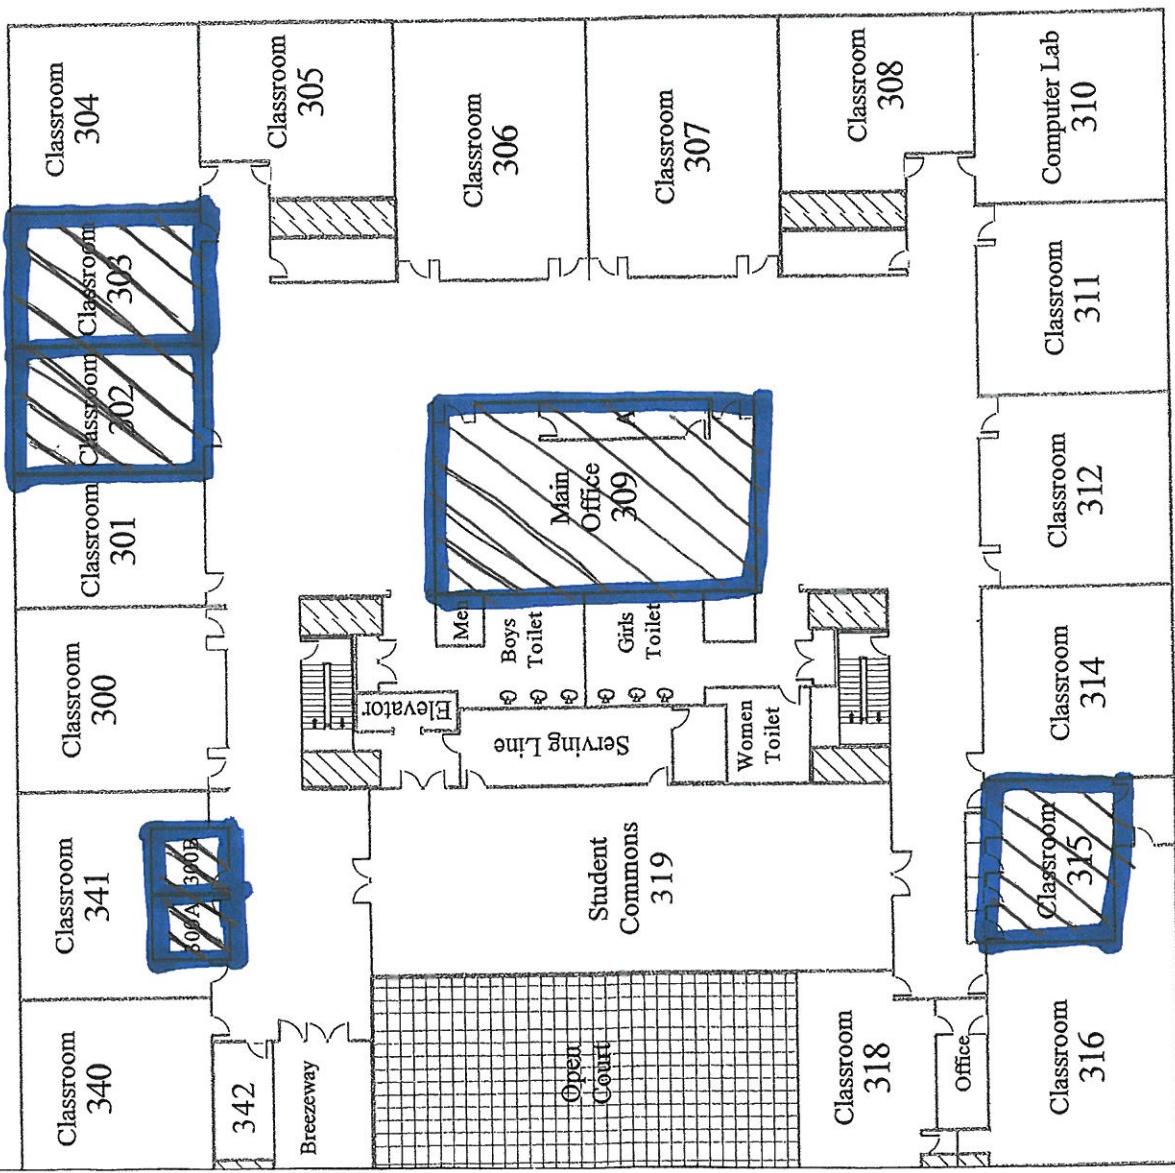
ORR Campus  
 3rd floor

HA 35 = 12x12 WHITE w/ BLUE &  
 HA 36 RED SPECS VFT  
 & MASTIC

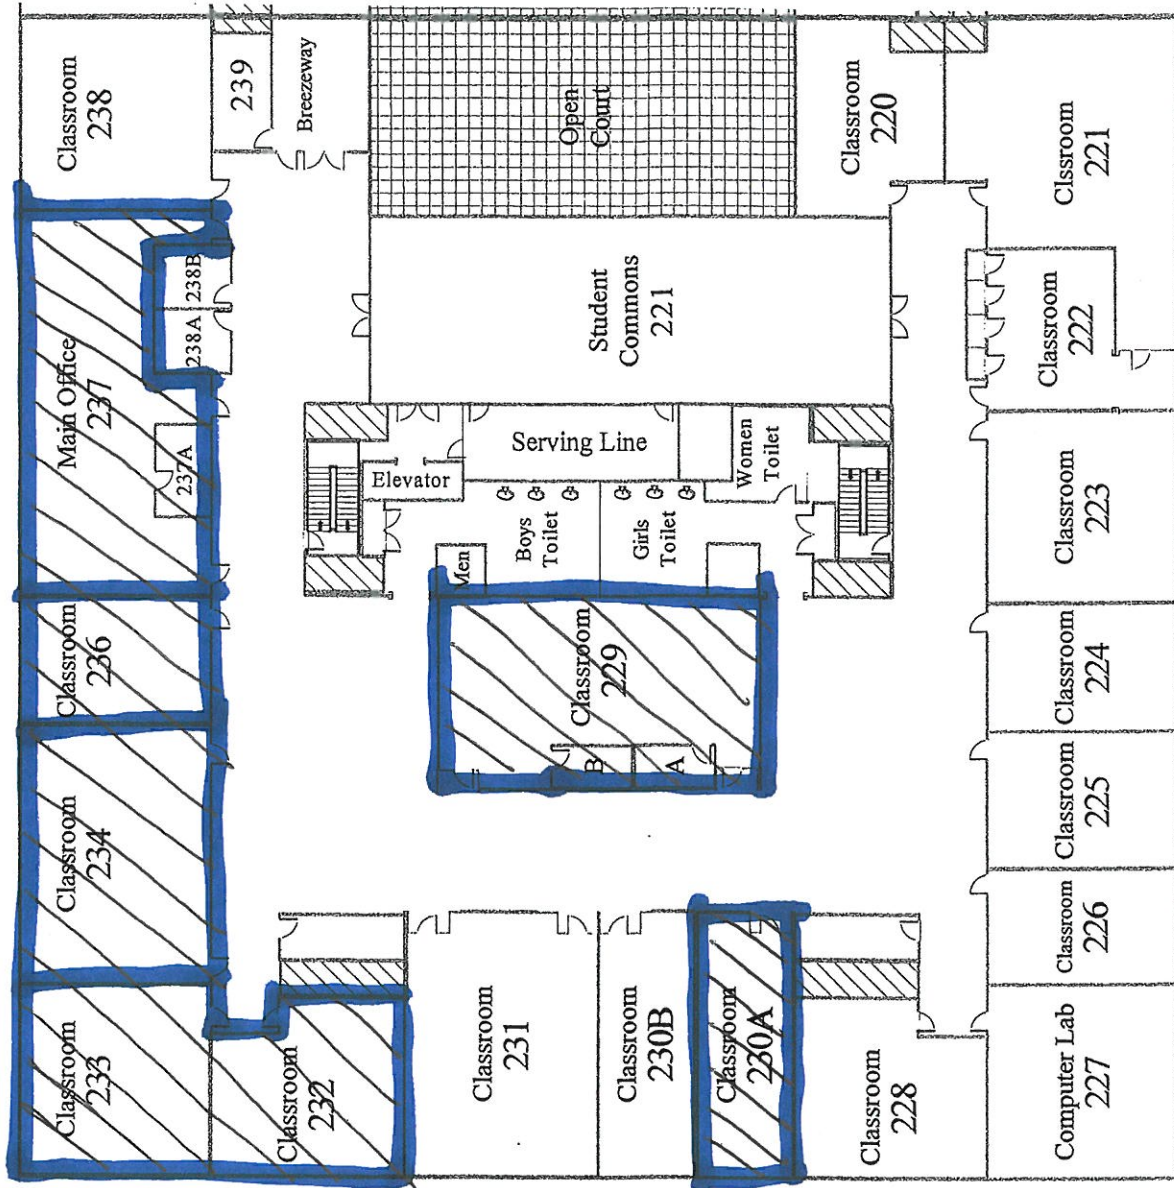
Orr C:  
 2nd Floor

HA 35 = 12x12 WHITE w/ BLUE  
 HA 36 & RED SPECS VFT &  
 MASTIC

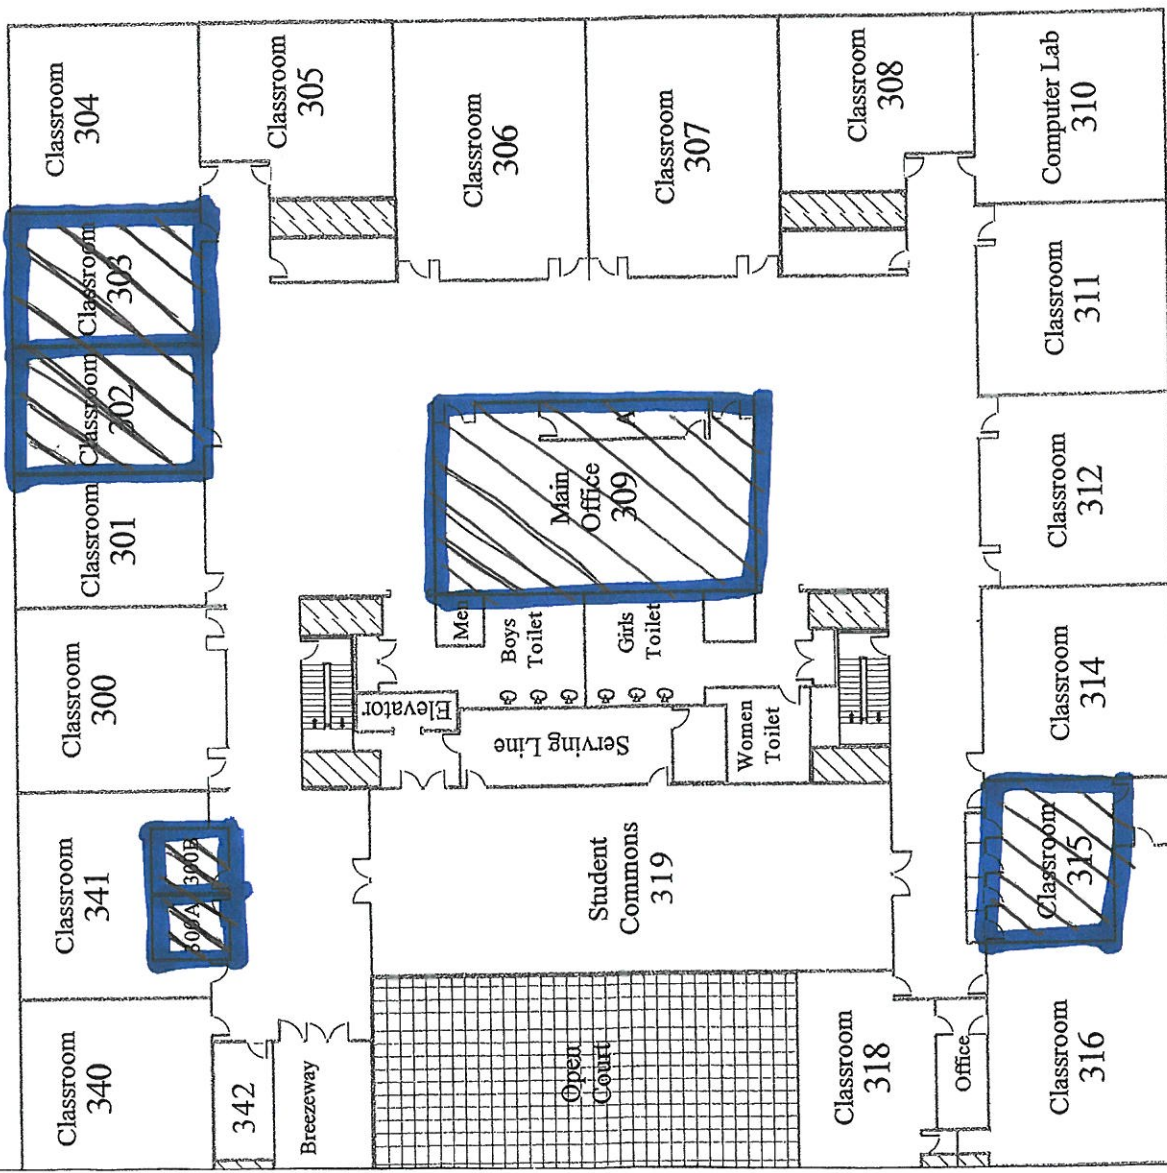
ORR Campus  
 3rd floor

HA 35 = 12x12 WHITE w/ BLUE &  
 HA 36 RED SPECS VFT  
 & MASTIC

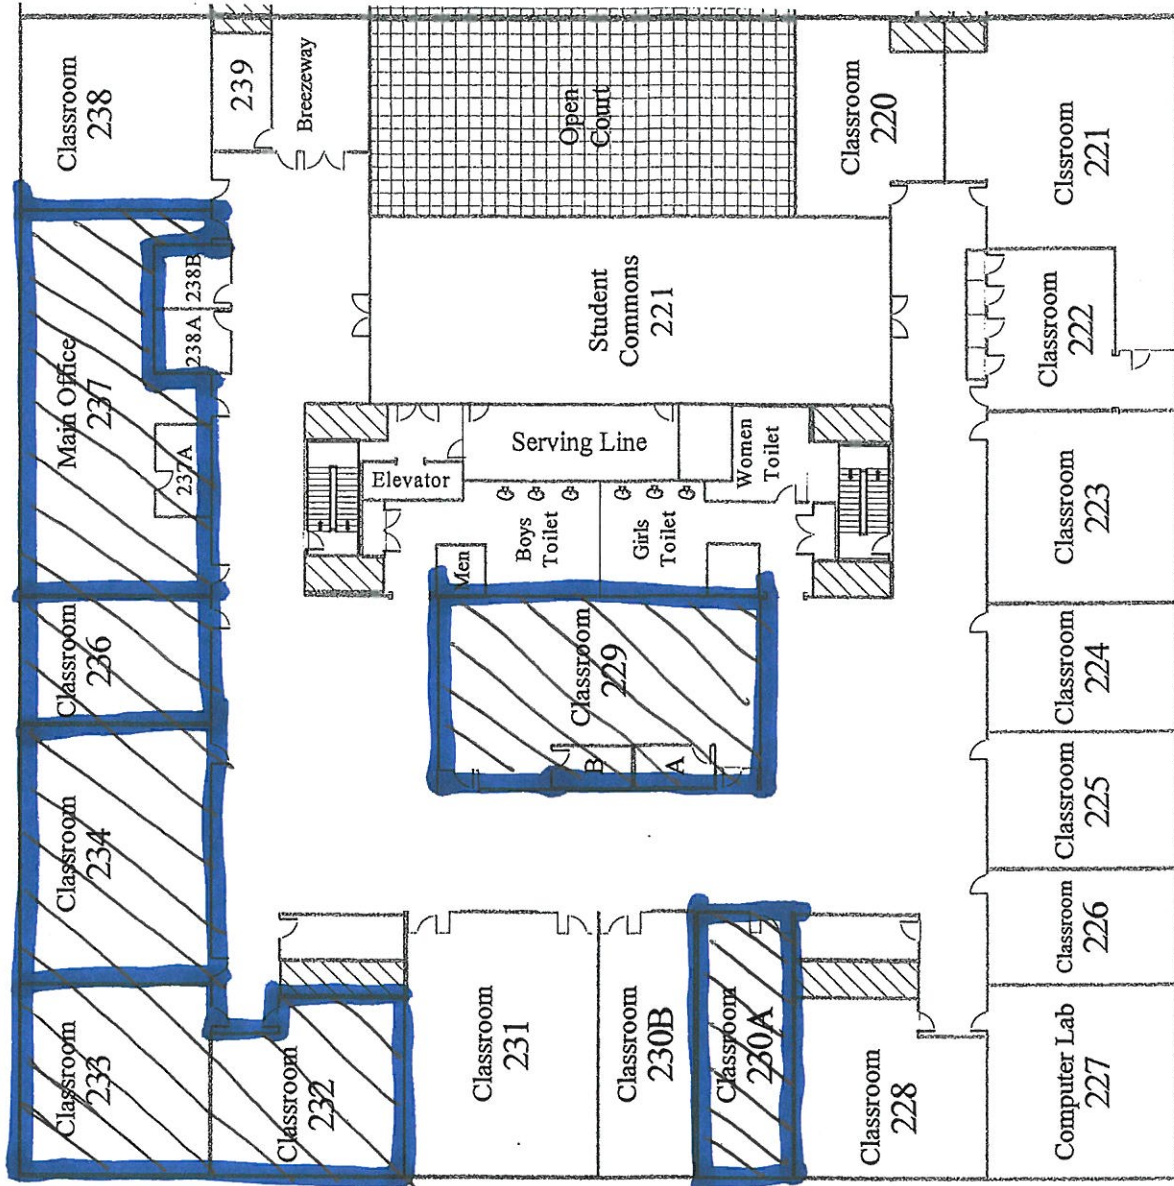
Orr C:  
 2nd Floor

HA 35 = 12x12 WHITE w/ BLUE  
 HA 36 & RED SPECS VFT &  
 MASTIC

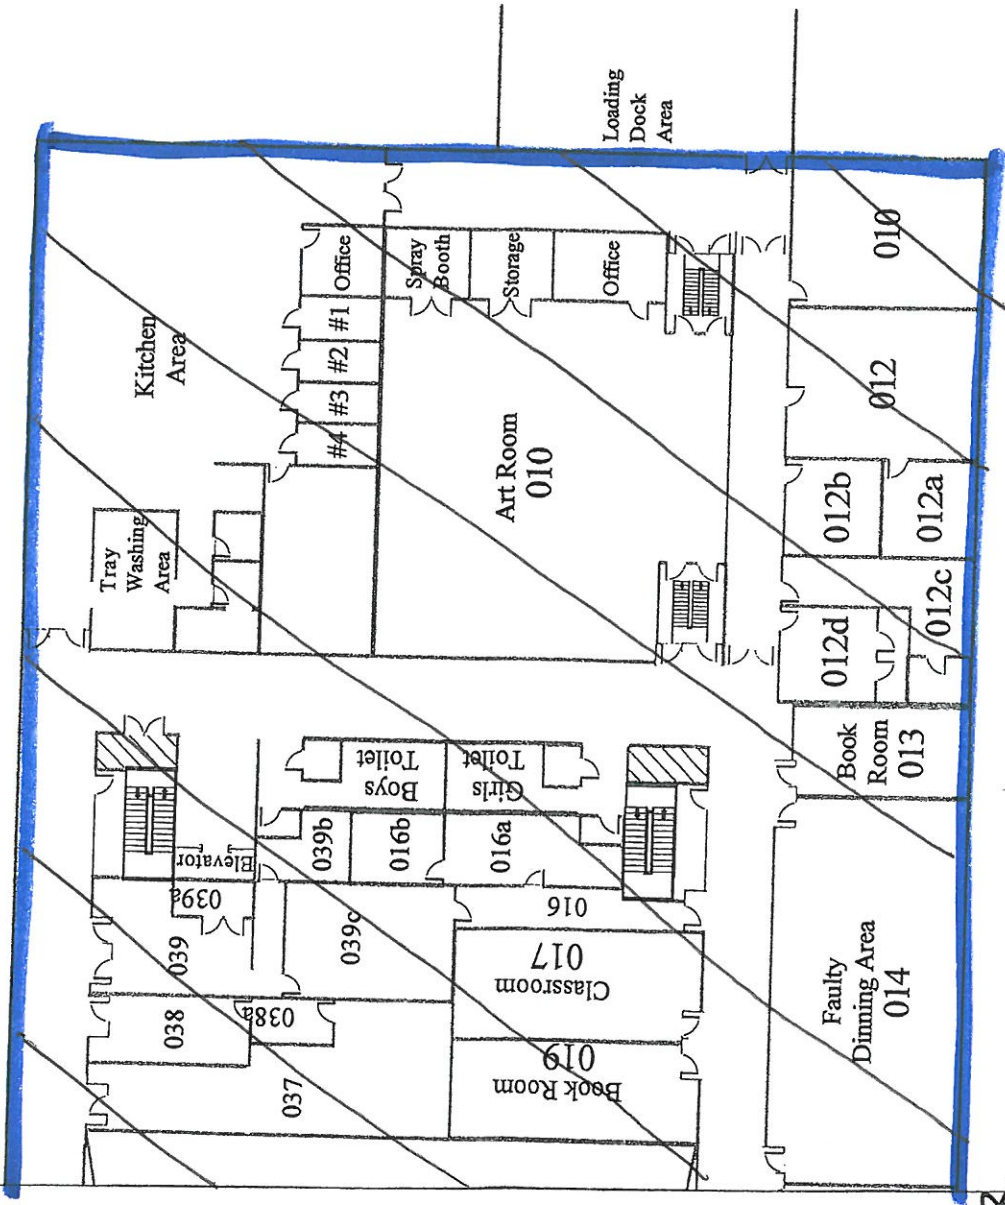
ORR  
Campus  
BASEMENT

PLAN = SPRAY ON  
FIRE PROOFING

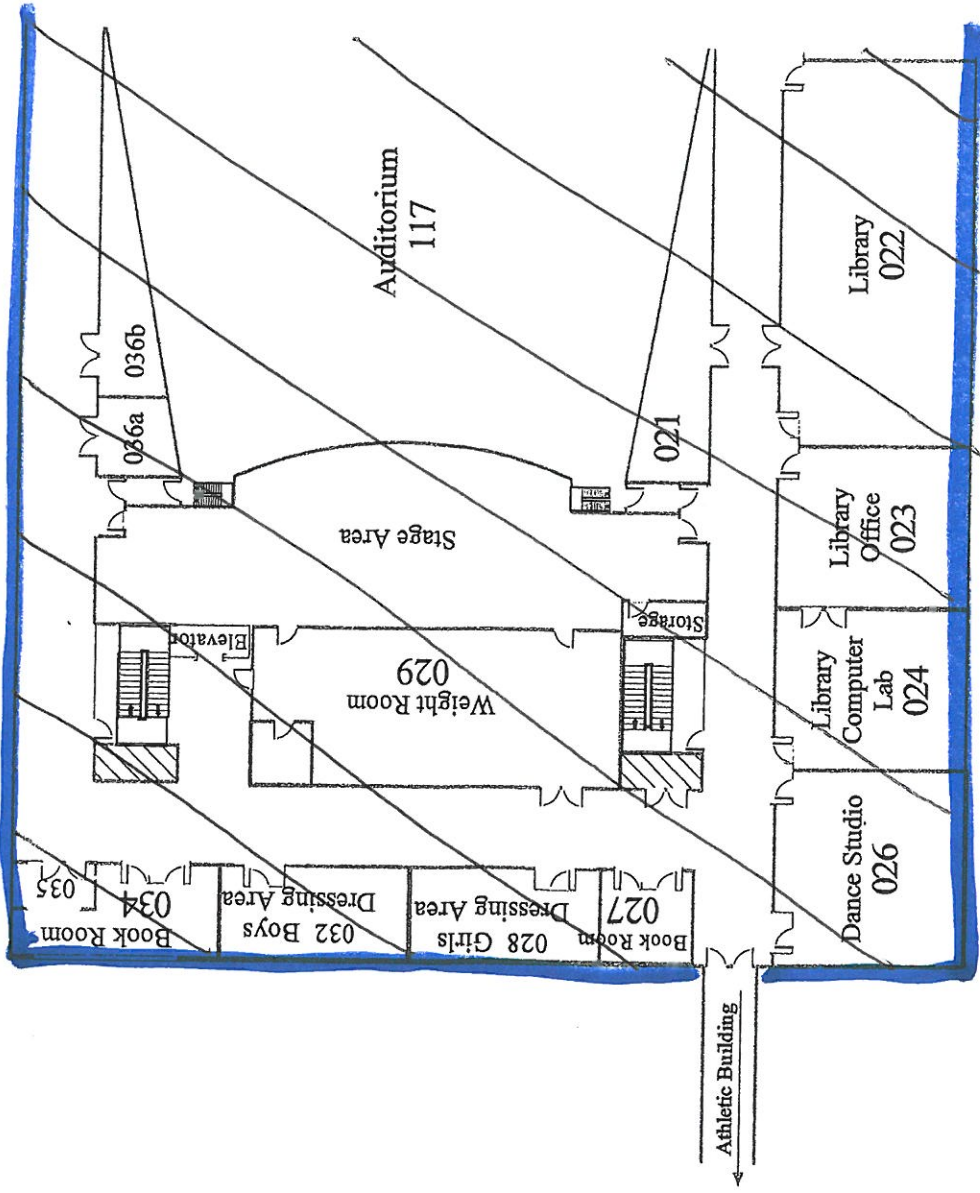
Orr Campus  
Basement

HAYO = SPRAY ON  
FIRE PROOFING
