**ILLINOIS DEPARTMENT OF PUBLIC HEALTH  
AHERA THREE YEAR REINSPECTION  
ASBESTOS ABATEMENT PROGRAM  
SCHOOL INFORMATION FORM**

**THREE-YEAR REINSPECTION**

**Orr Community Academy HS**

Unit: 51081  
Building ID: 1830

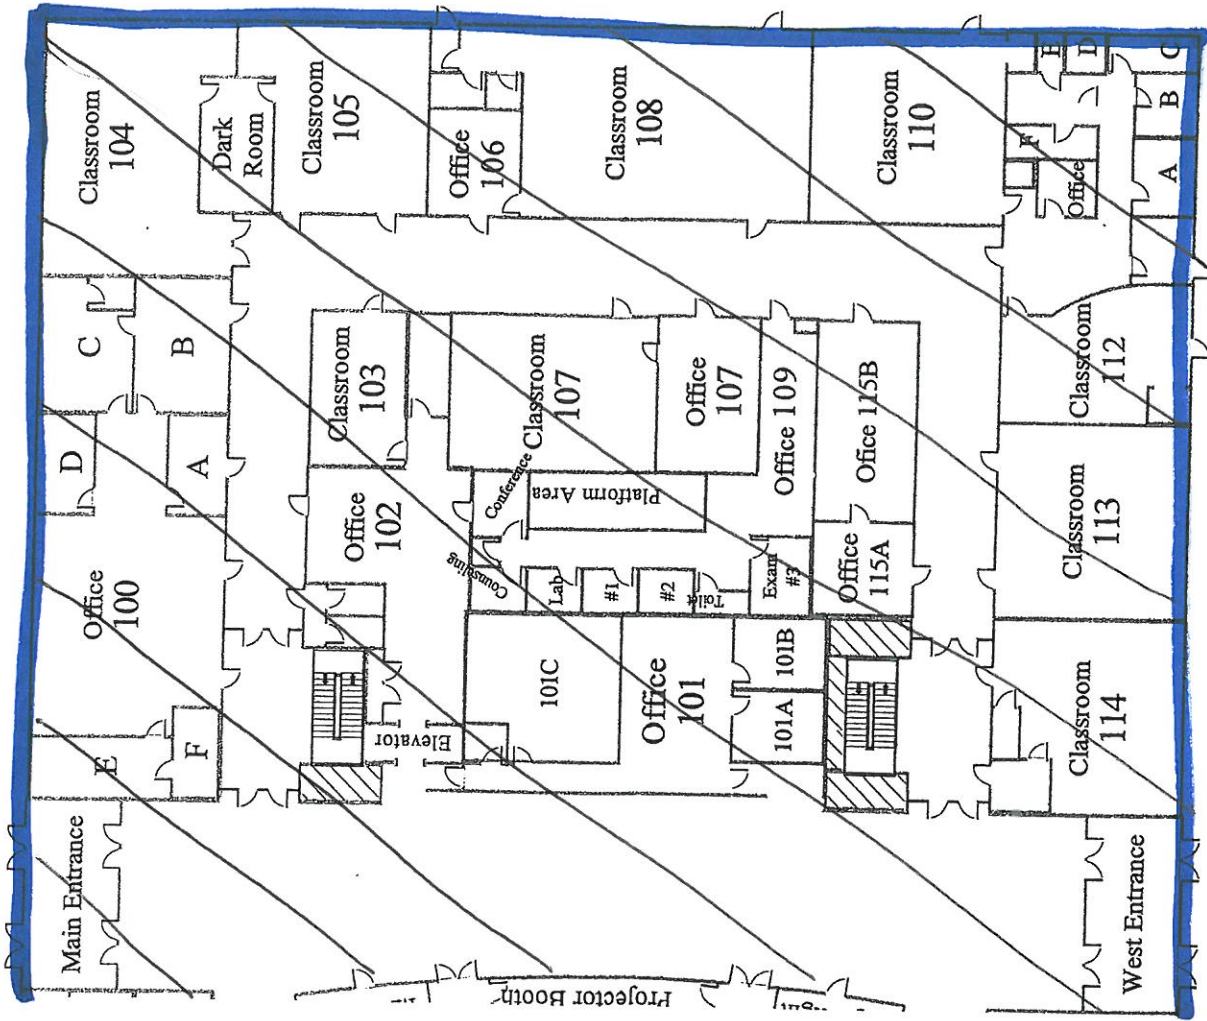
ORR Campus  
1st floor

H1A48 = SPRAY ON  
FIRE PROOFING.

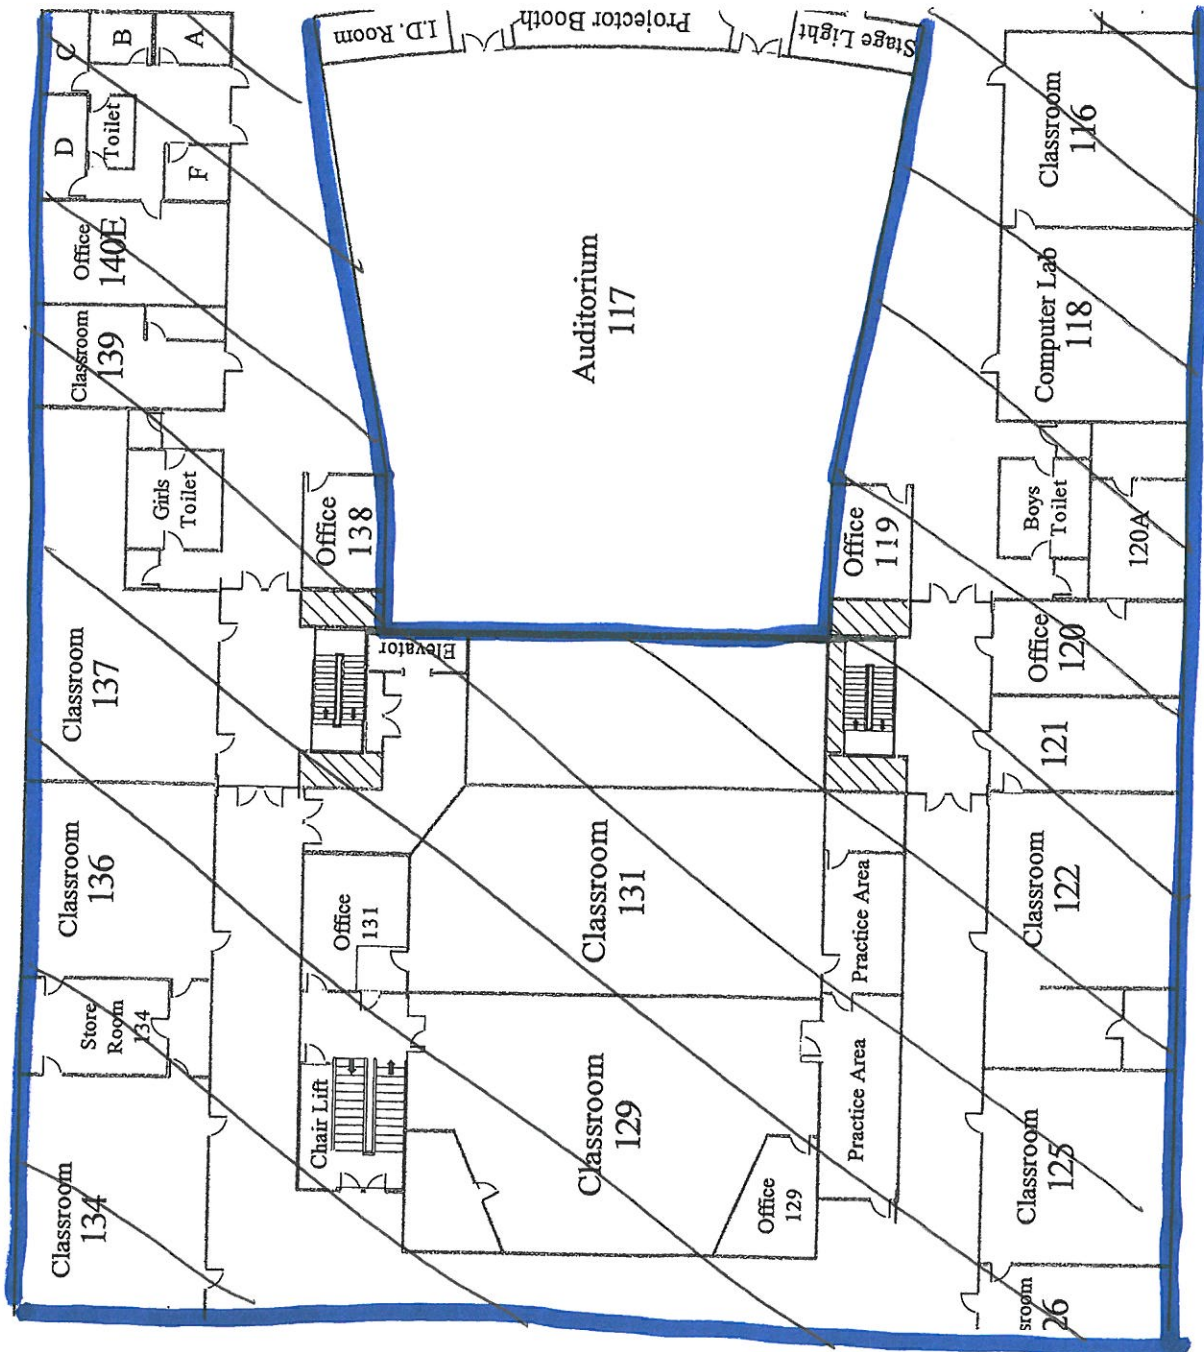
Orr Campus  
1st Floor

HAY8 = SPRAY ON  
FIRE PROOFING

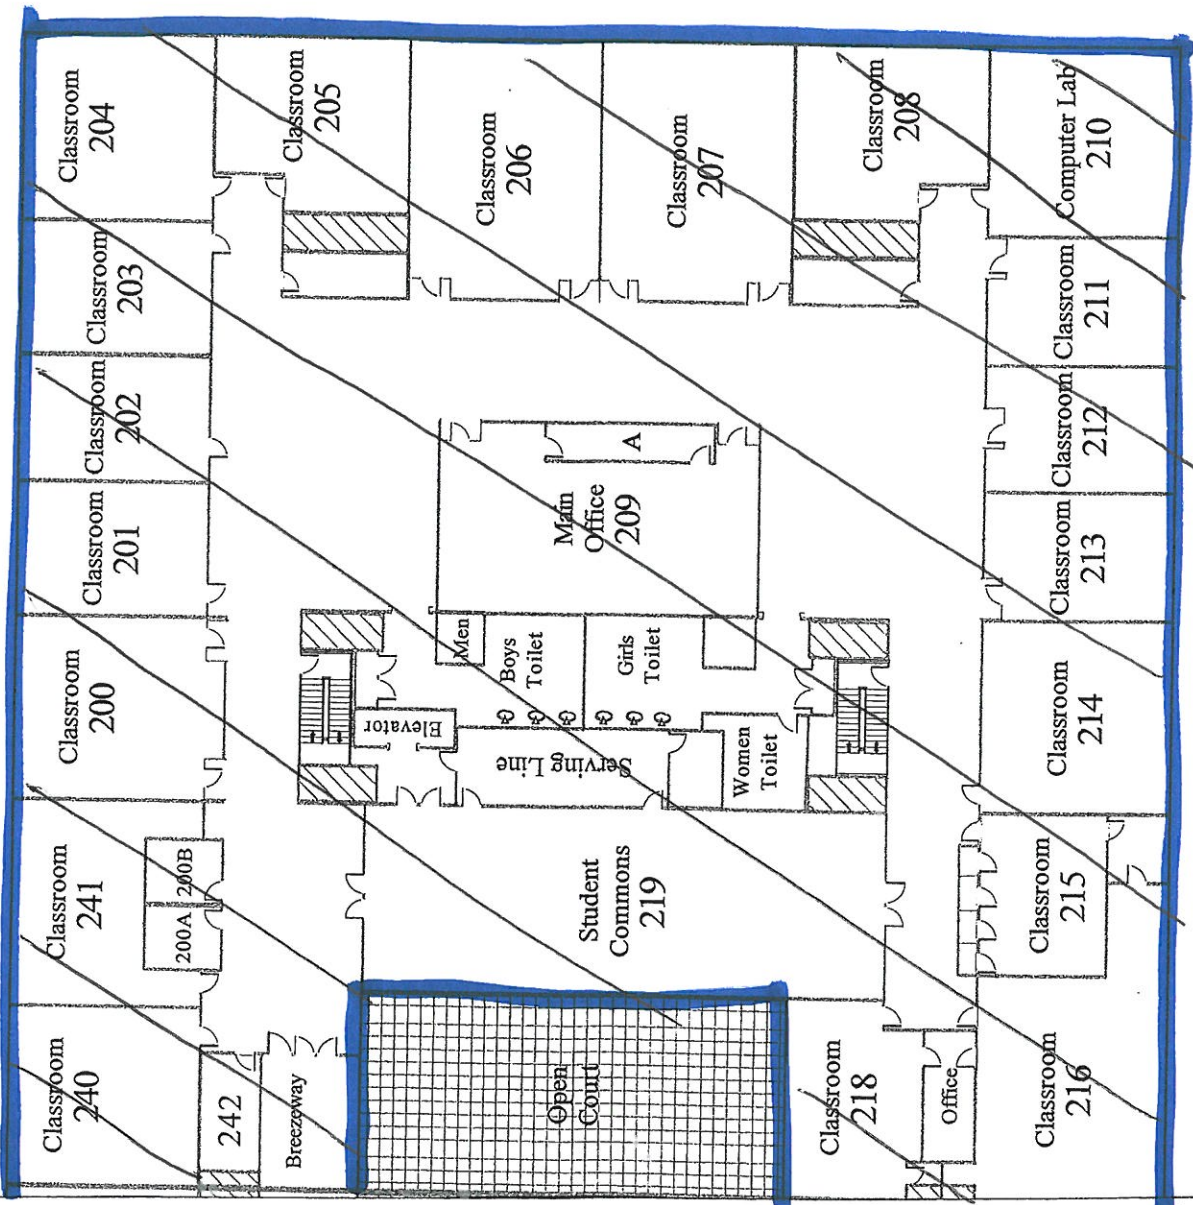
ORR Campus  
2ND Floor

HAY8 = SPRAY ON FIRE  
PROOFING

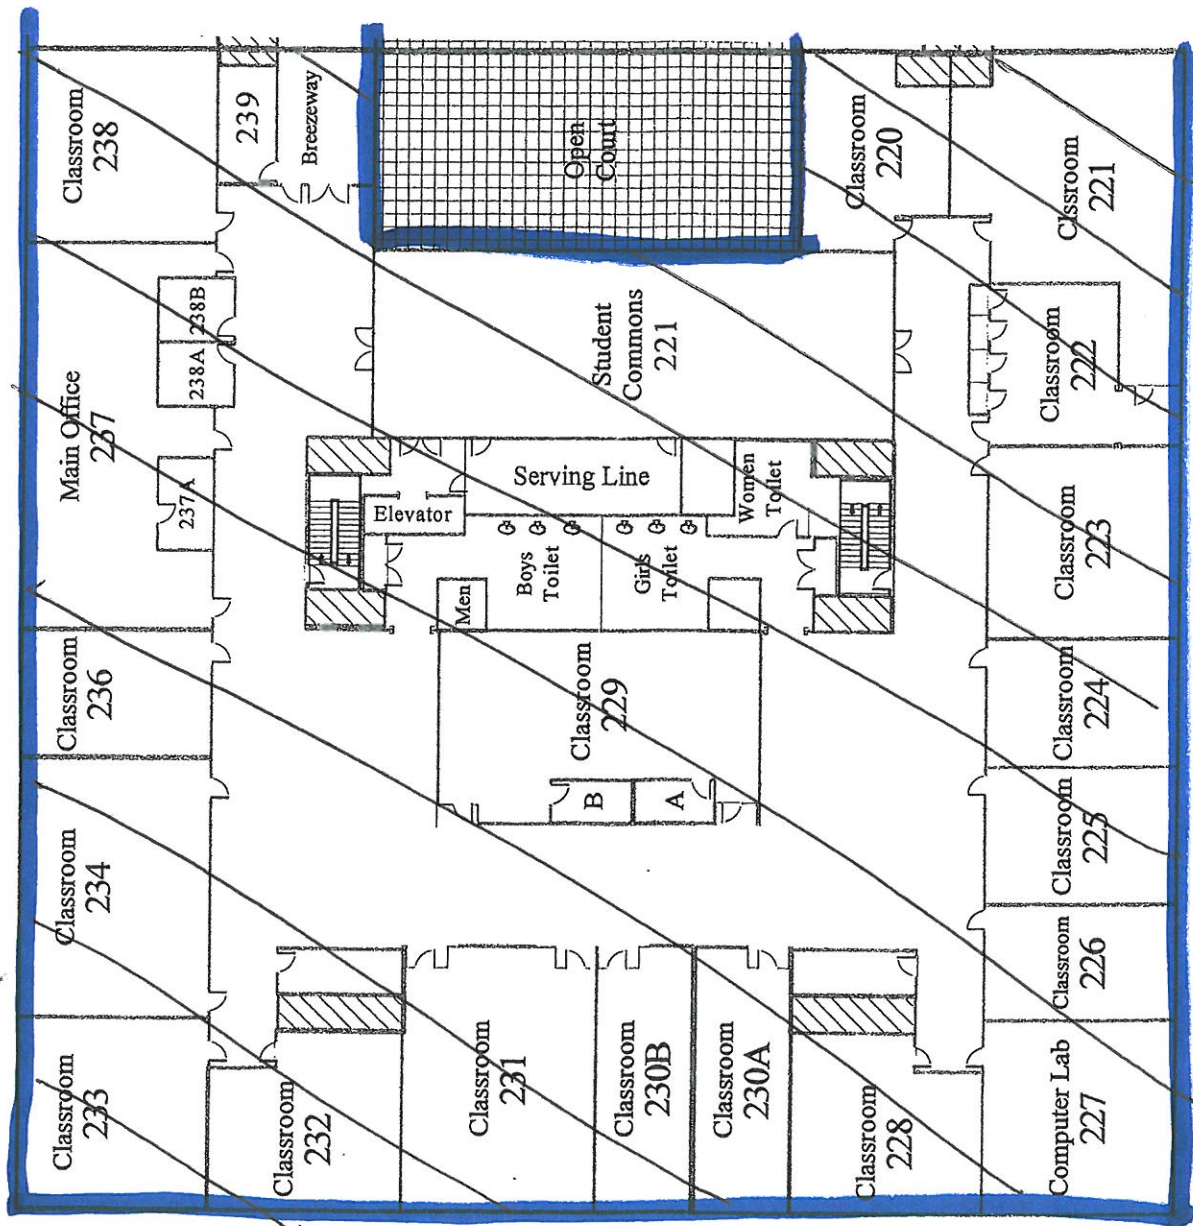
Off C:  
2nd Floor

H1A4B = SPRAY ON  
FIRE PROOFING

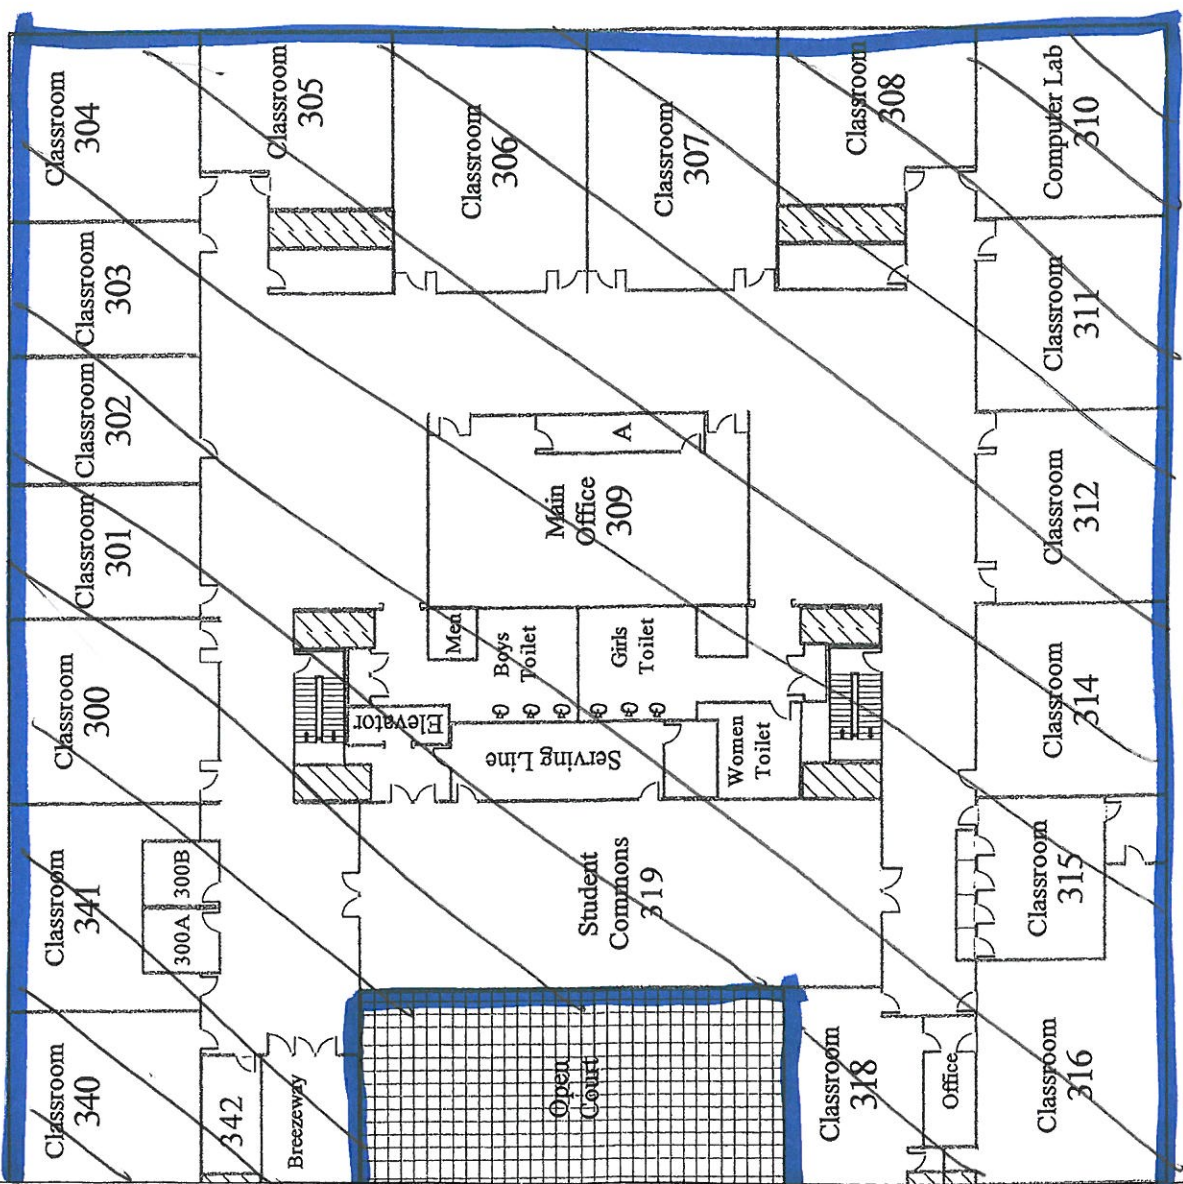
ORR  
Campus  
3rd floor

HRYG = SPRAY ON FIRE  
PROOFING.

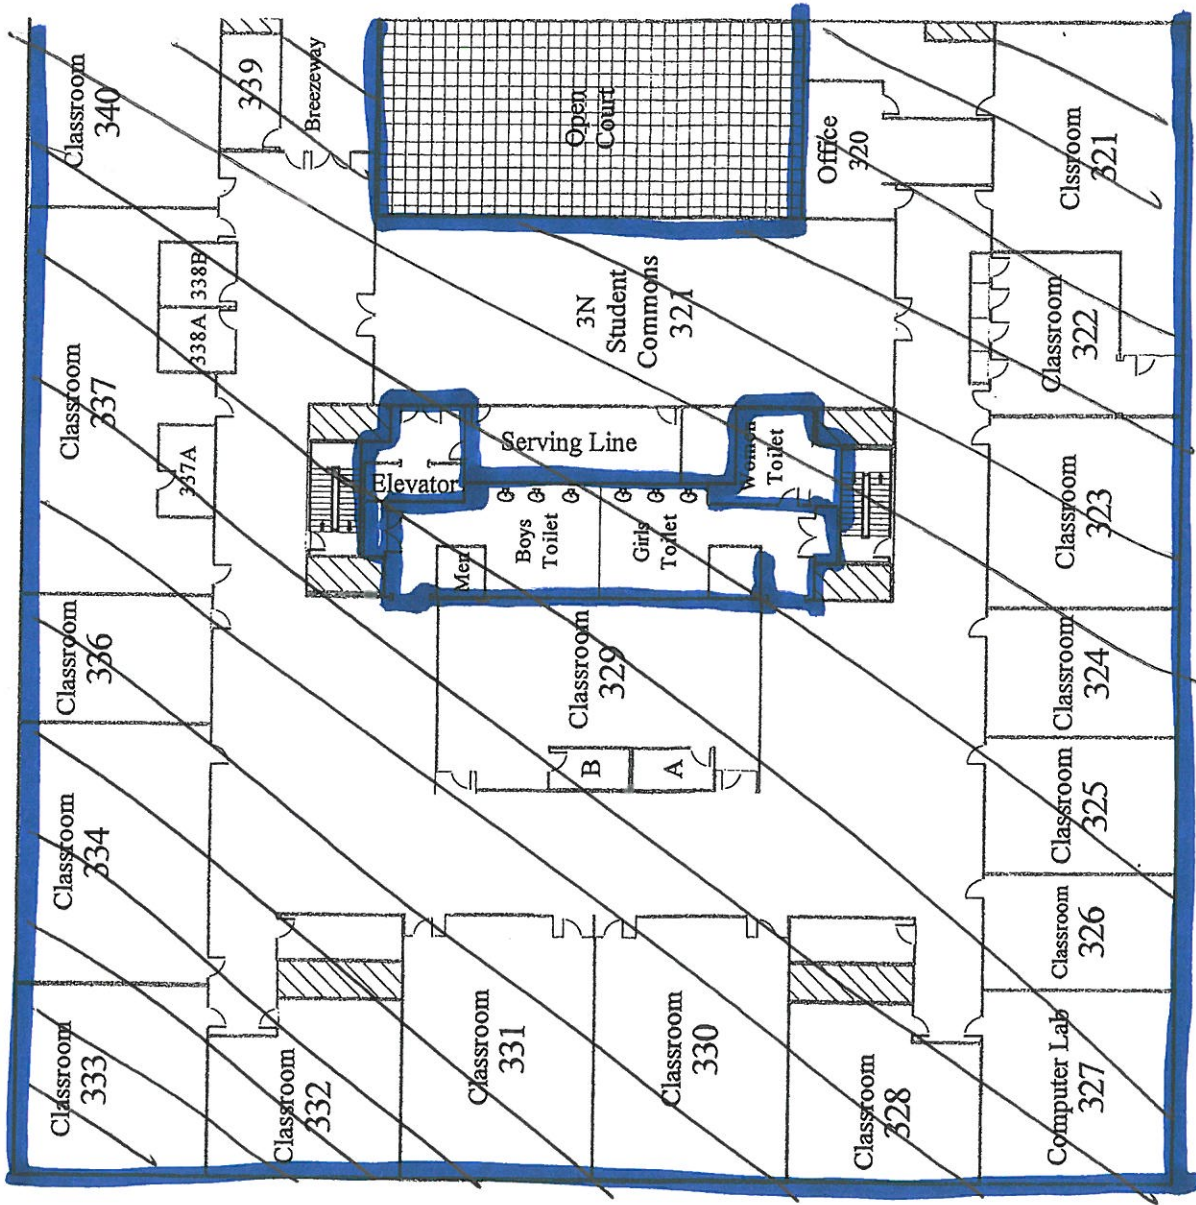
Orr Campus  
3rd Floor

H1A48 - SPRAY-ON FIRE PROOFING

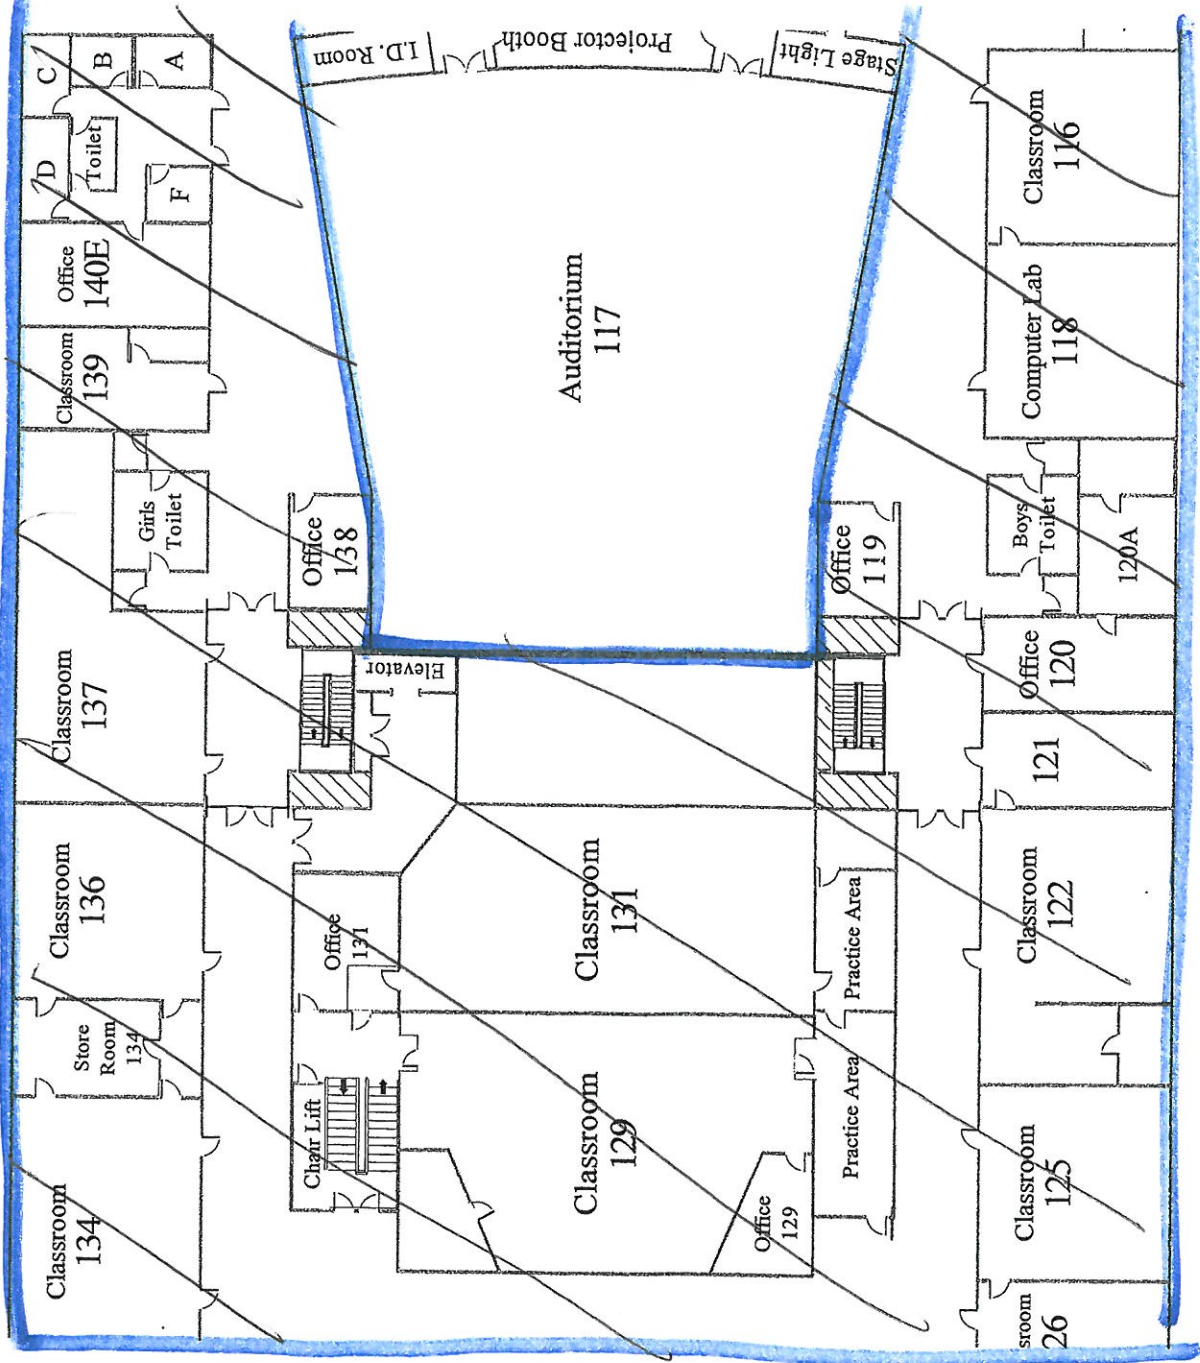
Orr Campus  
1st Floor

H1A34 = 2x4, 1x4, 1x1  
WHITE w/ PINKHOUE  
CEILING TILE

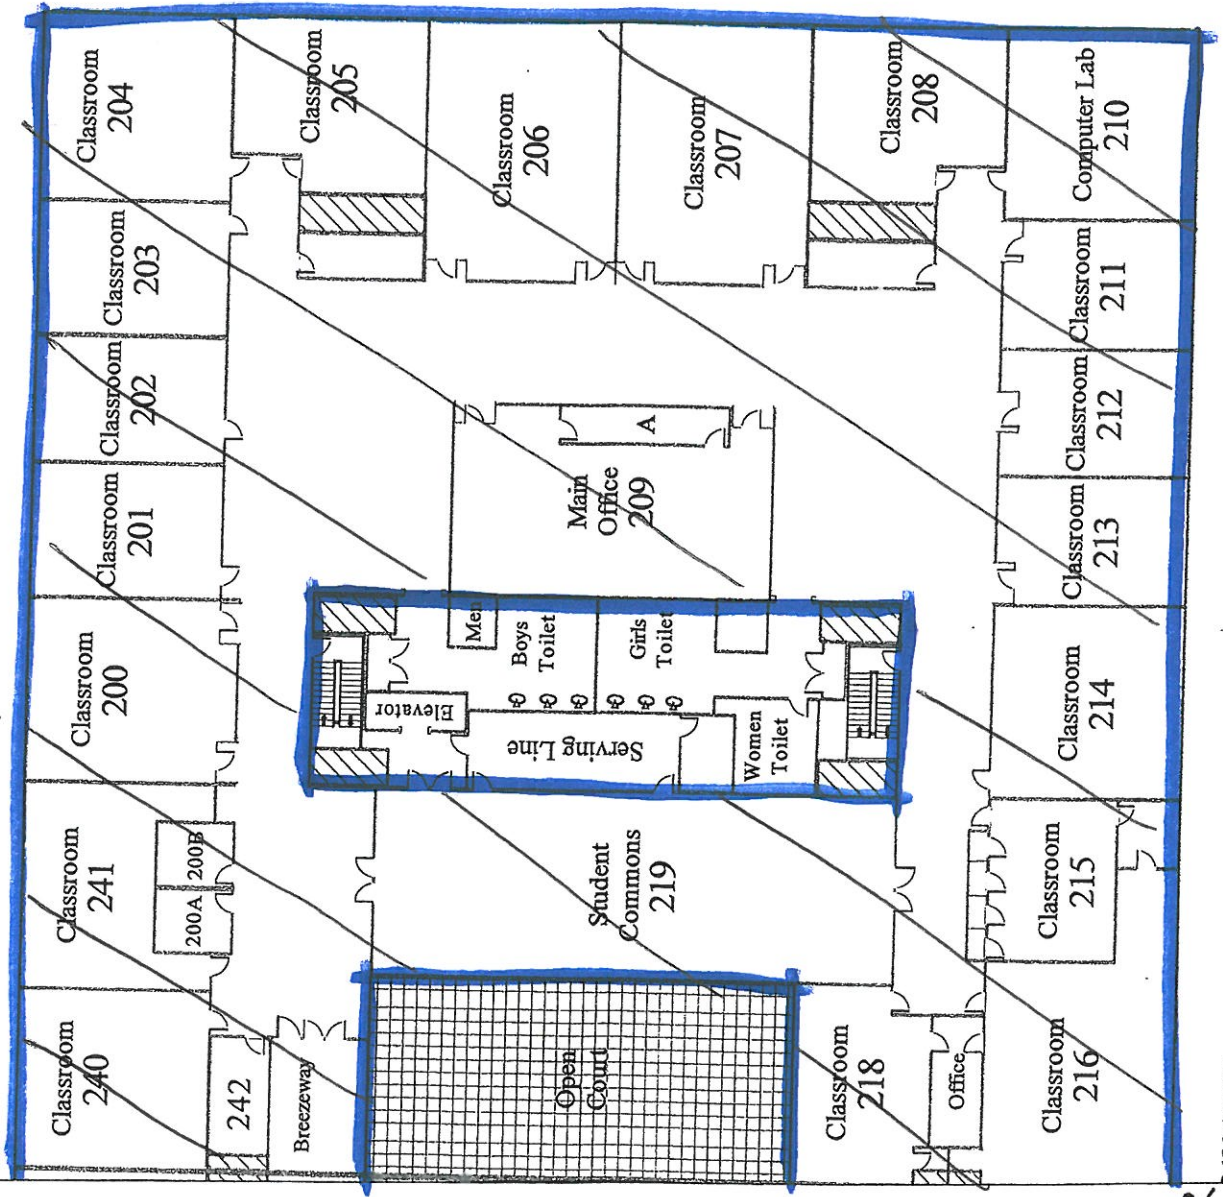
ORR Campus  
2<sup>ND</sup> FLOOR

HAB34 = 2x4, 1x4, 1x1  
WHITE w/ PINKHONEY  
CEILING, TRUE

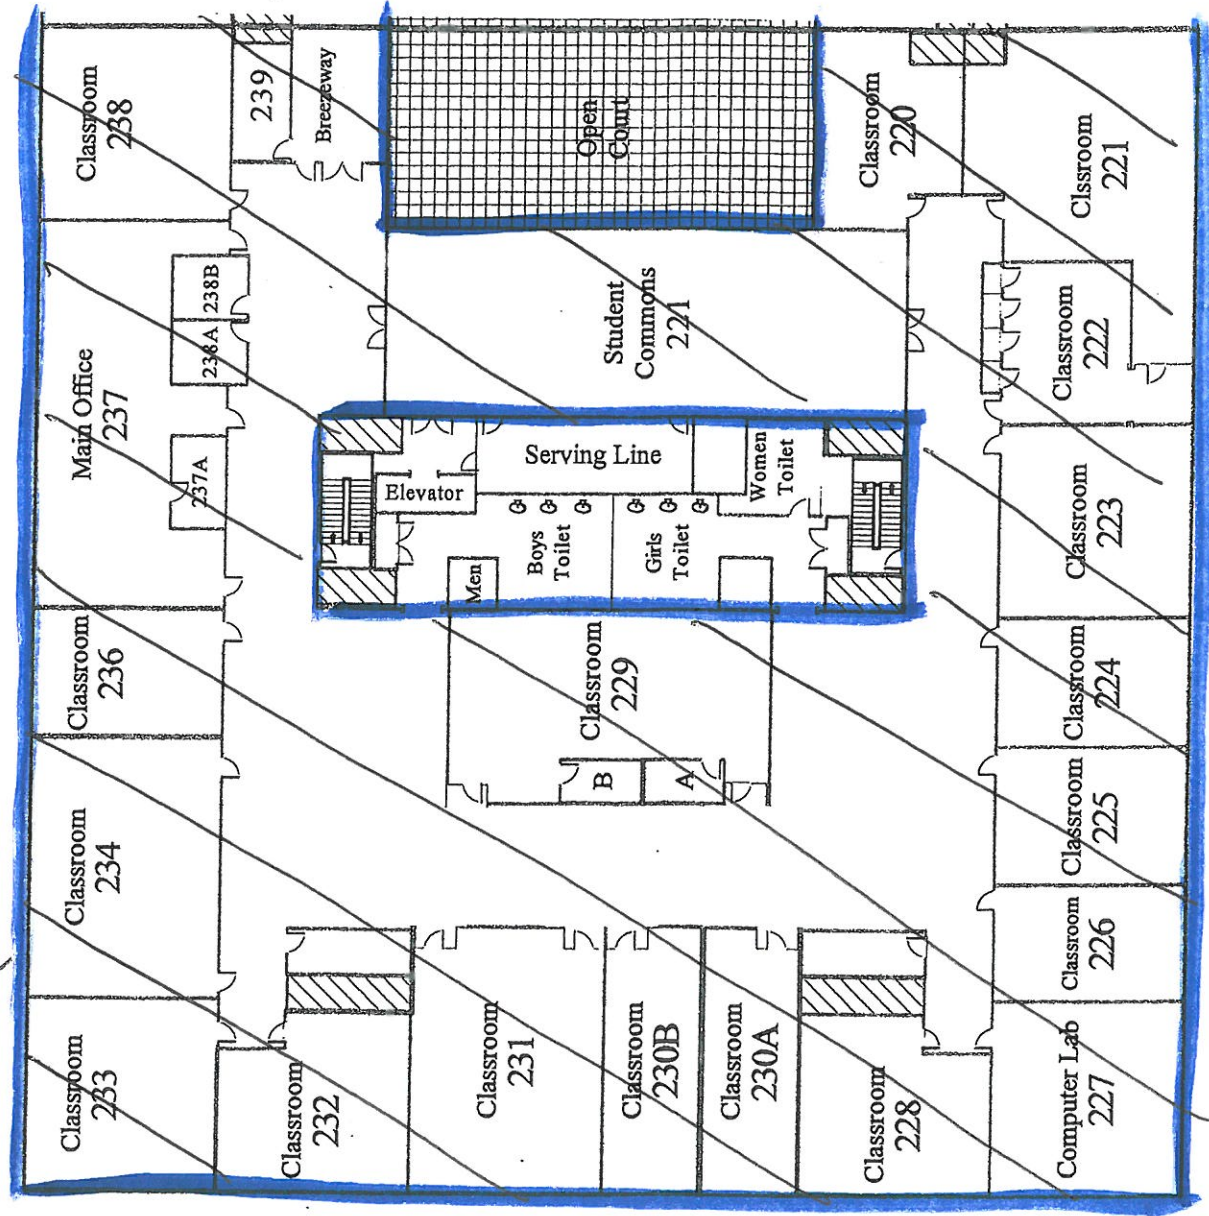
Orr C:  
 2nd Floor

HAZY = 2x4, 1x4, 1x1  
 WHITE w/ PINKHOUE  
 CEILING TILE

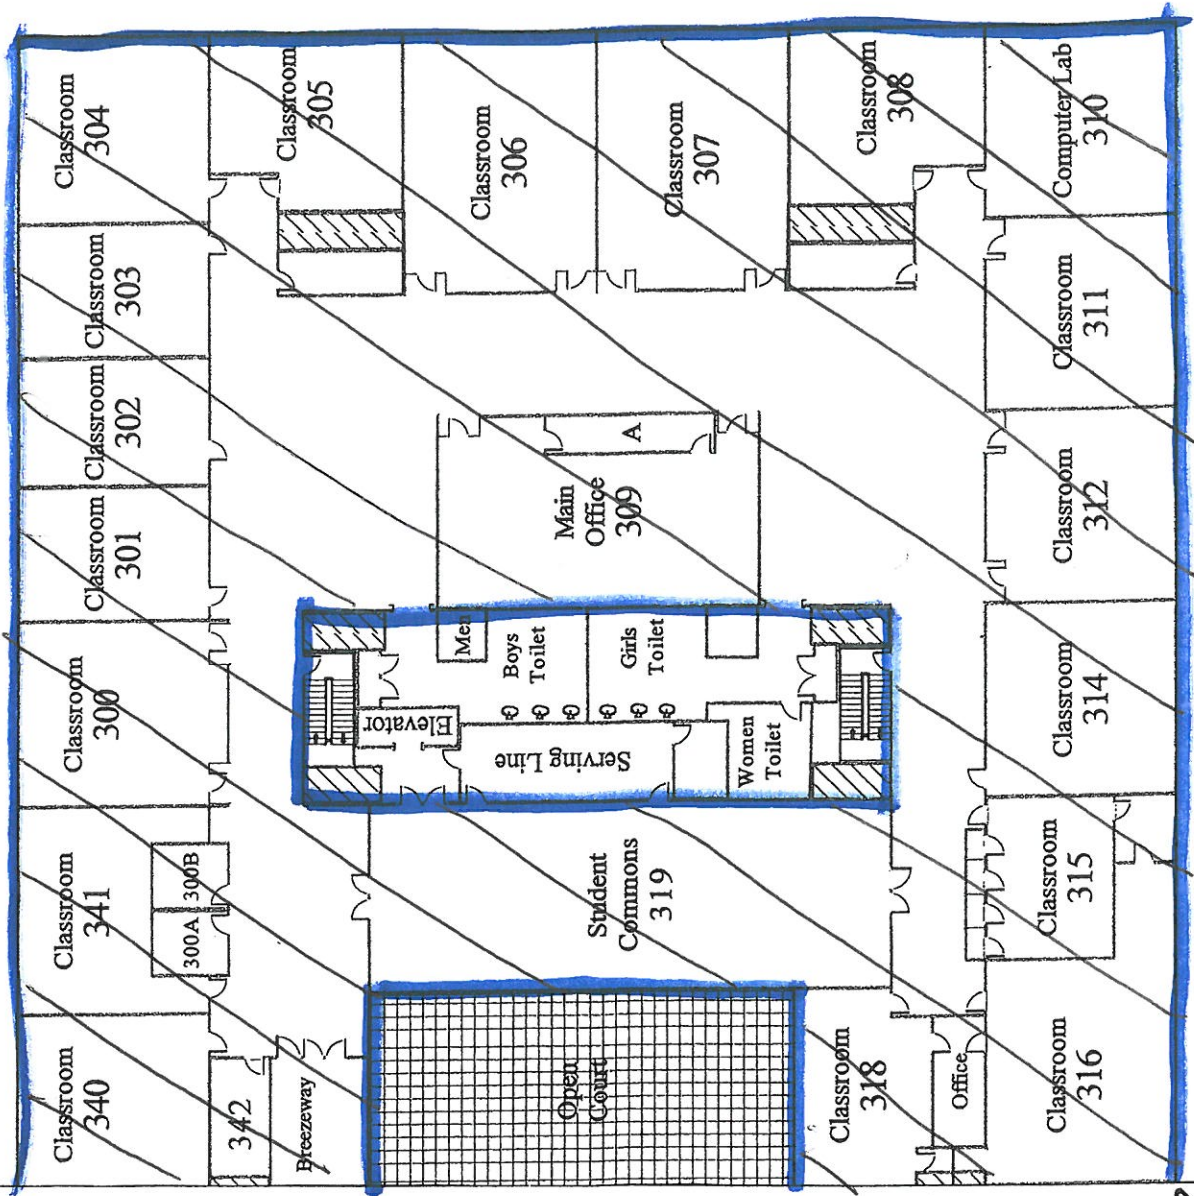
ORR Campus  
3rd floor

HA34 = 2x4, 1x4, 1x1  
WHITE w/ pinkie ceiling  
TILE

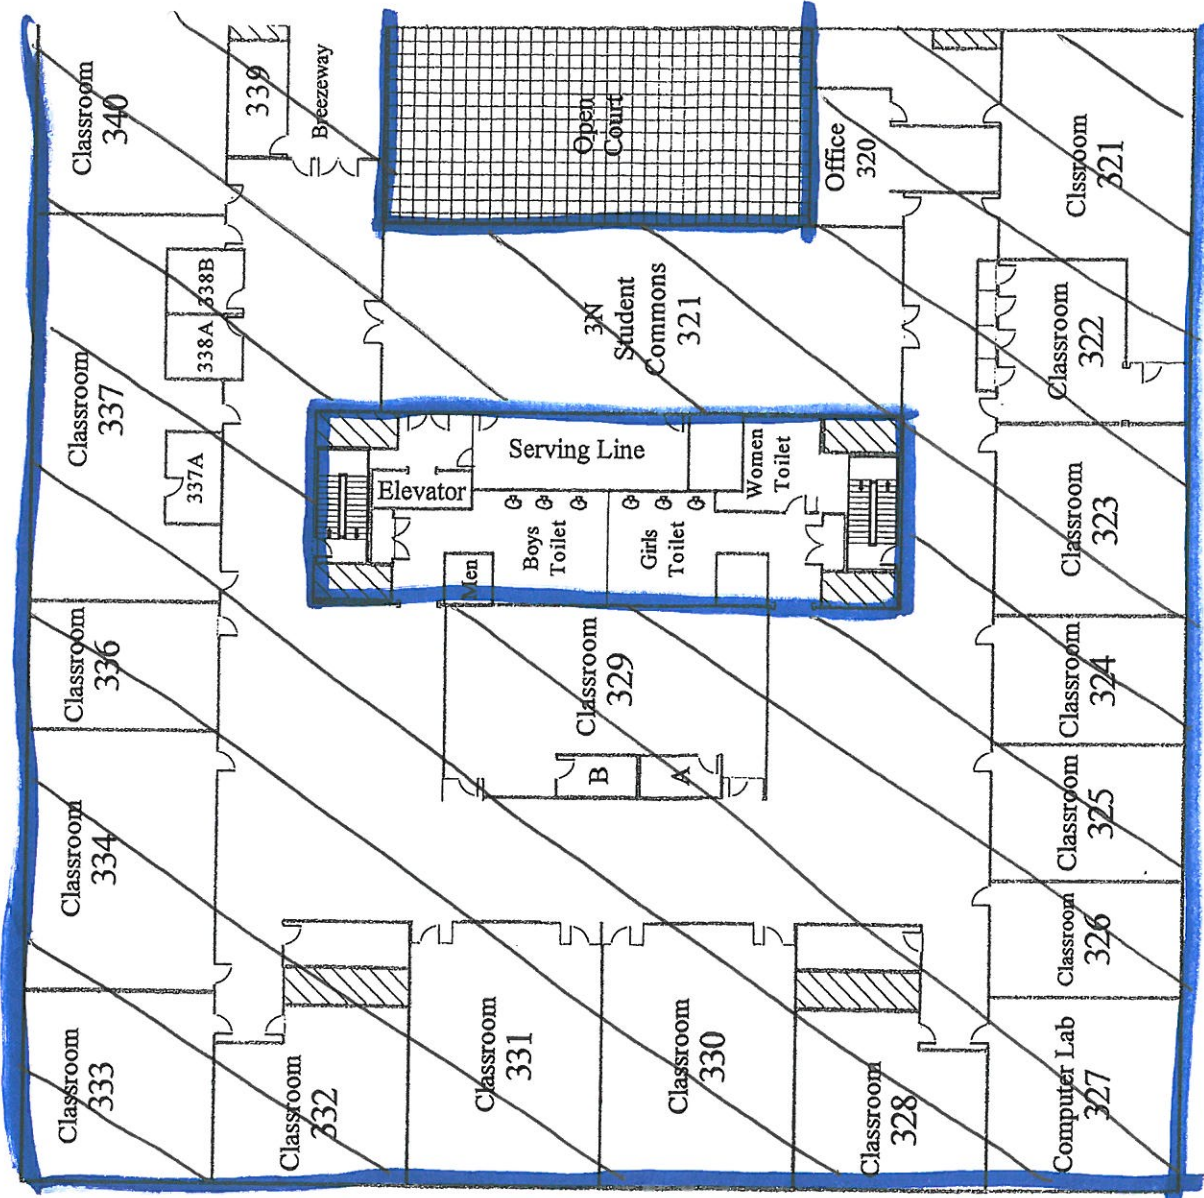
Orr Campus  
 3rd Floor

HA34 = 2x4, 1x4, 1x1  
 WHITE w/ PINHOLE CERAMIC  
 TILE

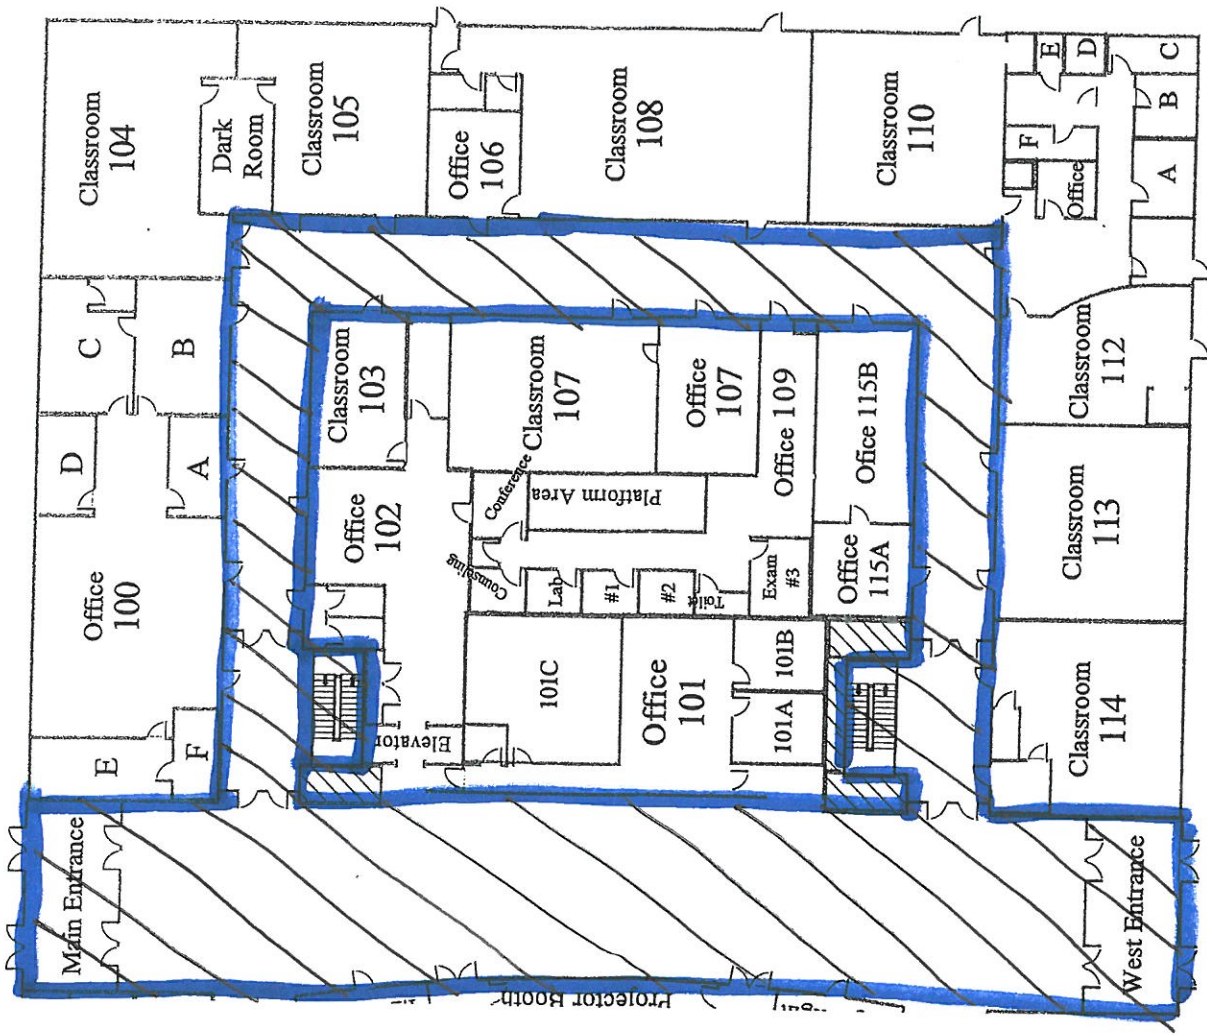
ORR Campus  
1st floor

HASI = TERRAZO

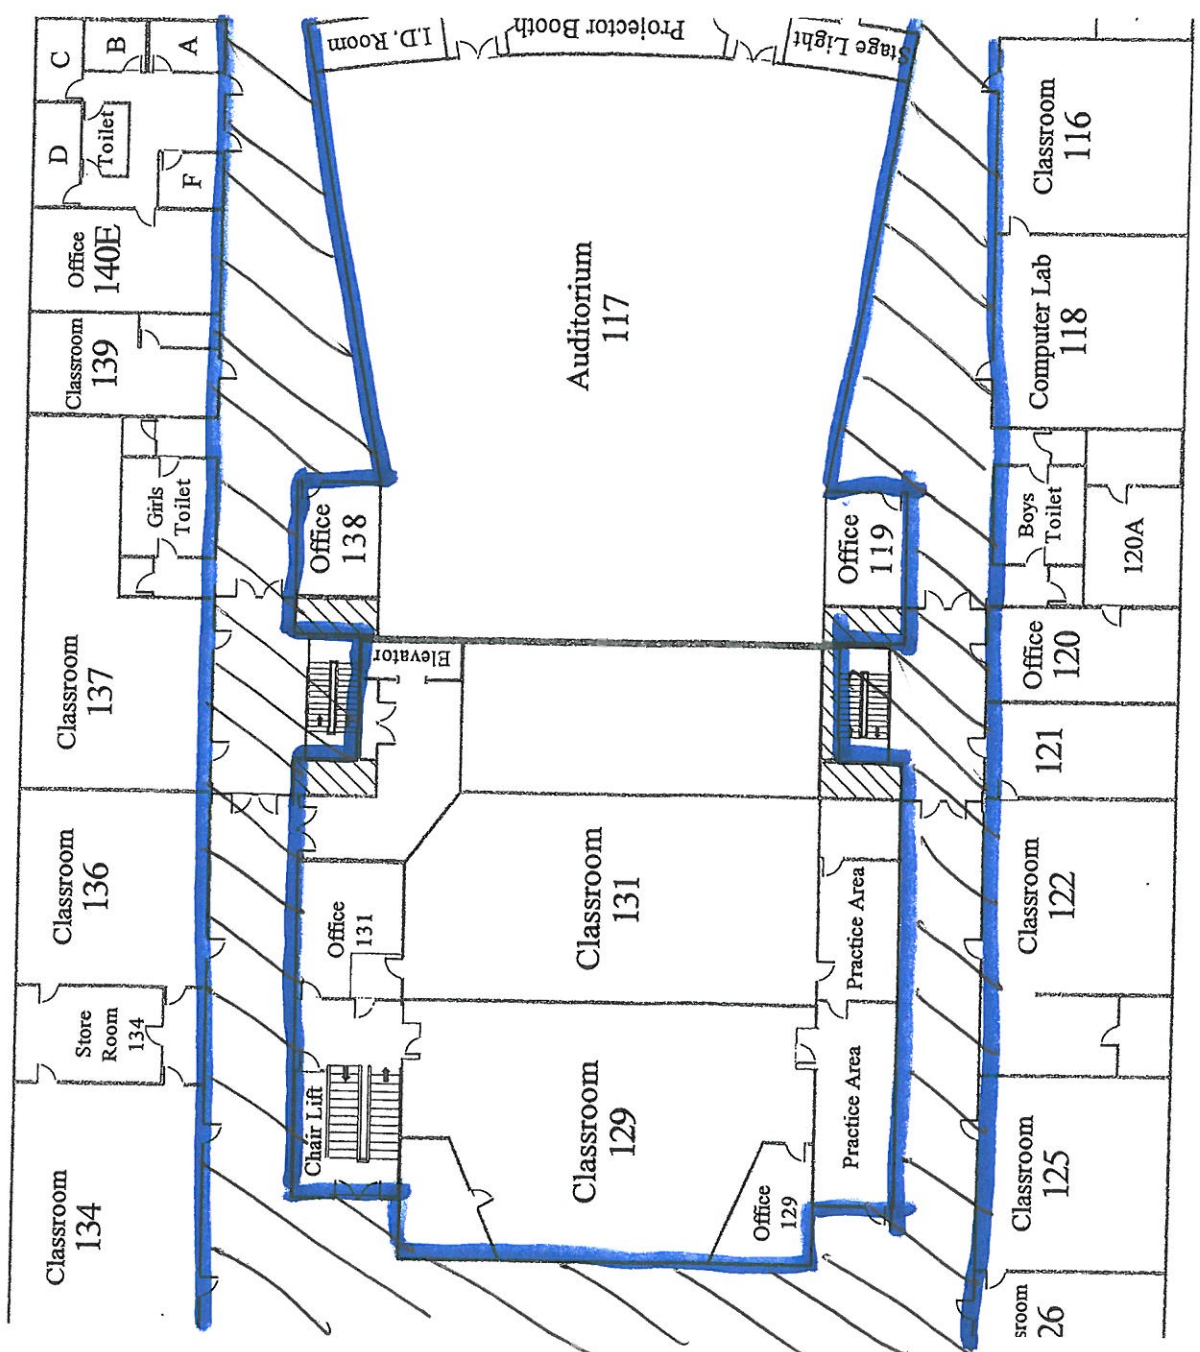
Orr Campus  
1st Floor

HASL = TERRAZO

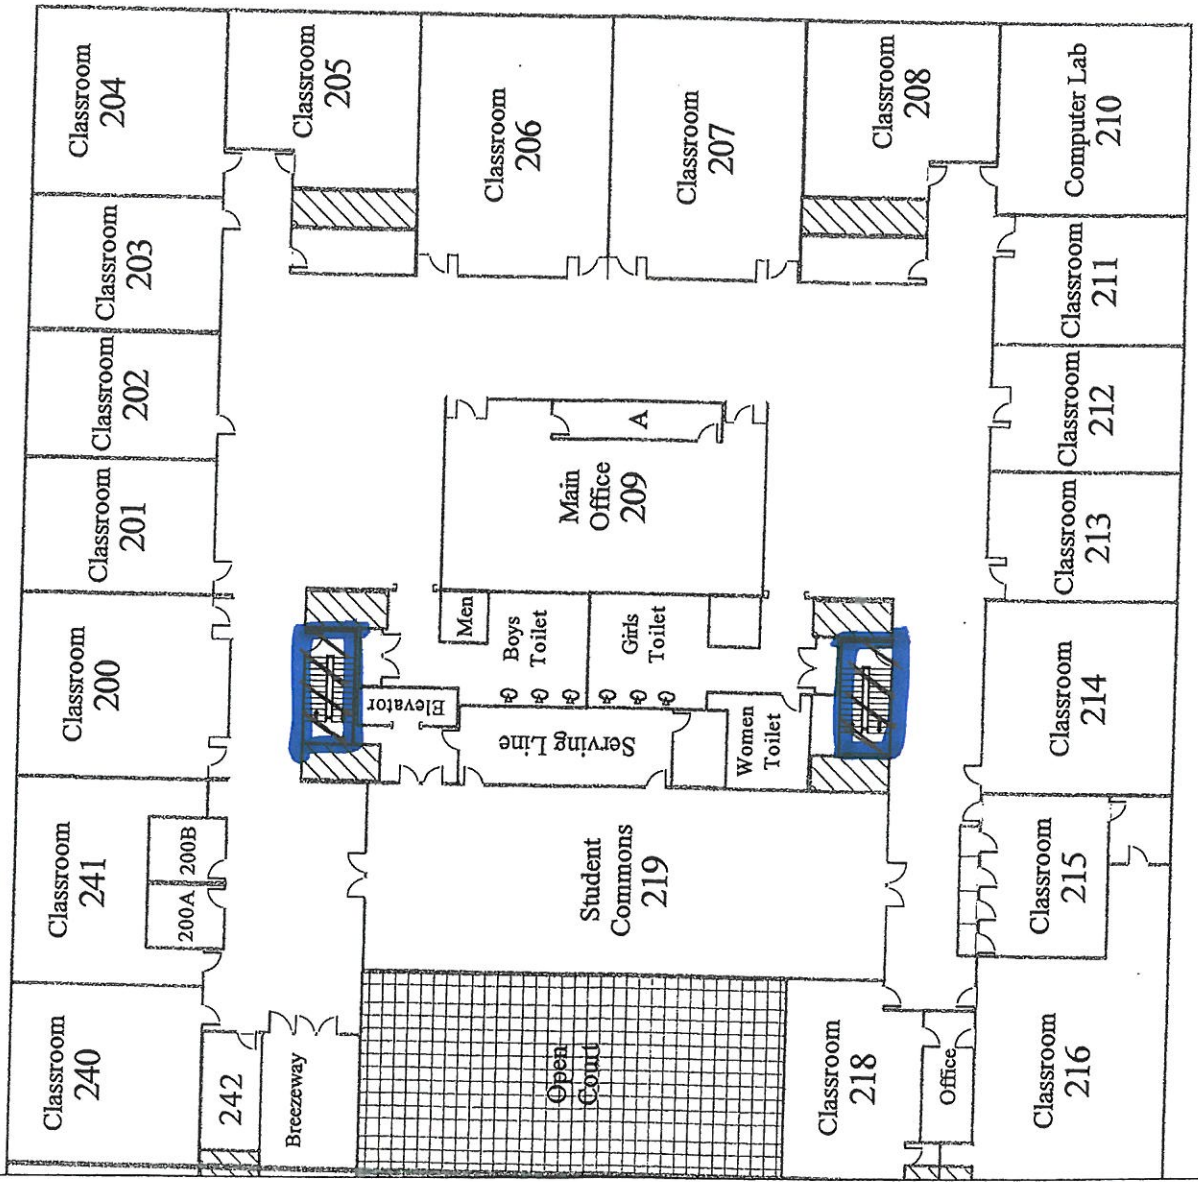
ORR Campus  
2<sup>ND</sup> Floor

HAS1 = TERRAZO

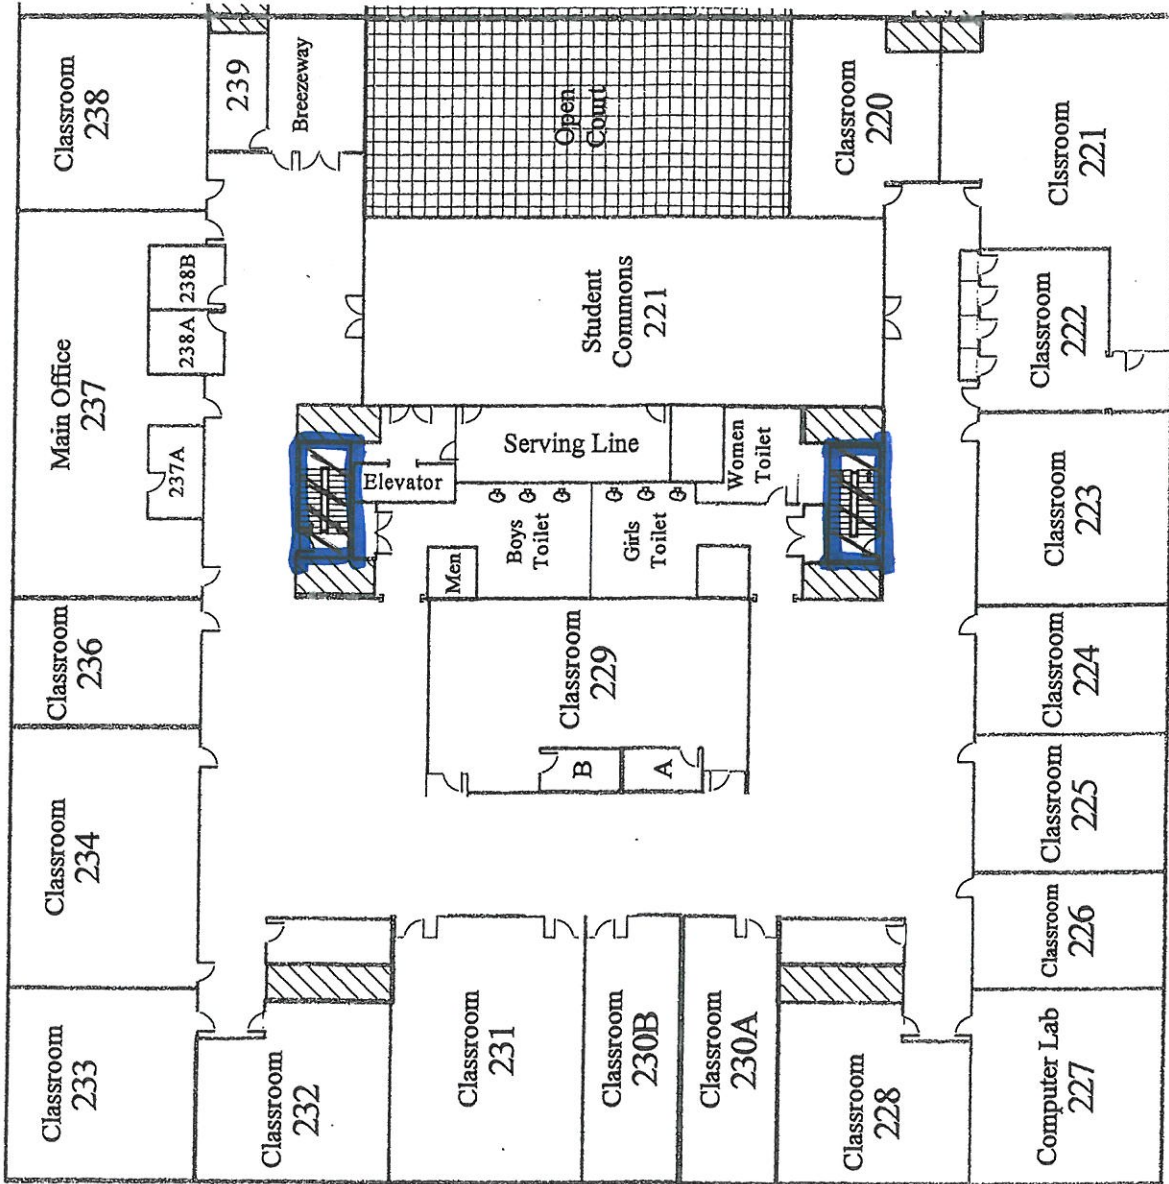
Orr C:  
2nd Floor

HAS1 = TERRAZO

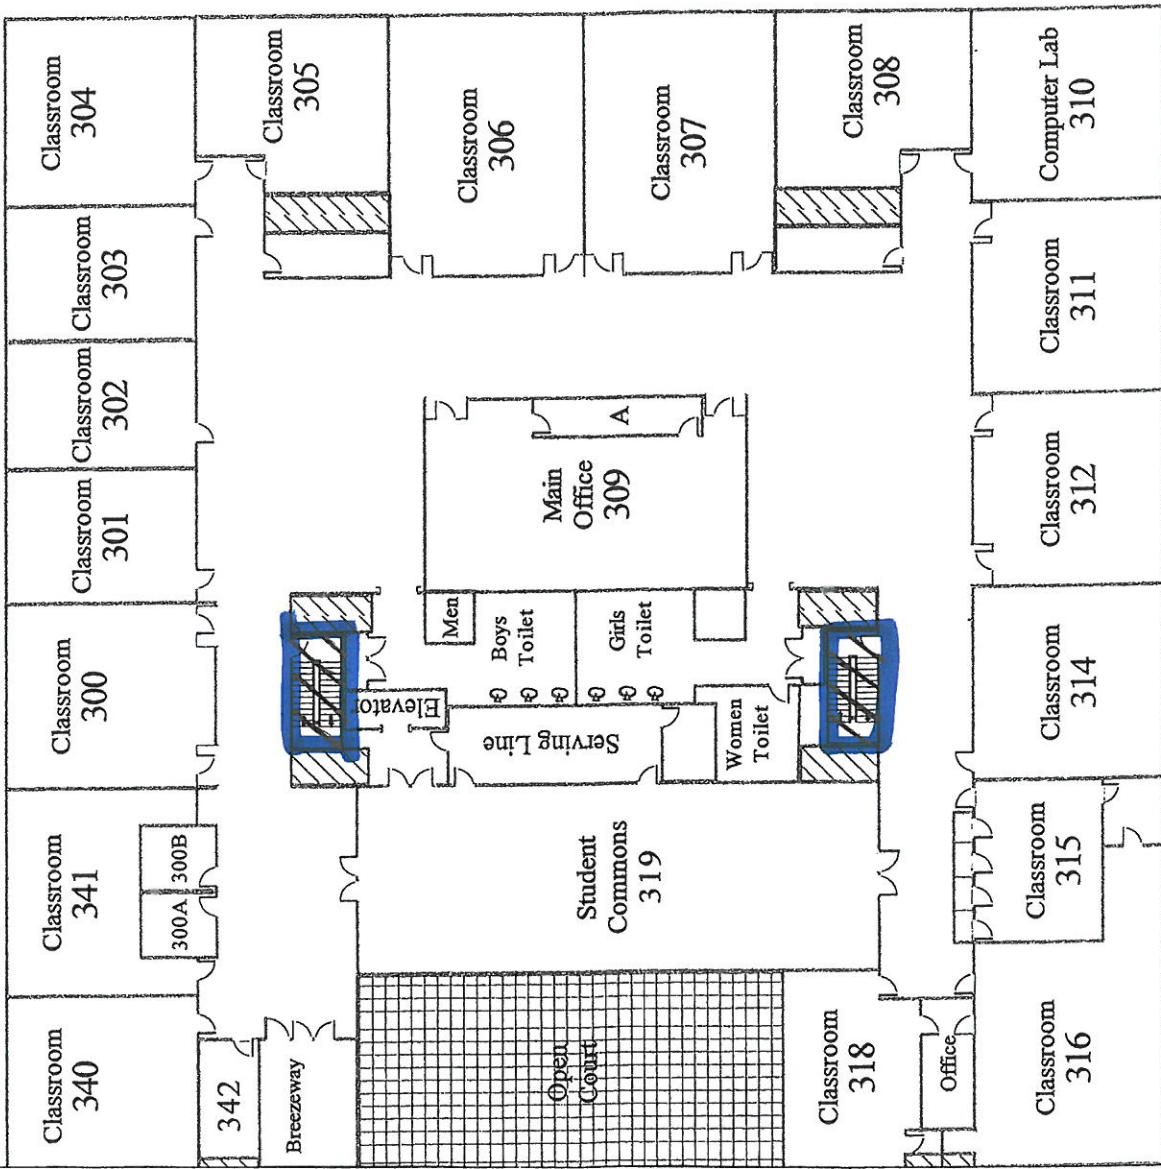
ORR Campus  
3rd floor

HAS1 = TERRAZO
