**ILLINOIS DEPARTMENT OF PUBLIC HEALTH  
AHERA THREE YEAR REINSPECTION  
ASBESTOS ABATEMENT PROGRAM  
SCHOOL INFORMATION FORM**

**THREE-YEAR REINSPECTION**

**Orr Community Academy HS**

Unit: 51081  
Building ID: 1830

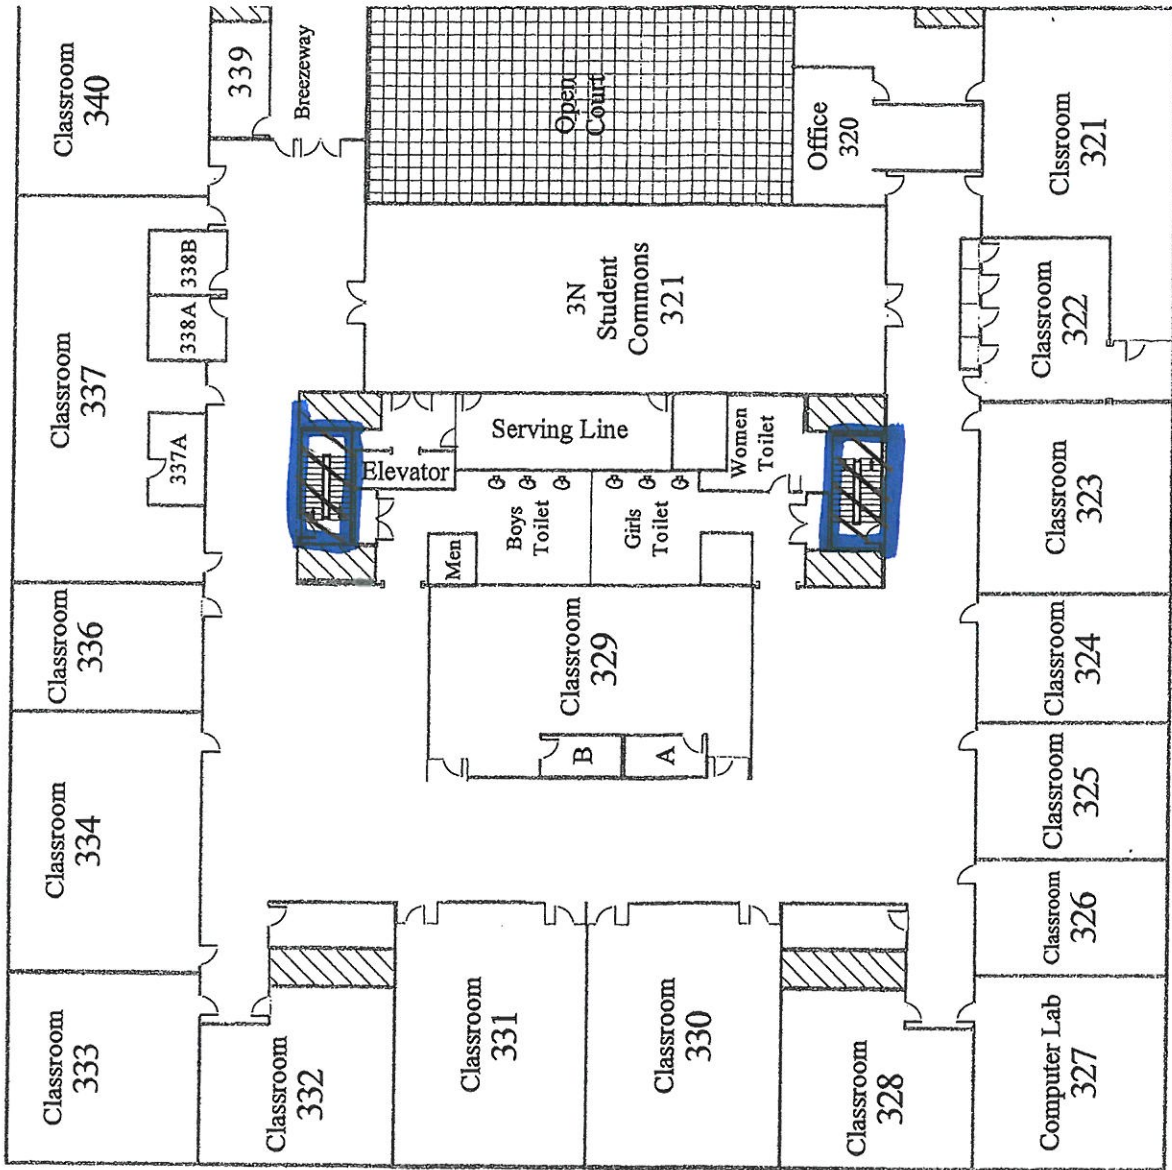
Orr Campus  
3rd Floor

HAS1 = TERRAZO

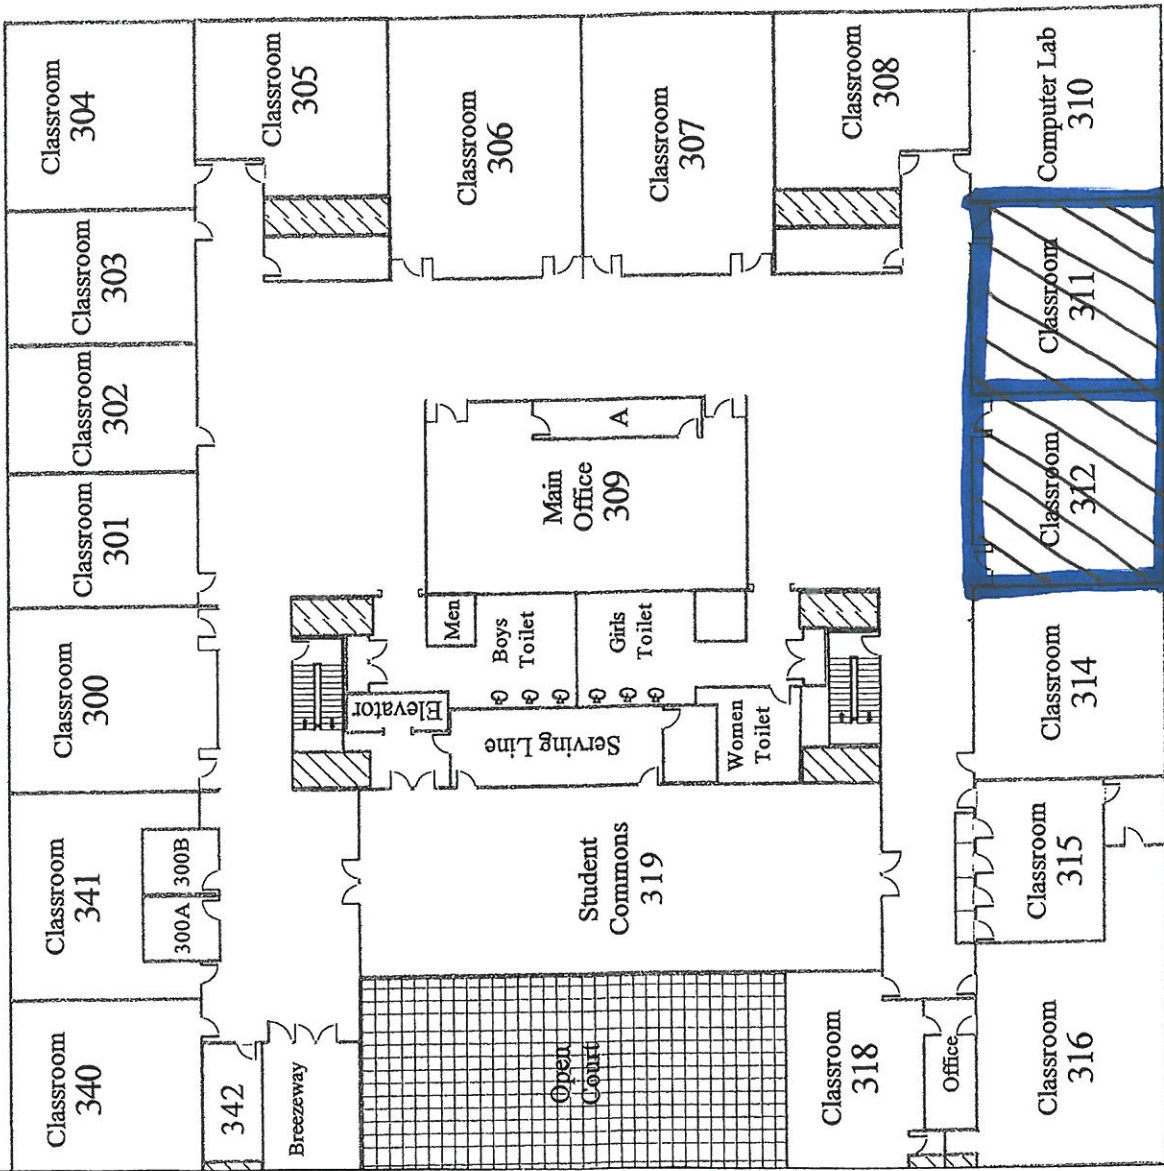
ORR  
Campus  
3rd floor

HA39 = 12x2 WHITE w/ DARK  
HA40 GREEN SPECKS w/ FT  
& MASTIC

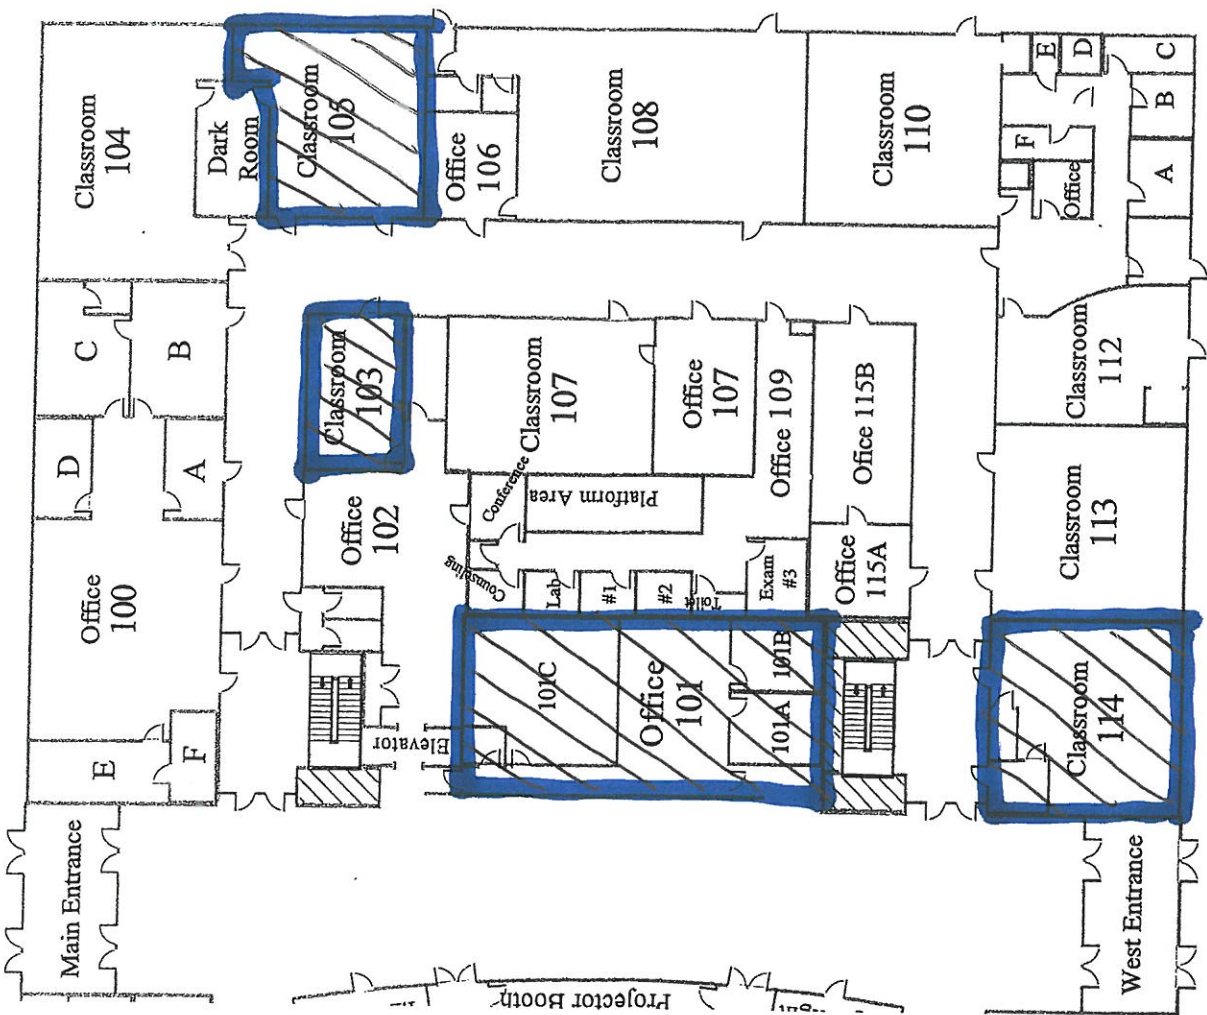
ORR Campus  
 1st floor

HAY2 = 12x12 white w/ BACK  
 HAY3 SPECS VFT & MASTIC

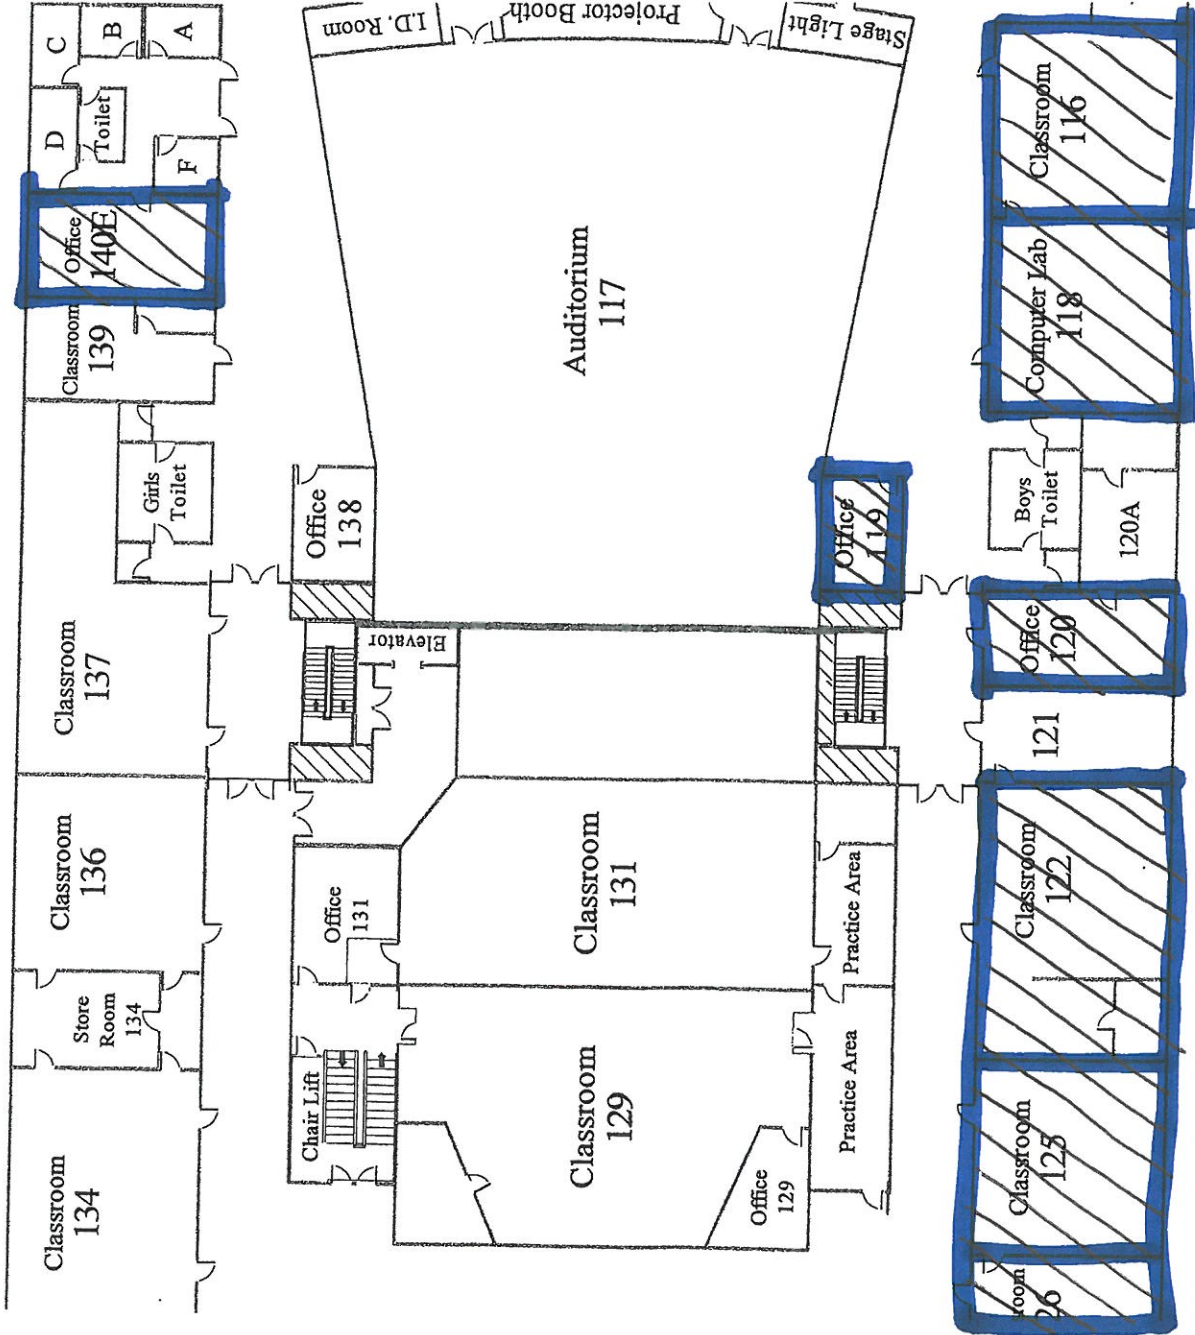
Orr Campus  
 1st Floor

HA42 = 12X12 WHITE w/  
 HA43 = BUAK SPEKRS VFT  
 & MASTIC

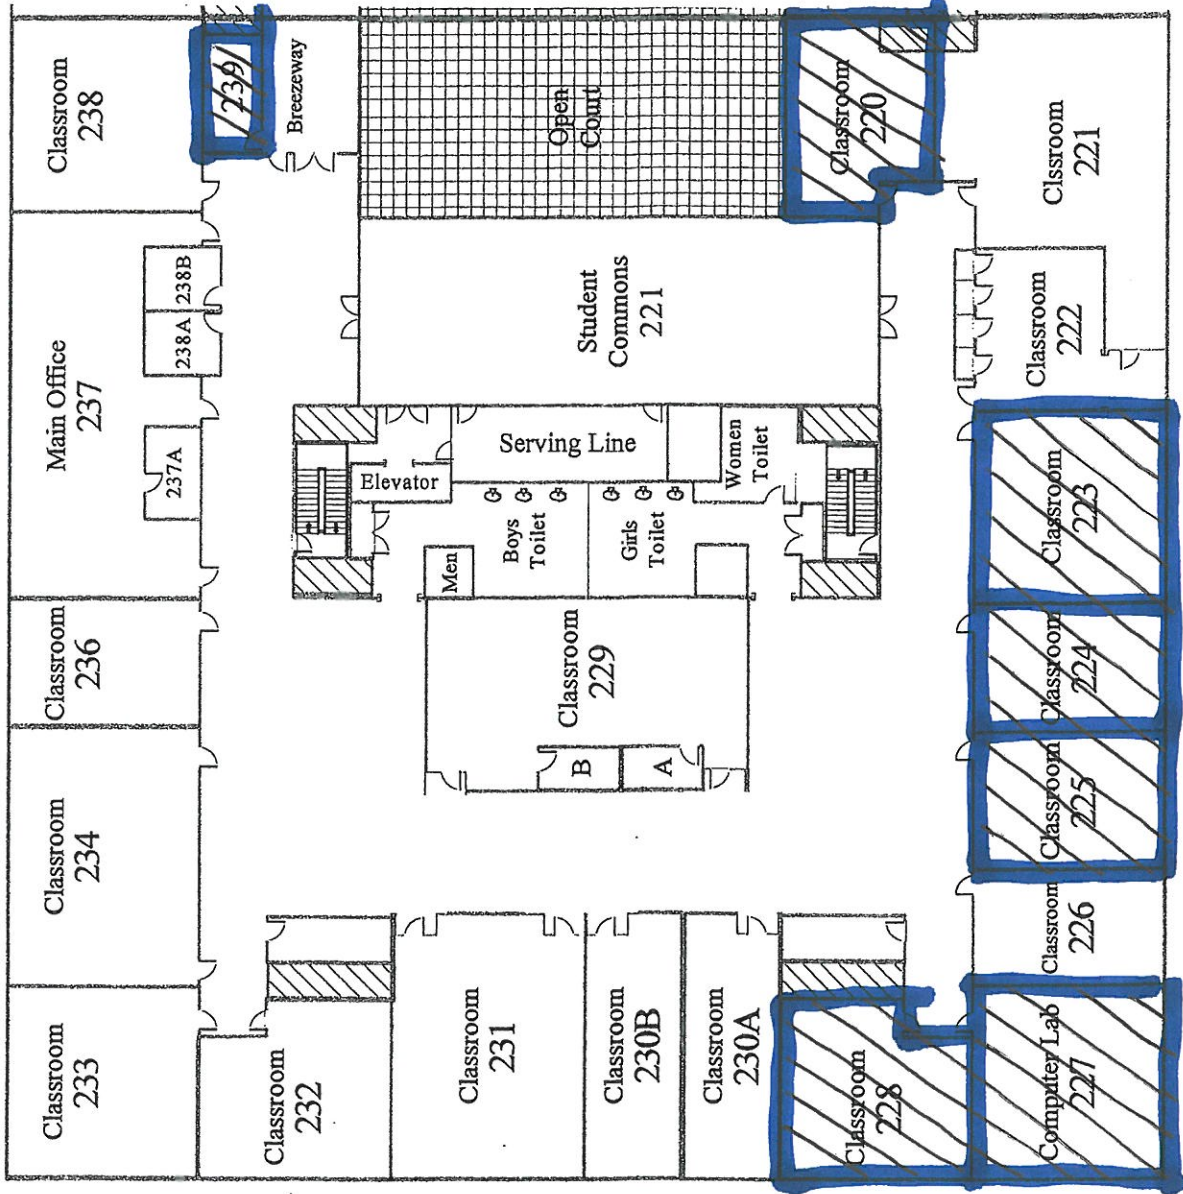
Off C:  
 2nd Floor

H1A42 = 12X12 WHITE w/  
 H1A43 = BLACK SPECKS VFT &  
 MASTIC

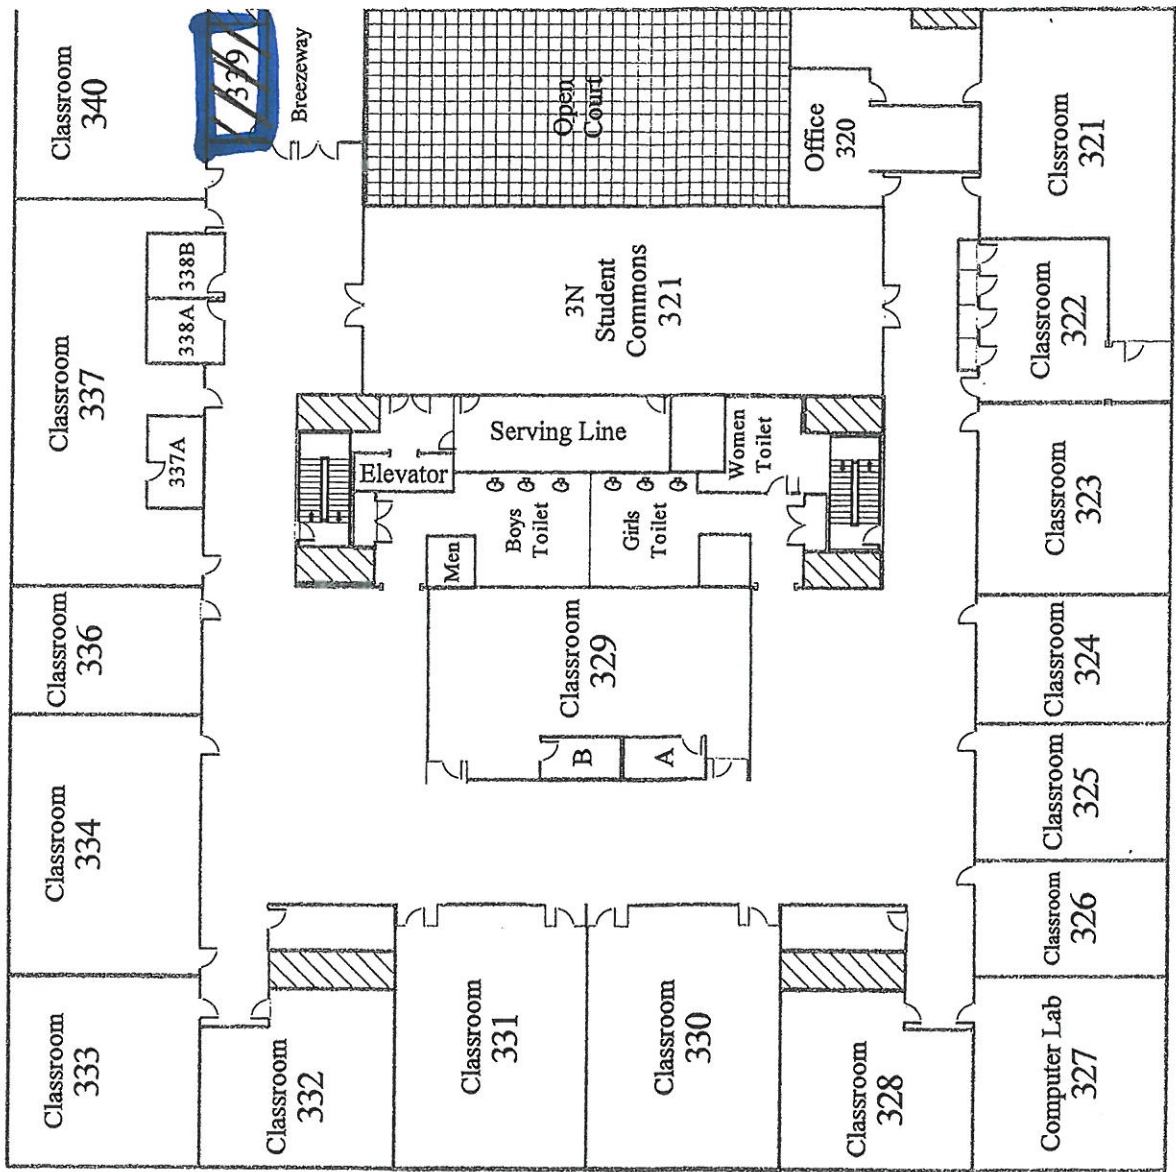
Orr Campus  
 3rd Floor

H1A42 = 12X12 WHITE w/  
 H1A43 = BLACK SPECKS VFT &  
 MASTIC

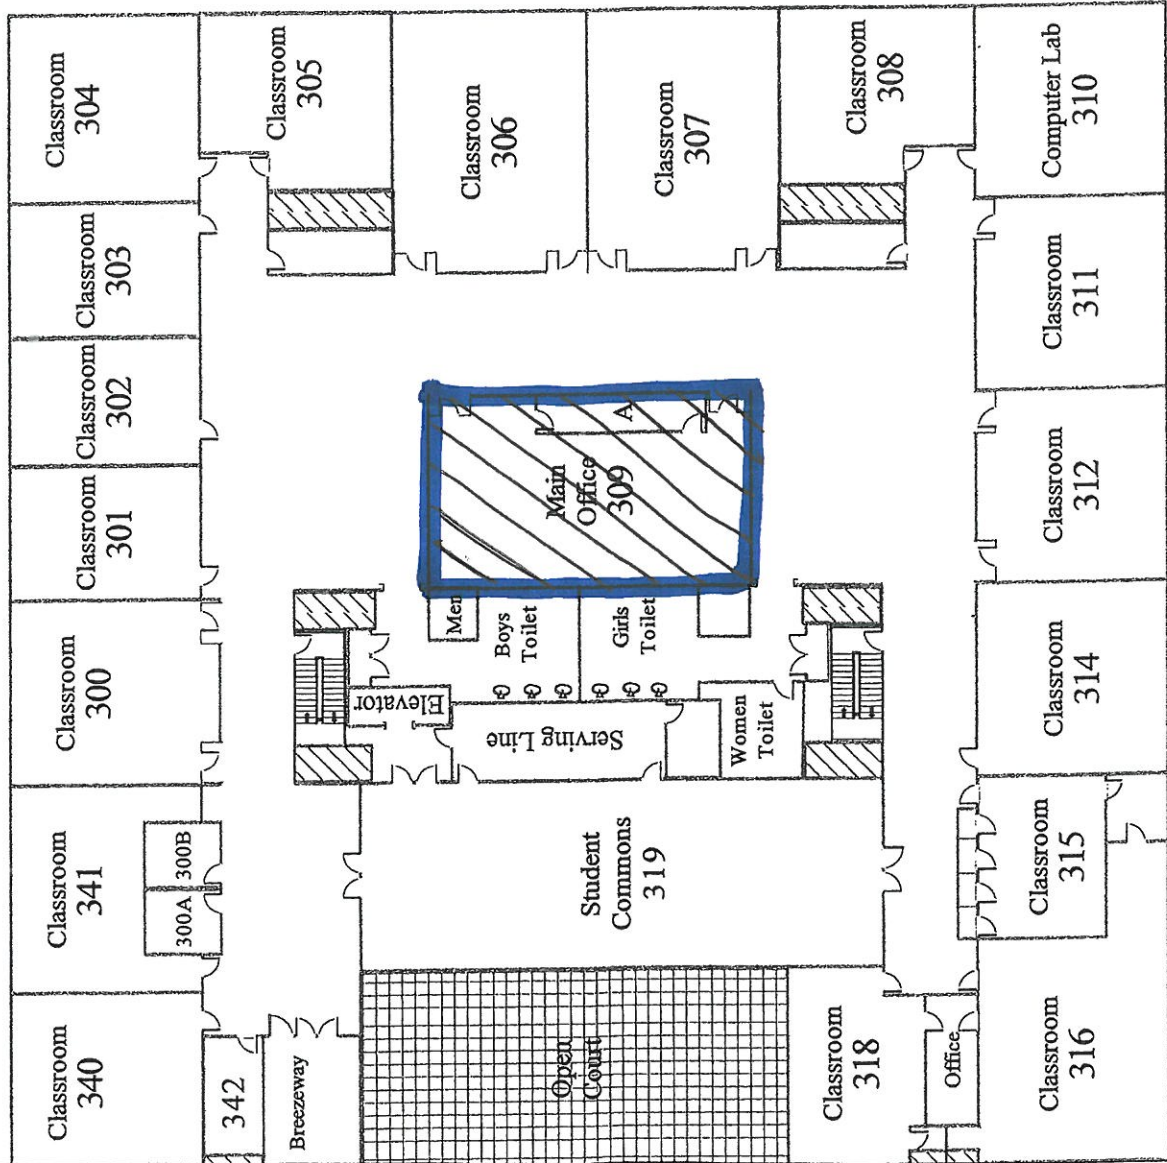
ORR  
Campus  
3<sup>rd</sup> floor

HA37 = 12x12 BLUE SPECKLED  
HA38 VFT & MASTIC

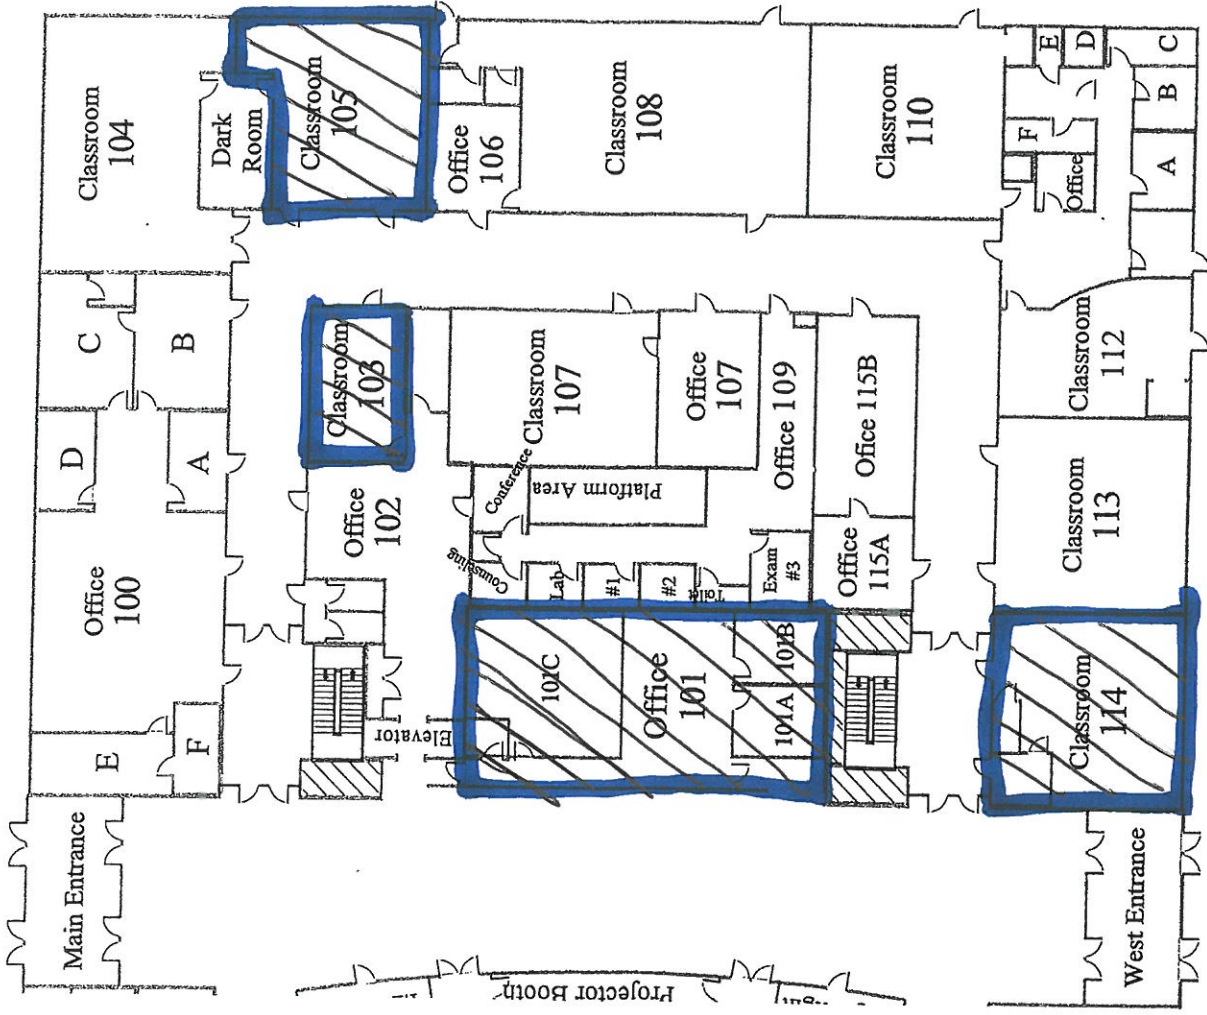
ORR Campus  
1st floor

HA37 = 12x12 BWSPECKLED  
HA38 VFT. & MASTIC

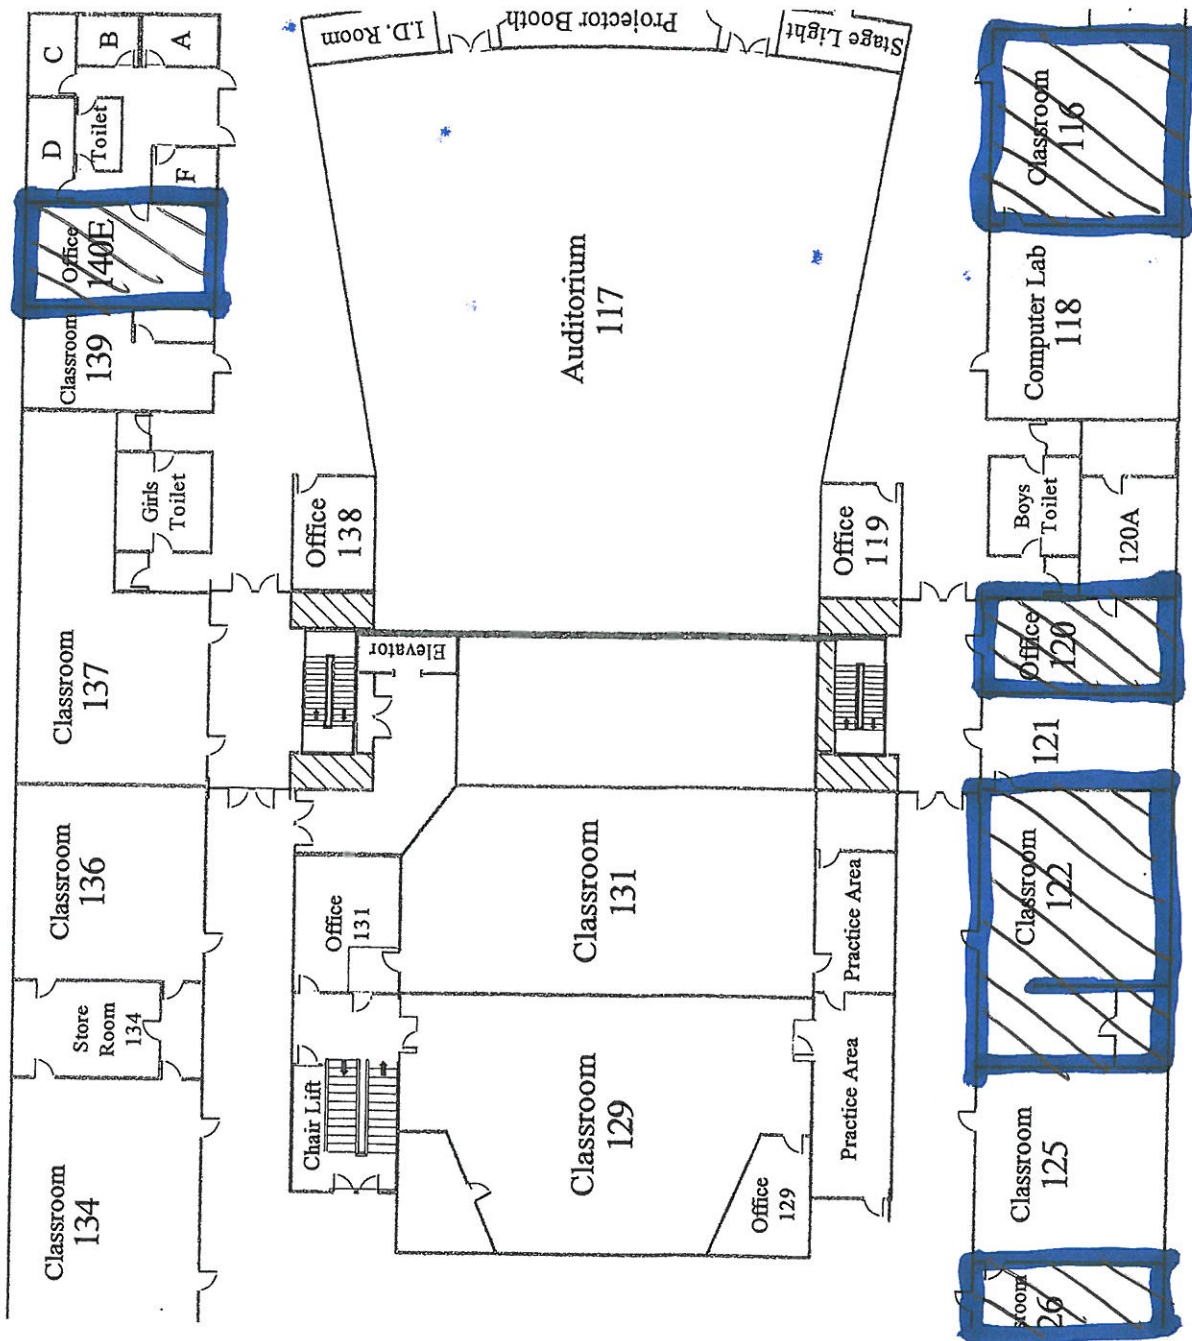
Orr Campus  
1st Floor

HA37 = 12x12 BUW SPECKED  
HA38 UFT & MASTIC

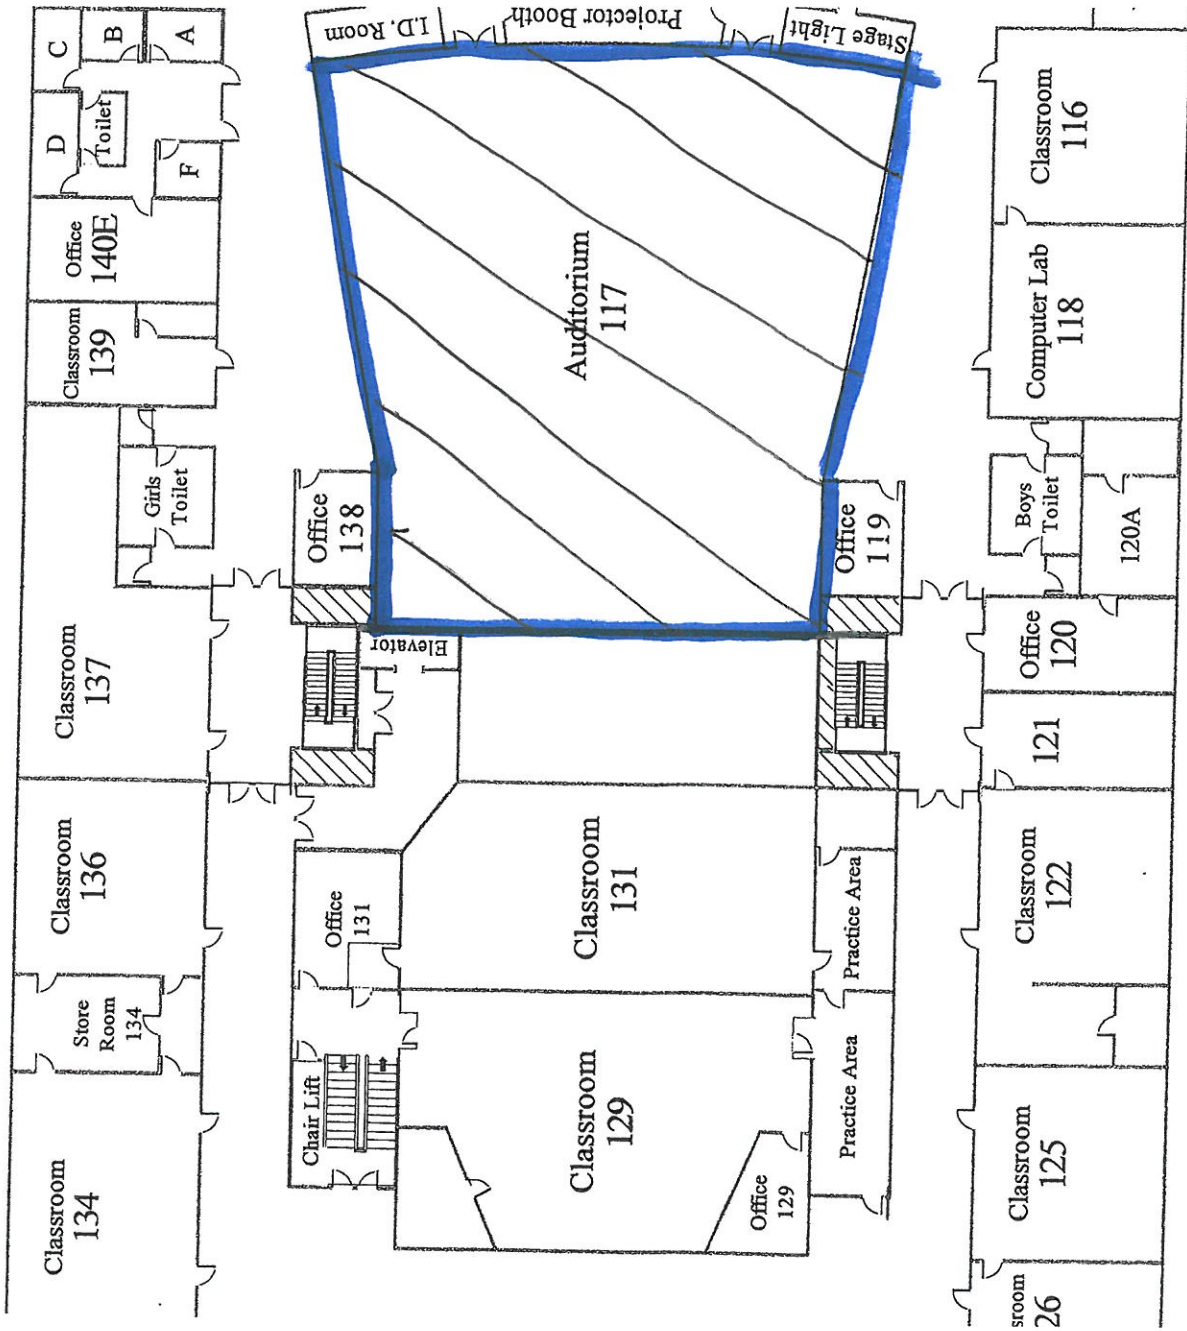
Orr Campus  
1st Floor

H1449 = CARPET MASTIC
