**ILLINOIS DEPARTMENT OF PUBLIC HEALTH
AHERA THREE YEAR REINSPECTION
ASBESTOS ABATEMENT PROGRAM
SCHOOL INFORMATION FORM**

THREE-YEAR REINSPECTION

Collins High School

1313 S. Sacramento
Chicago, IL, 60623

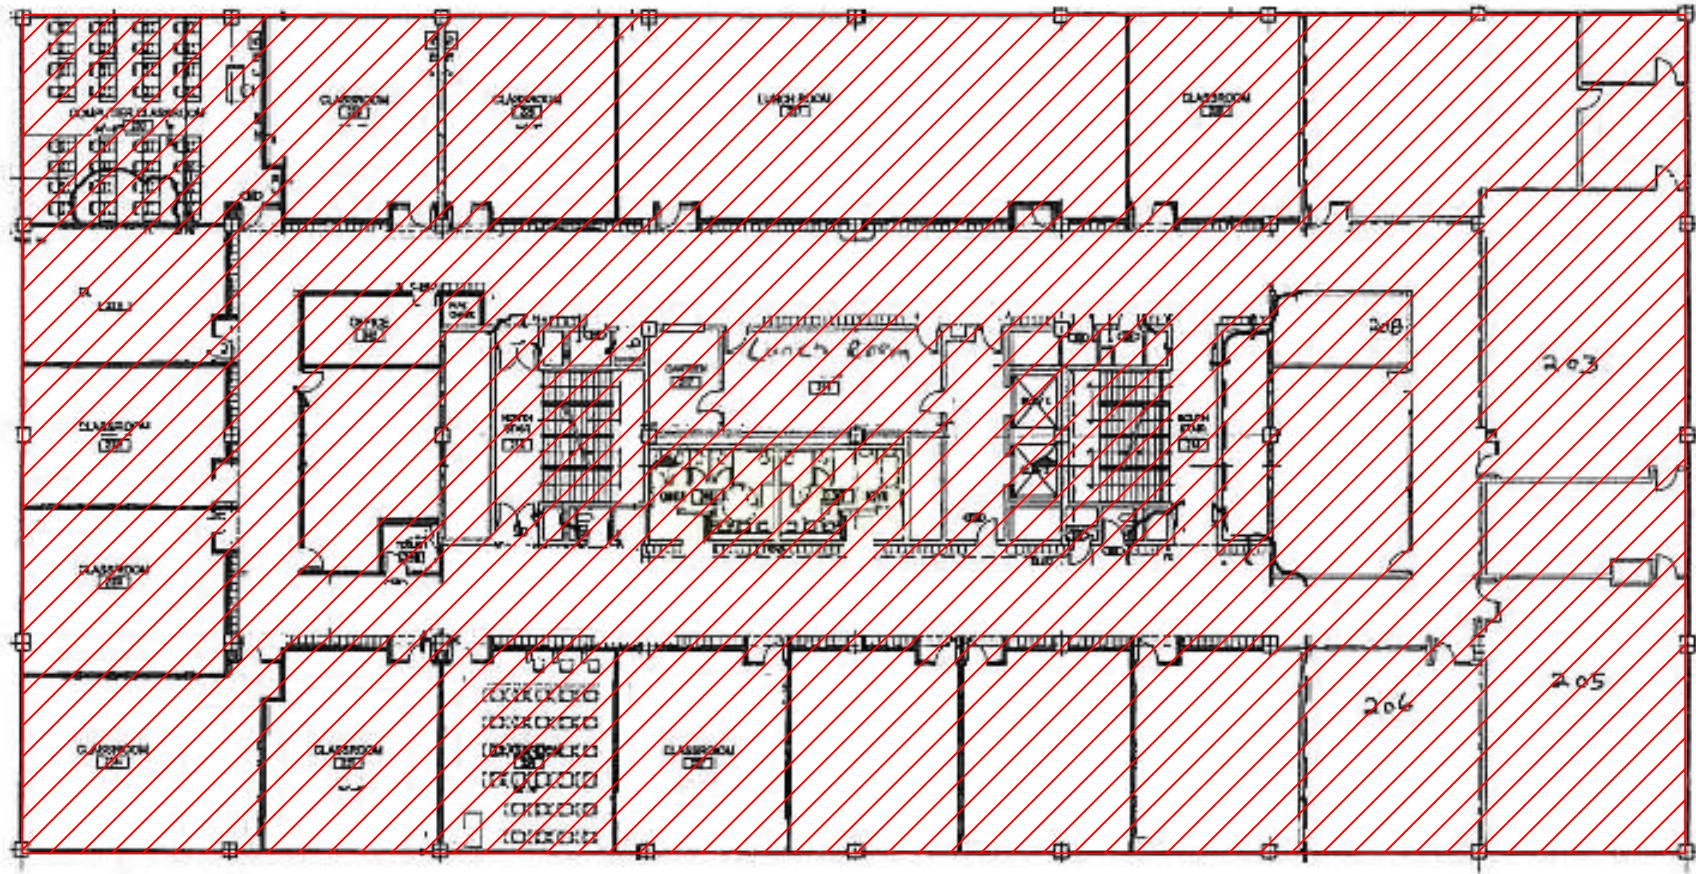
CCA PROJECT NUMBER
A320130001-19
DATE
03/08/2013
SHEET NUMBER
HA-215

HA-215 Mastic Associated with Yellow Vinyl Cove Base

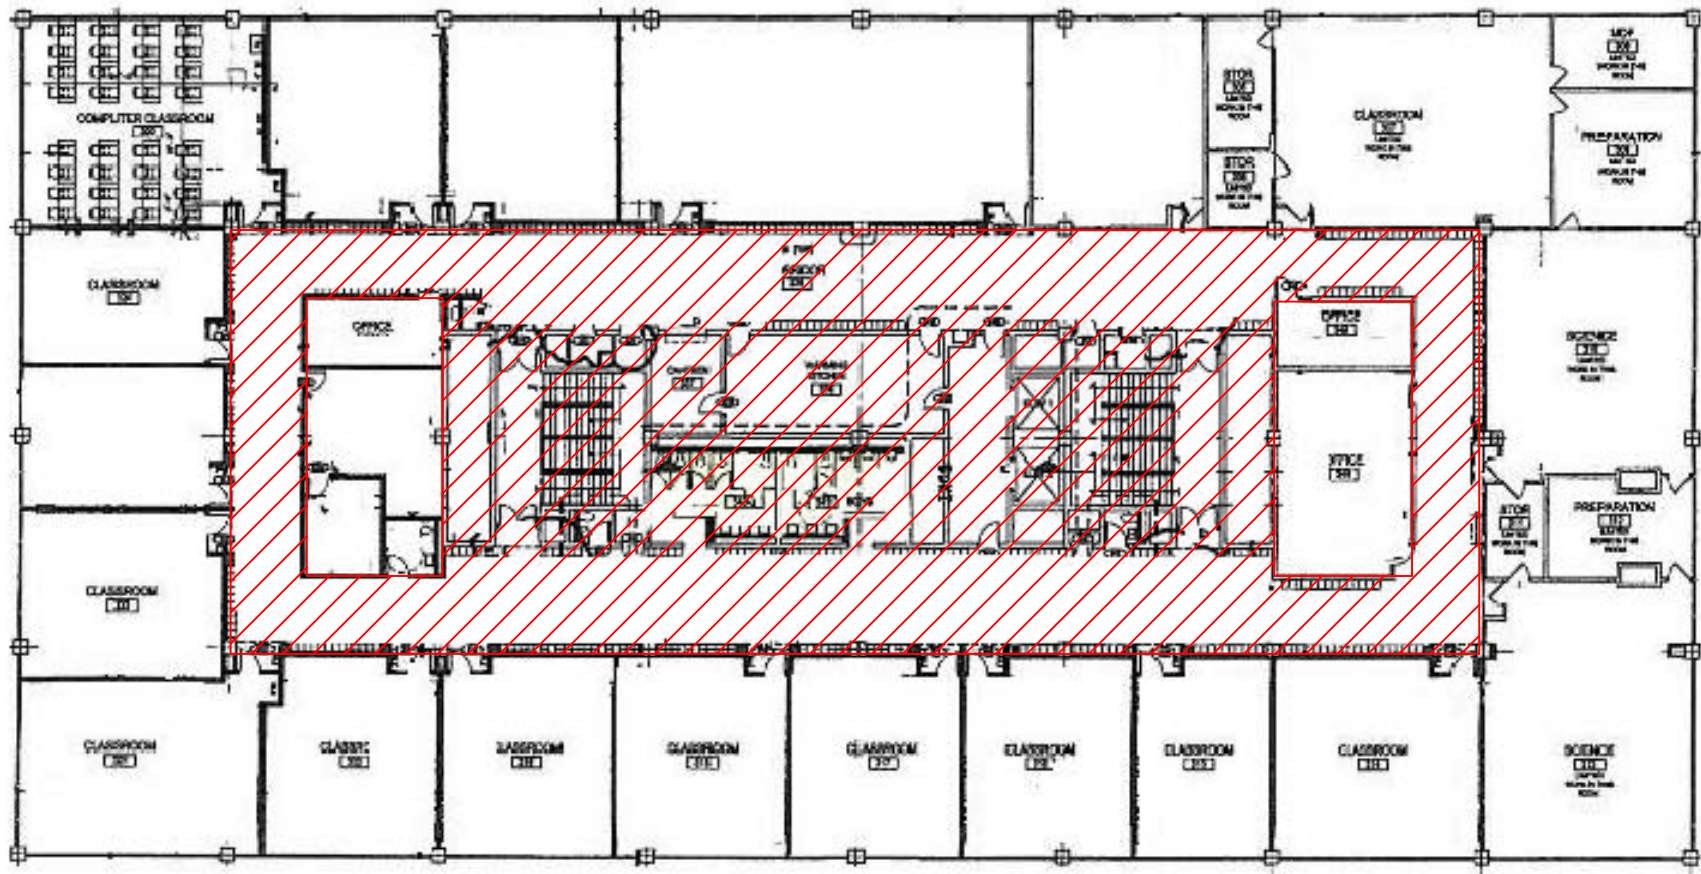
CCA PROJECT NUMBER
A320130001-19
DATE
03/08/2013
SHEET NUMBER
HA-214

HA-214 Yellow Vinyl Cove Base

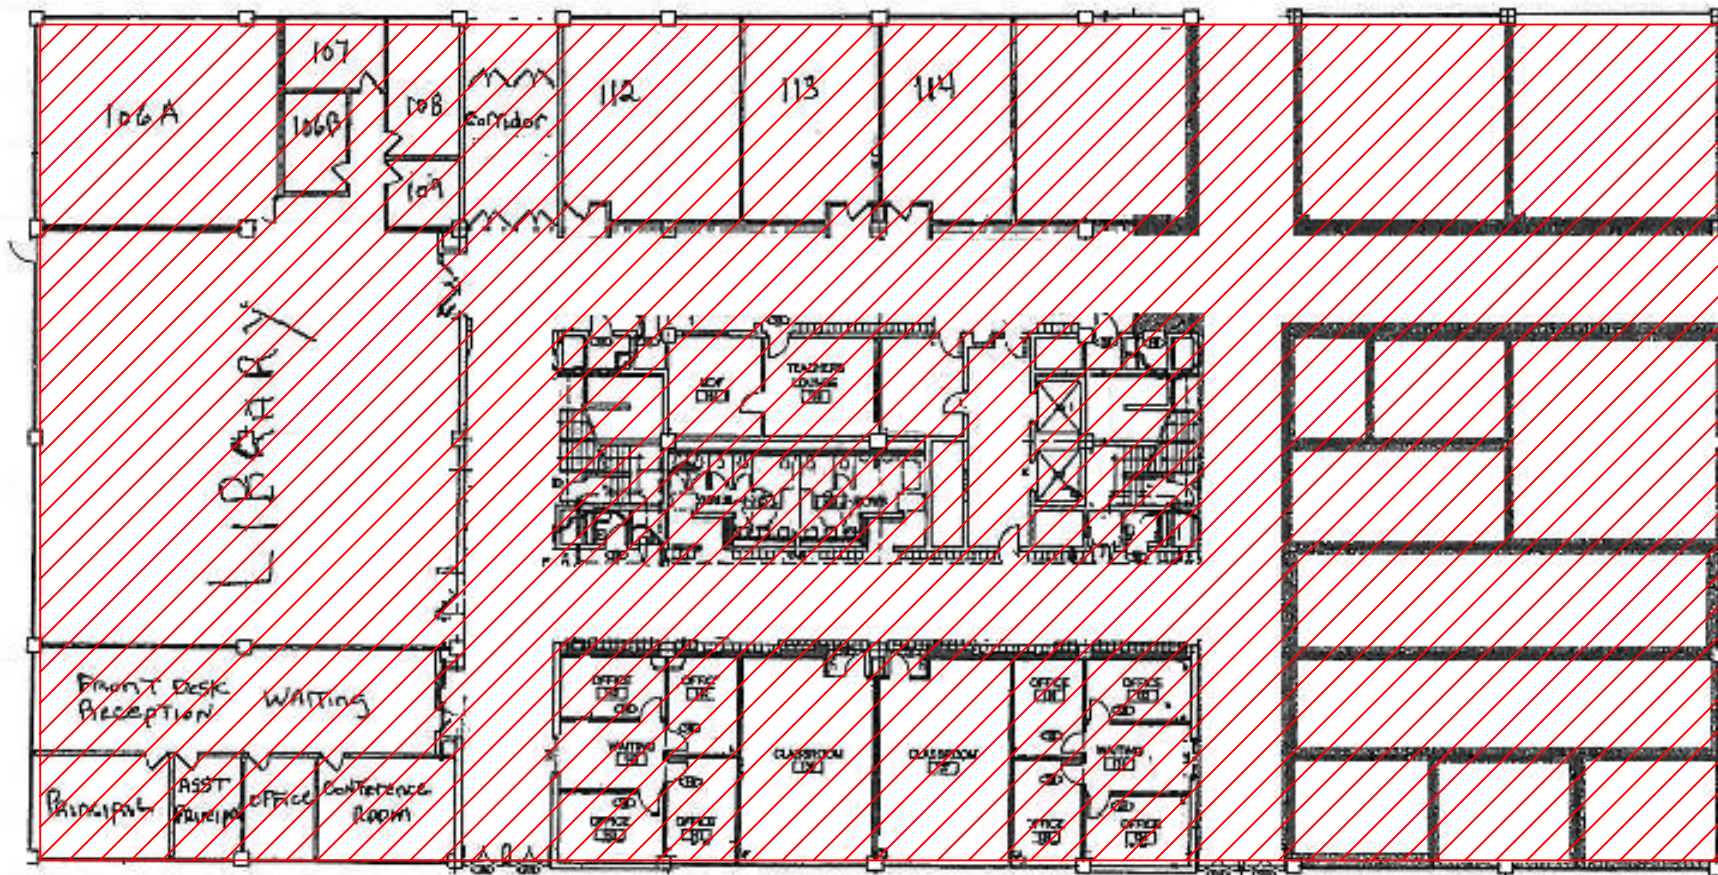
HA-219 Blue Vinyl Cove Base

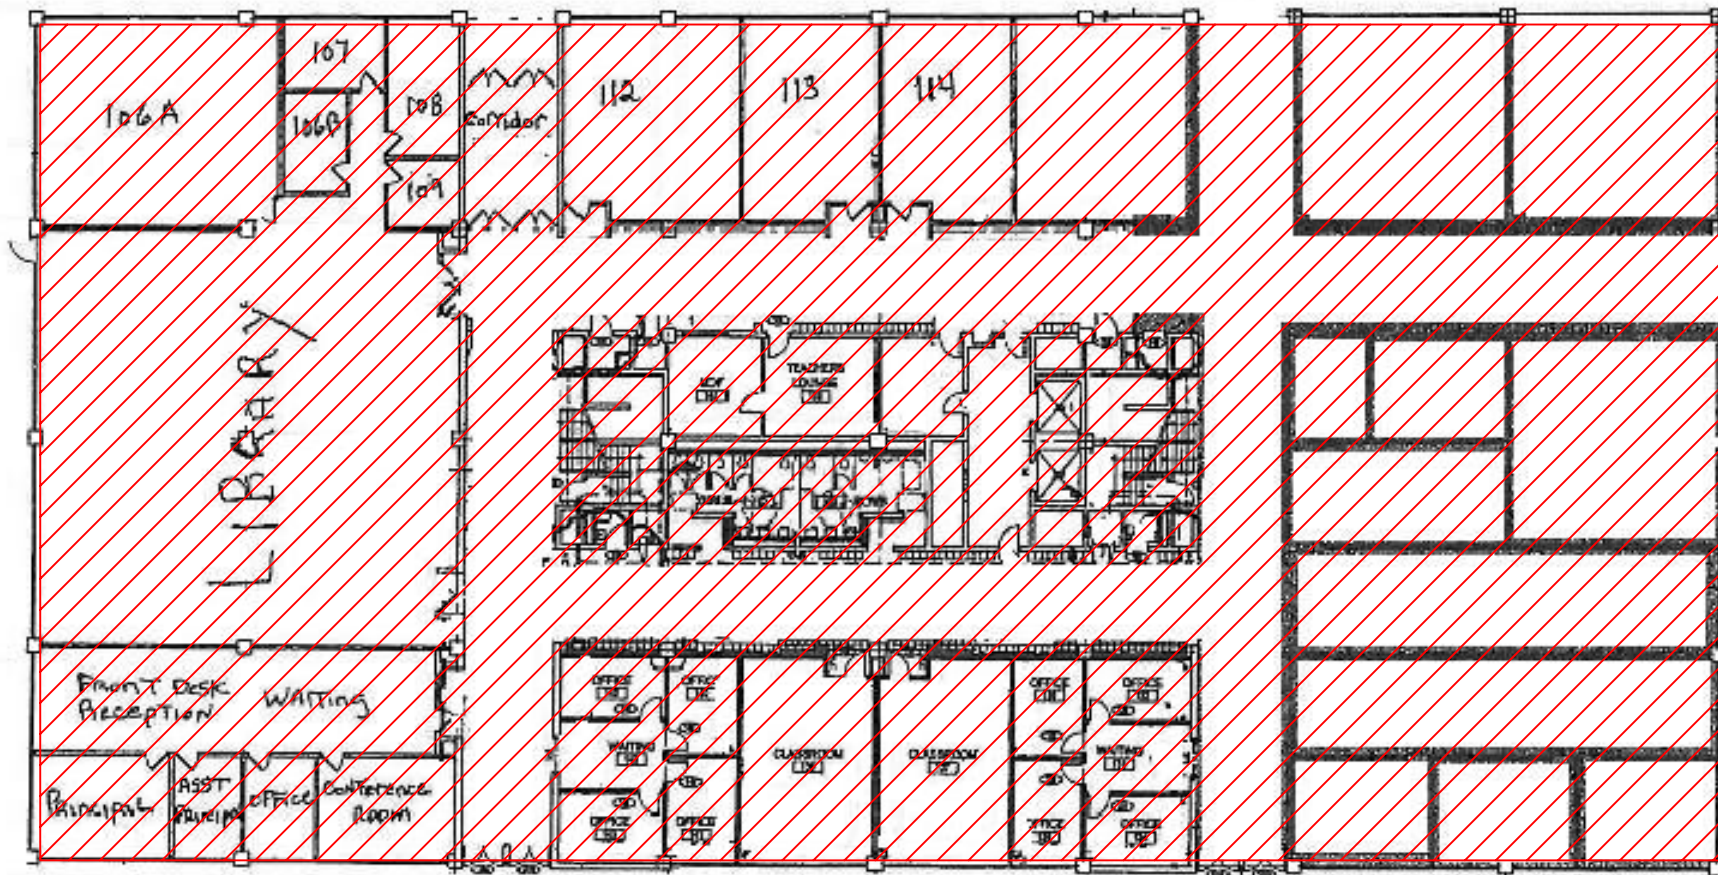
HA-220 Mastic Associated with Blue Vinyl Cove Base

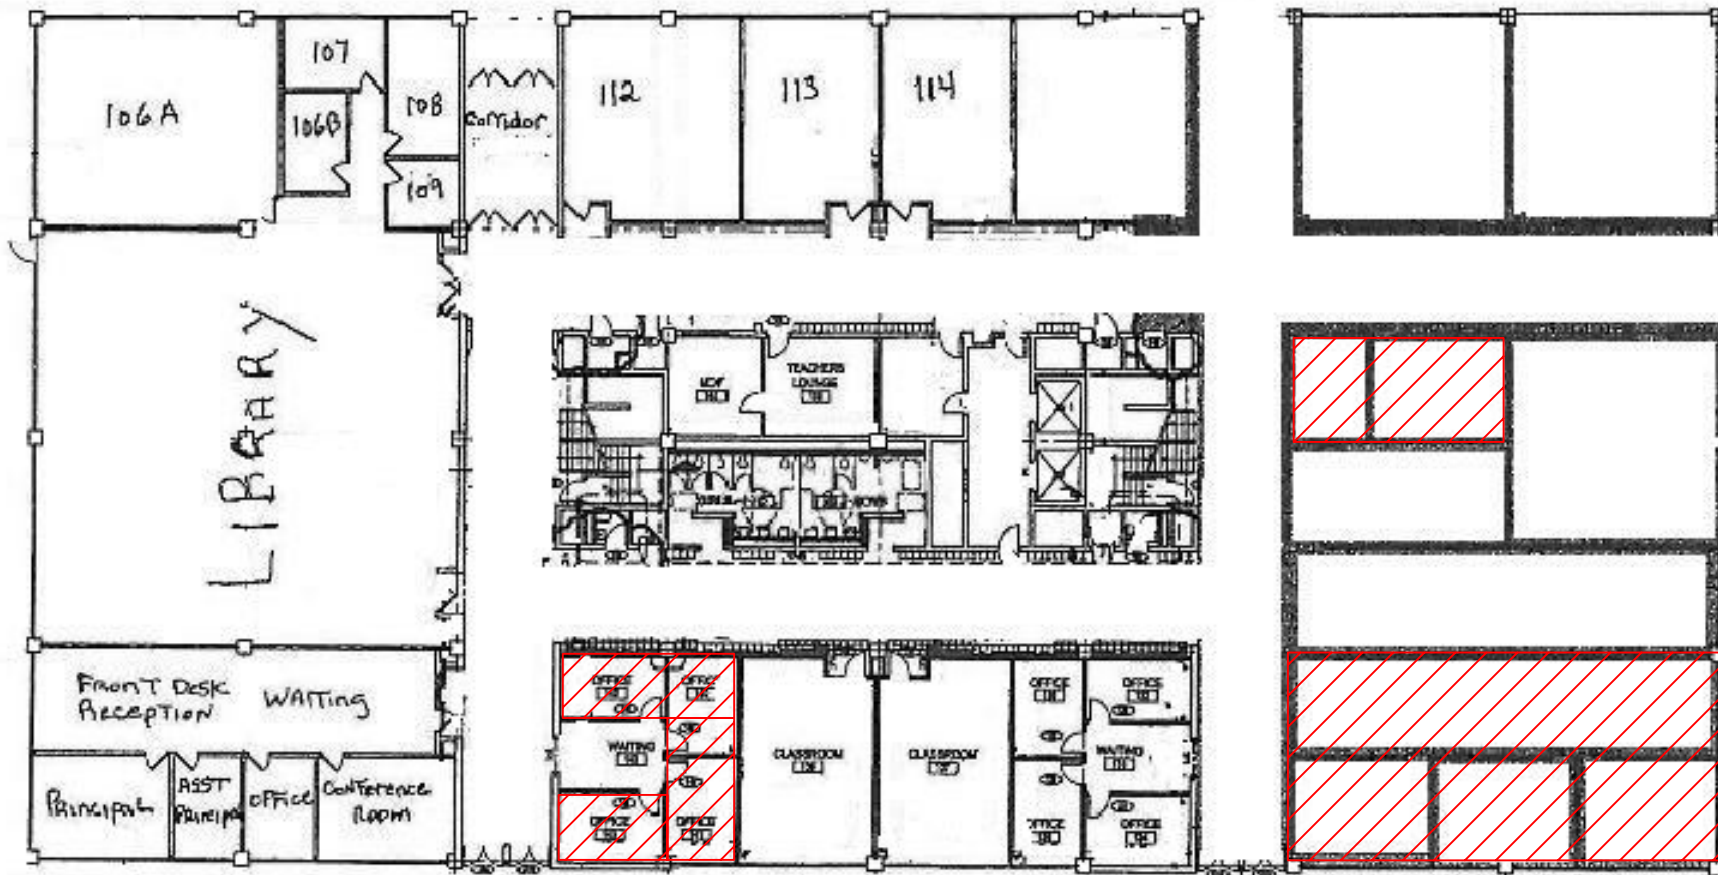
HA-217 Mastic Associated with Grey Carpet with Blue and Yellow Specs

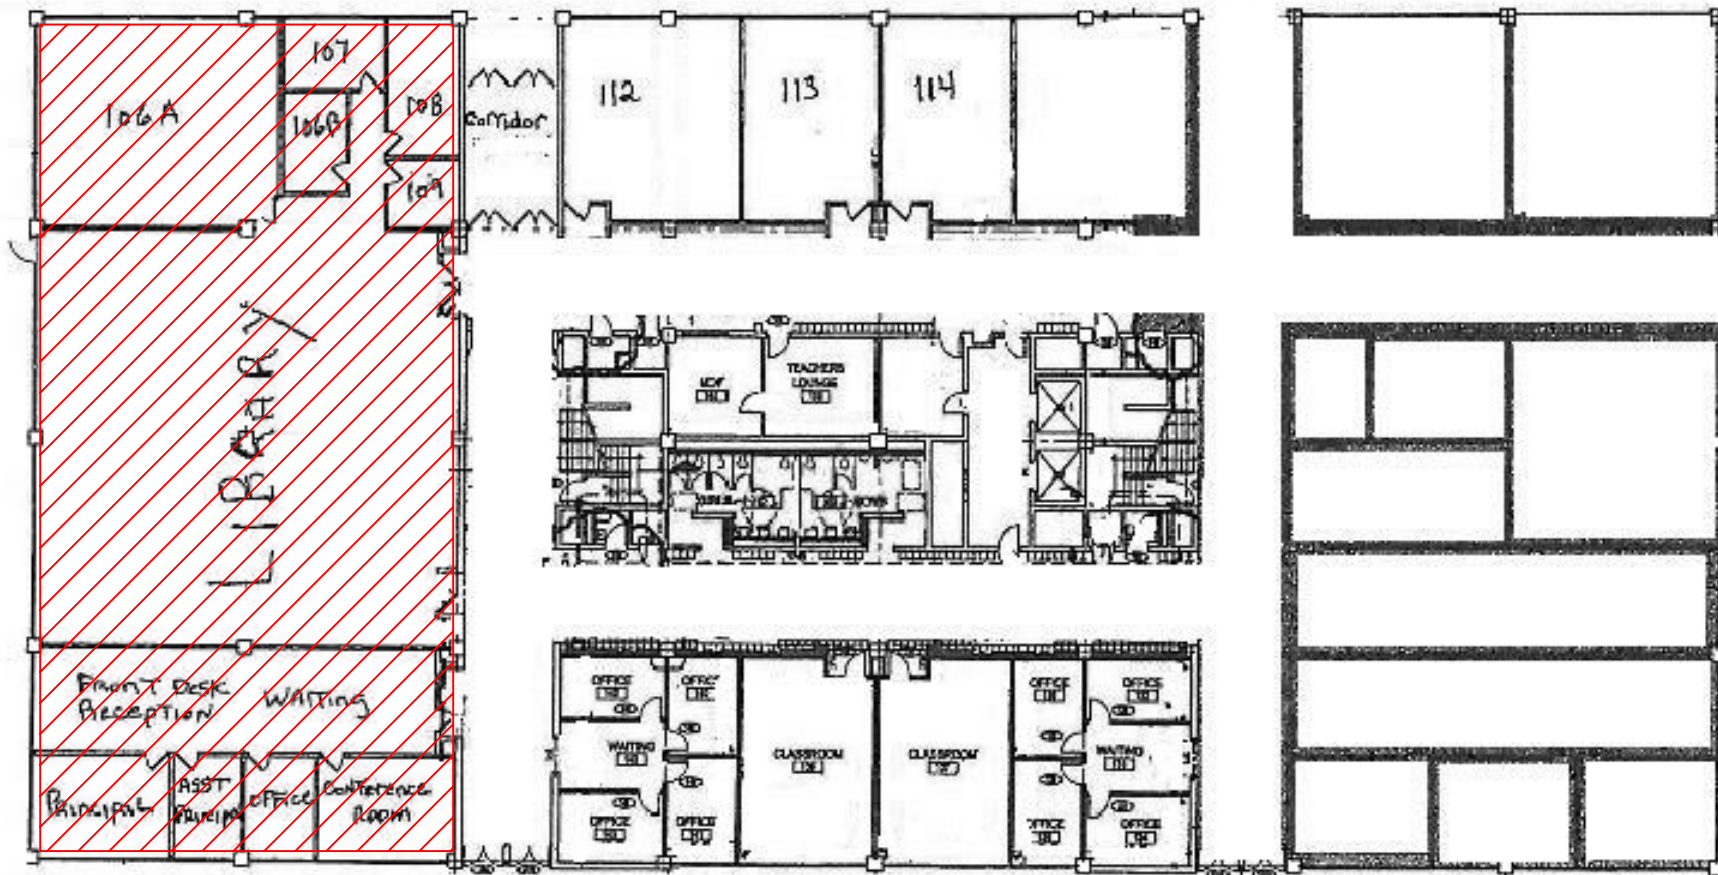
HA-216 Mastic Associated with Blue Carpet with Gold Lines
