**ILLINOIS DEPARTMENT OF PUBLIC HEALTH  
AHERA THREE YEAR REINSPECTION  
ASBESTOS ABATEMENT PROGRAM  
SCHOOL INFORMATION FORM**

**THREE-YEAR REINSPECTION**

**Chicago International Charter - Avalon South Shore**

Unit: 66371  
Building ID: 6580

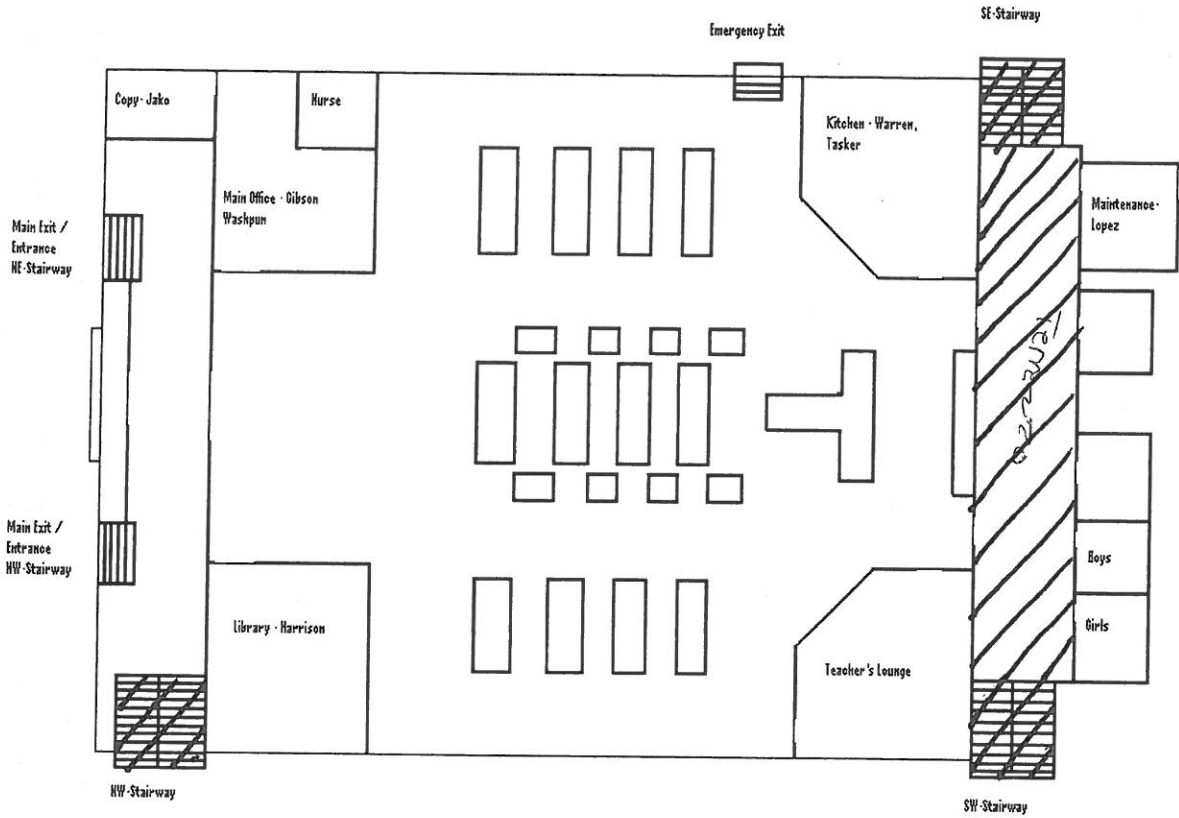
~~Basement~~

▨ - HA # 10

Gray Terrazzo

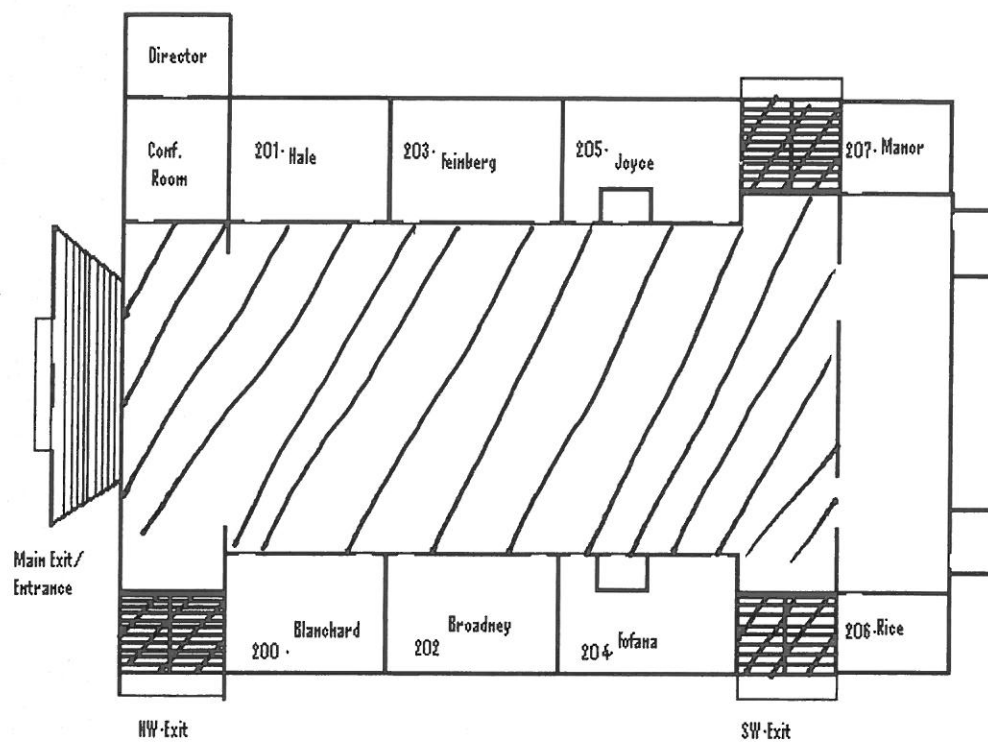
1<sup>st</sup>.Fl

HA # 10

Gray Terrazzo
