**ILLINOIS DEPARTMENT OF PUBLIC HEALTH
AHERA THREE YEAR REINSPECTION
ASBESTOS ABATEMENT PROGRAM
SCHOOL INFORMATION FORM**

THREE-YEAR REINSPECTION

Youth Connection - Austin Career Education Center

REPORT DATE:

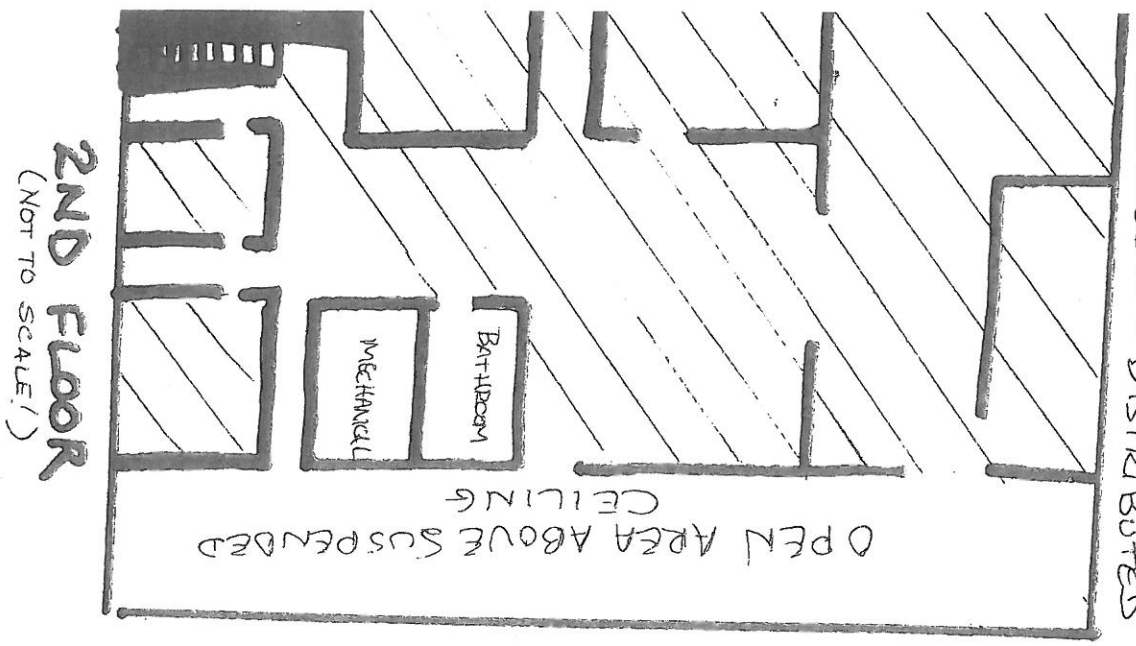
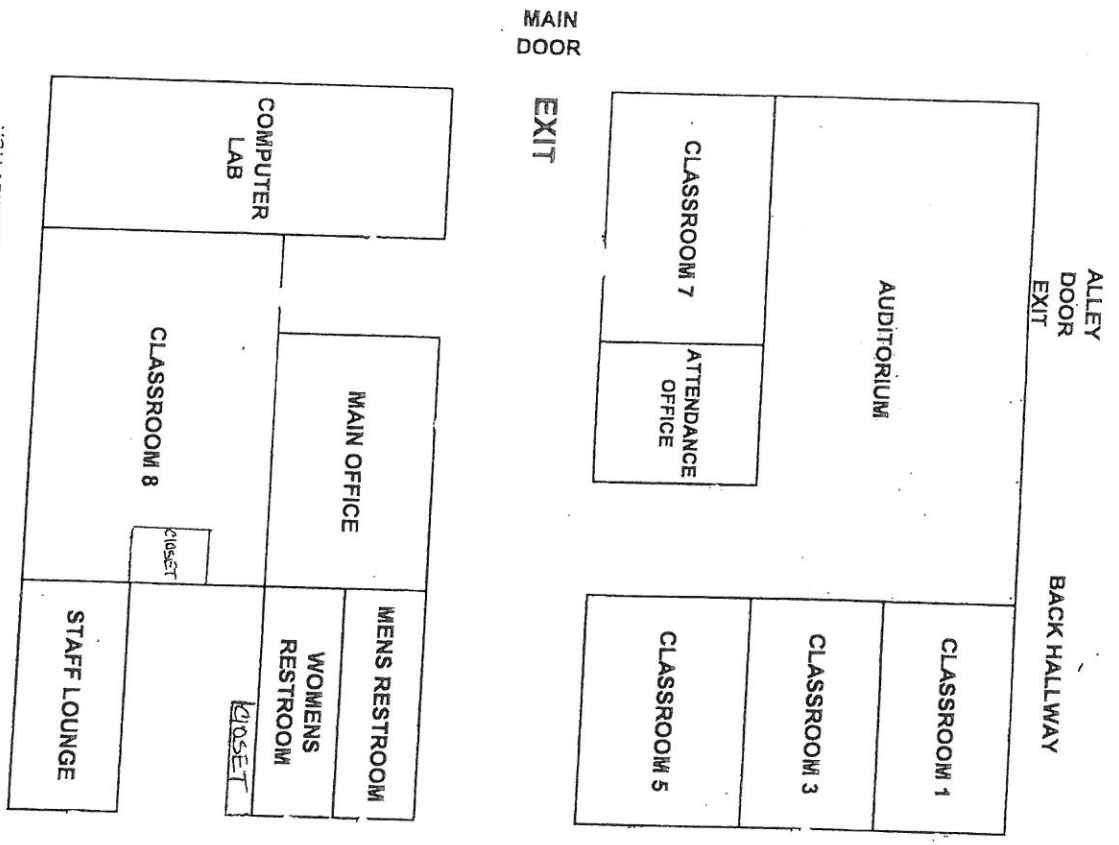
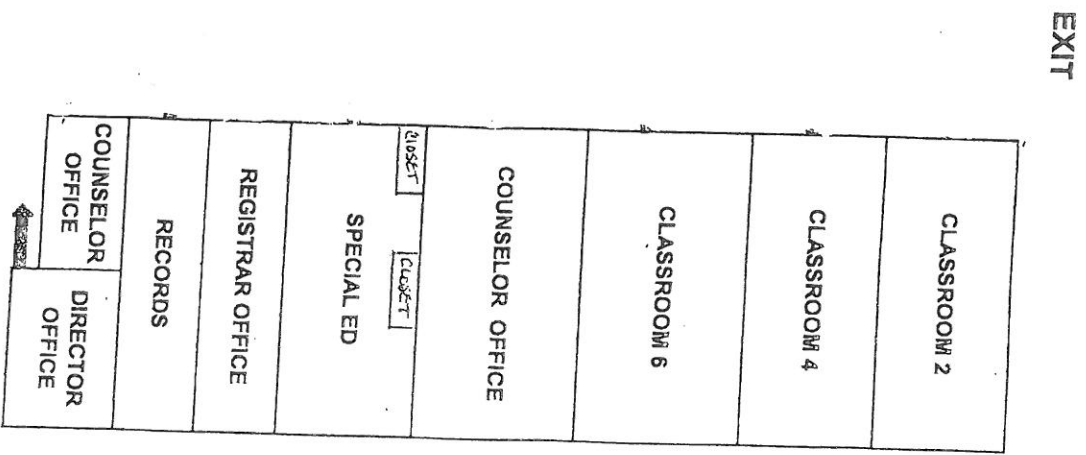
NEW! HA # 25 B

DAMAGED - DISTRIBUTED

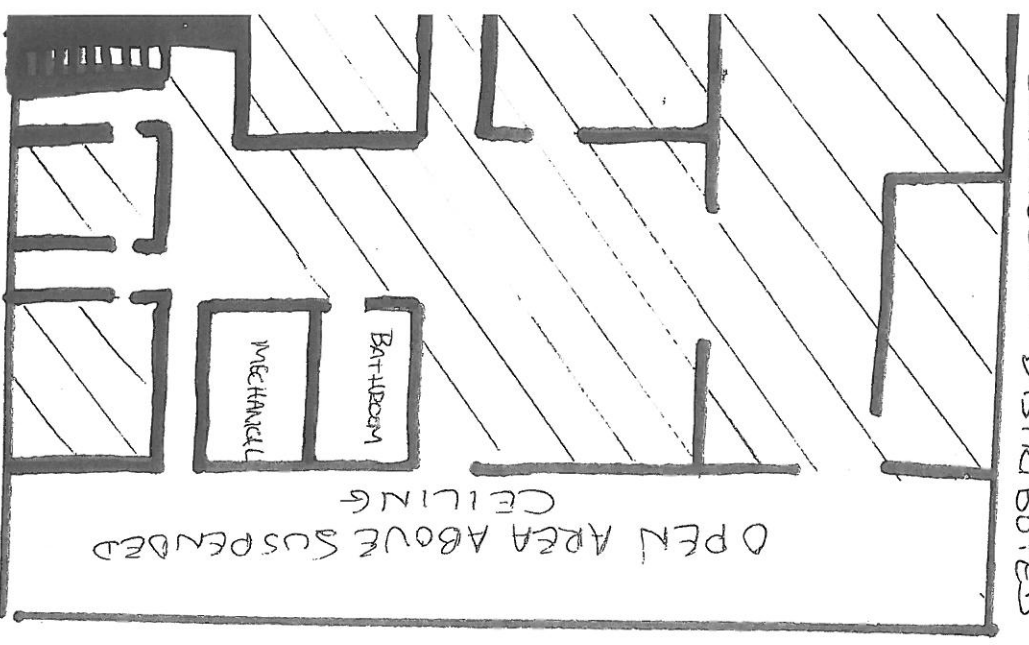
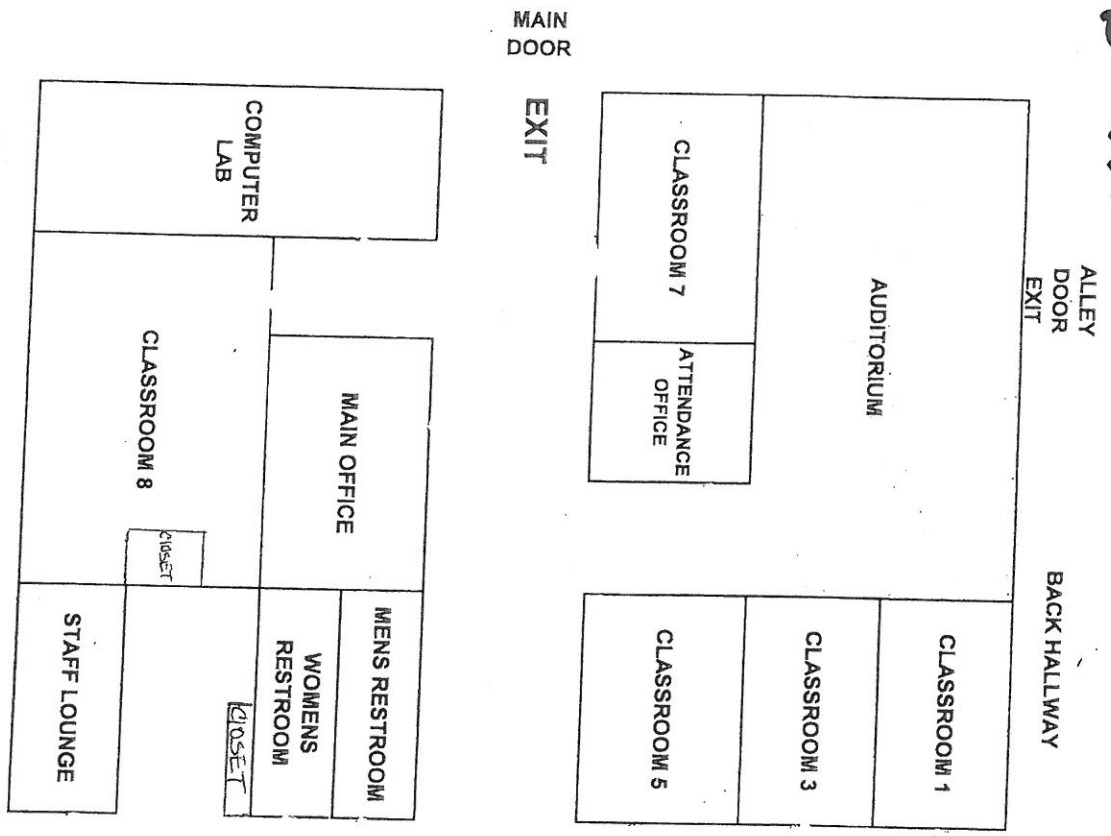
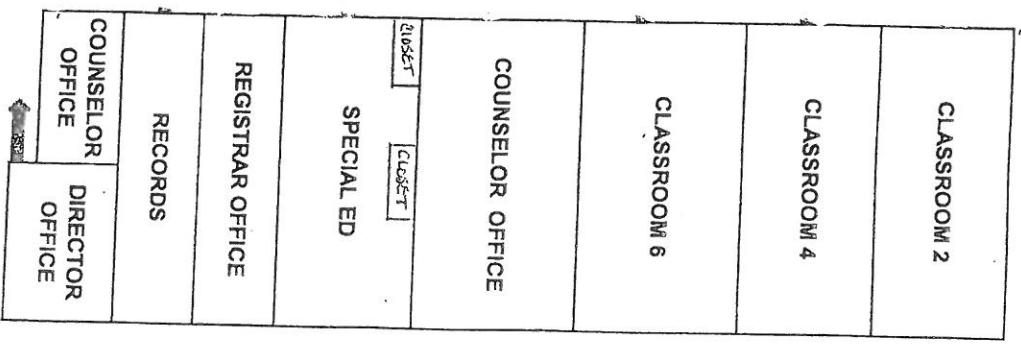
NEW! HA # 25A

5 S.F. Assoc. with #24 B - Ver
DAMAGED - DISTRIBUTED

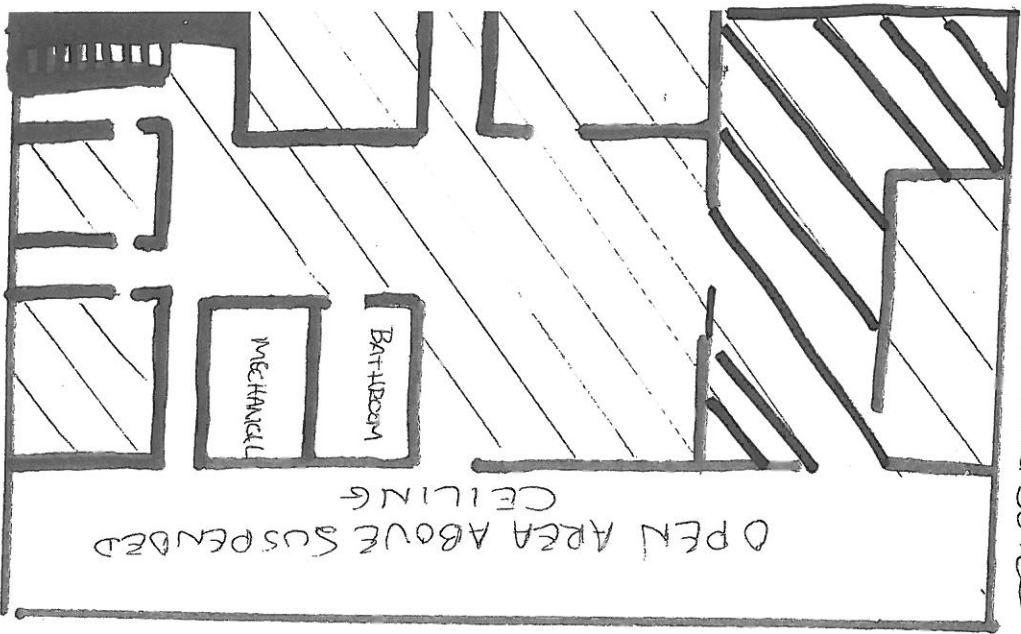
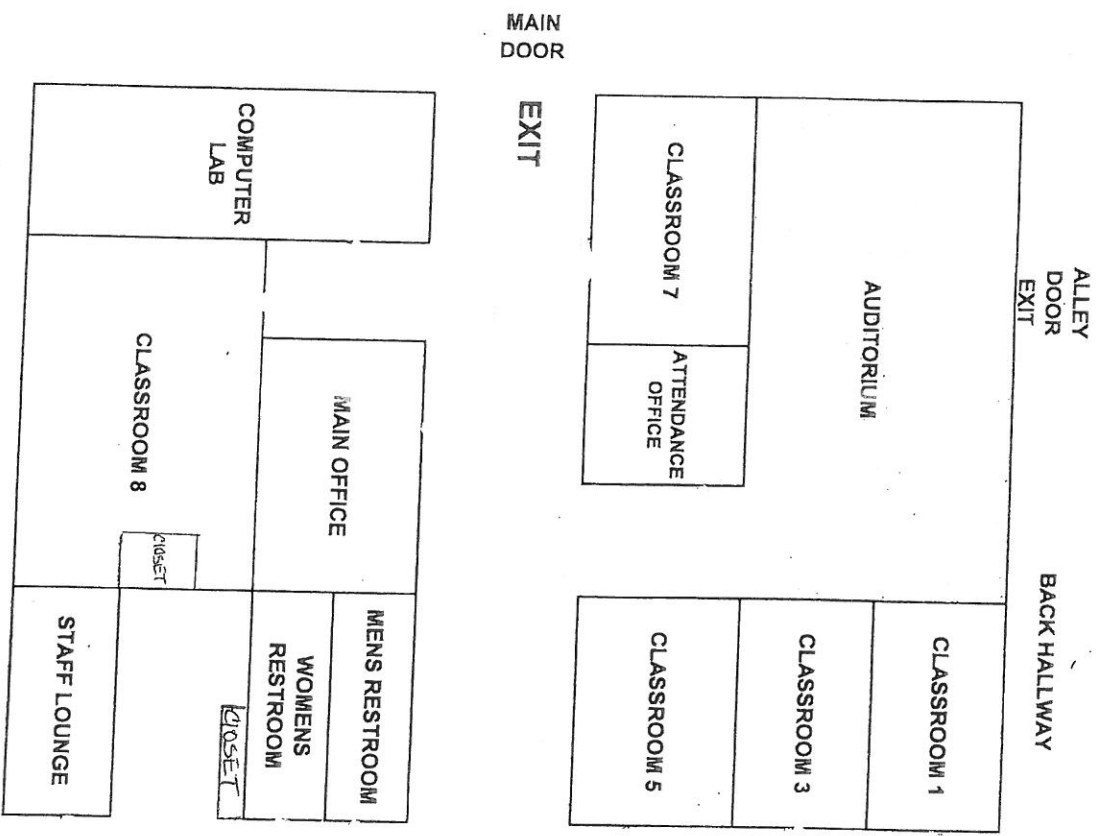
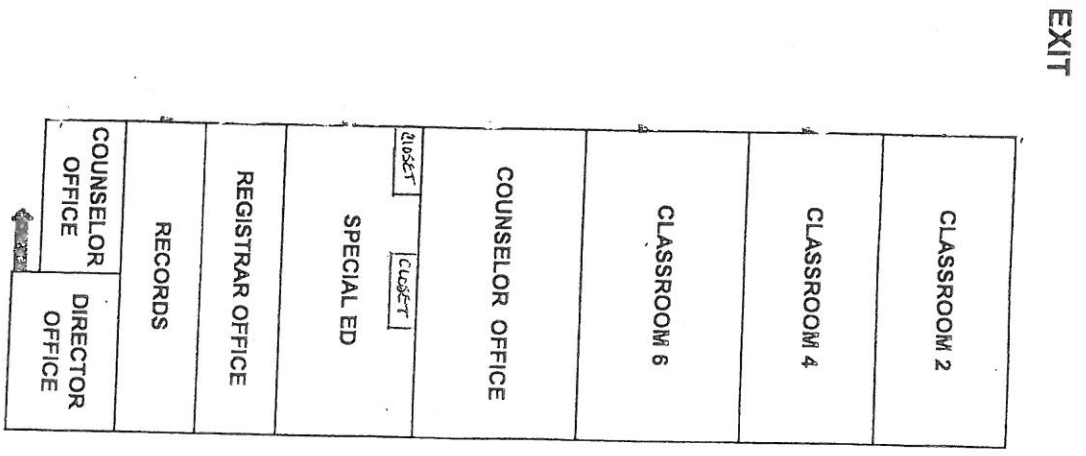
VFT

5 S.F.
DAMAGED - DISTRIBUTED

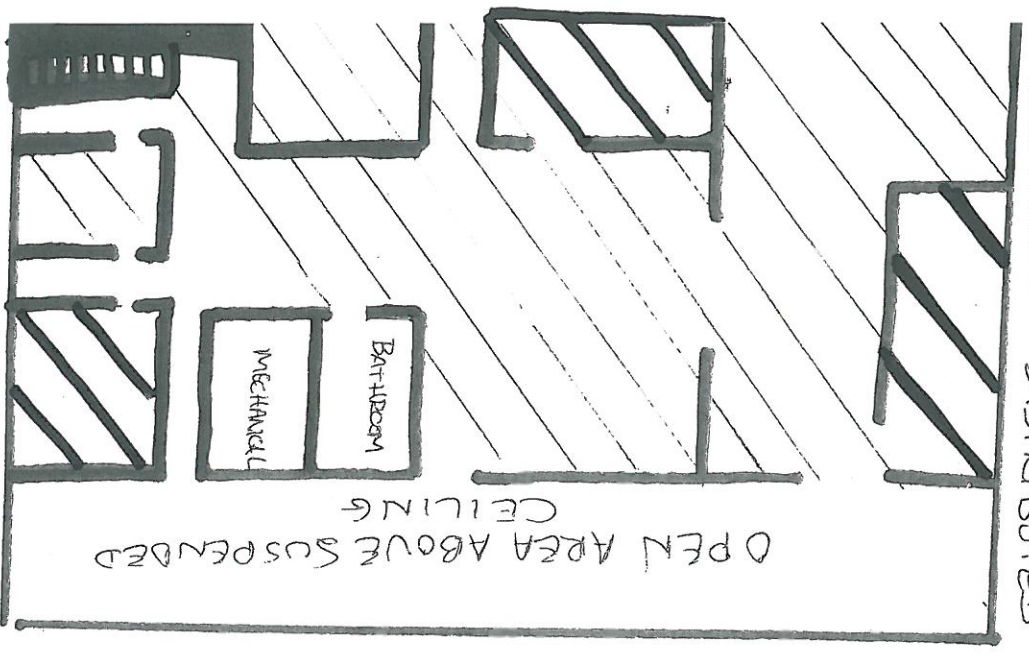
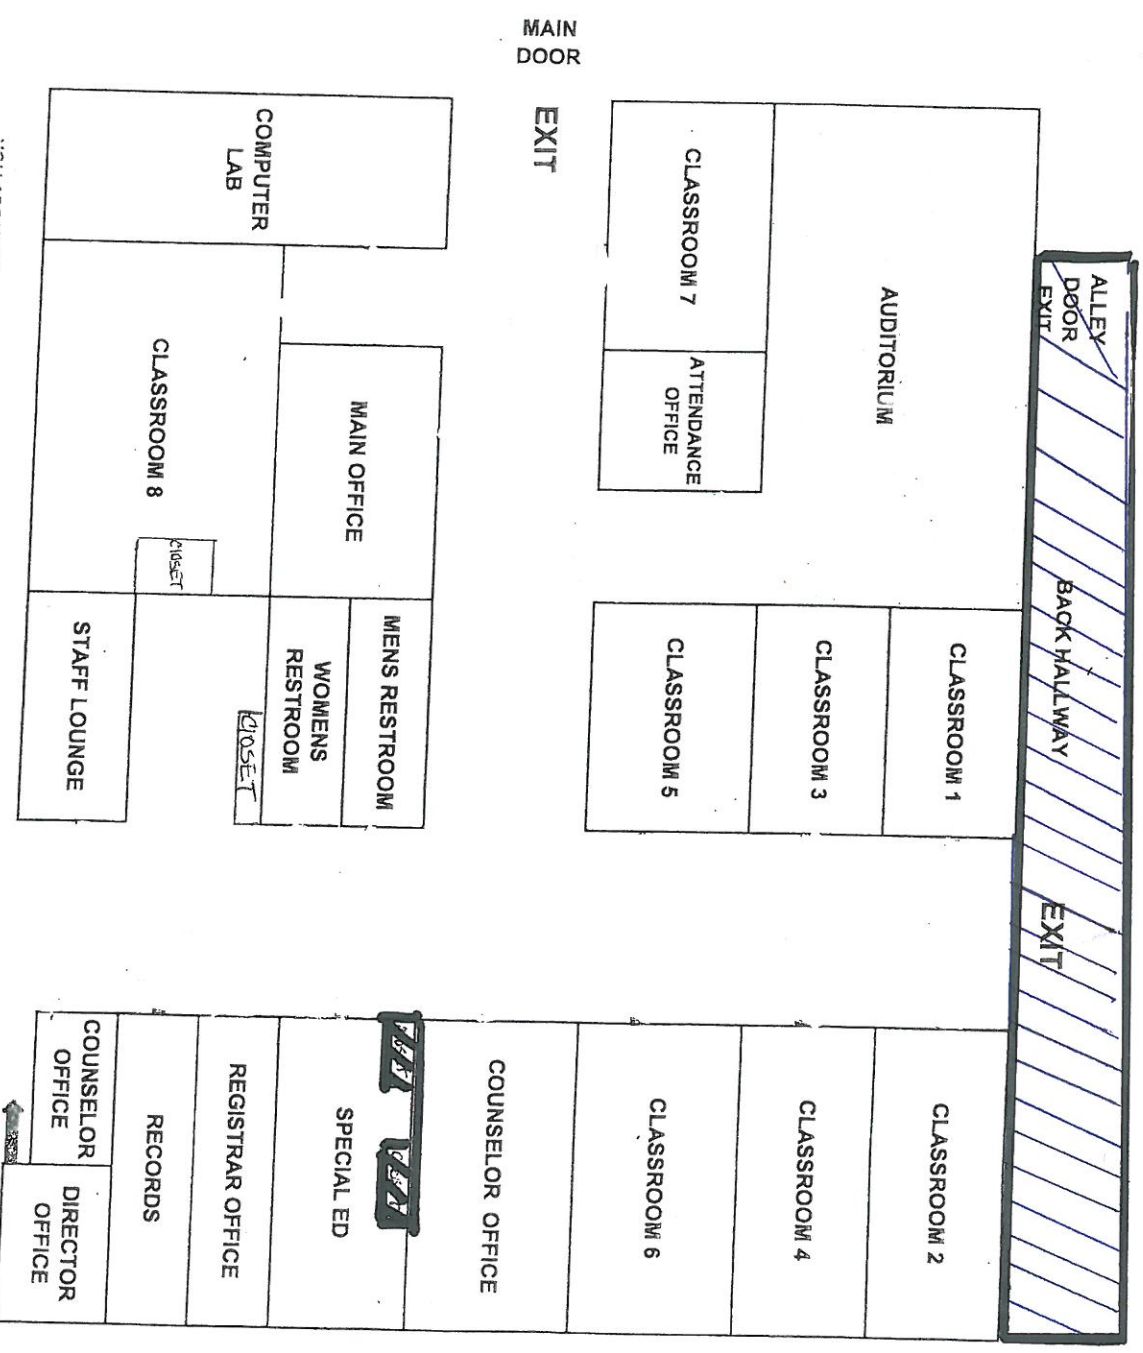
NEW HA # 35
 9"x9" BROWN WITH ORANGE
 + WHITE STREAKS
VFT

5 S.F.
 DAMAGED - DISTRIBUTED

HA Number	Management Comments
24B	Repair Damage as soon as possible
24C	Repair Damage as soon as possible
25	
25A	
25B	
25C	
26	
27	
28	
29	
30	
31	
32	
33	
34	
35	Repair Damage as soon as possible
36	
37	
38	
39	
40	
41	
42
