**ILLINOIS DEPARTMENT OF PUBLIC HEALTH
AHERA THREE YEAR REINSPECTION
ASBESTOS ABATEMENT PROGRAM
SCHOOL INFORMATION FORM**

THREE-YEAR REINSPECTION

Bass School

1140 W. 66th
Chicago, IL, 60621

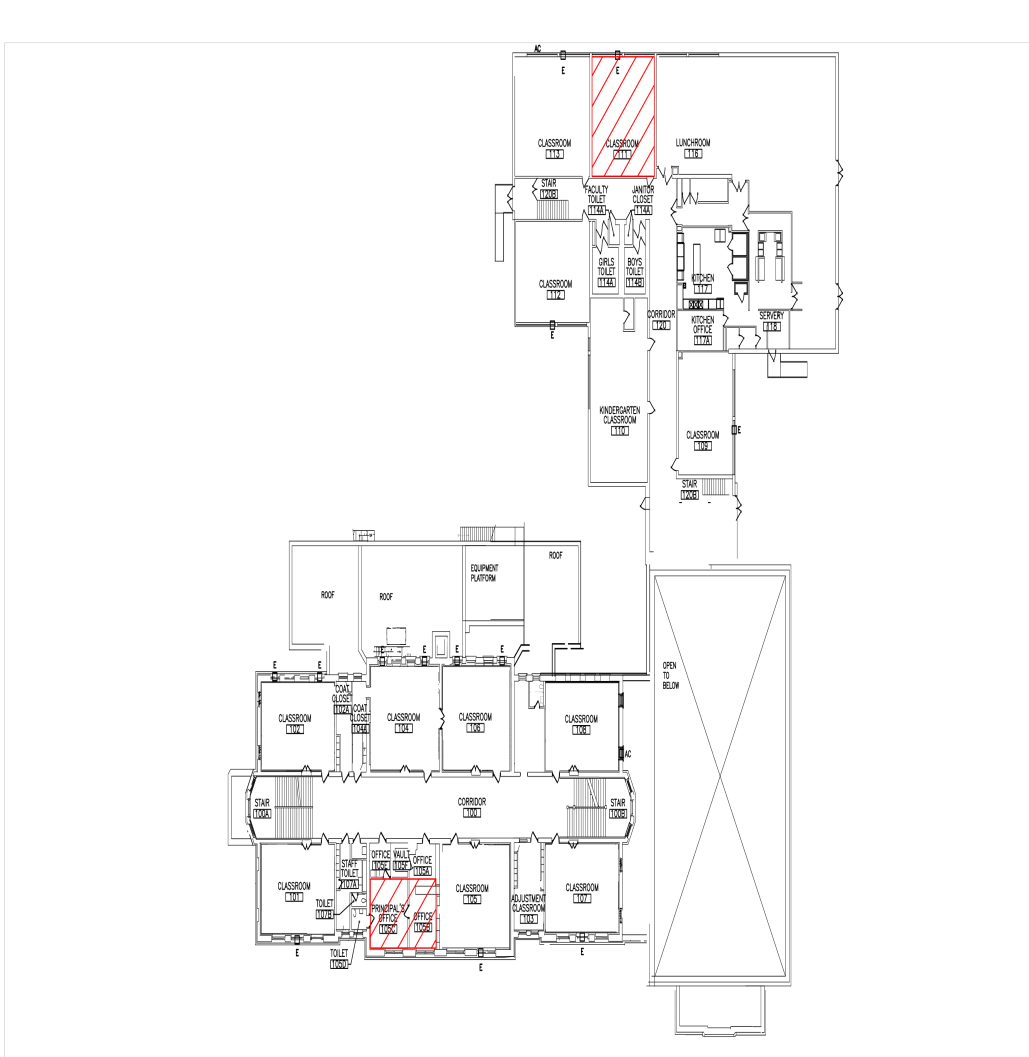
HA-16 12"x12" Blue & White Floor Tile
