ILLINOIS DEPARTMENT OF PUBLIC HEALTH
AHERA THREE YEAR REINSPECTION
ASBESTOS ABATEMENT PROGRAM
SCHOOL INFORMATION FORM

THREE-YEAR REINSPECTION

Lowell School

3320 W. Hirsch Street
Chicago, IL, 60651

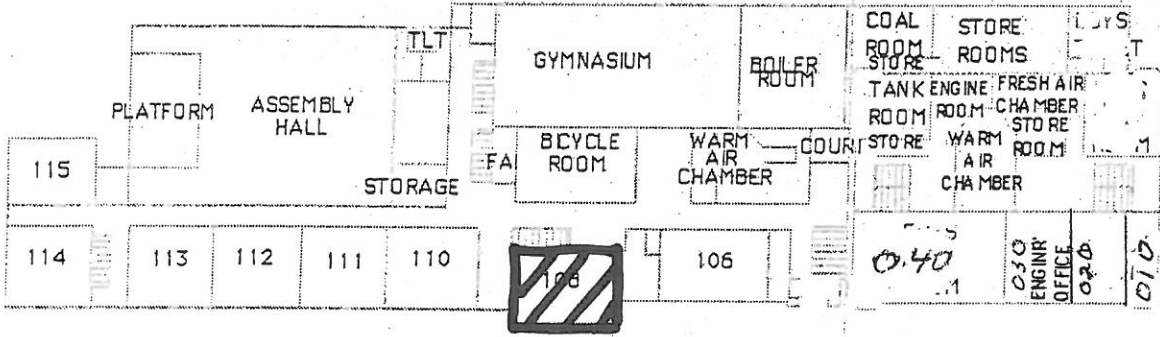
1st Floor Plan

HAY4 - 12x12 Brown w/ yellow
HAYS - SPELS UP & MASTIC

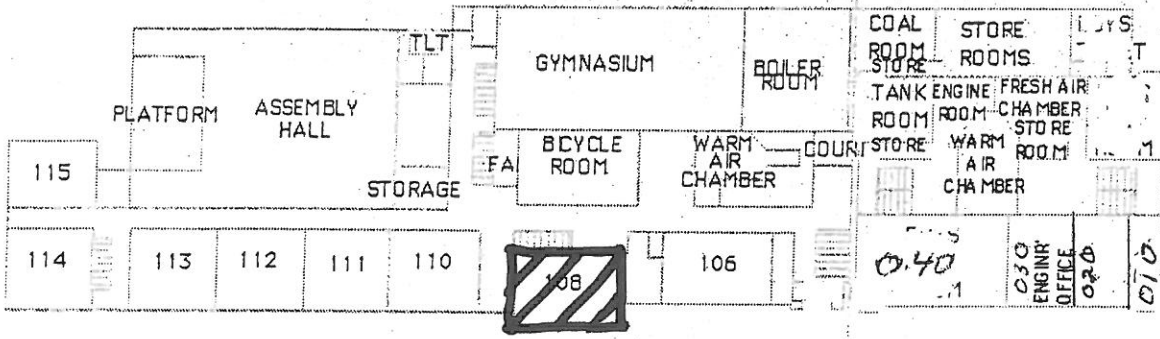
1st Floor Plan

HA42 = 12x12 YELLOW w/ RED SPECS
HA43 = UFT & MASTIC

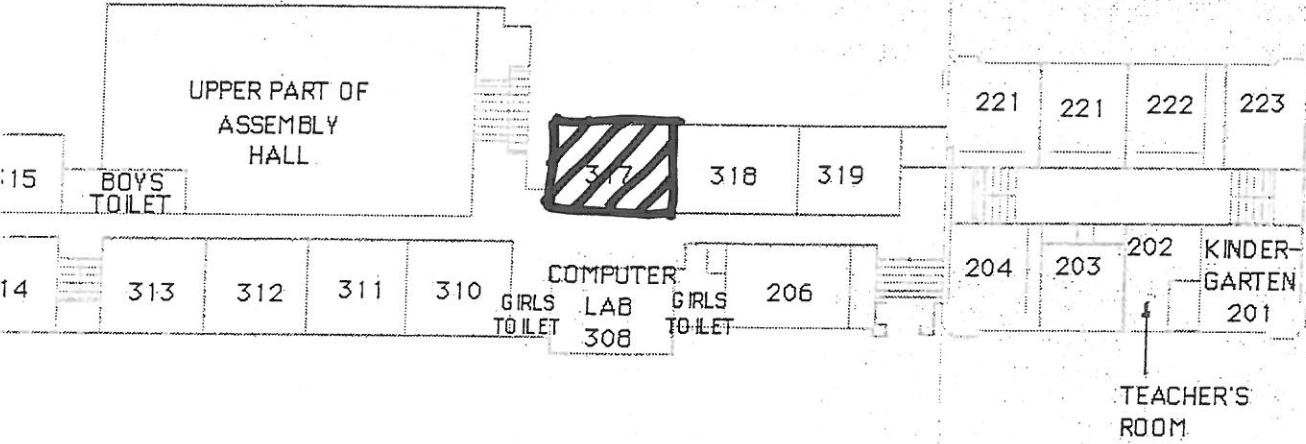
3rd Floor Plan

HA39 = 12x12 TAN w/ WHITE
HA40 = SPECS LAT & MASTIC

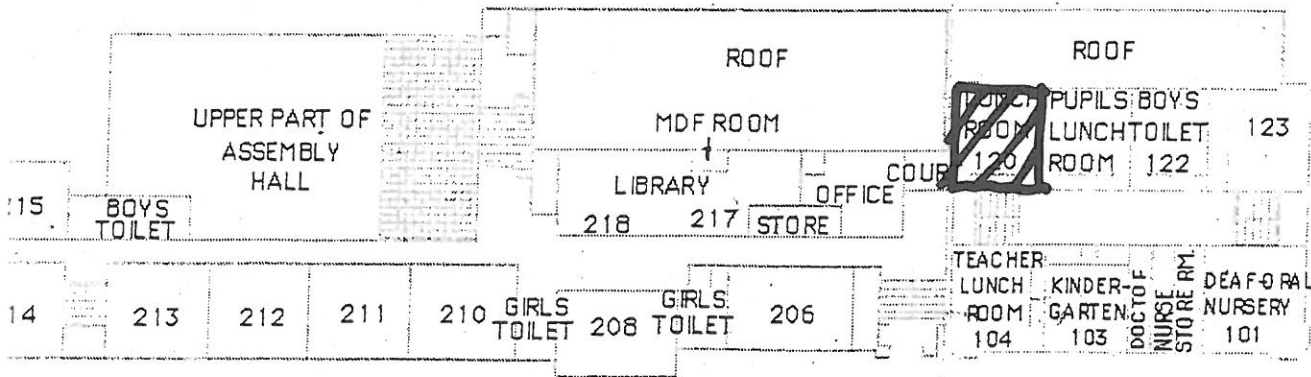
2nd Floor Plan

HAY6 = 2x4 white wormy ceiling tile

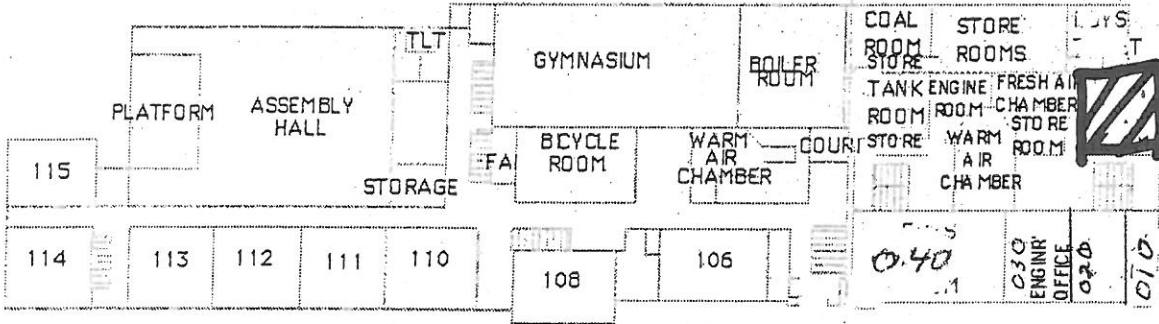
1st Floor Plan

HAY7 = 1x1 WHITE WORMY CEILING TILE
HAY8 & MASTIC

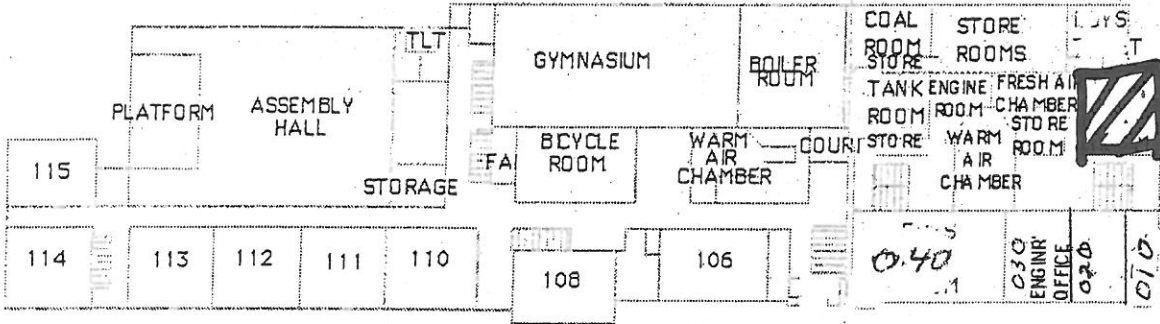
1st Floor Plan

HAY7 = 1x1 WHITE WORMY CEILING TILE
HAY8 & MASTIC

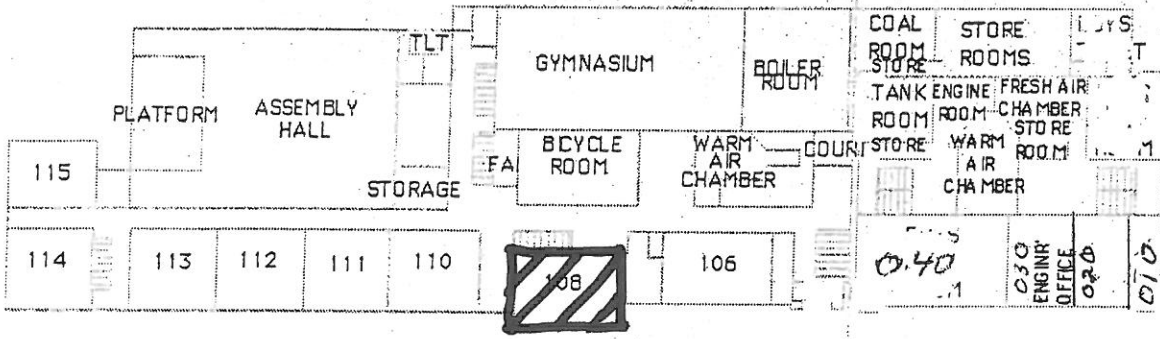
1st Floor Plan

HA42 = 12x12 YELLOW w/ RED SPECS
HA43 = UFT & MASTIC

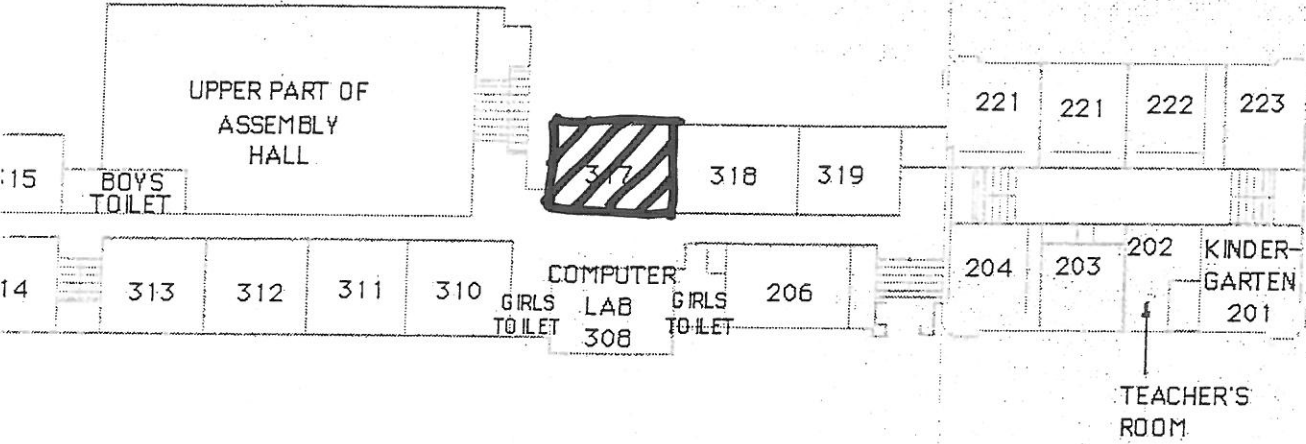
3rd Floor Plan

HA39 = 12x12 TAN w/ WHITE
HA40 = SPECS LAT & MASTIC

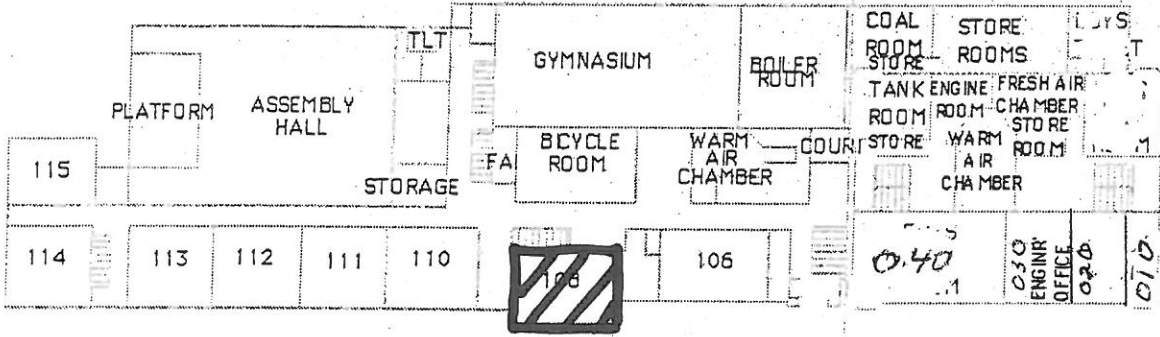
1st Floor Plan

HAY 4 - 12x12 Brown w/ yellow
HAY 5 - SPELS UP & MASTIC
