**ILLINOIS DEPARTMENT OF PUBLIC HEALTH
AHERA THREE YEAR REINSPECTION
ASBESTOS ABATEMENT PROGRAM
SCHOOL INFORMATION FORM**

THREE-YEAR REINSPECTION

Ryder School

Thursday, April 25, 2013

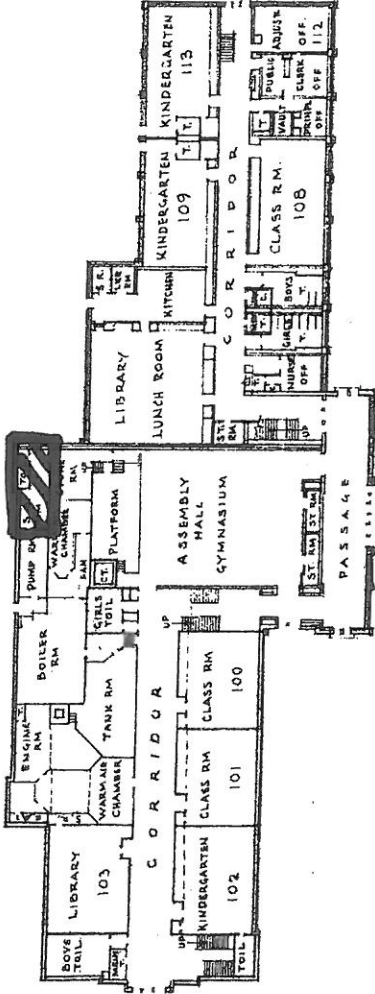
HA 39 + 39A

12"x12" ORANGE STREAKED VET
MASTIC

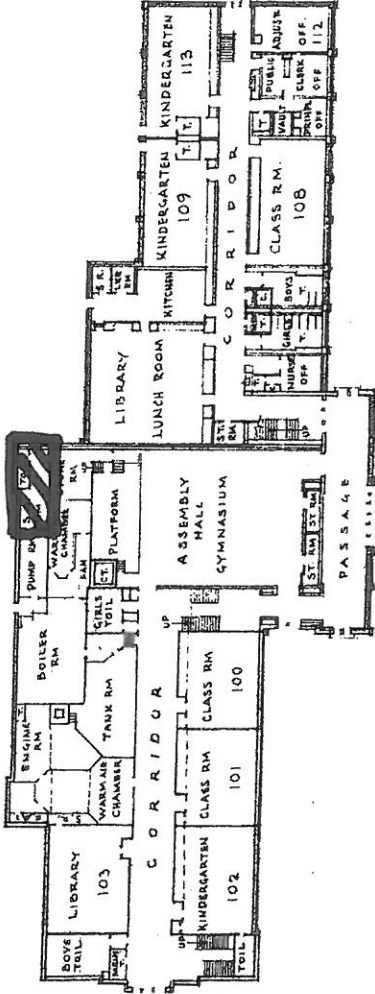
HA 39 + 39A

12"x12" ORANGE STREAKED VET
MASTIC
