ILLINOIS DEPARTMENT OF PUBLIC HEALTH
AHERA THREE YEAR REINSPECTION
ASBESTOS ABATEMENT PROGRAM
SCHOOL INFORMATION FORM

THREE-YEAR REINSPECTION

Disney II Magnet Elementary School

Tuesday, May 14, 2013

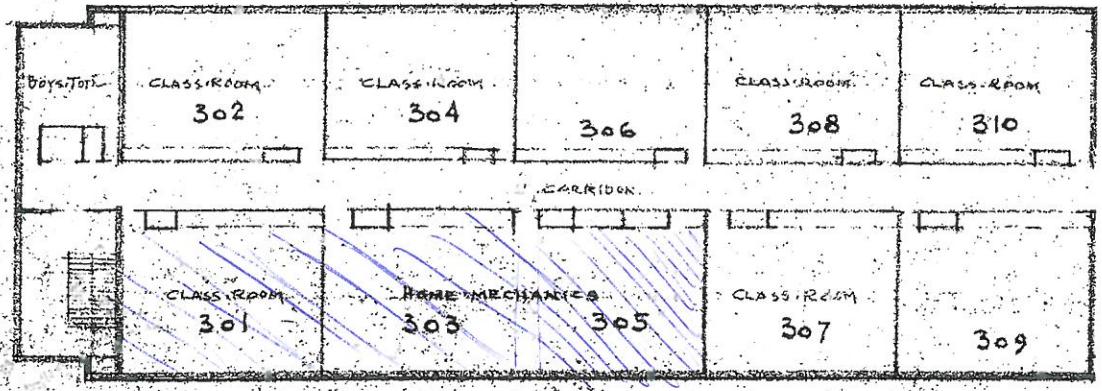
THIRD FLOOR PLAN

HA -18 3 18A
1 FT 12" x 12" Gray w/ black specs & mastic

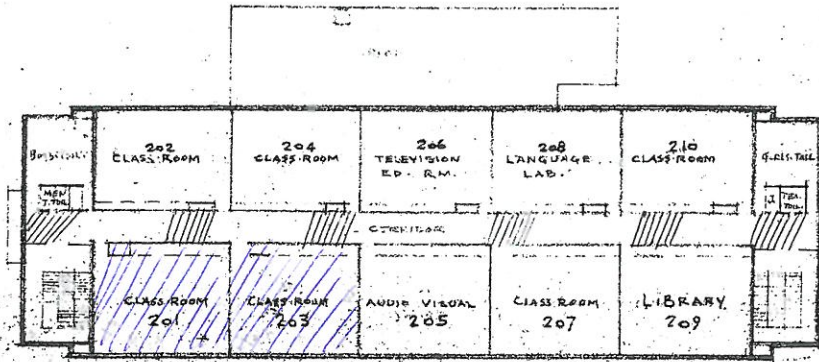
SECOND FLOOR-PLAN

Hatched Area - 2 1/2" Blue Mash
 H.A. 26 & 20A

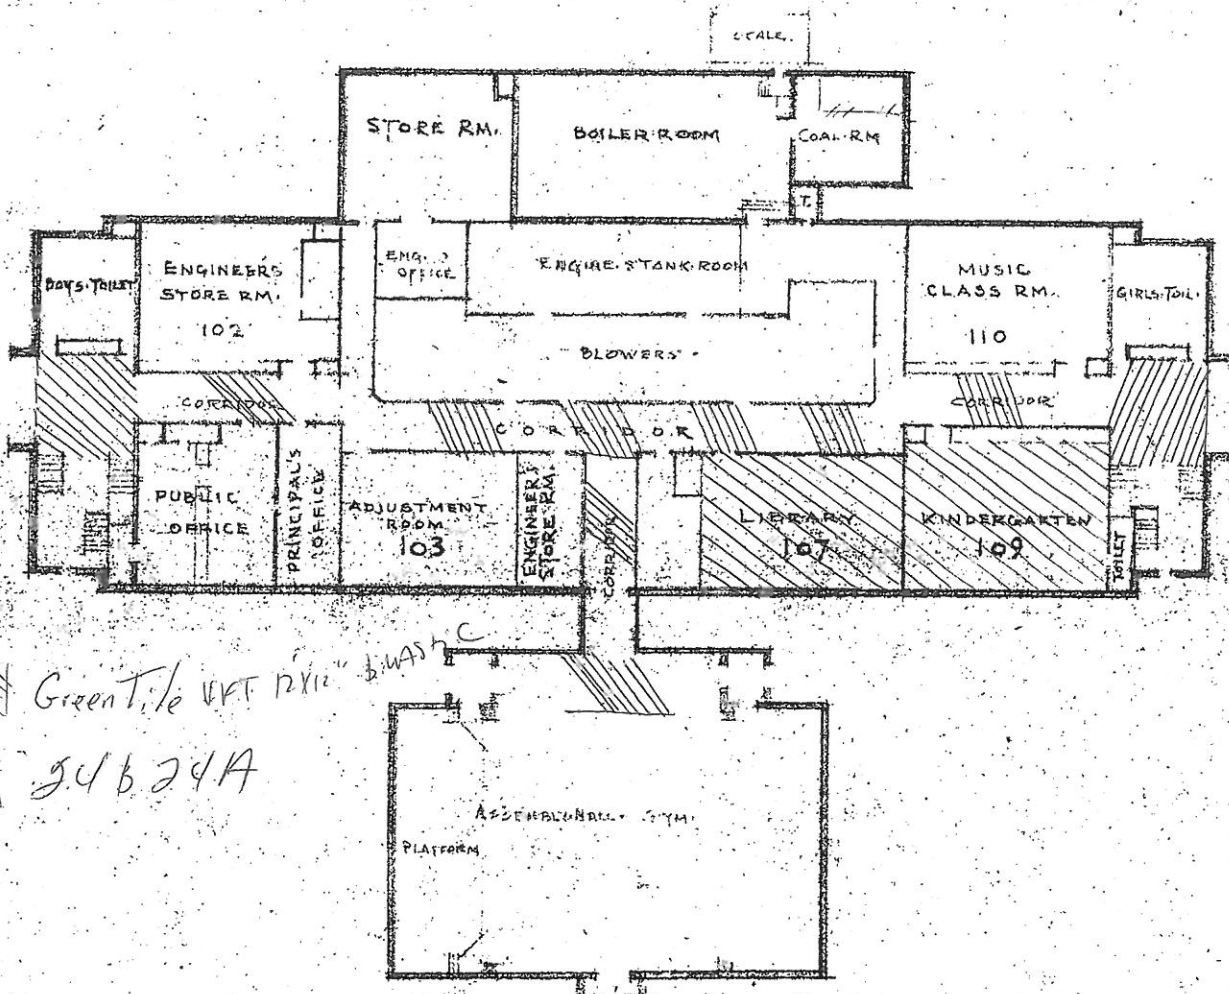
FIRST FLOOR PLAN

Green Tile VFT 12x12" 1/4" mesh
HA 54624A

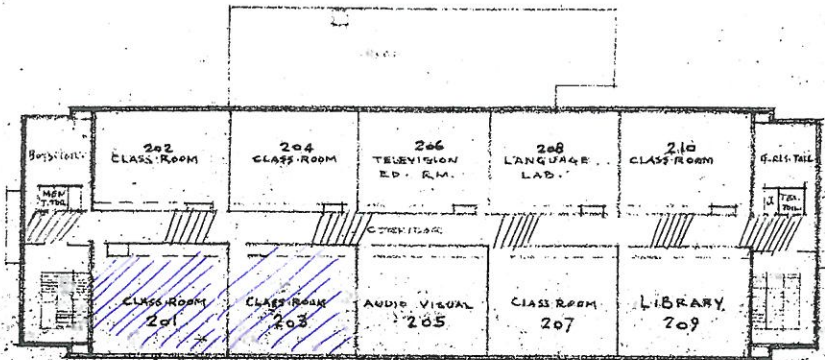
SECOND FLOOR PLAN

UPPER Green Tile & Marble
 HA-34321A

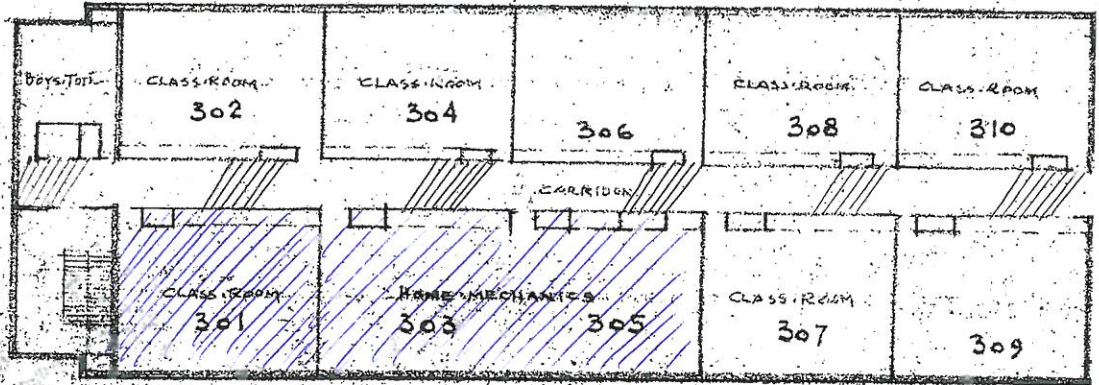
THIRD FLOOR PLAN

12x12 Green Tile & mastic

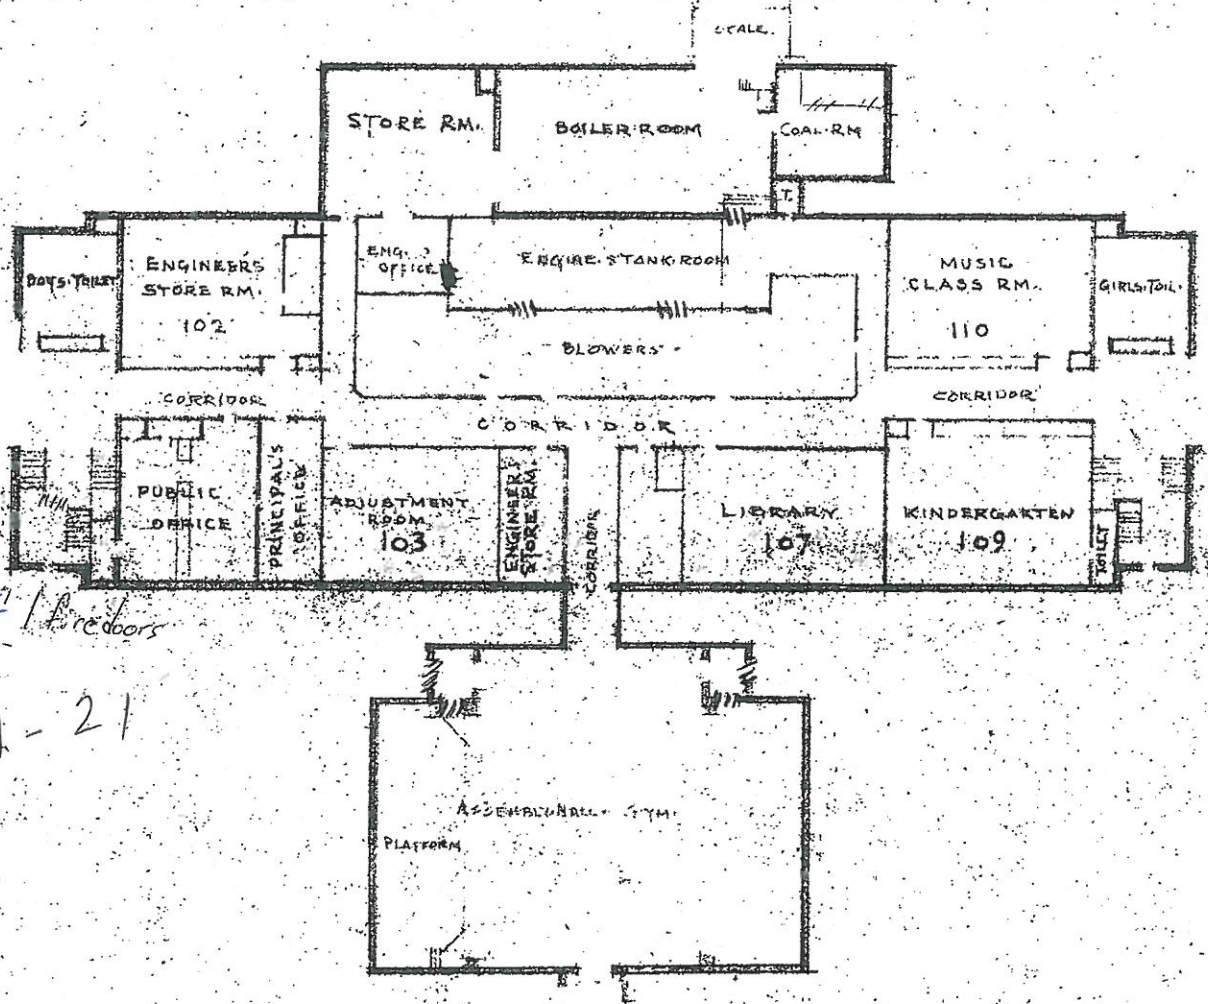
HA-21

1 fire doors

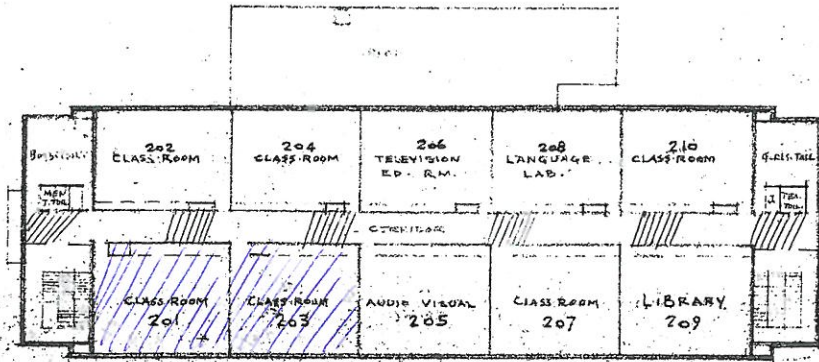
SECOND FLOOR - PLAN

Hatched Area - 2 1/2" Blue Mash
 H.A. 26 & 20A

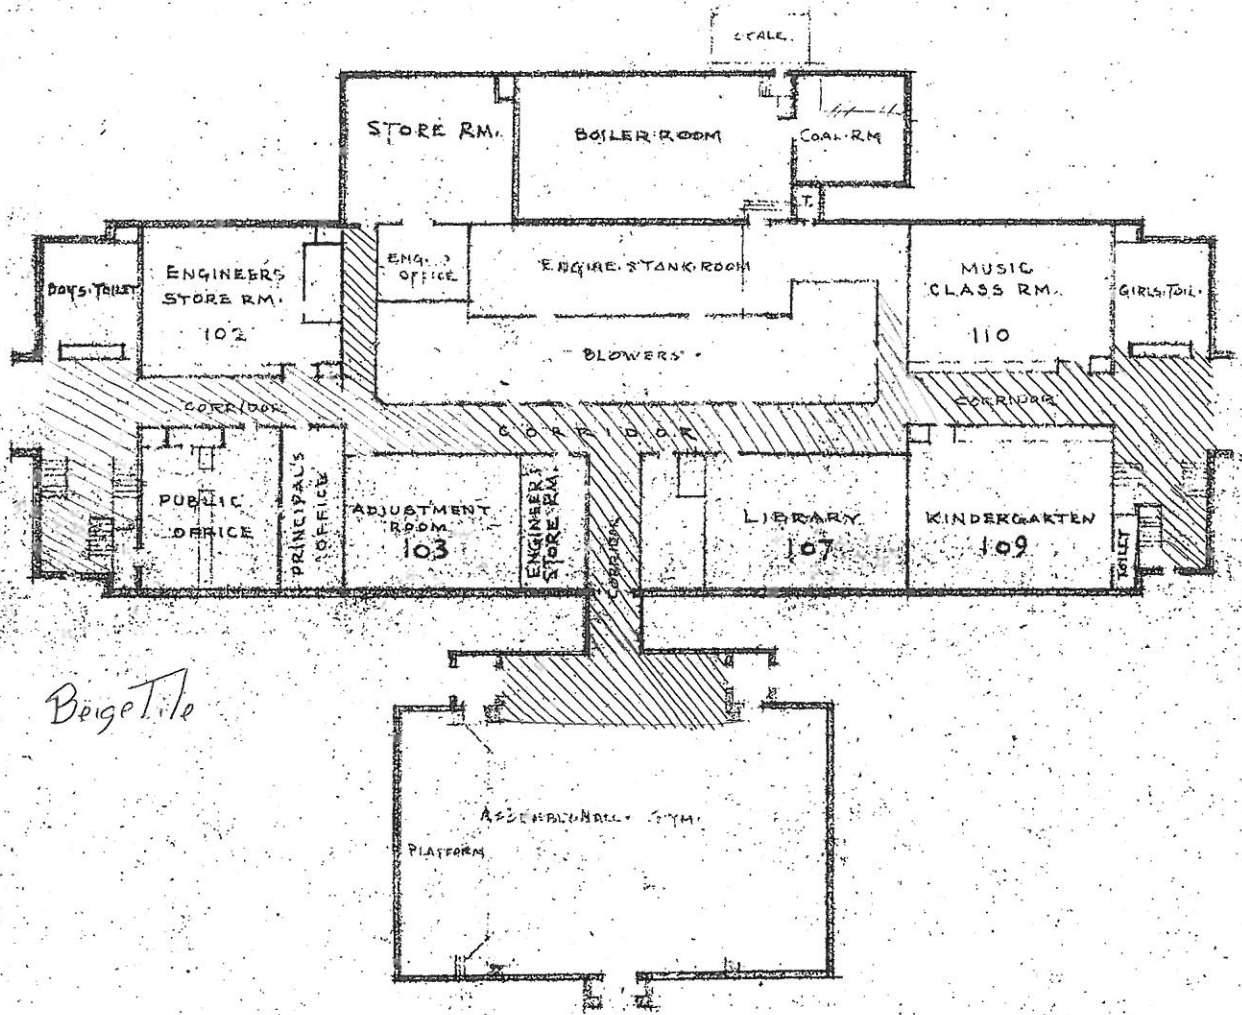
FIRST FLOOR PLAN

Beige Tile

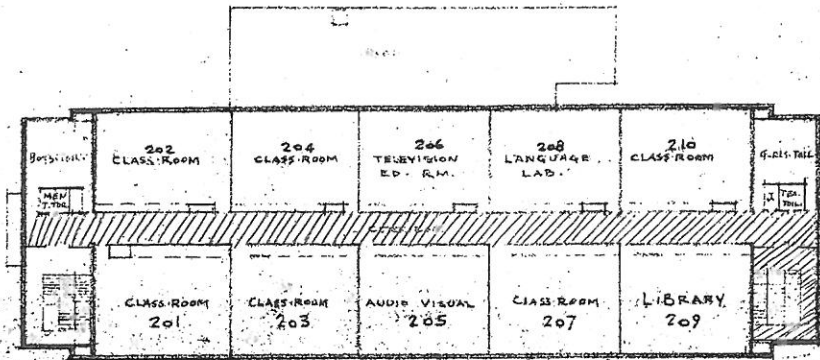
SECOND FLOOR PLAN

Beige Tile & Marble

H/A 23 & 23A

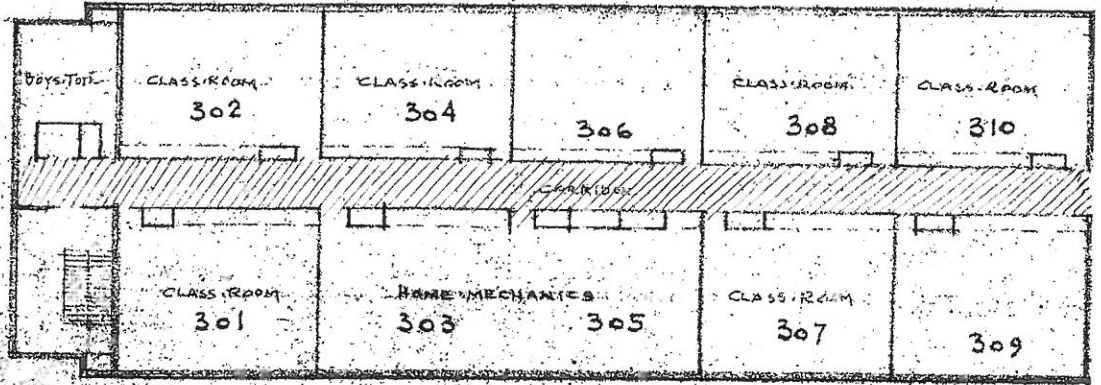
1/4" FT 12x12" Beige Tile & MASH C

H/A 23 & 23 1/2

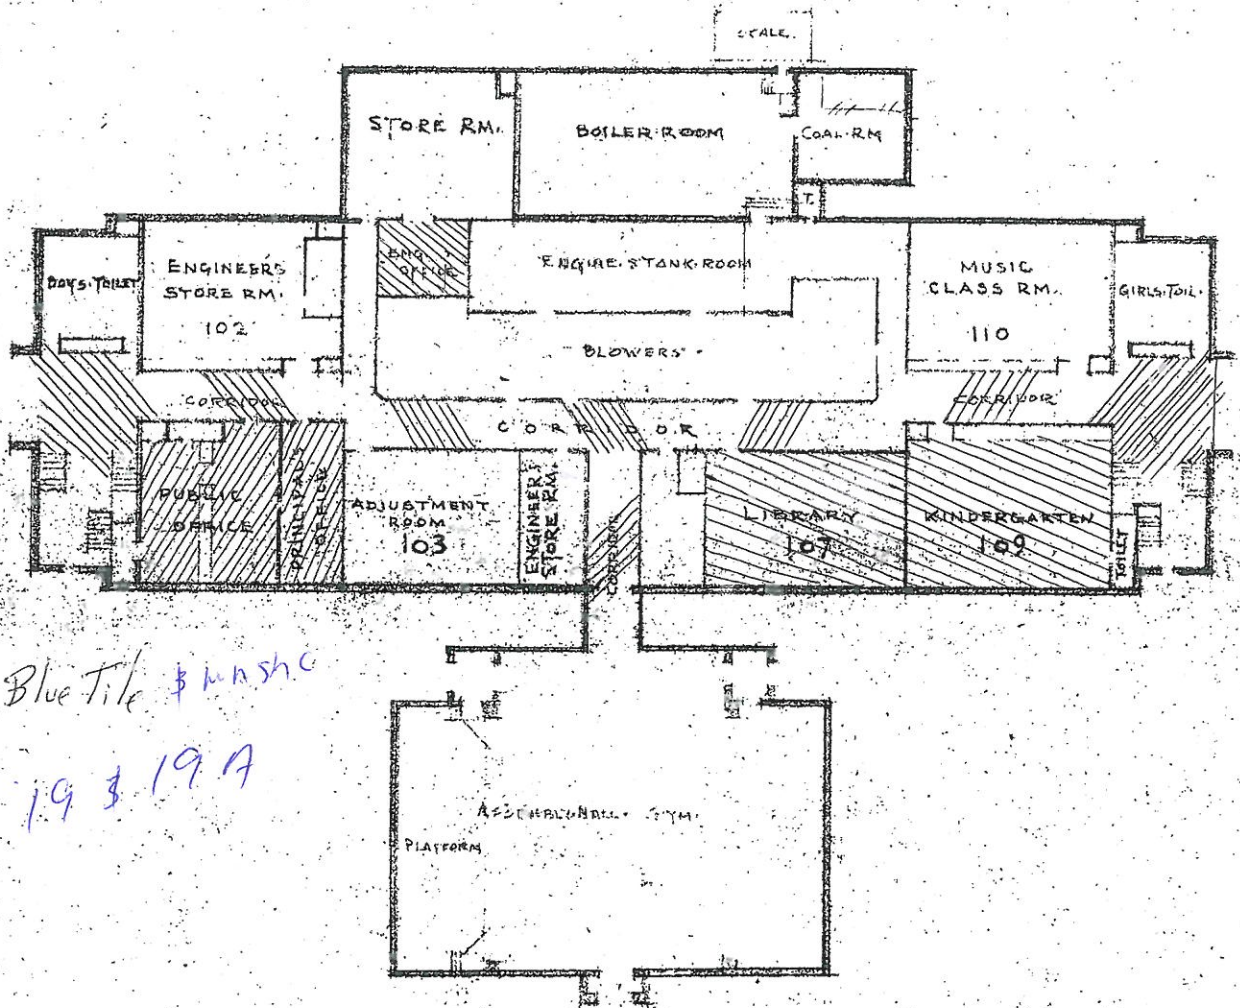
Blue Tile \$ m.s.h.c.
 H.A. 19 & 19A

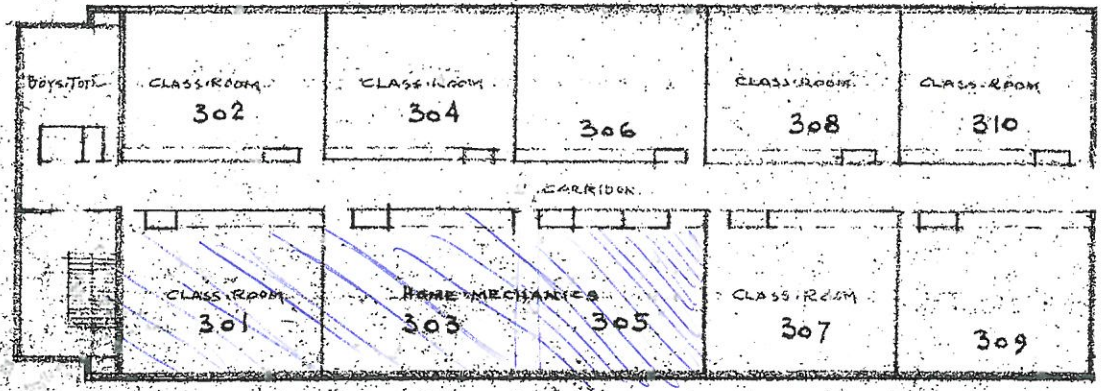
THIRD FLOOR PLAN

HA -18 3 18A
1 FT 12" x 12" Gray w/ black specs & mastic

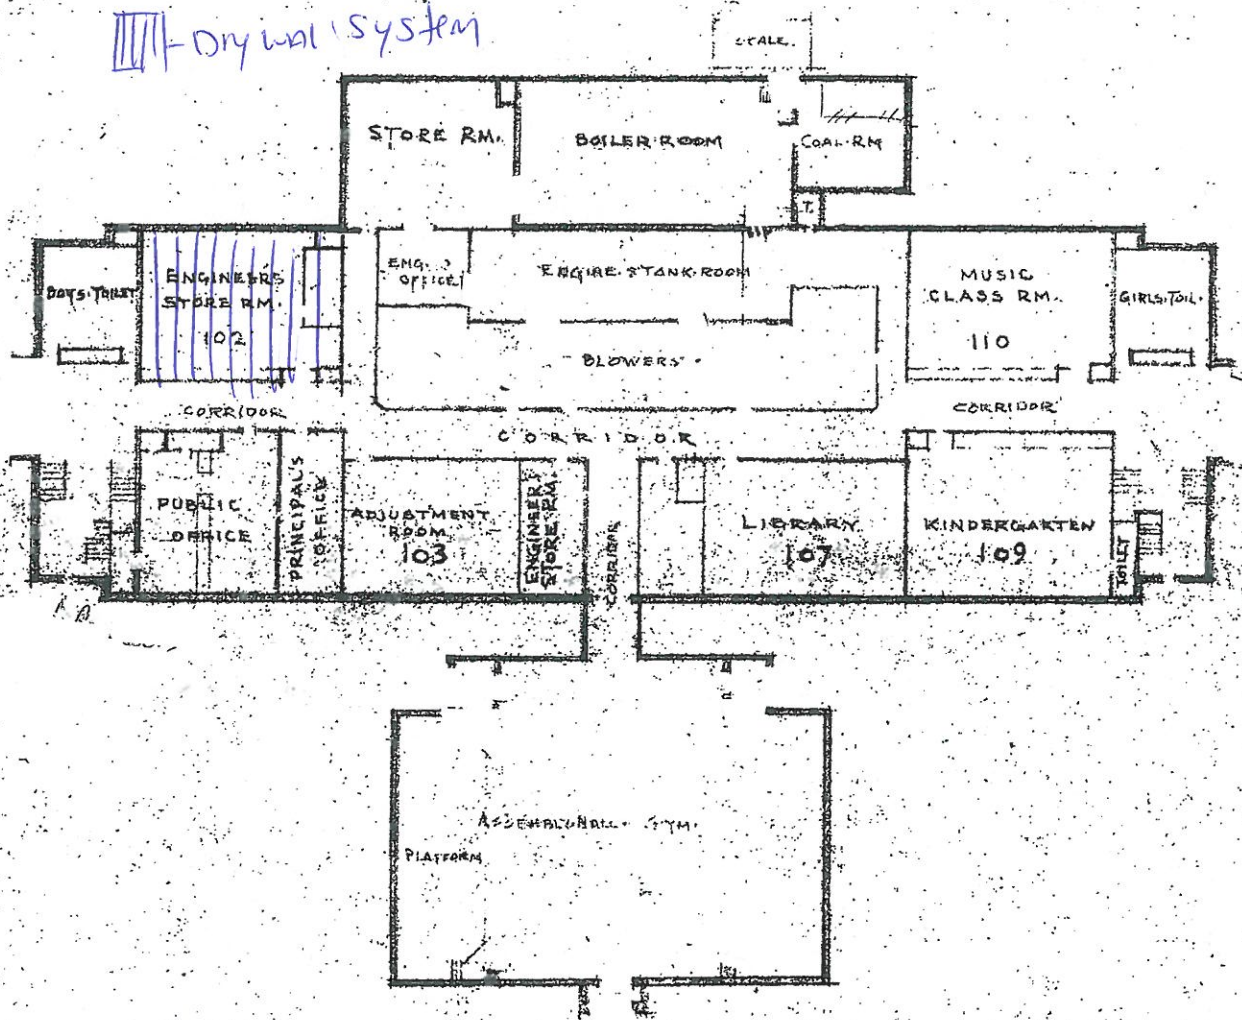
FIRST FLOOR PLAN

11A 20
Dry wall system

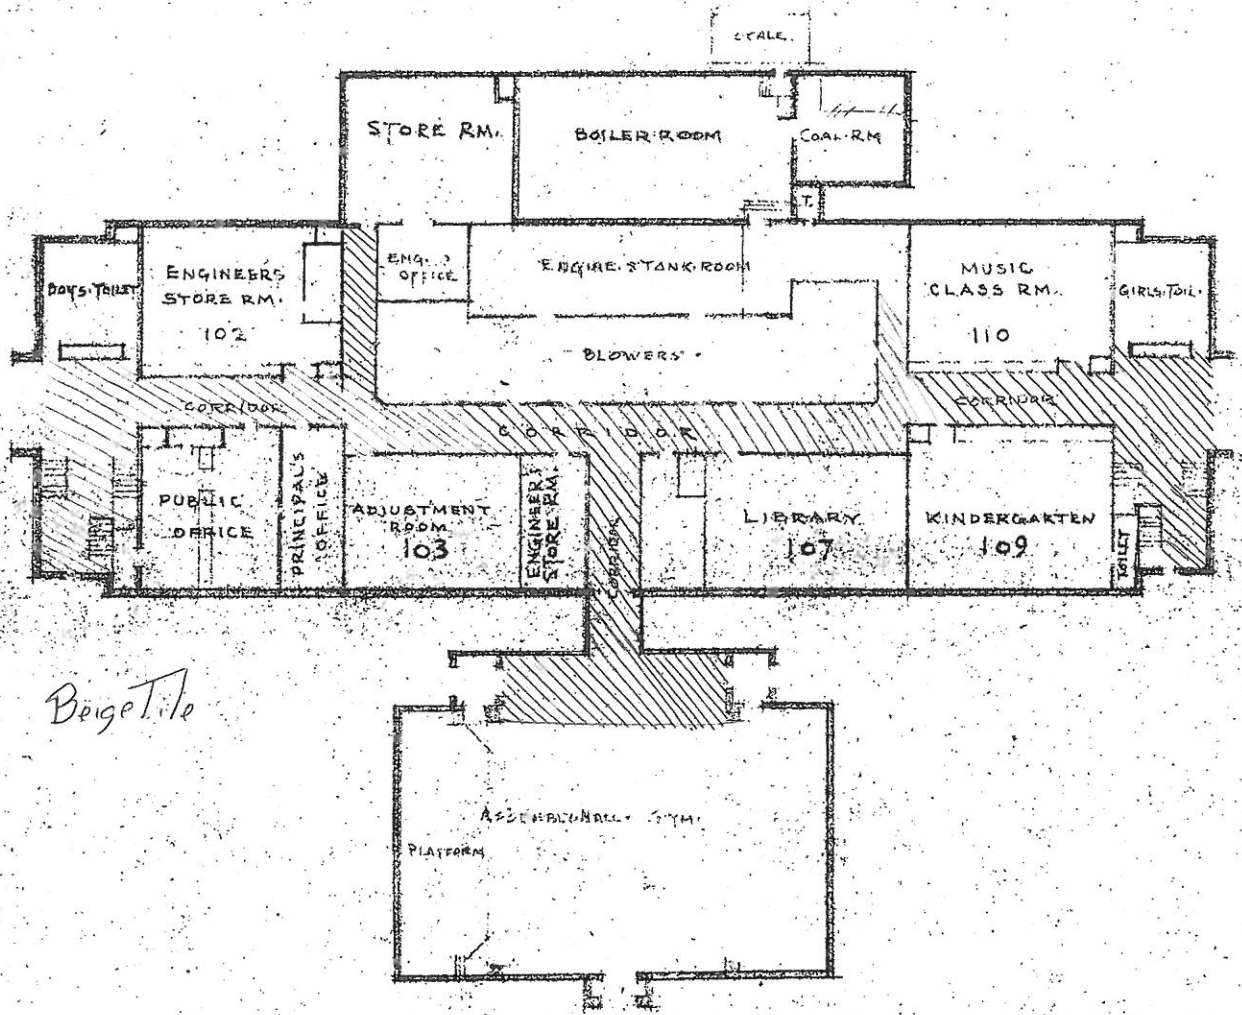
FIRST FLOOR PLAN

Beige Tile

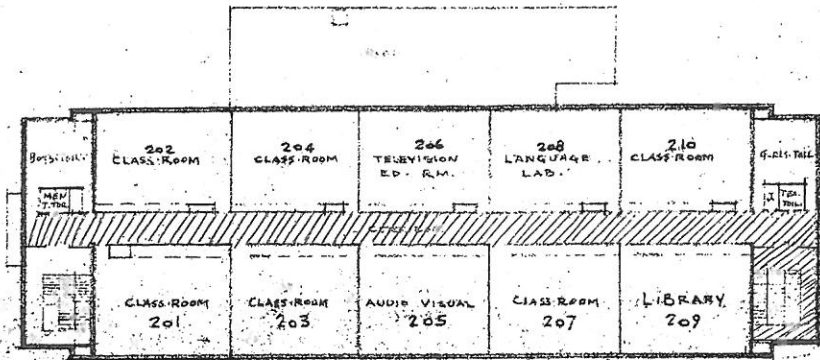
SECOND FLOOR PLAN

Beige Tile & Marble

H/A - 23 & 23A

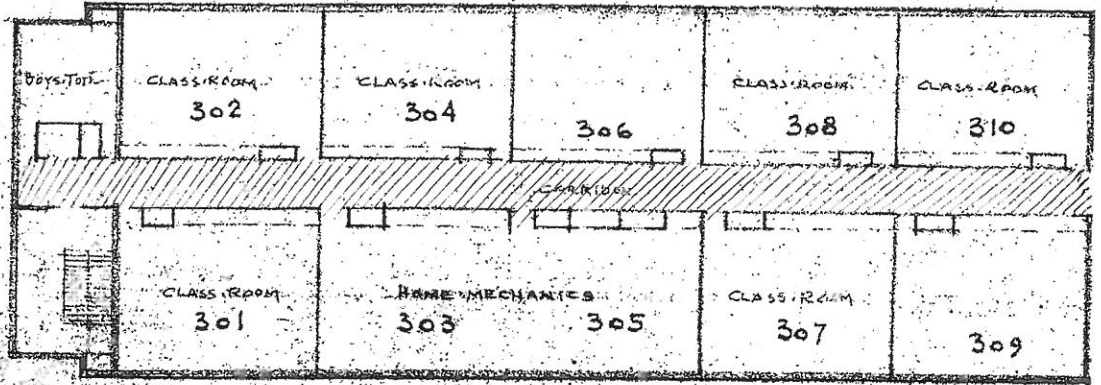
1/4" FT 12x12" Beige Tile & MASH C

H/A 23 B 23 D

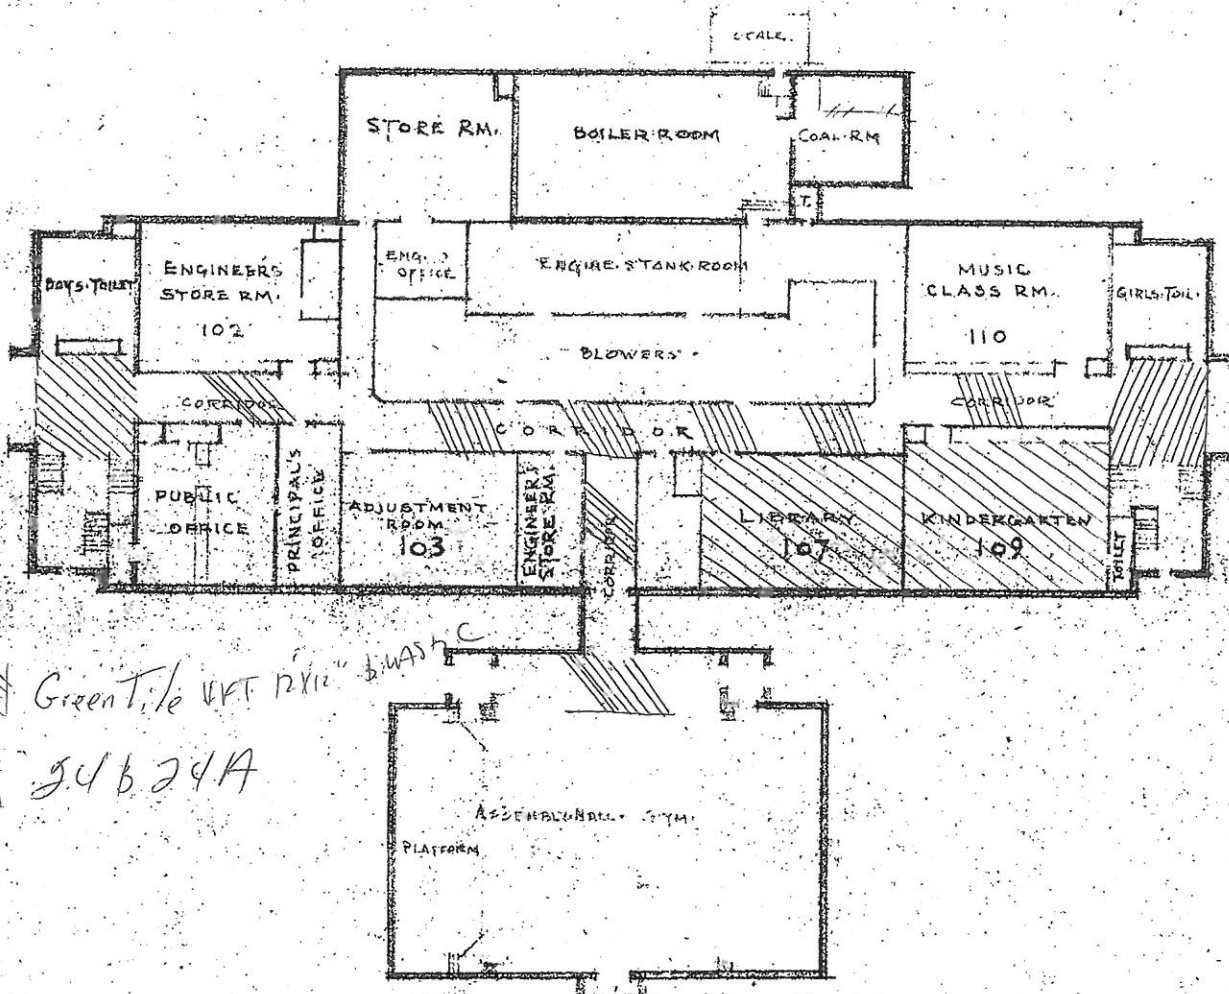
FIRST FLOOR PLAN

Green Tile VFT 12x12" 1/4" thick
HA 54624A

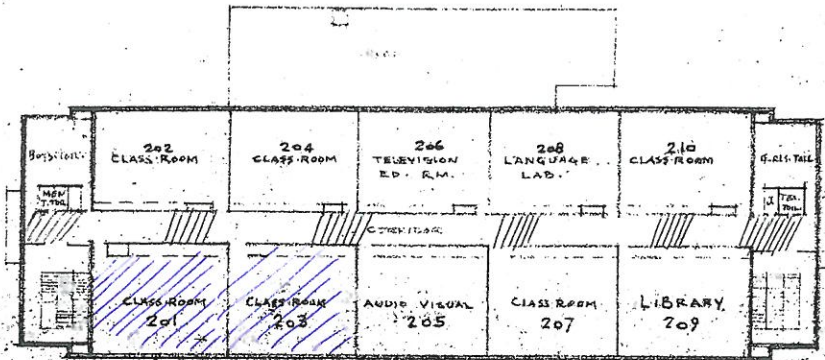
SECOND FLOOR PLAN

UPPER Green Tile & Marble
 HA-34321A

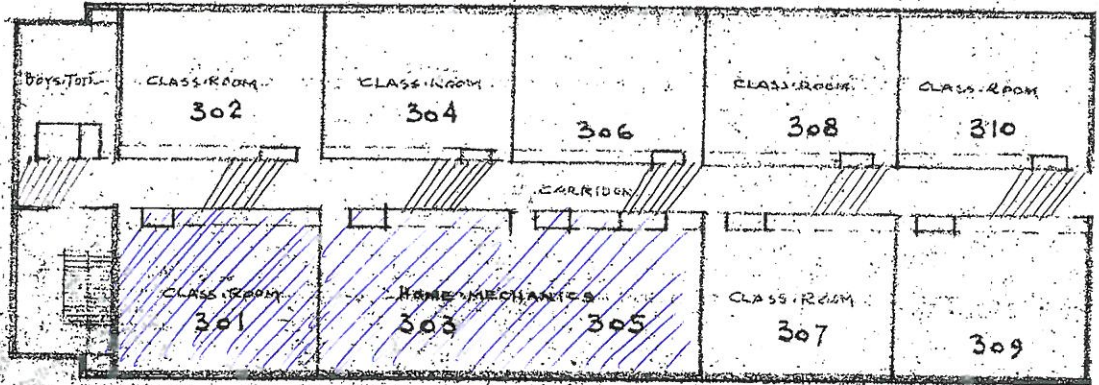
THIRD FLOOR PLAN

12x12 Green Tile & mastic

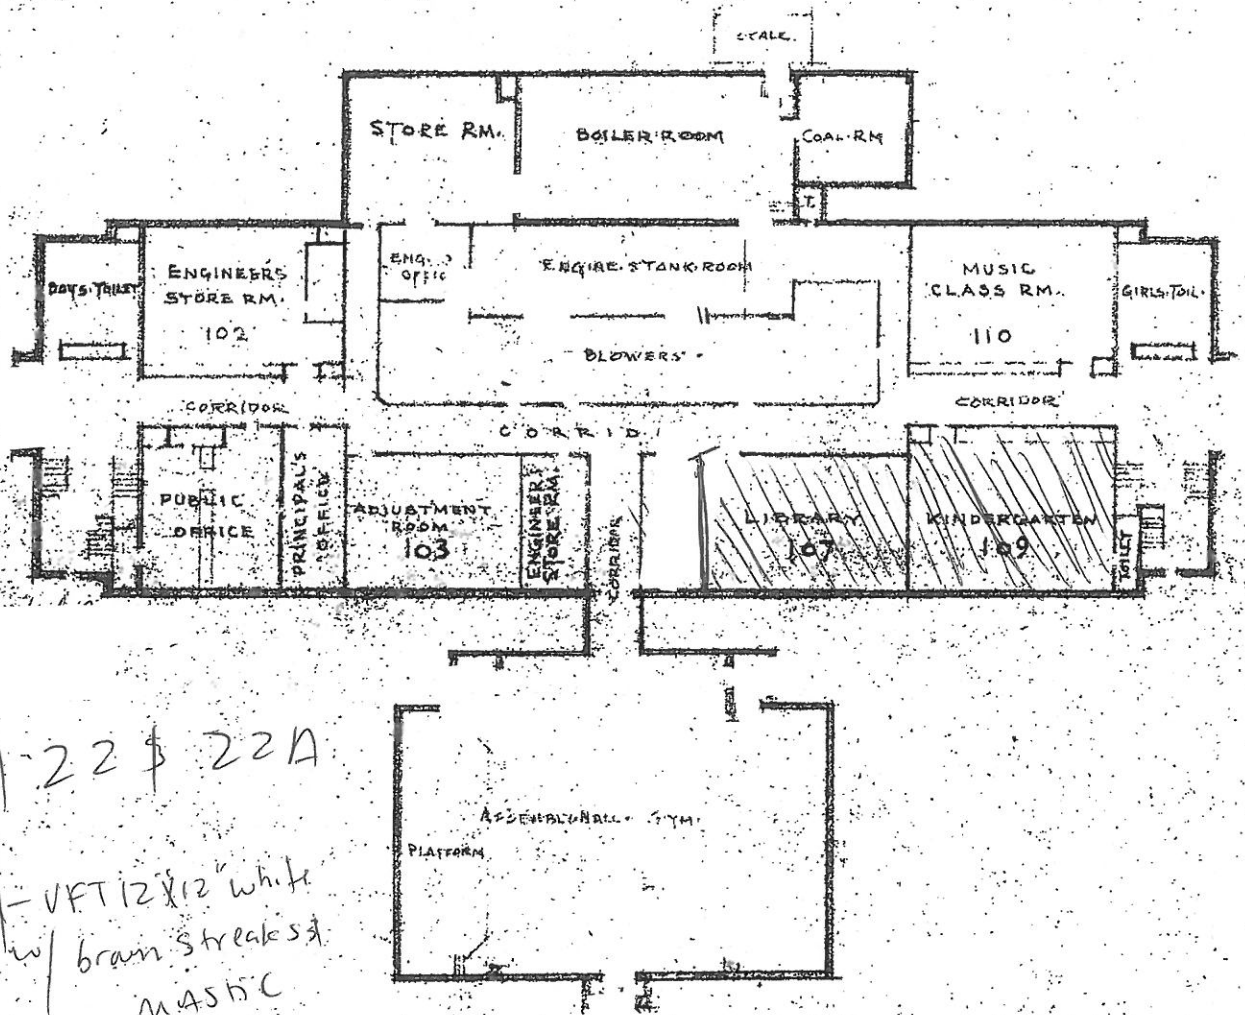
HA-22 & 22A

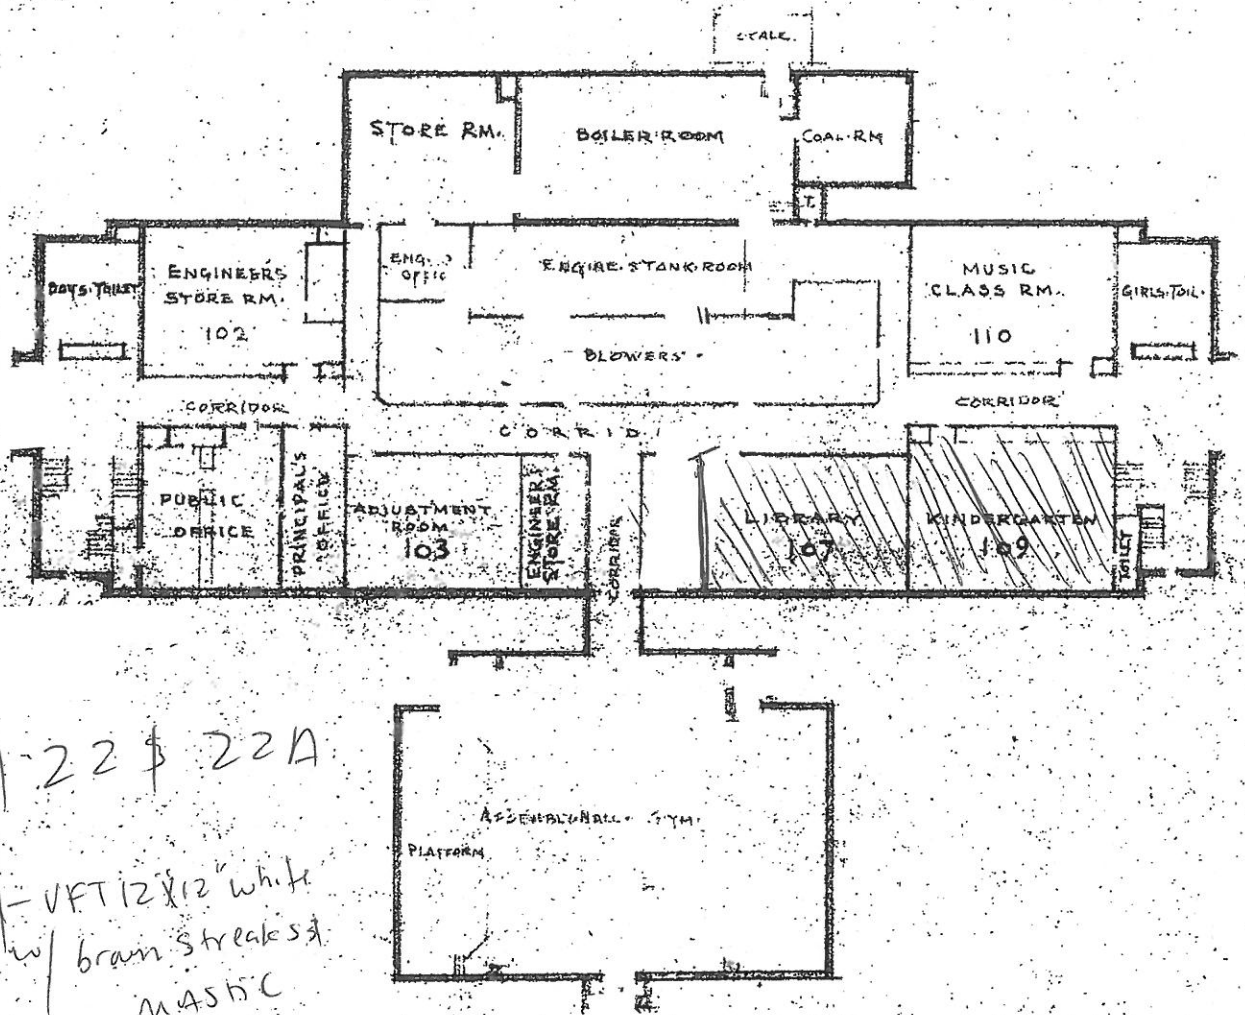
HA-22 & 22A

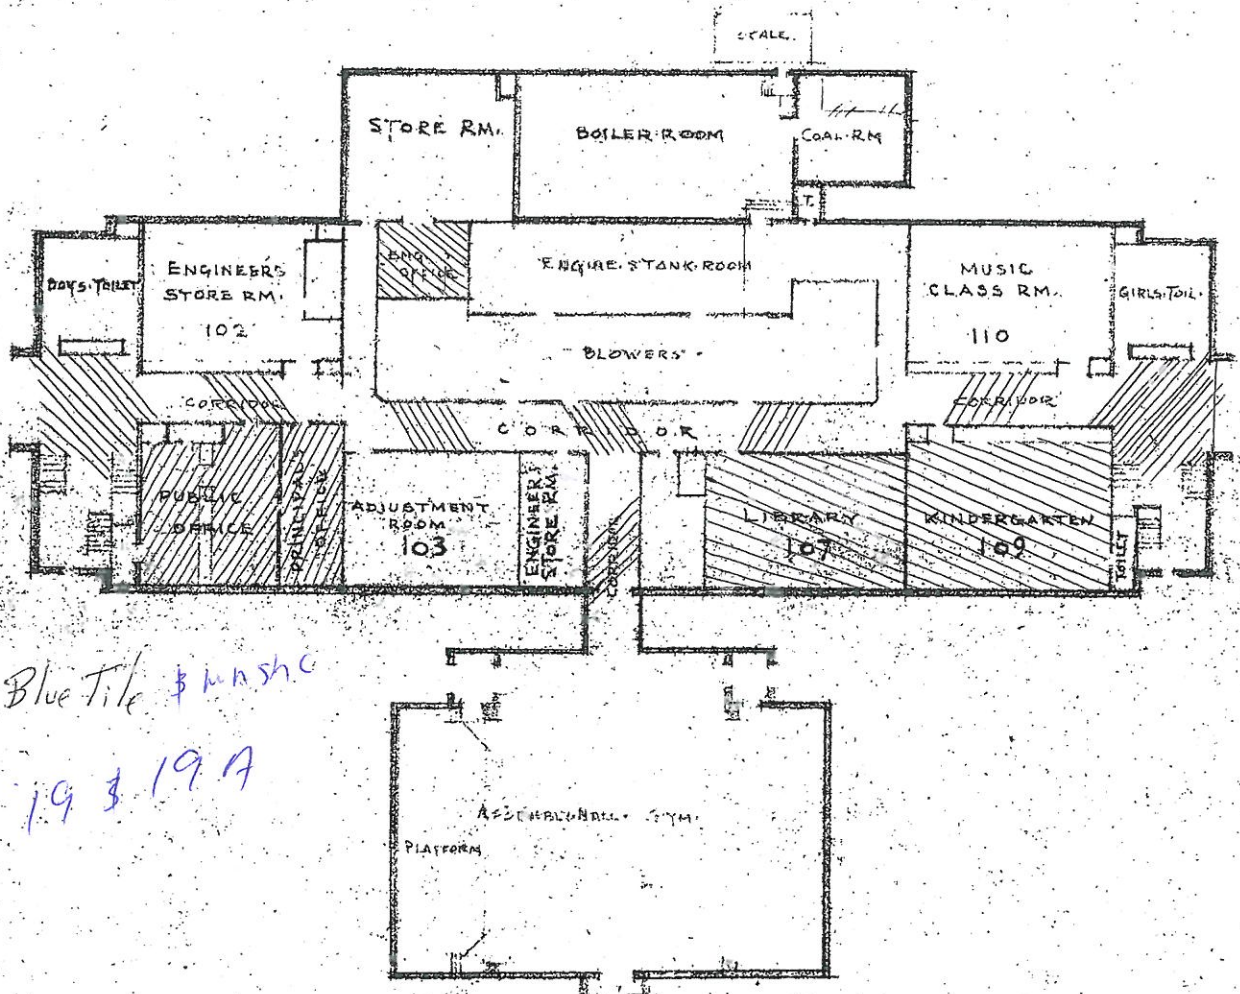
Blue Tile \$ m.s.h.c.
 H.A. 19 & 19A
