ILLINOIS DEPARTMENT OF PUBLIC HEALTH
AHERA THREE YEAR REINSPECTION
ASBESTOS ABATEMENT PROGRAM
SCHOOL INFORMATION FORM

THREE-YEAR REINSPECTION

Bowen Campus

Friday, May 10, 2013

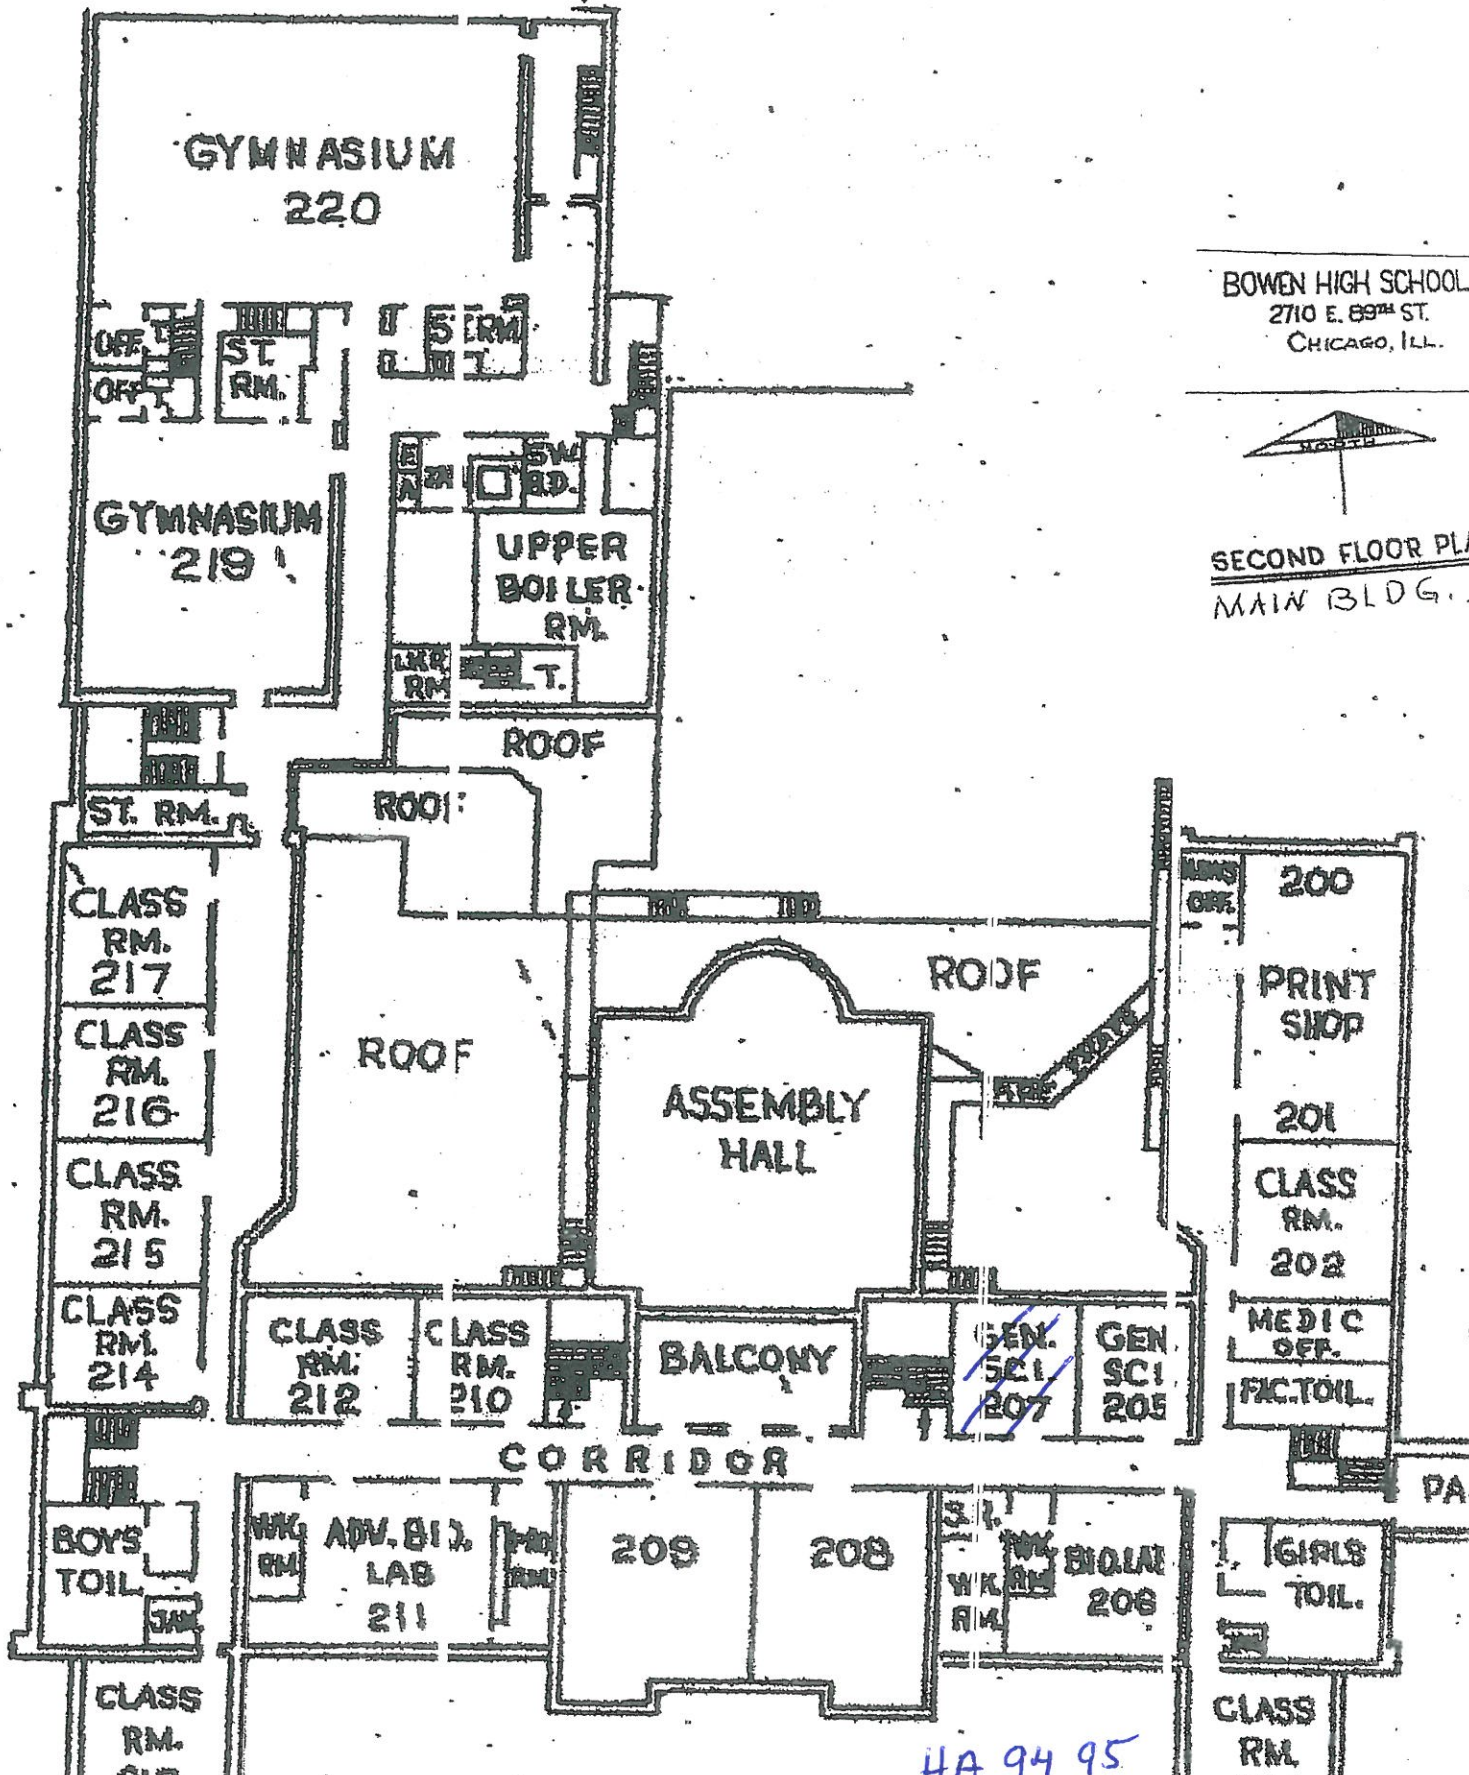
HA 94.95
 12x12
 Vanilla mixed
 speckled
 @ mastic

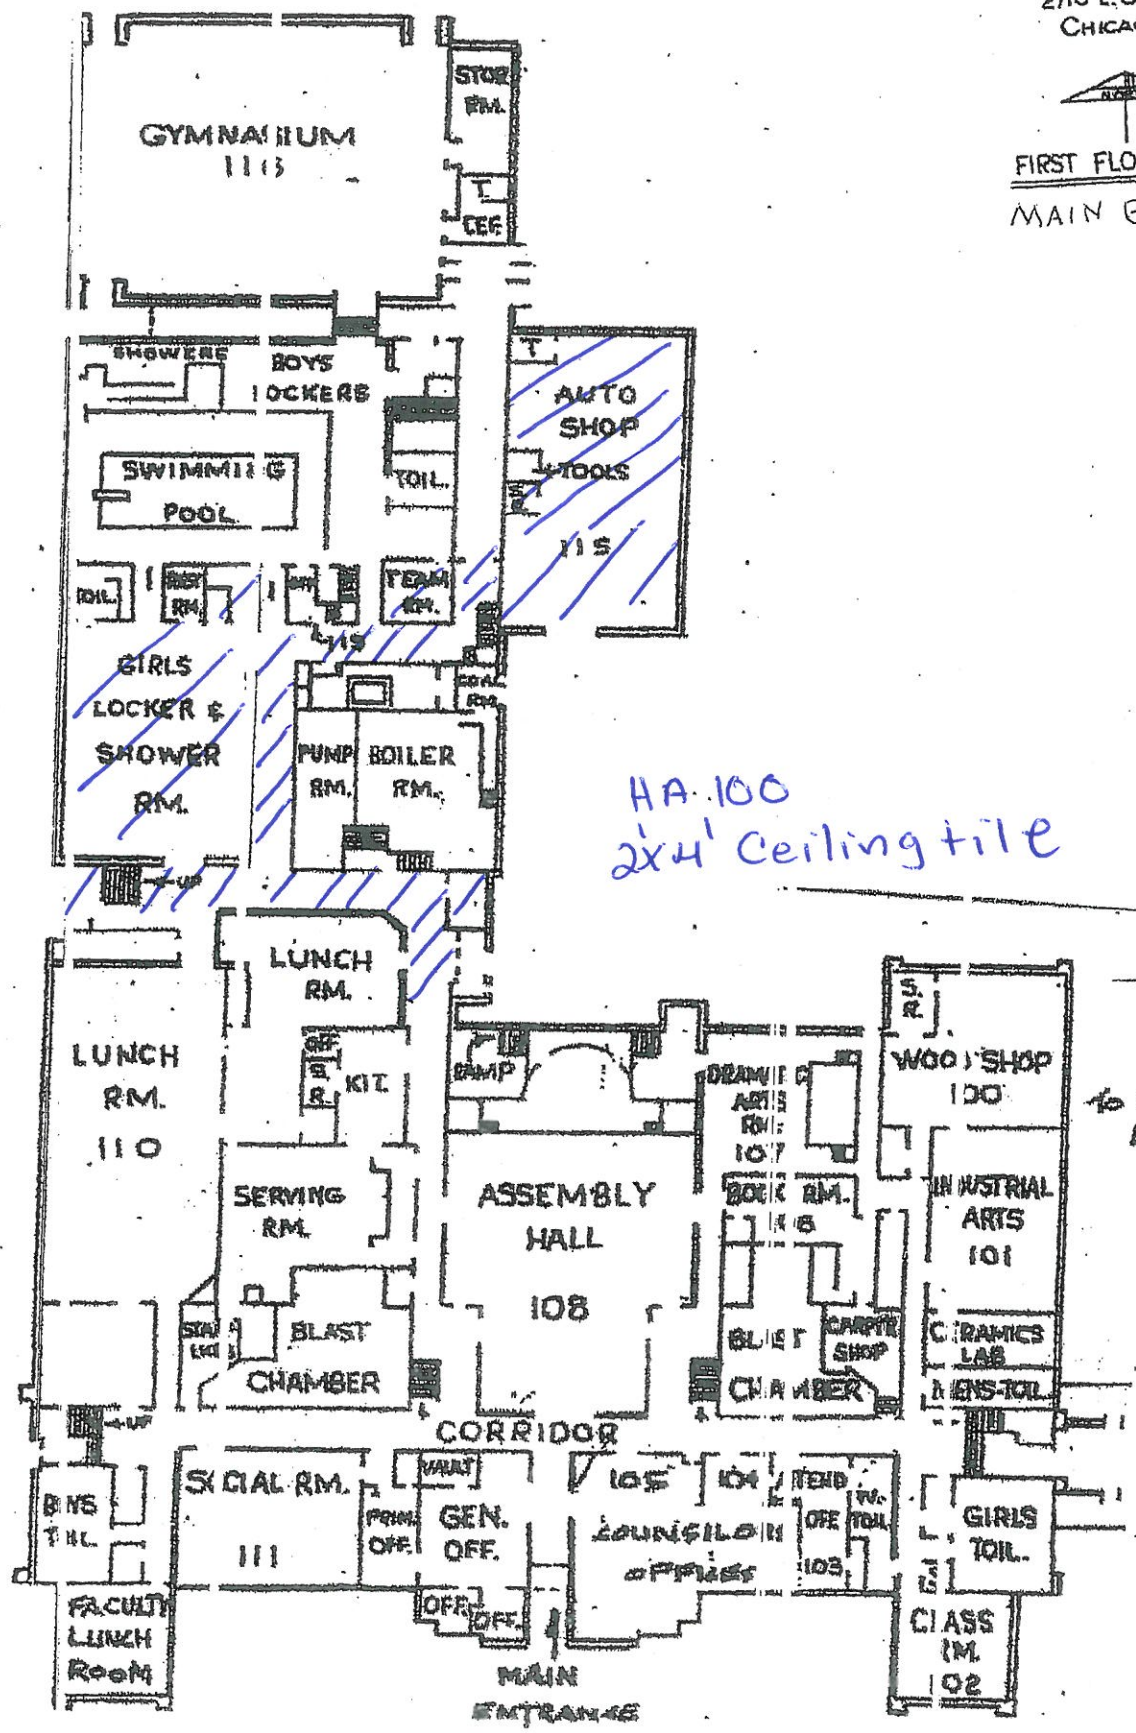
FIRST FLOOR PLAN
MAIN BLDG

HA-100
2x4' ceiling tile

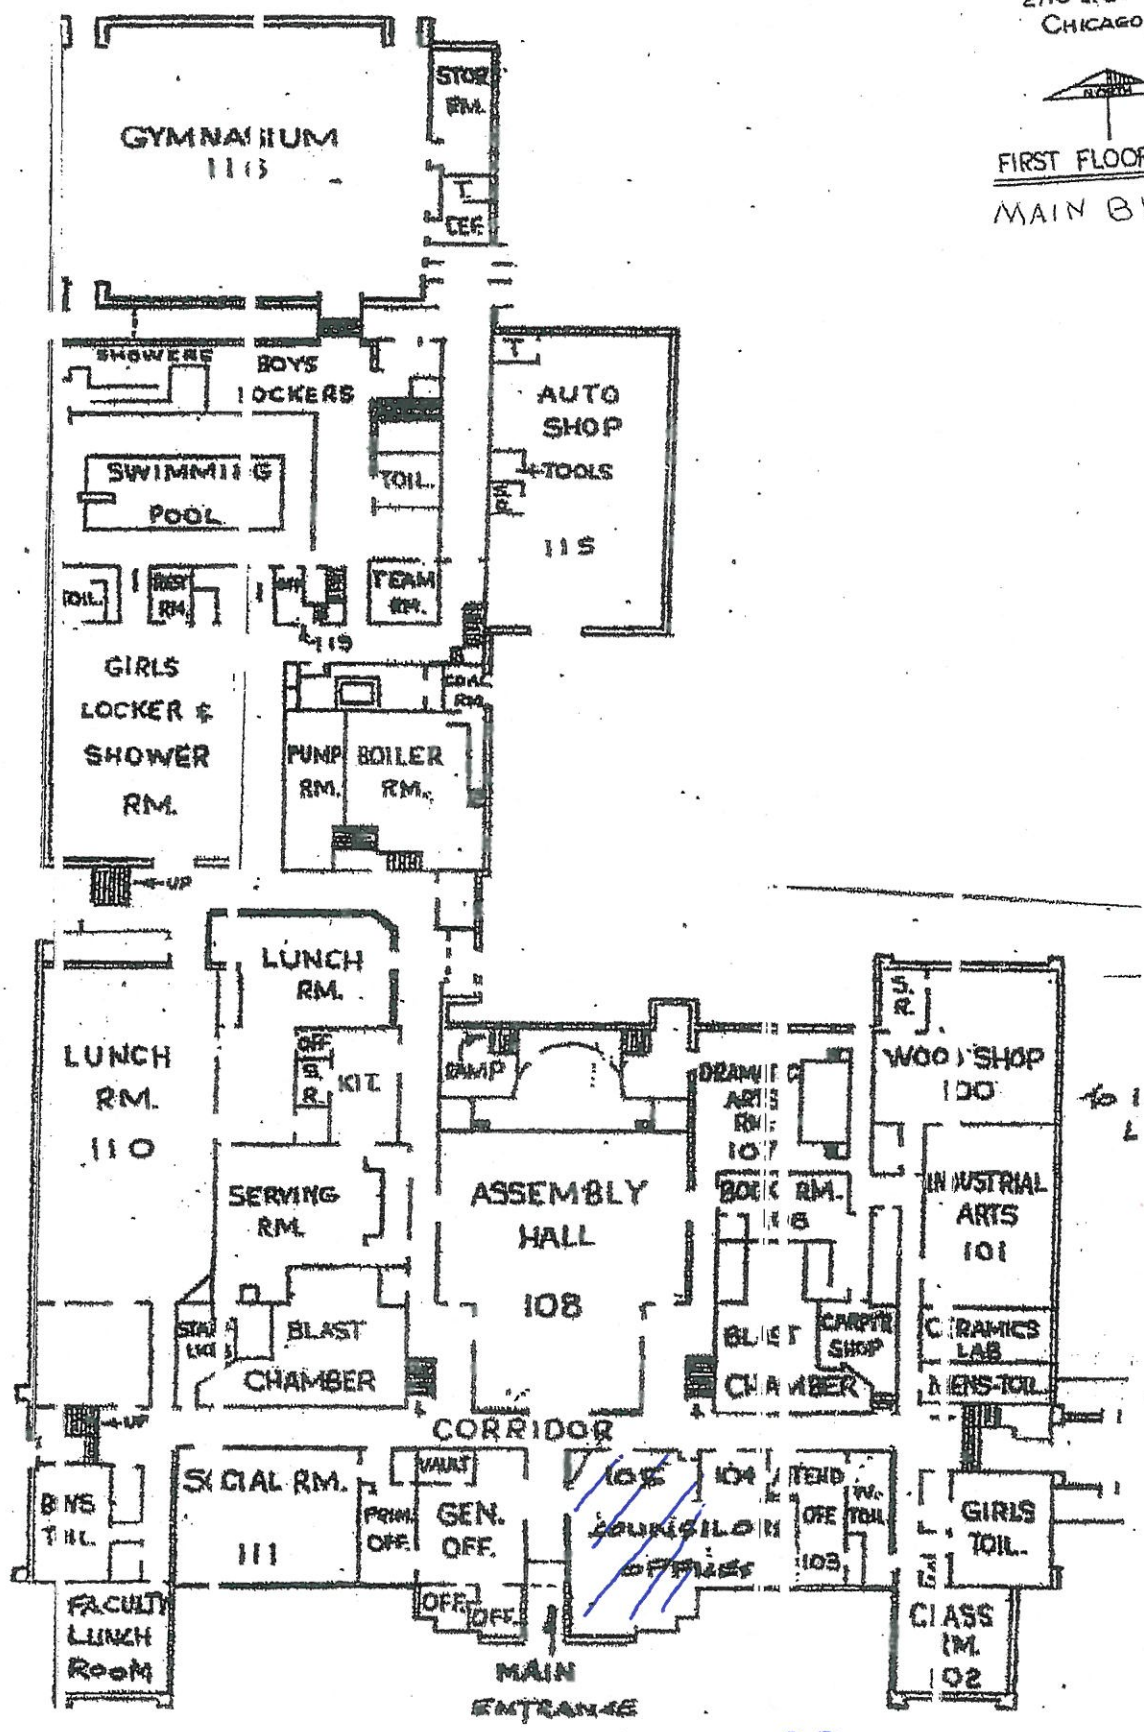
FIRST FLOOR PLAN
MAIN BLDG

HA 92.93

12x12 ft. Cream mixed
speckled & mastic

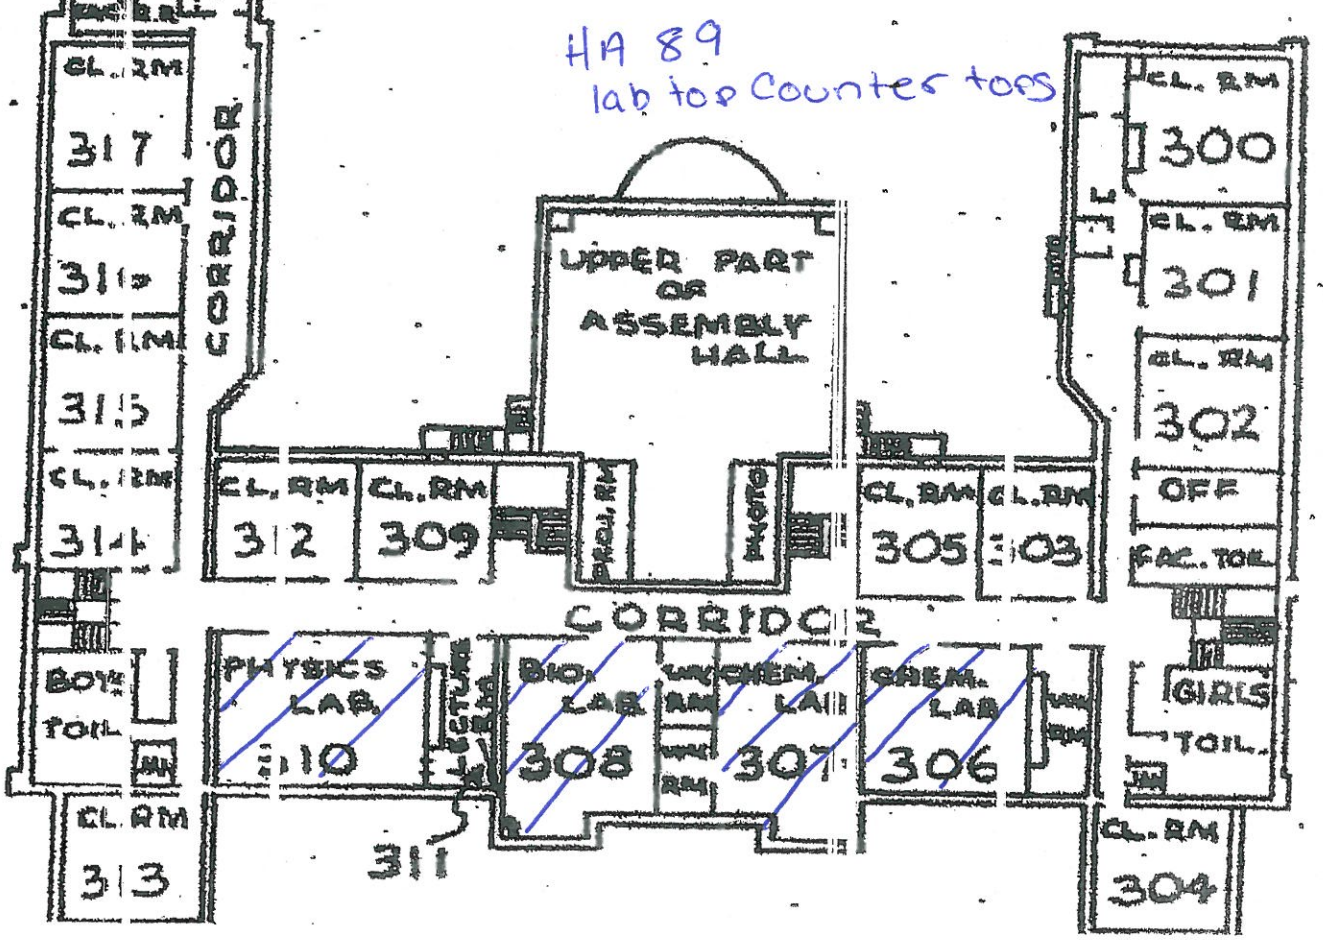
THIRD FLOOR
MAIN BLDG.

HA 89
lab top Counter tops

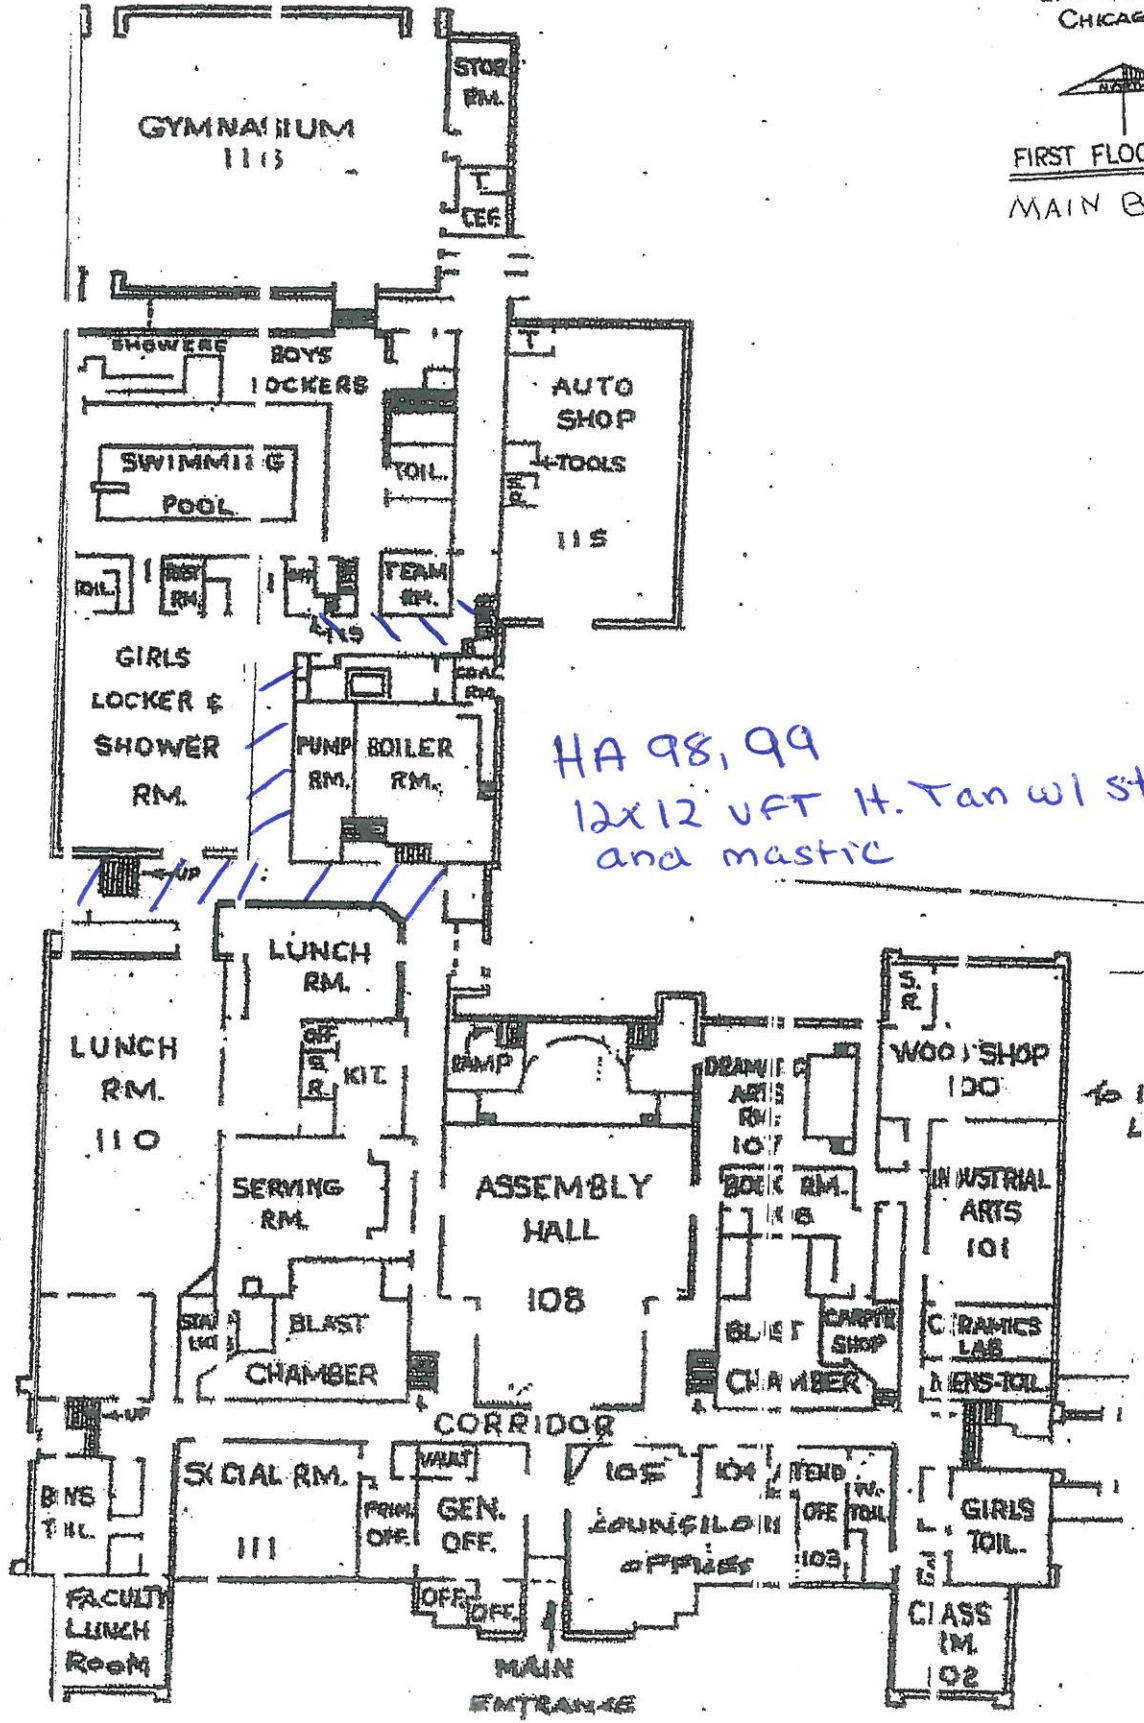
FIRST FLOOR PLAN
MAIN BLDG

HA 98, 99
12x12 VFT H. Tan w/ streaks
and mastic

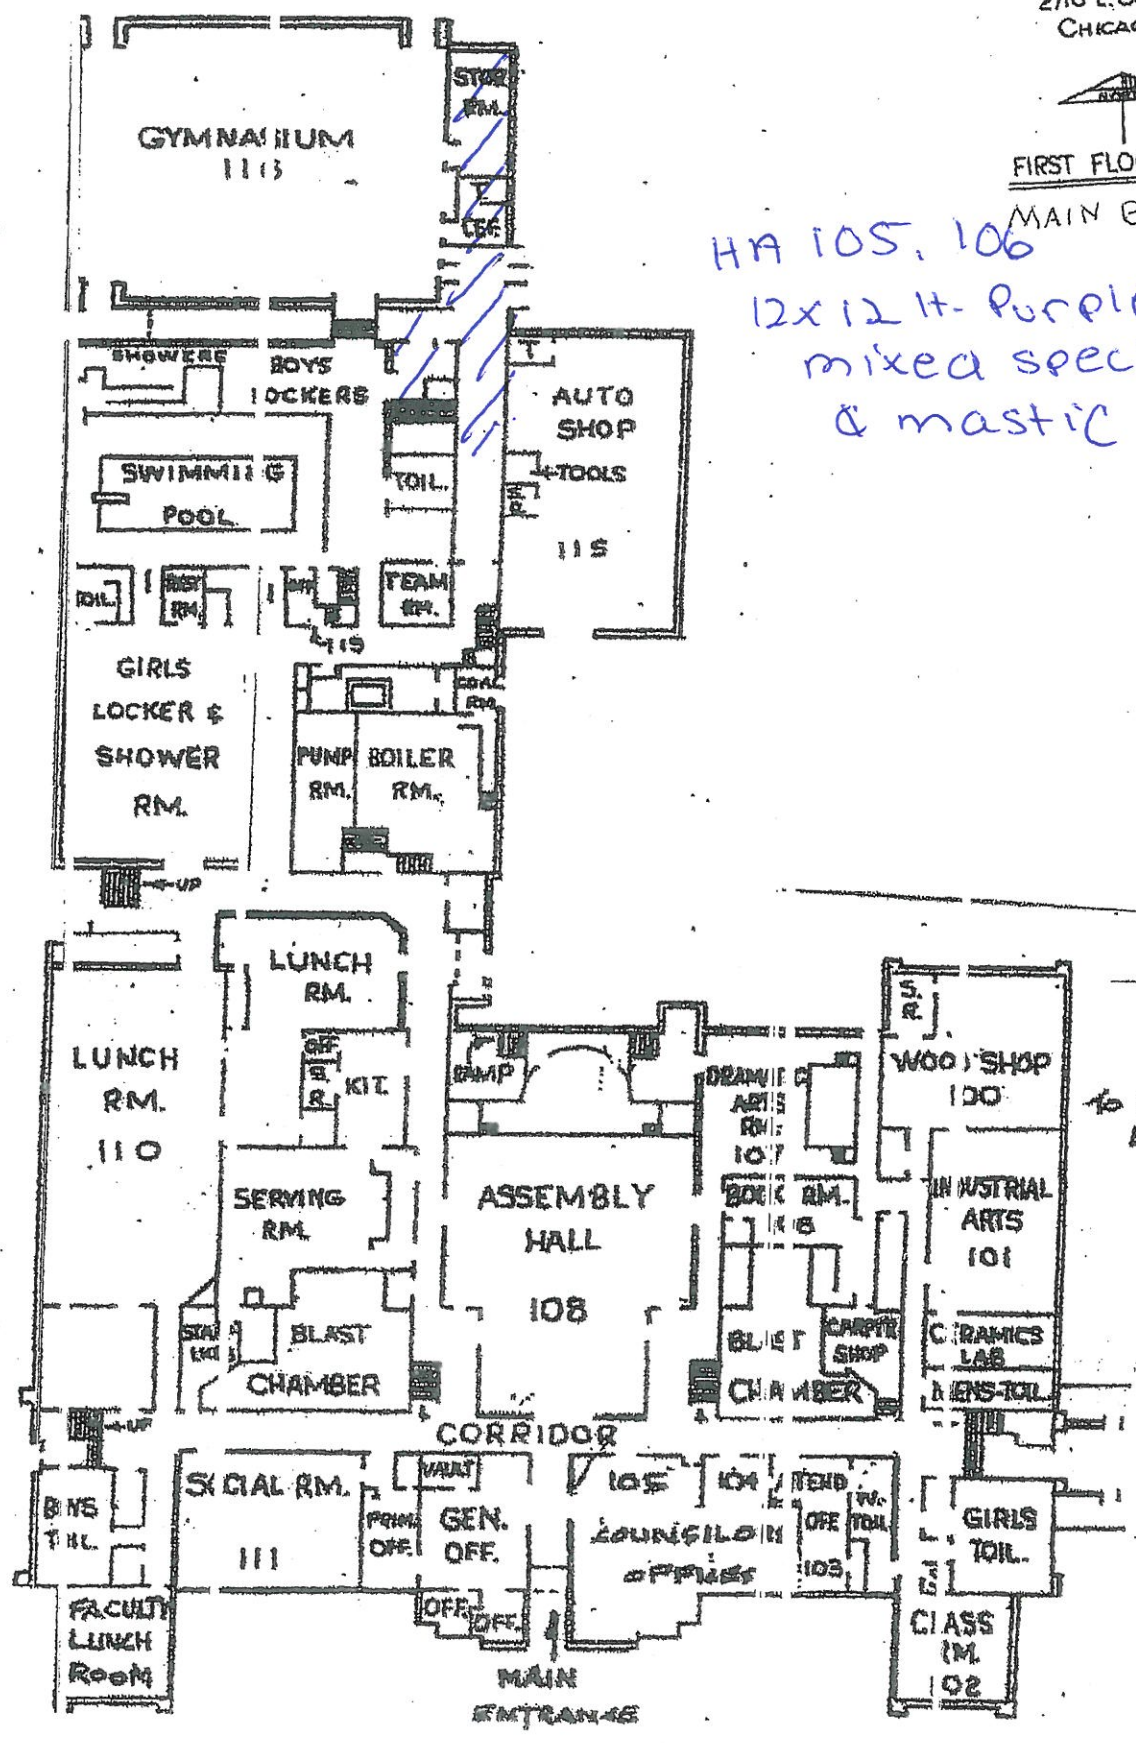
FIRST FLOOR PLAN
MAIN BLDG

HA 105, 106
12x12 lt. Purple
mixed speckled
& mastic

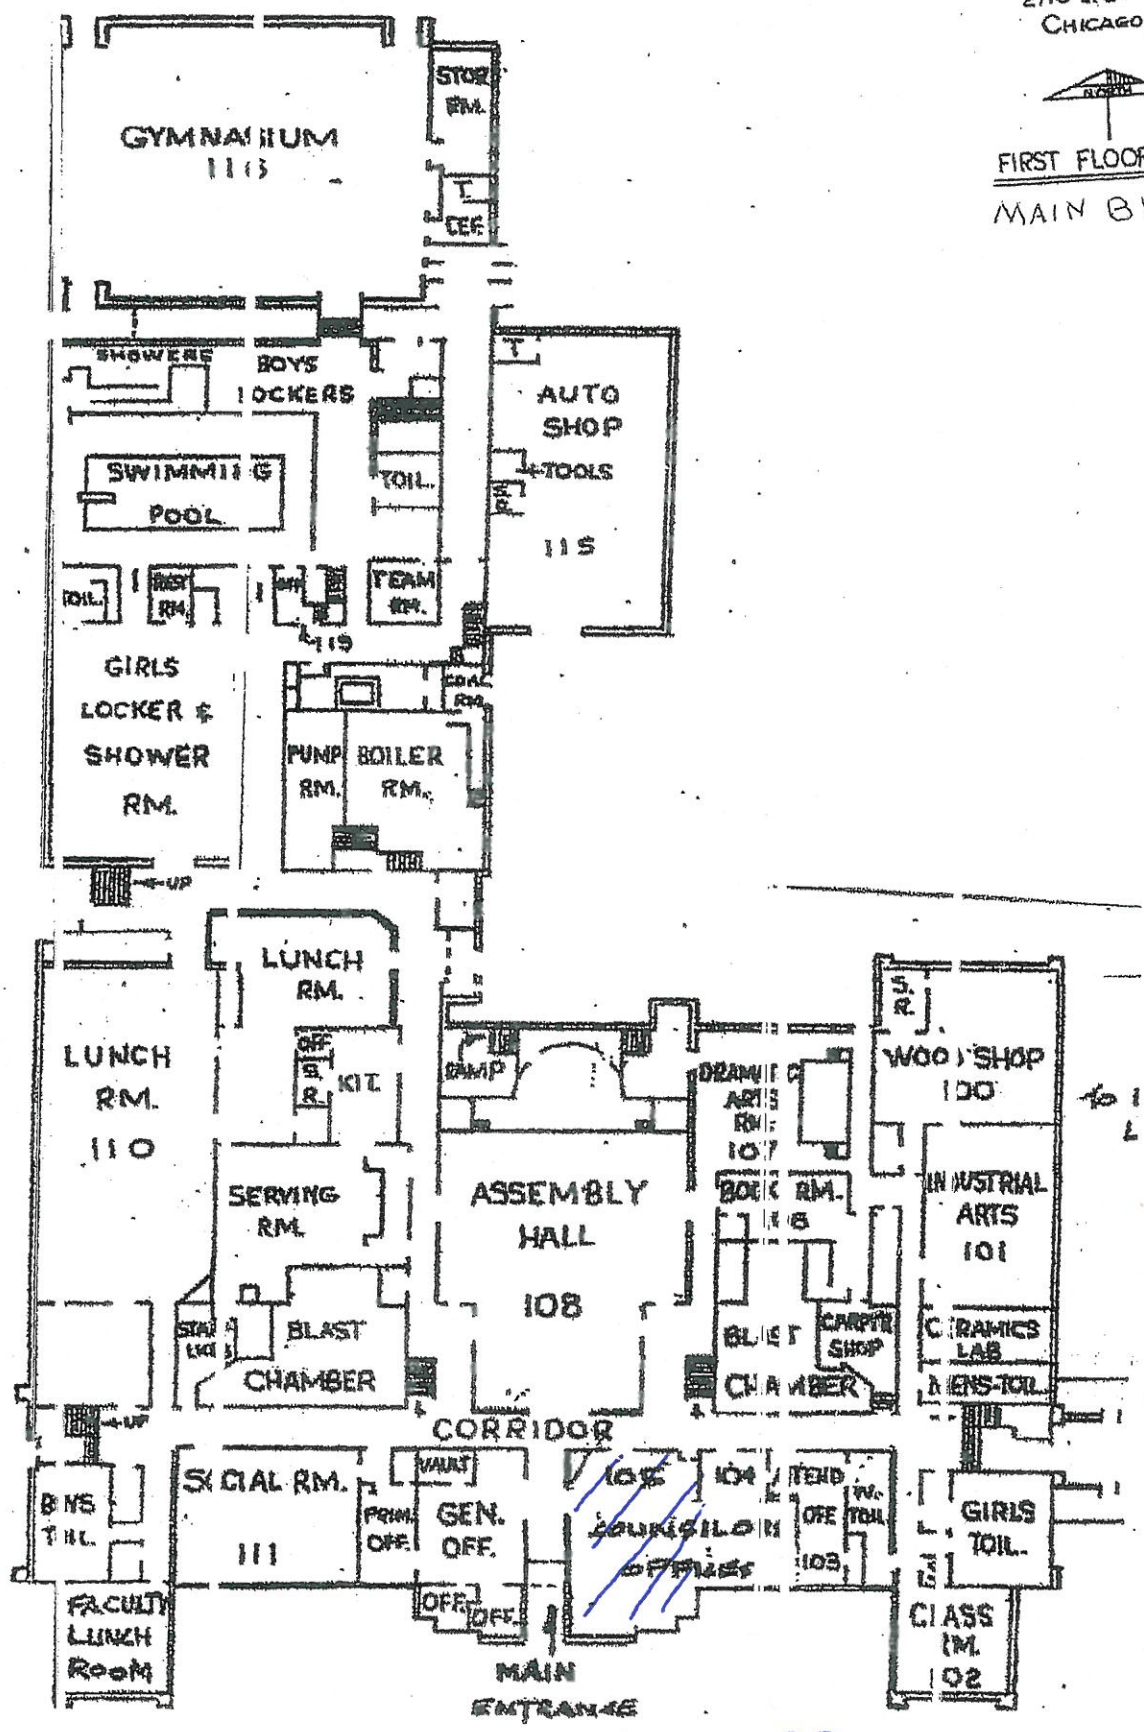
FIRST FLOOR PLAN
MAIN BLDG

HA 92.93

12x12 ft. Cream mixed
speckled & mastic

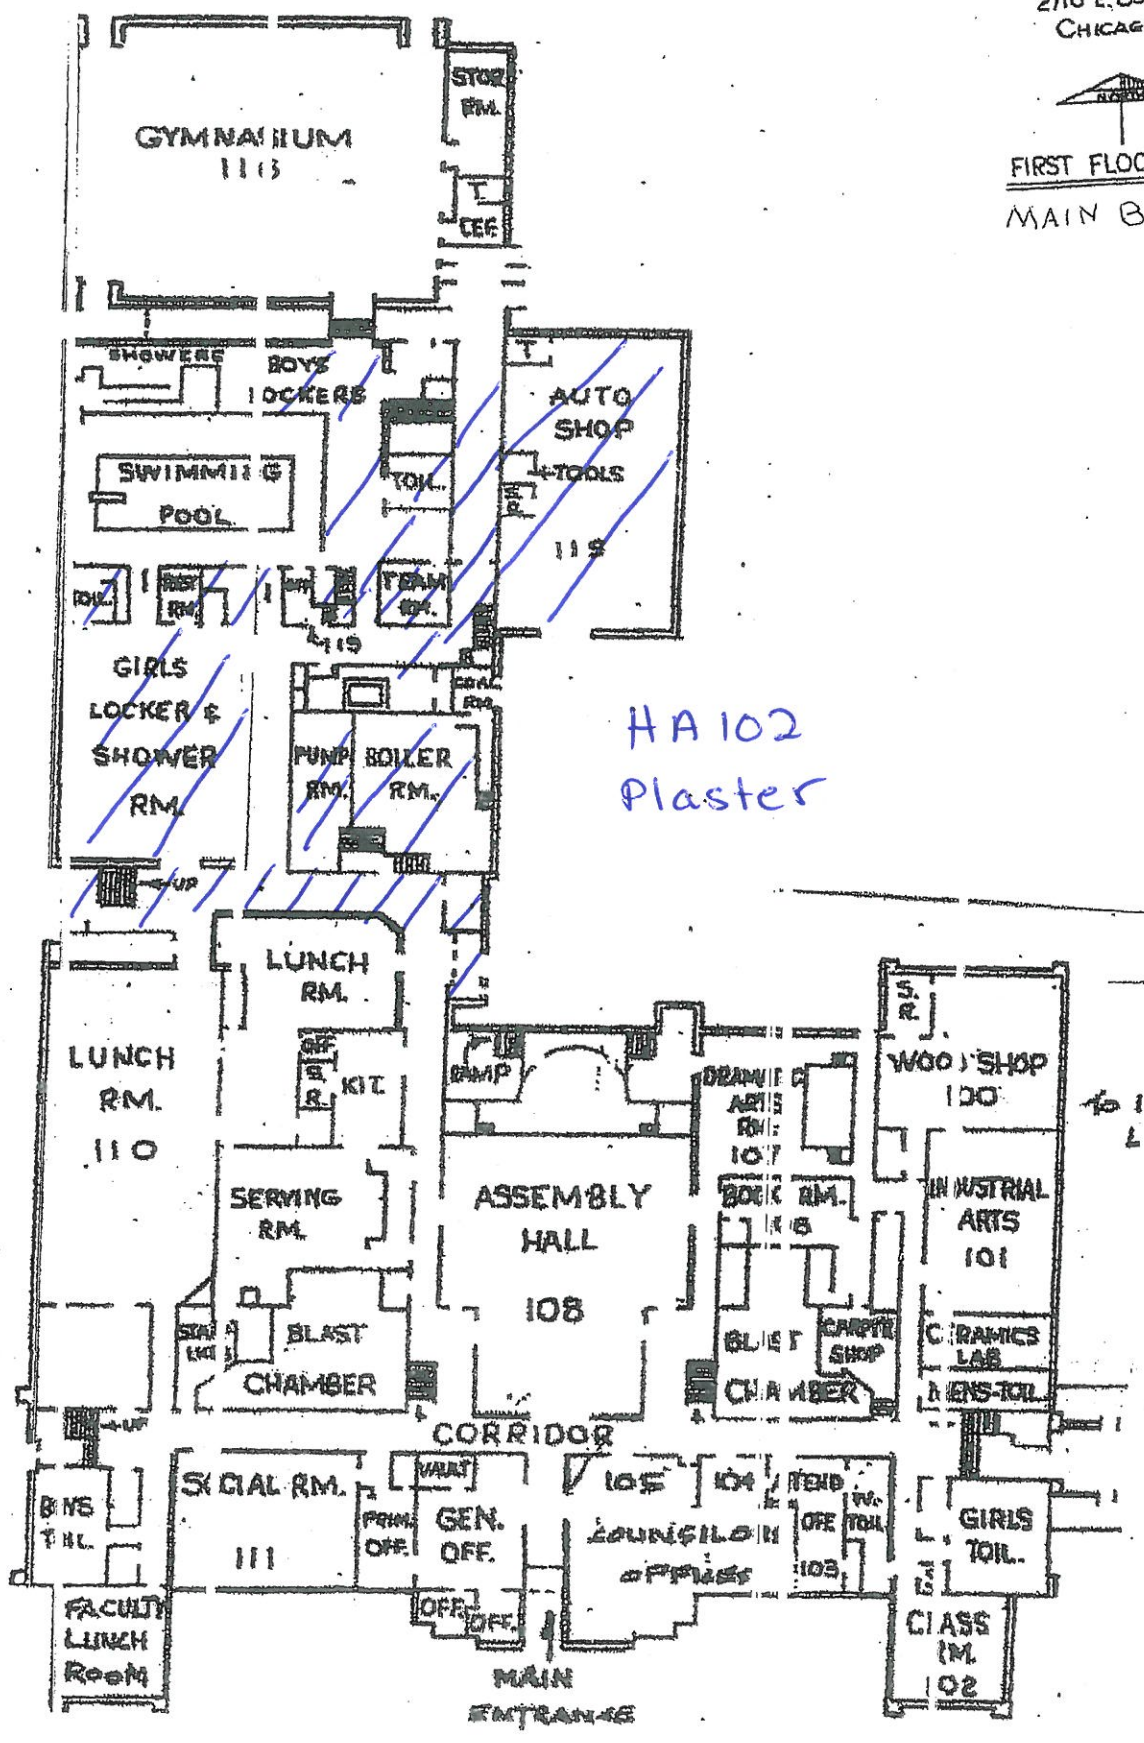
FIRST FLOOR PLAN
MAIN BLDG

HA 102
Plaster

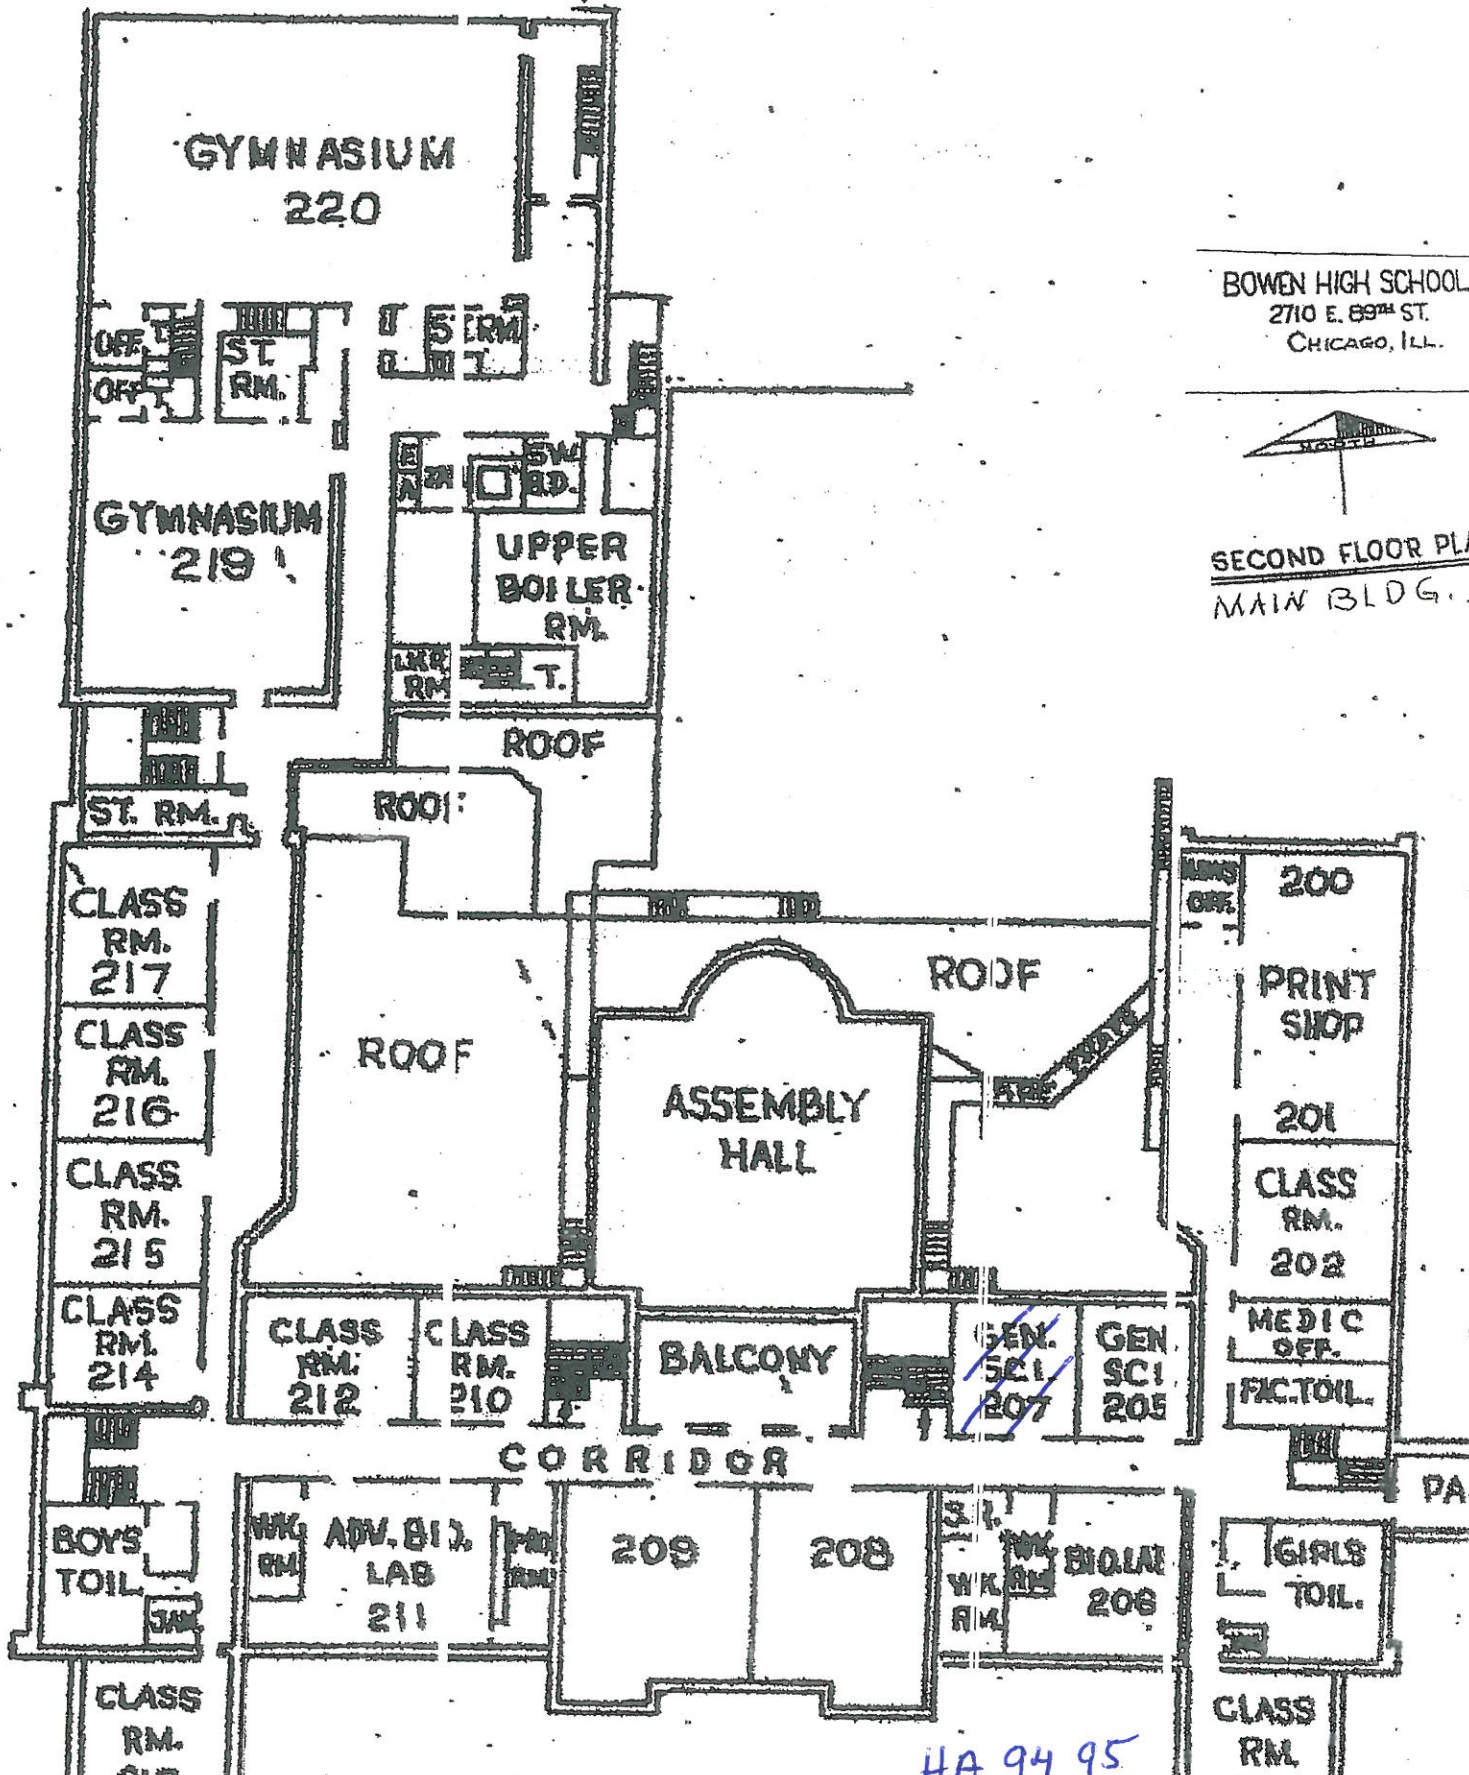
HA 94.95
 12x12
 Vanilla mixed
 speckled
 @ mastic

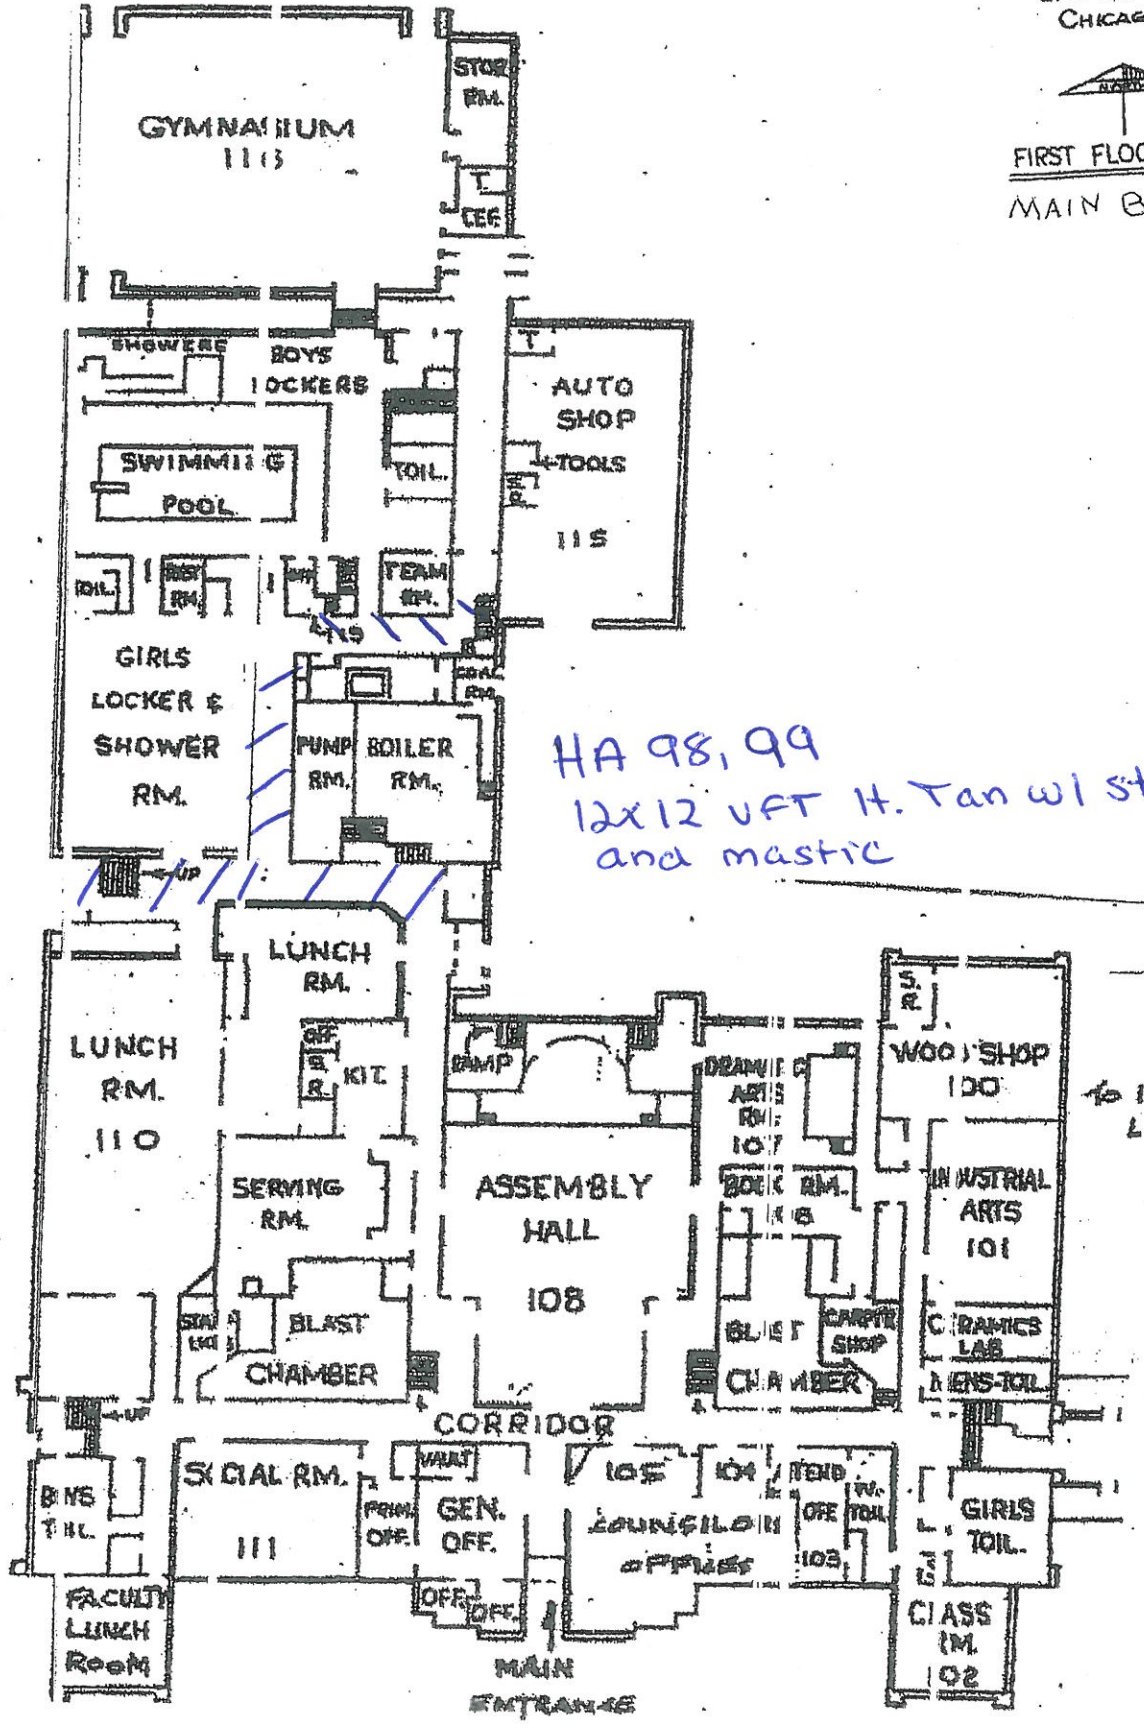
FIRST FLOOR PLAN
MAIN BLDG

HA 98, 99
12x12 VFT H. Tan w/ streaks
and mastic

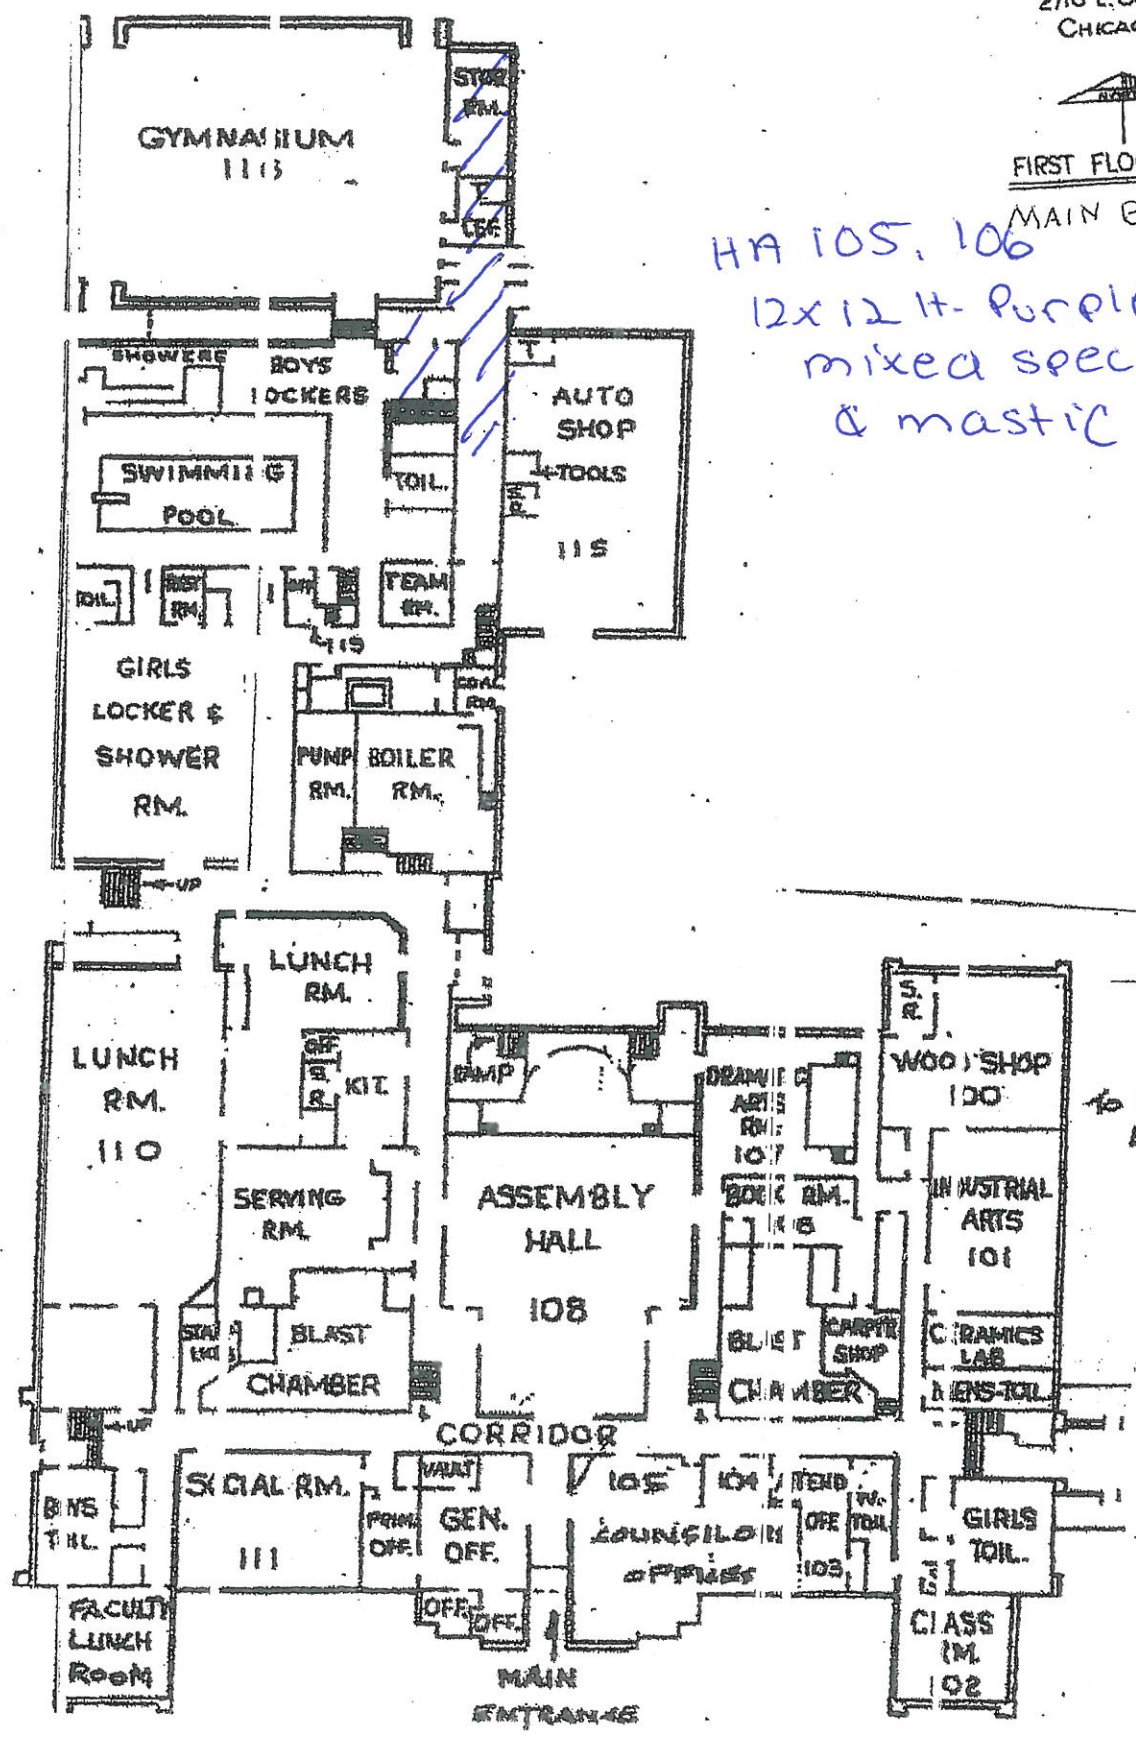
FIRST FLOOR PLAN
MAIN BLDG

HA 105, 106
12x12 lt. Purple
mixed speckled
& mastic
