**ILLINOIS DEPARTMENT OF PUBLIC HEALTH
AHERA THREE YEAR REINSPECTION
ASBESTOS ABATEMENT PROGRAM
SCHOOL INFORMATION FORM**

THREE-YEAR REINSPECTION

Chicago International Charter - Irving Park Campus

3820 N. Irving Park Road
Chicago, IL, 60618

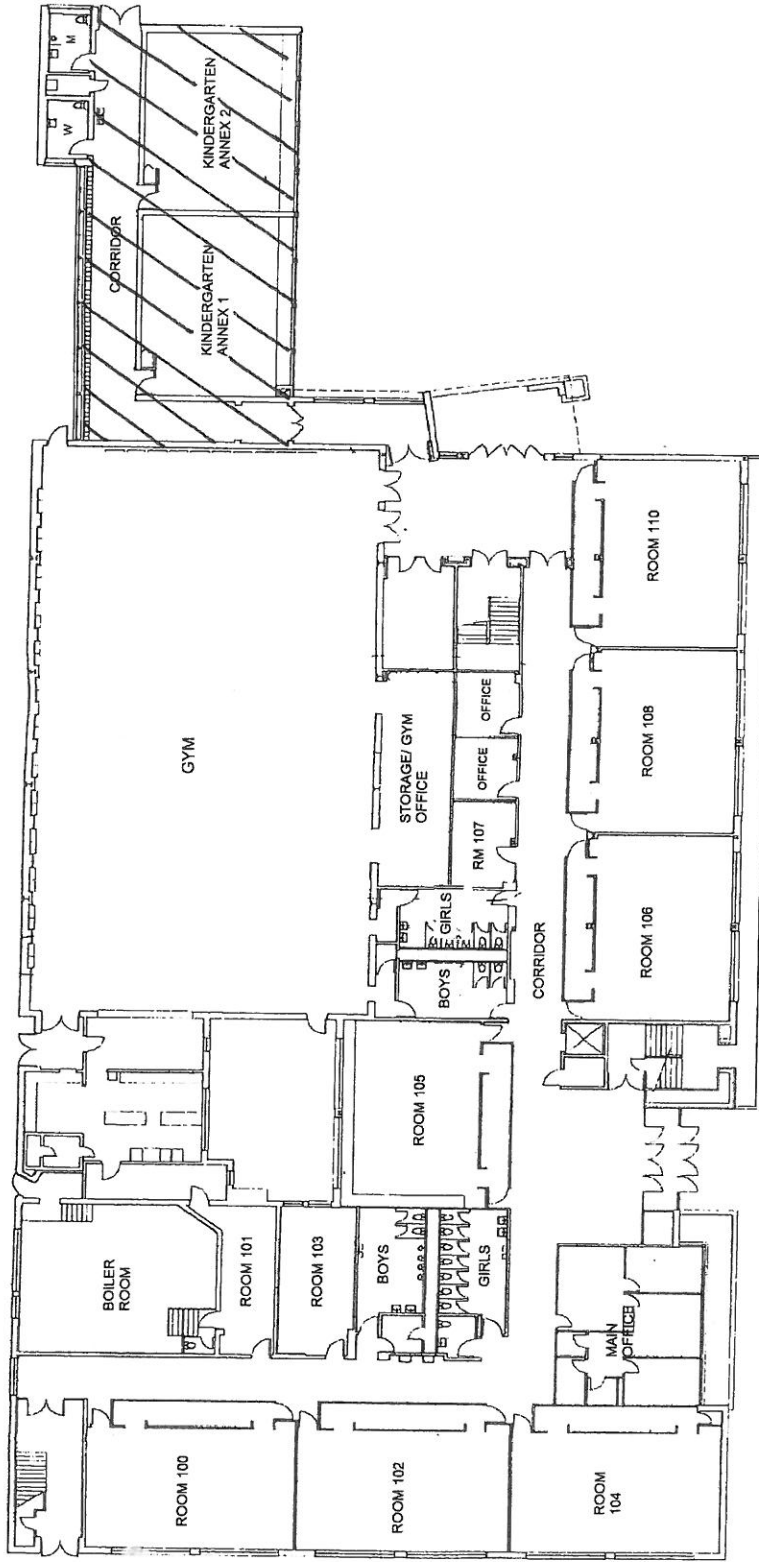
FIRST FLOOR PLAN
SCALE: 1/8" = 1'-0"

HA # 19
 18" X 18" Red streaked vFT
 HA # 19A
 MASTIC

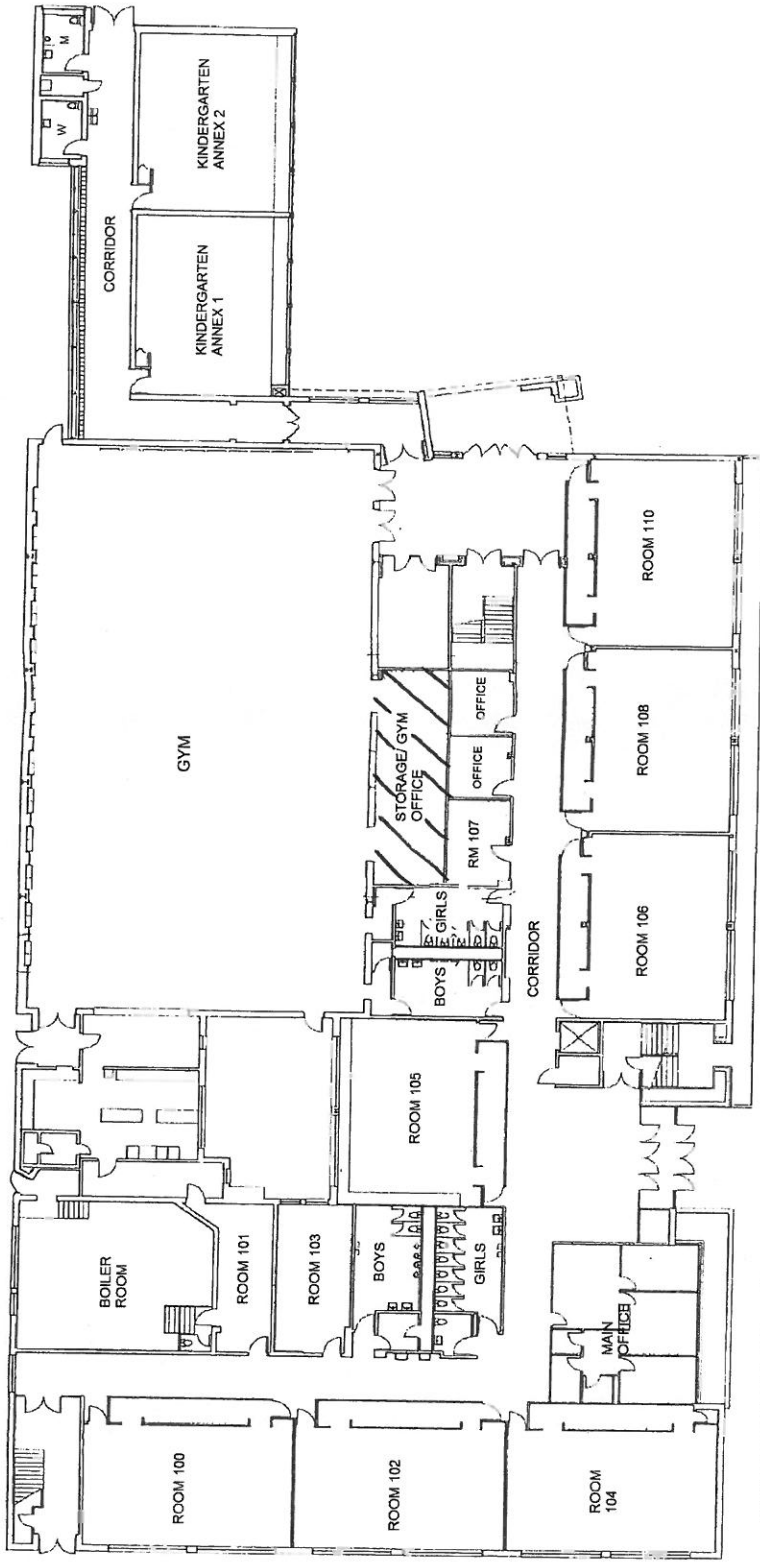
FIRST FLOOR PLAN
 DATE: 10/1/10
 SCALE: 3/8" = 1'-0"

HA # 17
 12" X 12" Black w/ white streaks UFT
 HA # 17A
 MASTIC

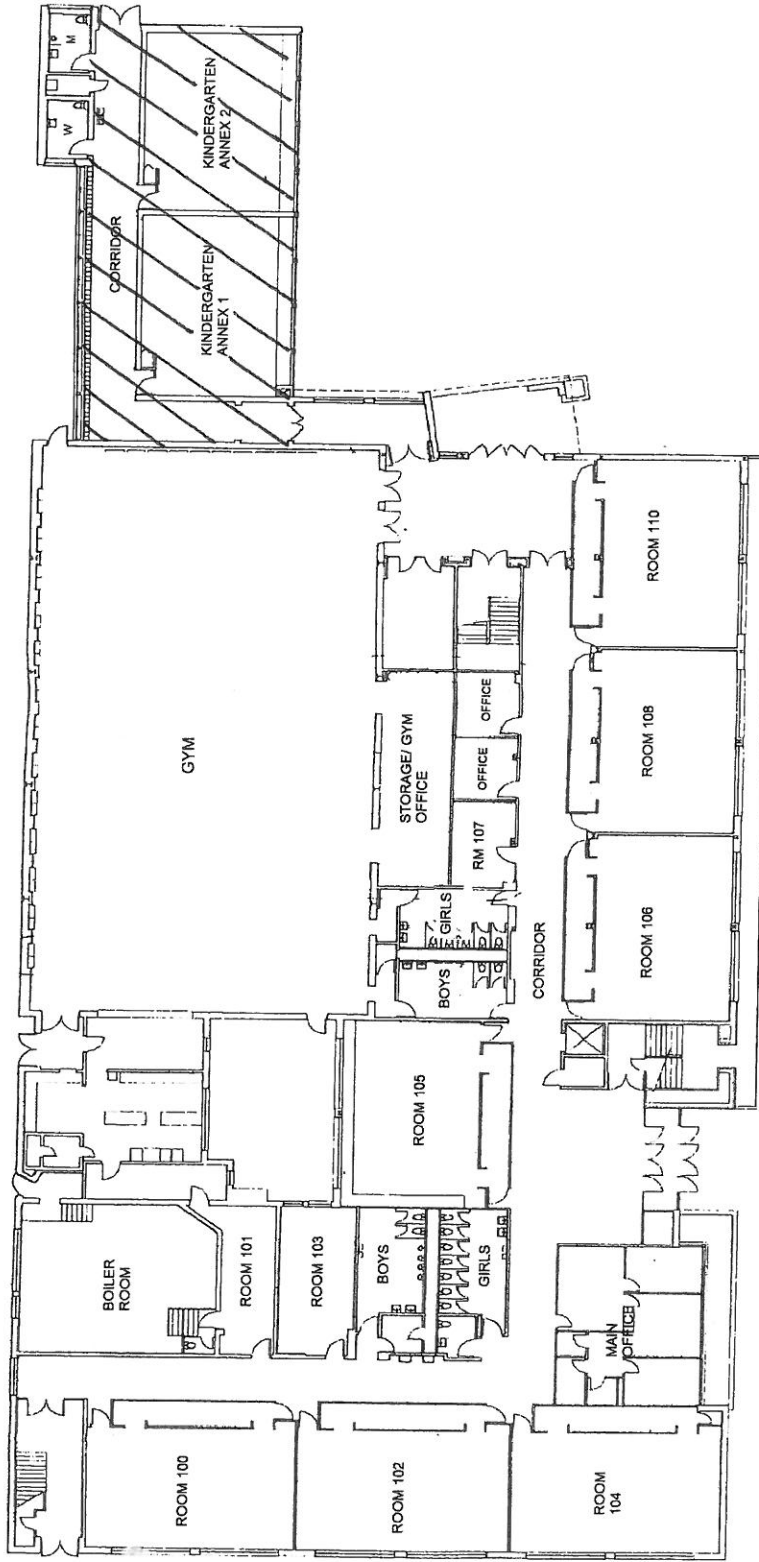
FIRST FLOOR PLAN
SCALE: 1/8" = 1'-0"

HA # 19
 18" X 18" Red streaked vFT
