ILLINOIS DEPARTMENT OF PUBLIC HEALTH
AHERA THREE YEAR REINSPECTION
ASBESTOS ABATEMENT PROGRAM
SCHOOL INFORMATION FORM

THREE-YEAR REINSPECTION

Chicago International Charter - Prairie

Wednesday, May 15, 2013

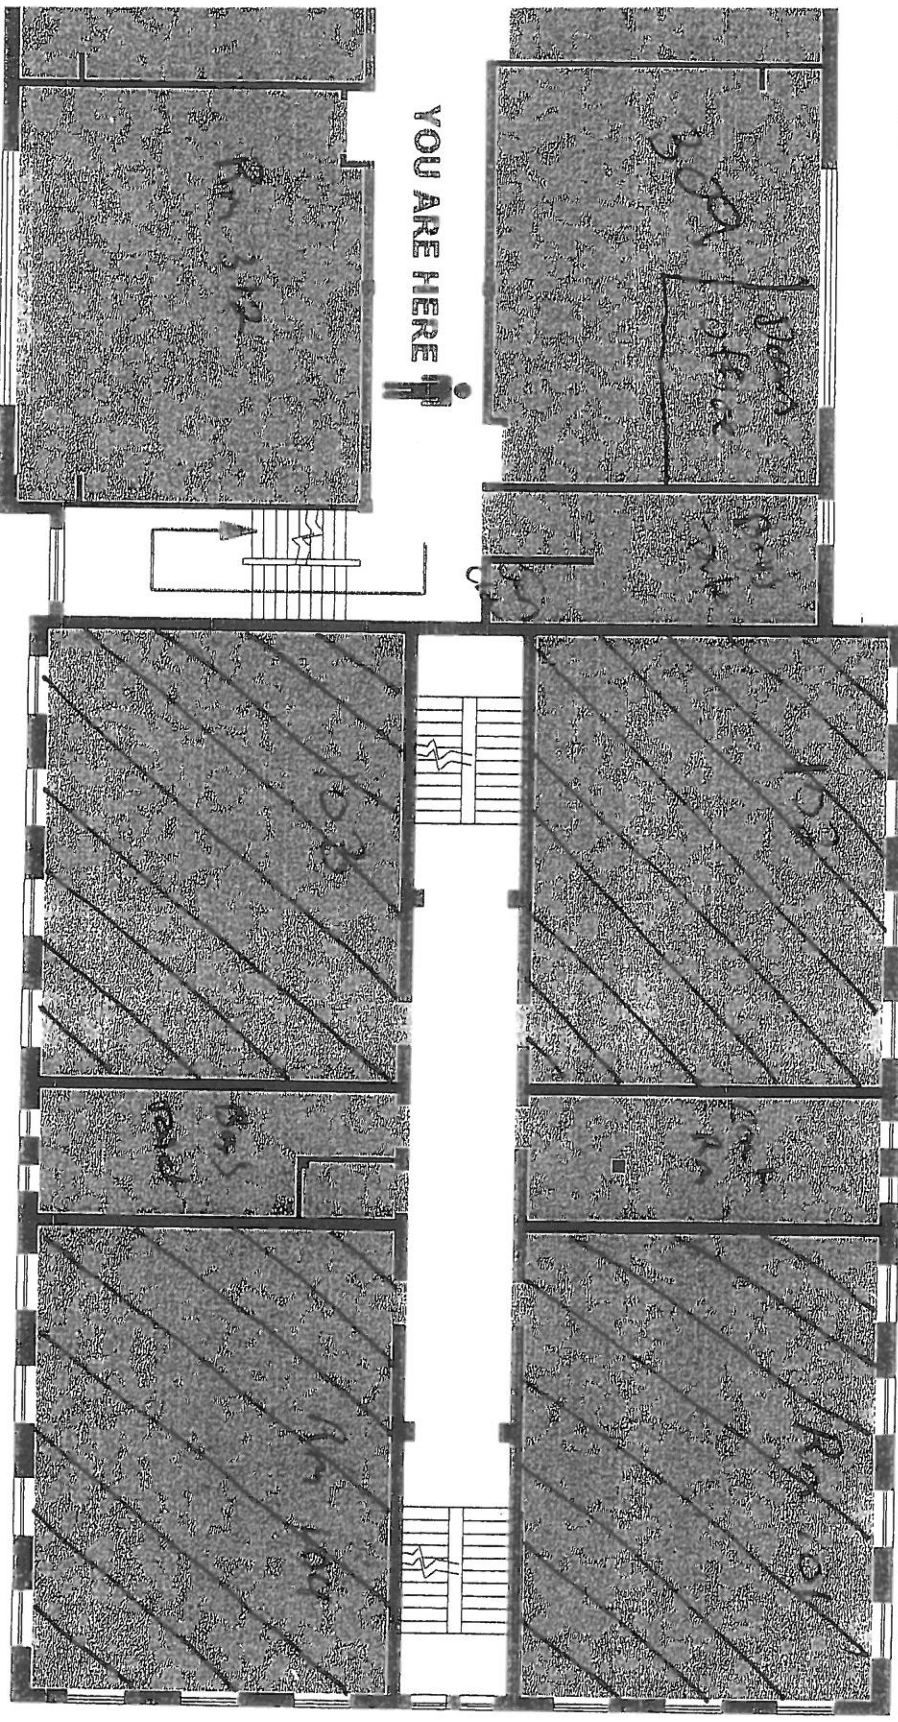
HA # 21+22
12x12 Red Floor tile + Mastic

21	12x12 Red VFT	1,500	SF	Rooms 101-104, 205-208, primary building	ASSUMED	MISC	N	NONE				ACBM with the potential for damage		MODERATE
22	12x12 Red VFT Mastic	1,500	SF	rooms 101-104, 205-208, primary bldg	ASSUMED	MISC	N	NONE				ACBM with the potential for damage		MODERATE
23	12x12 Grey VFT	1,600	SF	rooms 101-104, coat room and toilet, primary bldg, 205-208, asst principal office and toilet, 2nd fl janitors closet	ASSUMED	MISC	N	NONE				ACBM with the potential for damage		MODERATE
24	12x12 Grey VFT Mastic	1,600	SF	rooms 101-104, coat room and toilet primary building, 205-208, asst principal office and toilet, 2nd fl janitors closet	ASSUMED	MISC	N	NONE				ACBM with the potential for damage		MODERATE
25	12x12 Light Grey w/ grey specs VFT	2,000	SF	primary bldg 2nd fl corridor	ASSUMED	MISC	N	NONE				ACBM with the potential for damage		MODERATE
26	12x12 light grey w/ grey specs VFT Mastic	2,000	SF	primary bldg 2nd fl corridor	ASSUMED	MISC	N	NONE				ACBM with the potential for damage		MODERATE

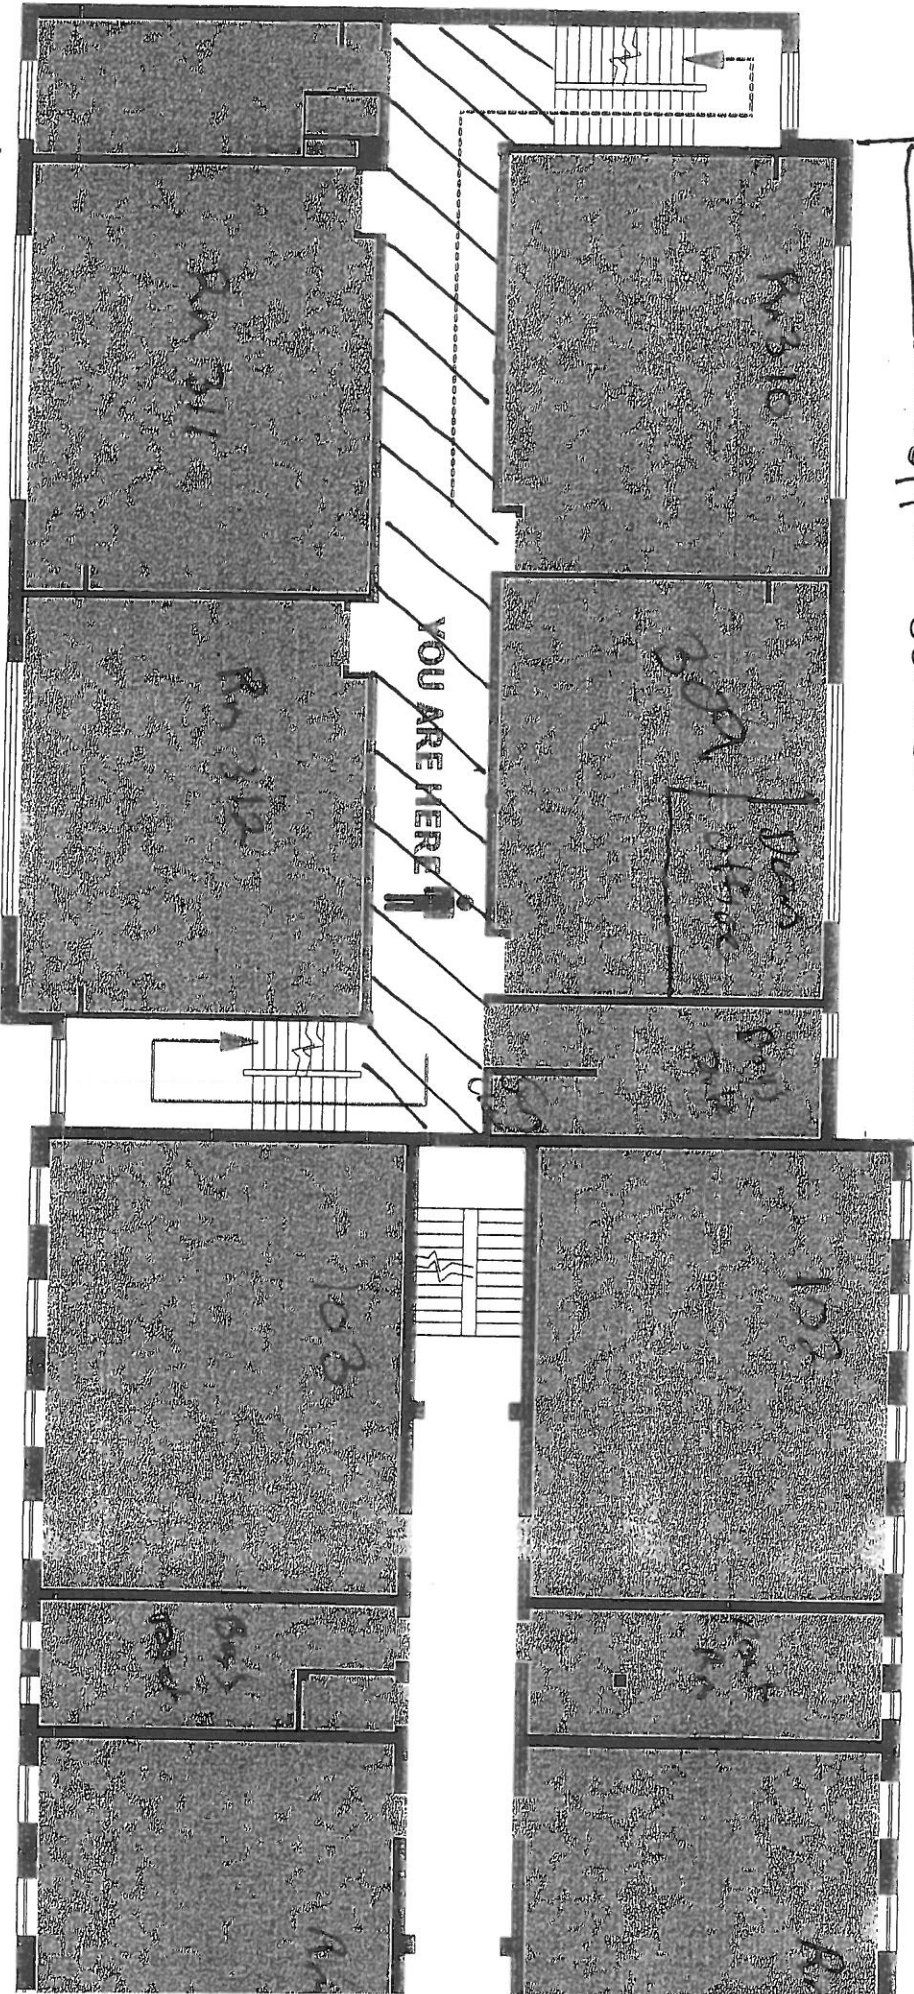
HA # 32+33

4x9 Black w/ grey specs Floor tile
+ Mastec

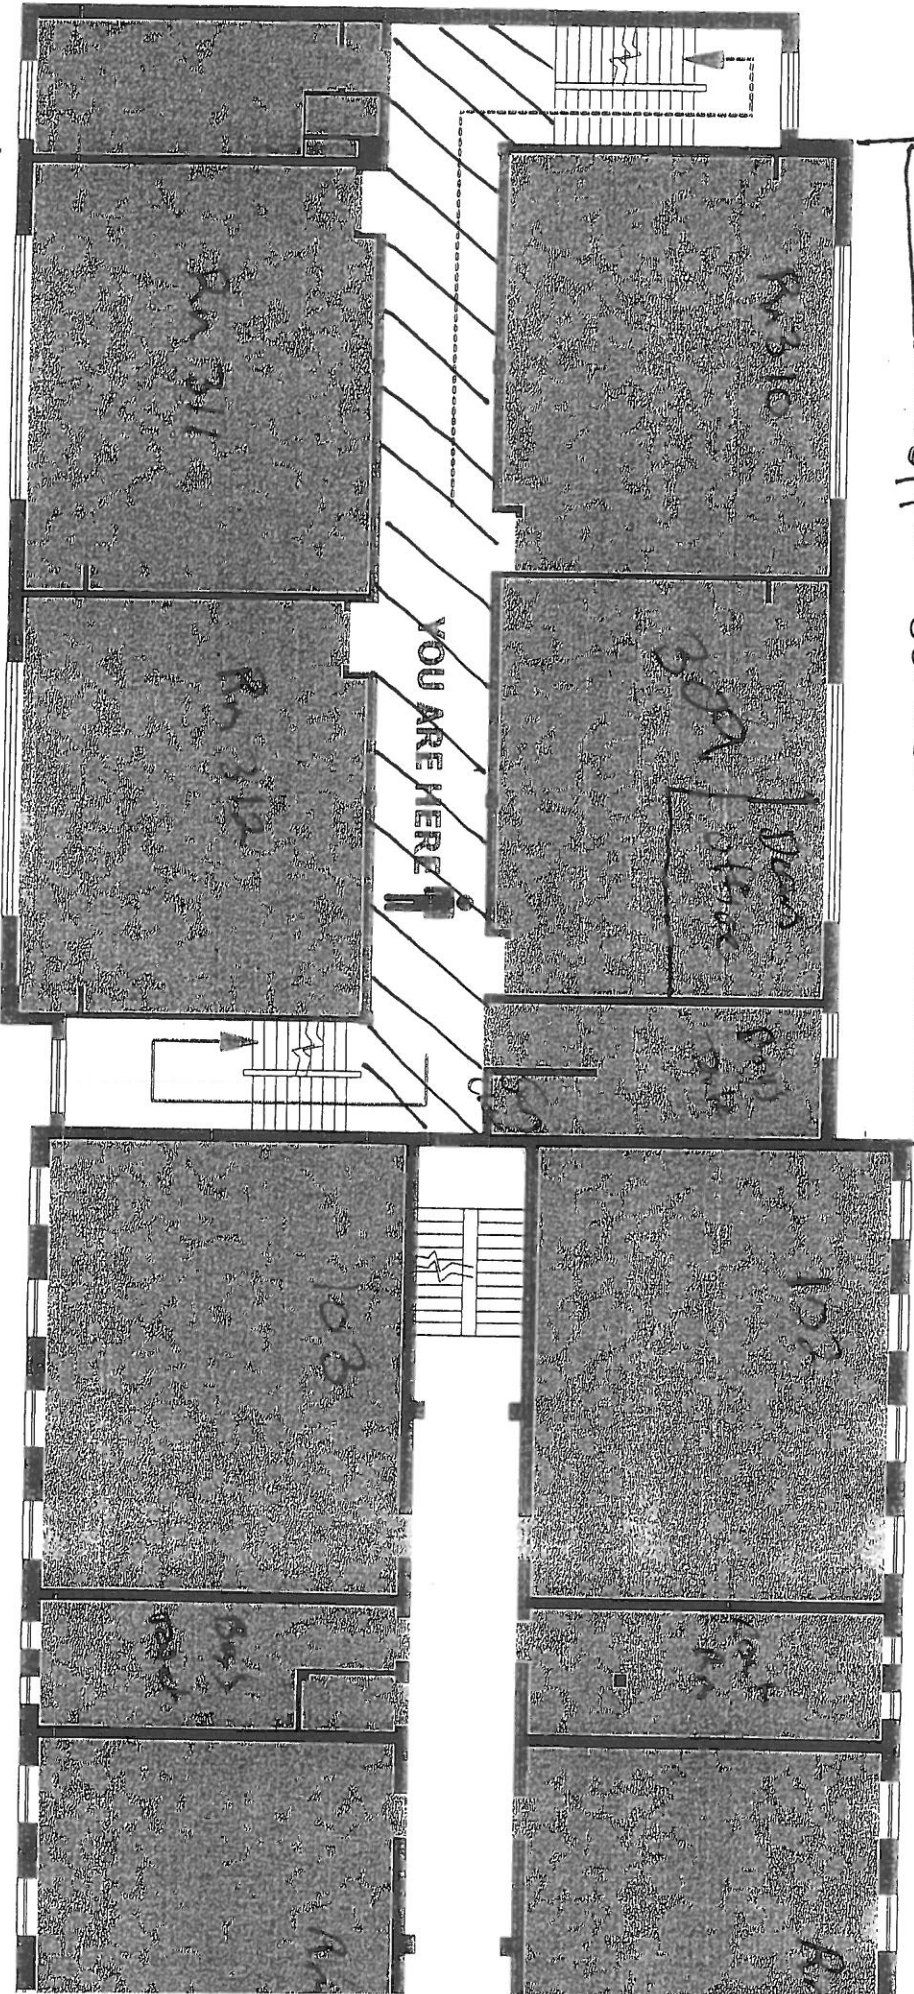
HA # 32+33

4x9 Black w/ grey specs Floor tile
+ Mastec

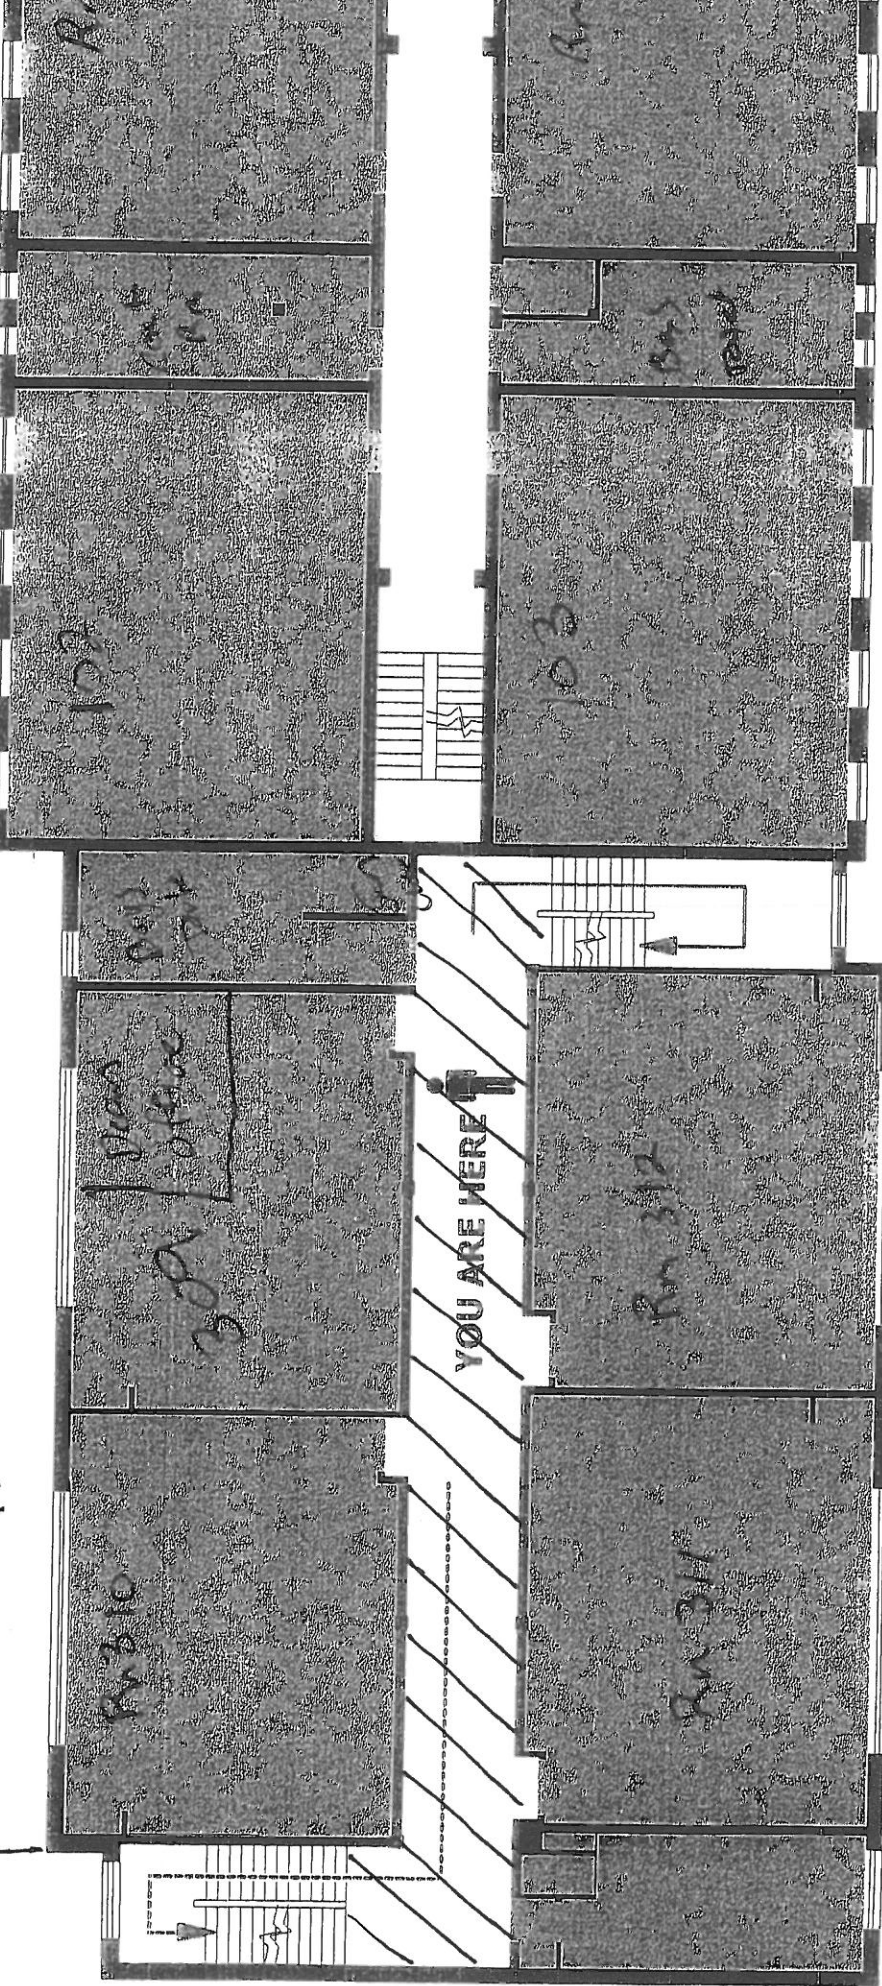
HA # 34 + 35
 9x9 Tan w/ Red streaks + Mosaic

34	9x9 Tan w/ red streaks VFT	1,000	SF	1st and 2nd fl hallway upper level bldg	ASSUMED	MISC	N	NONE				ACBM with the potential for damage		MODERATE
35	9x9 tan w/ red streaks VFT Mastic	1,000	SF	1st and 2nd fl hallway upper level bldg	ASSUMED	MISC	N	NONE				ACBM with the potential for damage		MODERATE
36	9x9 white + pink VFT	600	SF	Room 400 and hallway to multi-purpose room	ASSUMED	MISC	N	NONE				ACBM with the potential for damage		MODERATE
37	9x9 White + pink VFT Mastic	600	SF	Room 400 and hallway to multi-purpose room	ASSUMED	MISC	N	NONE				ACBM with the potential for damage		MODERATE
38	12x12 Gold VFT	400	SF	rooms 415 + 416	ASSUMED	MISC	N	NONE				ACBM with the potential for damage		MODERATE
39	12x12 gold VFT mastic	400	SF	rooms 415 + 416	ASSUMED	MISC	N	NONE				ACBM with the potential for damage		MODERATE
40	12x12 White w/ Gold specs	400	SF	rooms 415 + 416	ASSUMED	MISC	N	NONE				ACBM with the potential for damage		MODERATE

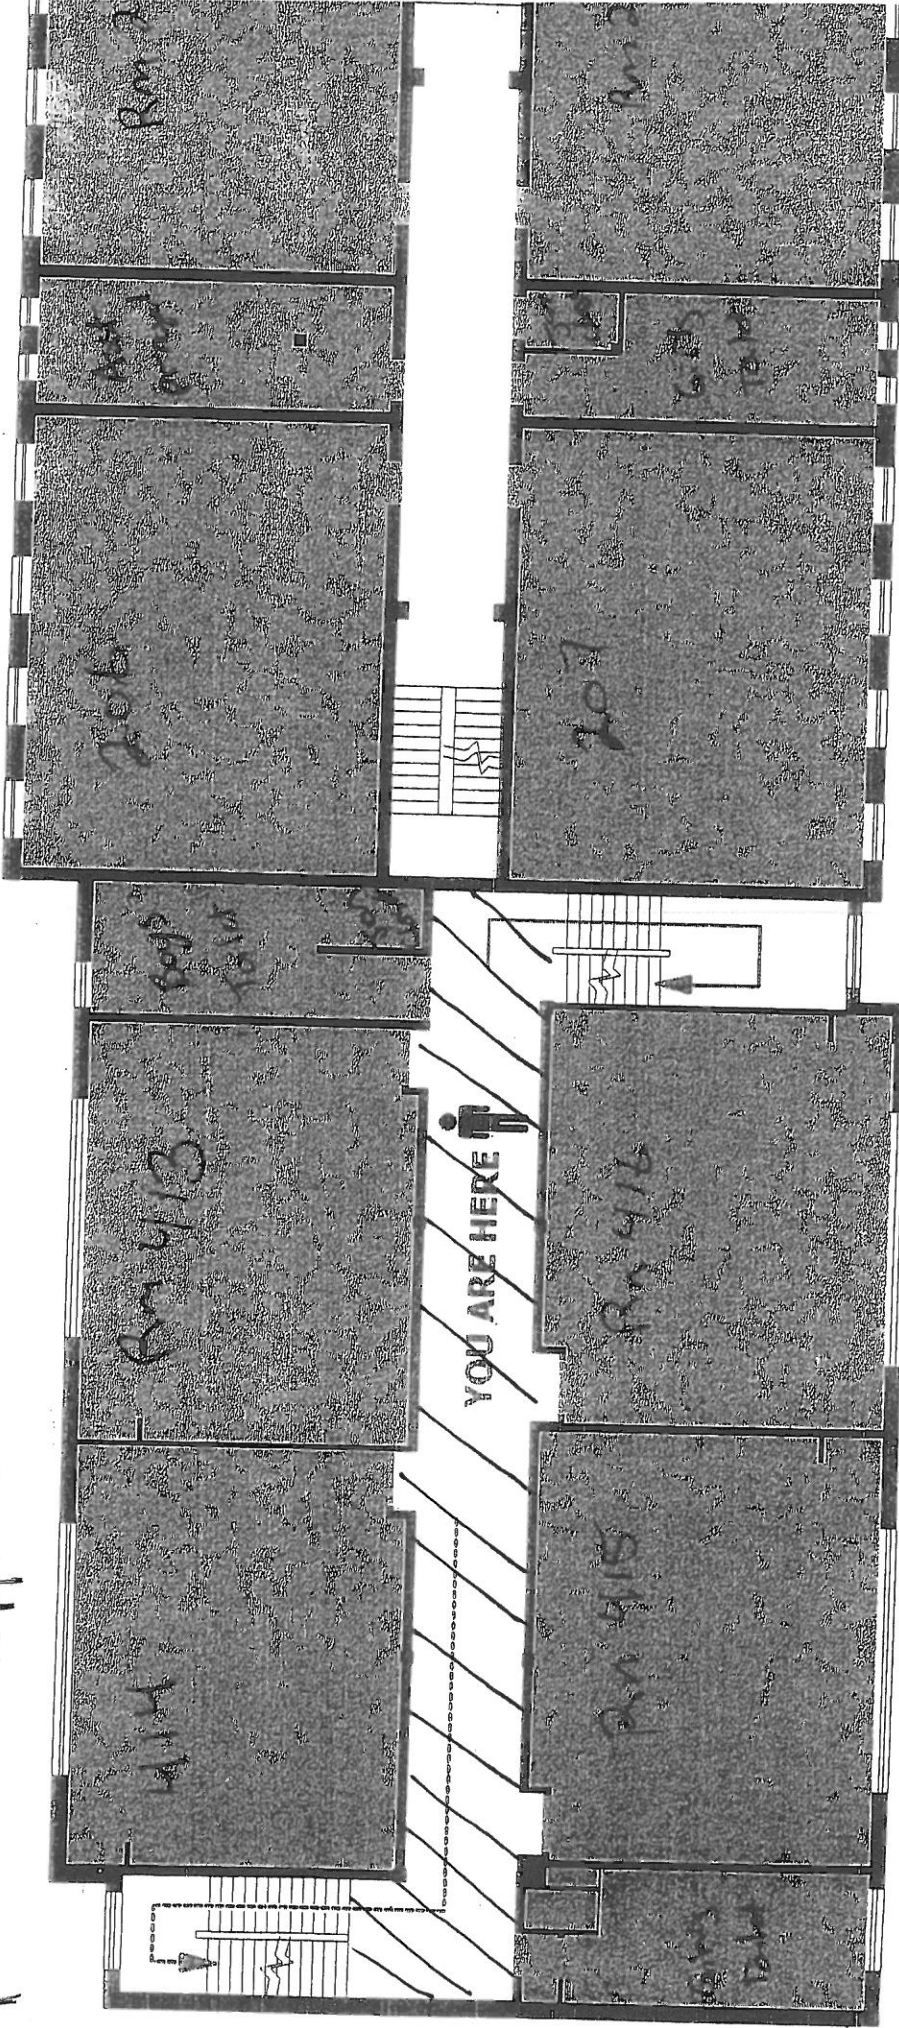
HA # 34 + 35

9x9 Tan w/Red streaks Floor-tile

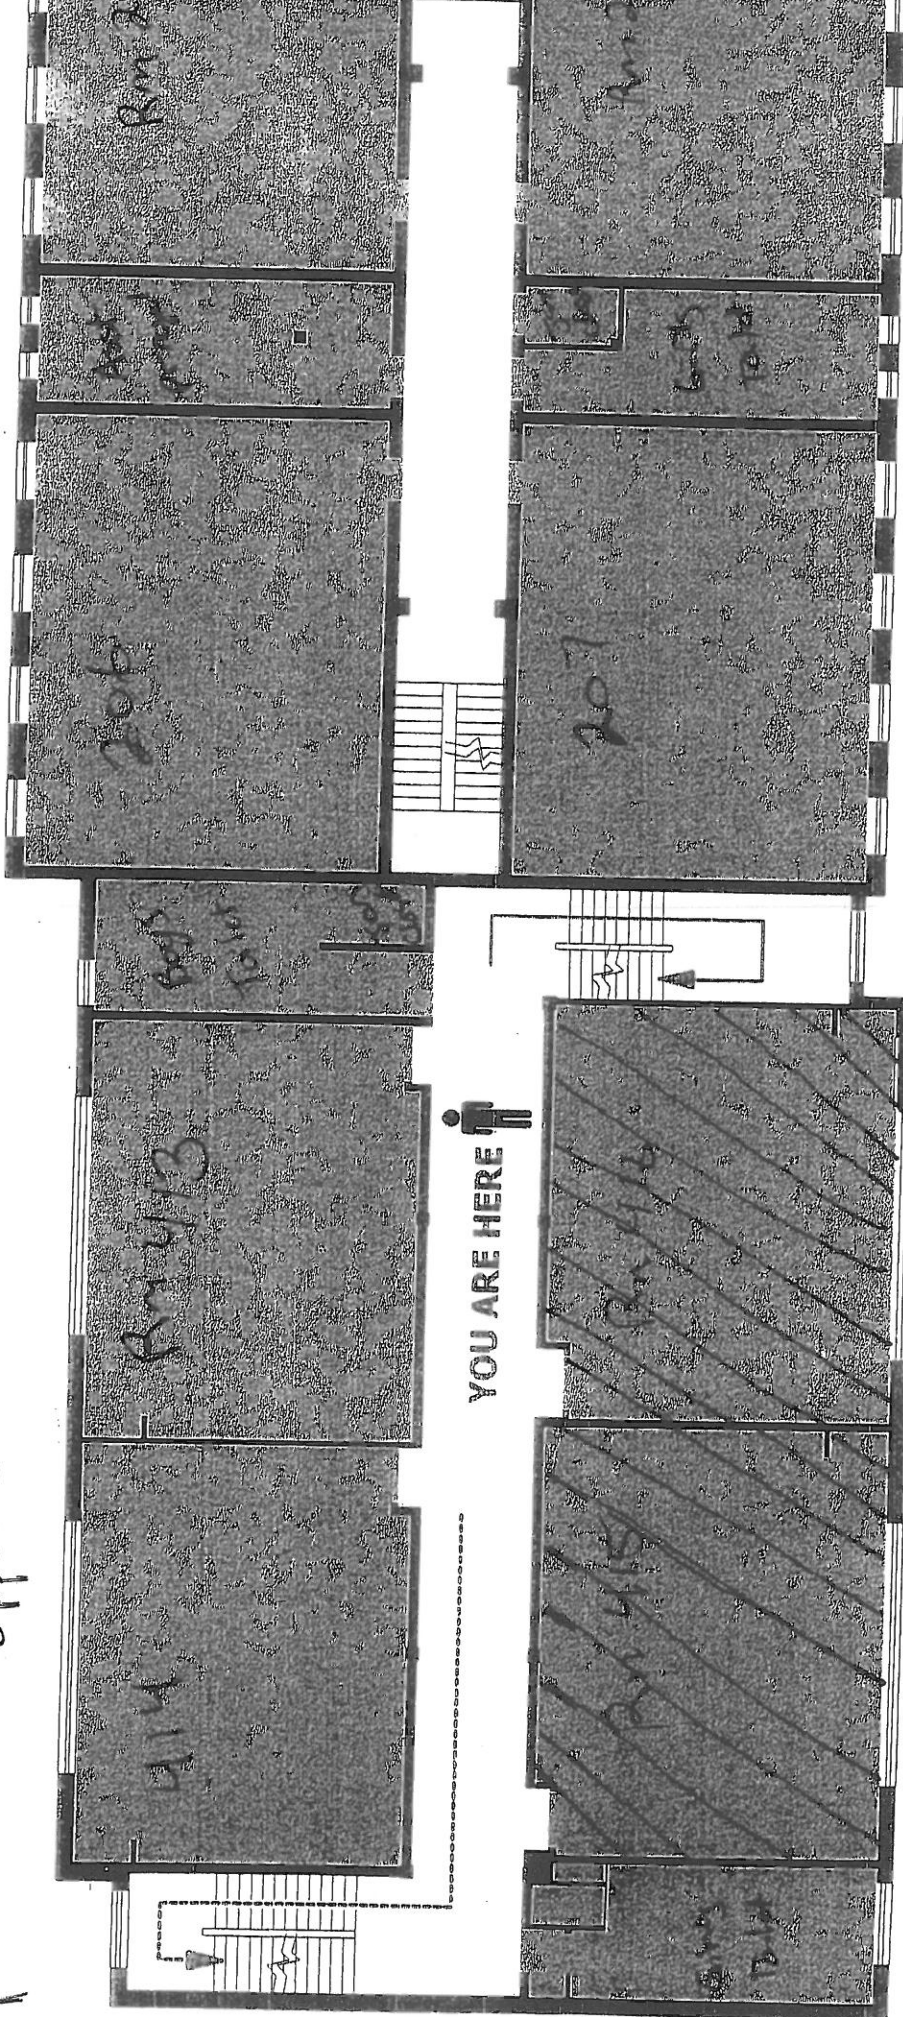
HA # 40+41
12x12 white w/ Gold Floor Tile
+ Mastic

41	12x12 white w/ gold specs VFT mastic	400	SF	rooms 415 + 416	ASSUMED	MISC	N	NONE				ACBM with the potential for damage		MODERATE

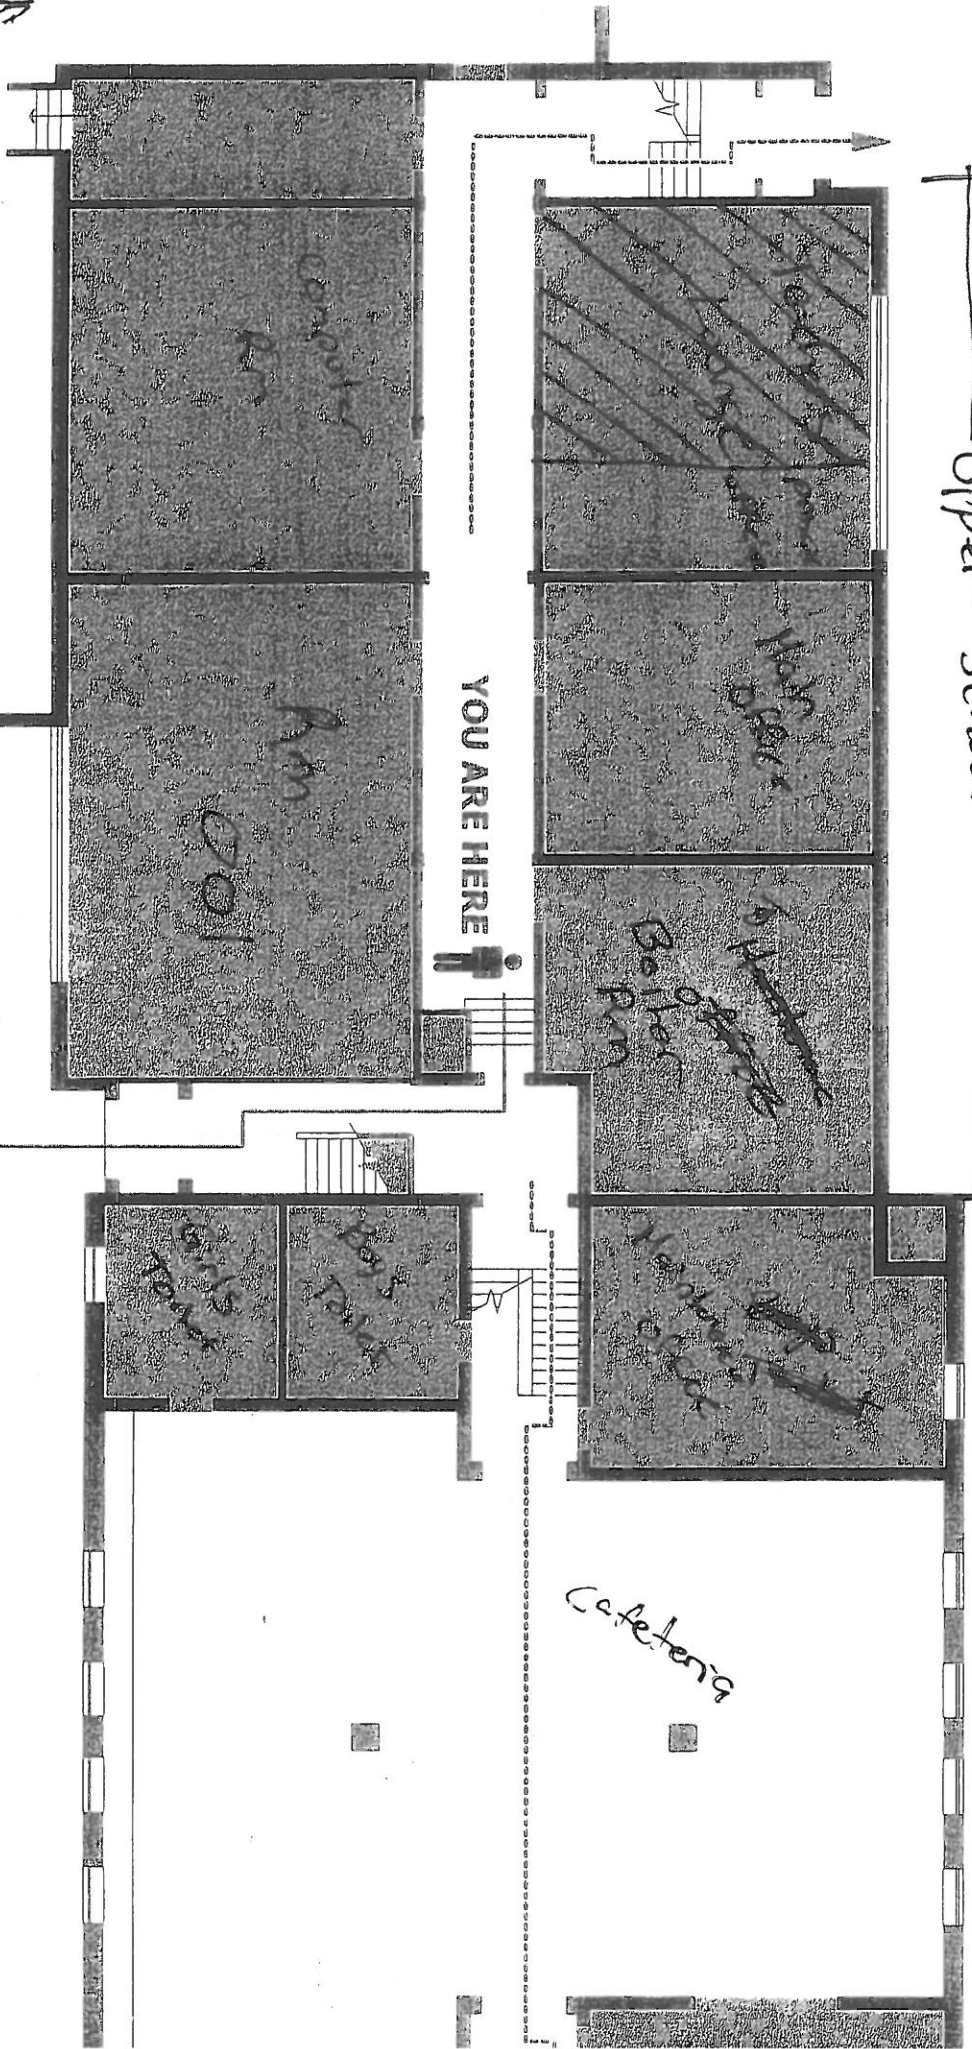
HA # 27488
12x12 Cream w/ Berge
Specs Floor Tile +
MASHC

27	12x12 Cream w/ beige specs VFT	400	SF	teachers lounge upper school upper school bldg	ASSUMED	MISC	N	NONE				ACBM with the potential for damage		MODERATE
28	12x12 Cream w/ beige specs VFT Mastic	400	SF	teachers lounge upper school upper school bldg	ASSUMED	MISC	N	NONE				ACBM with the potential for damage		MODERATE

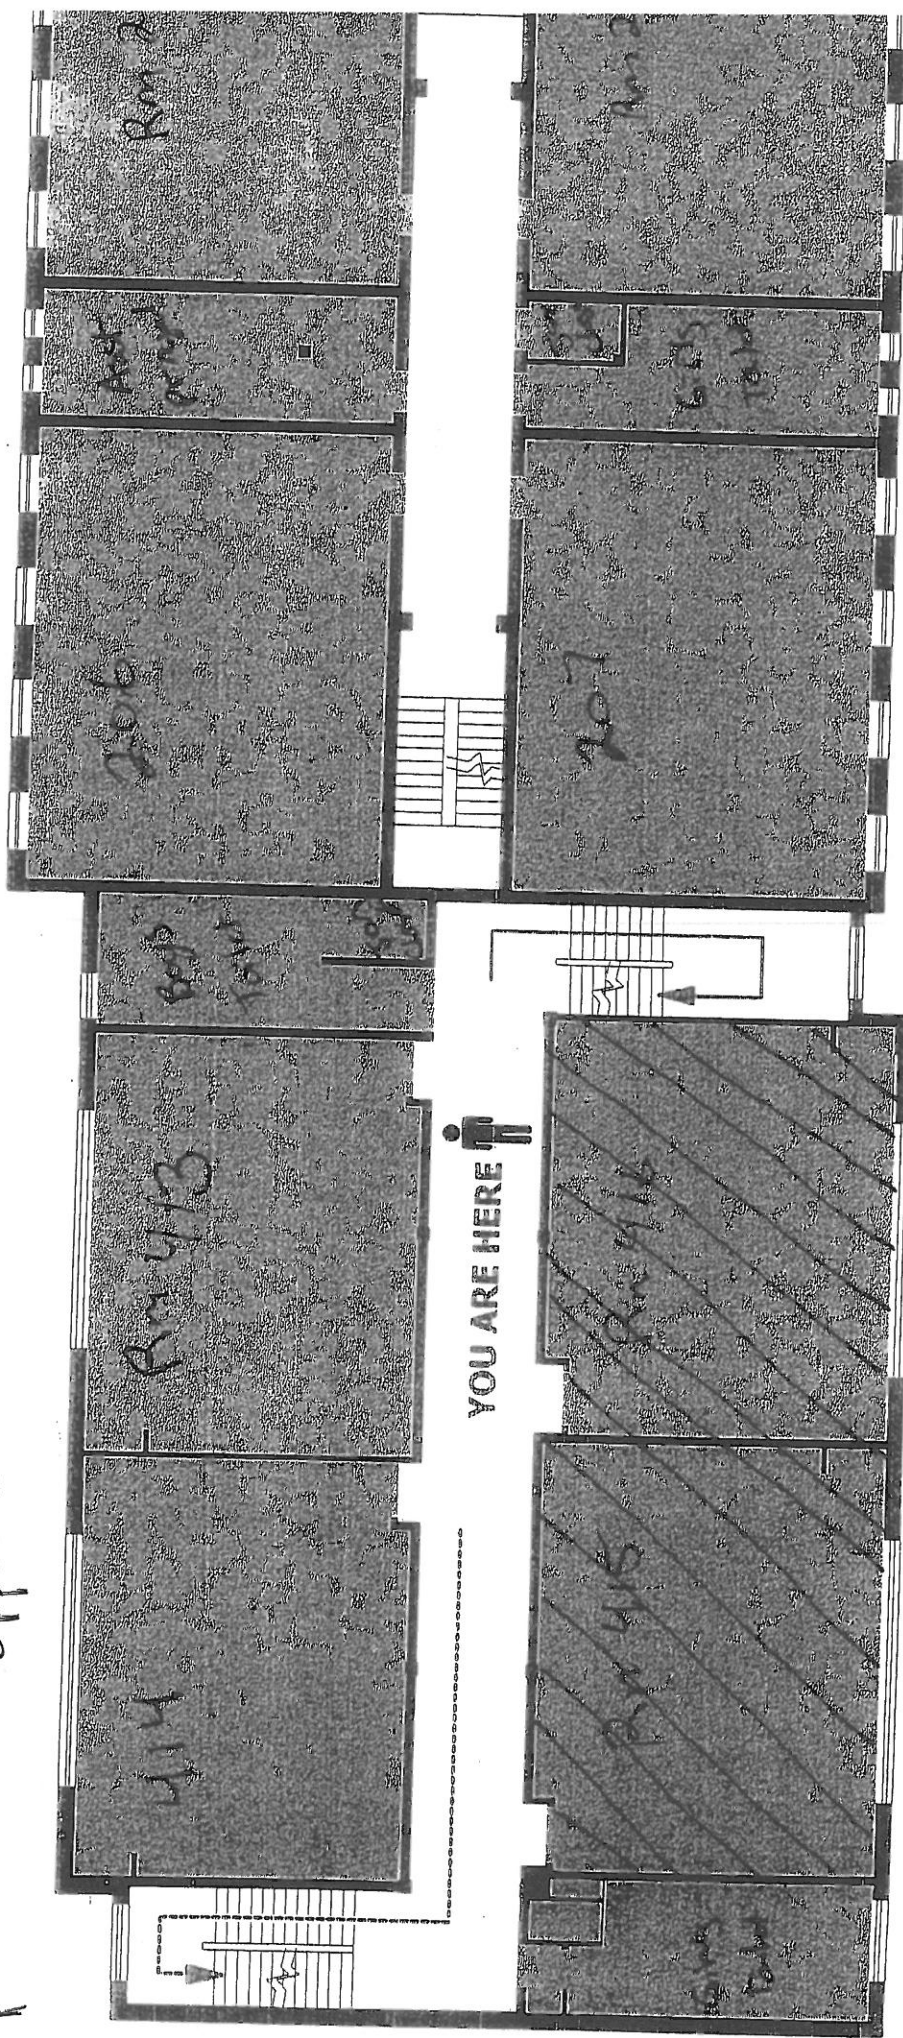
HA # 38 + 39

12x12 Gold Floor Tile + Mastic

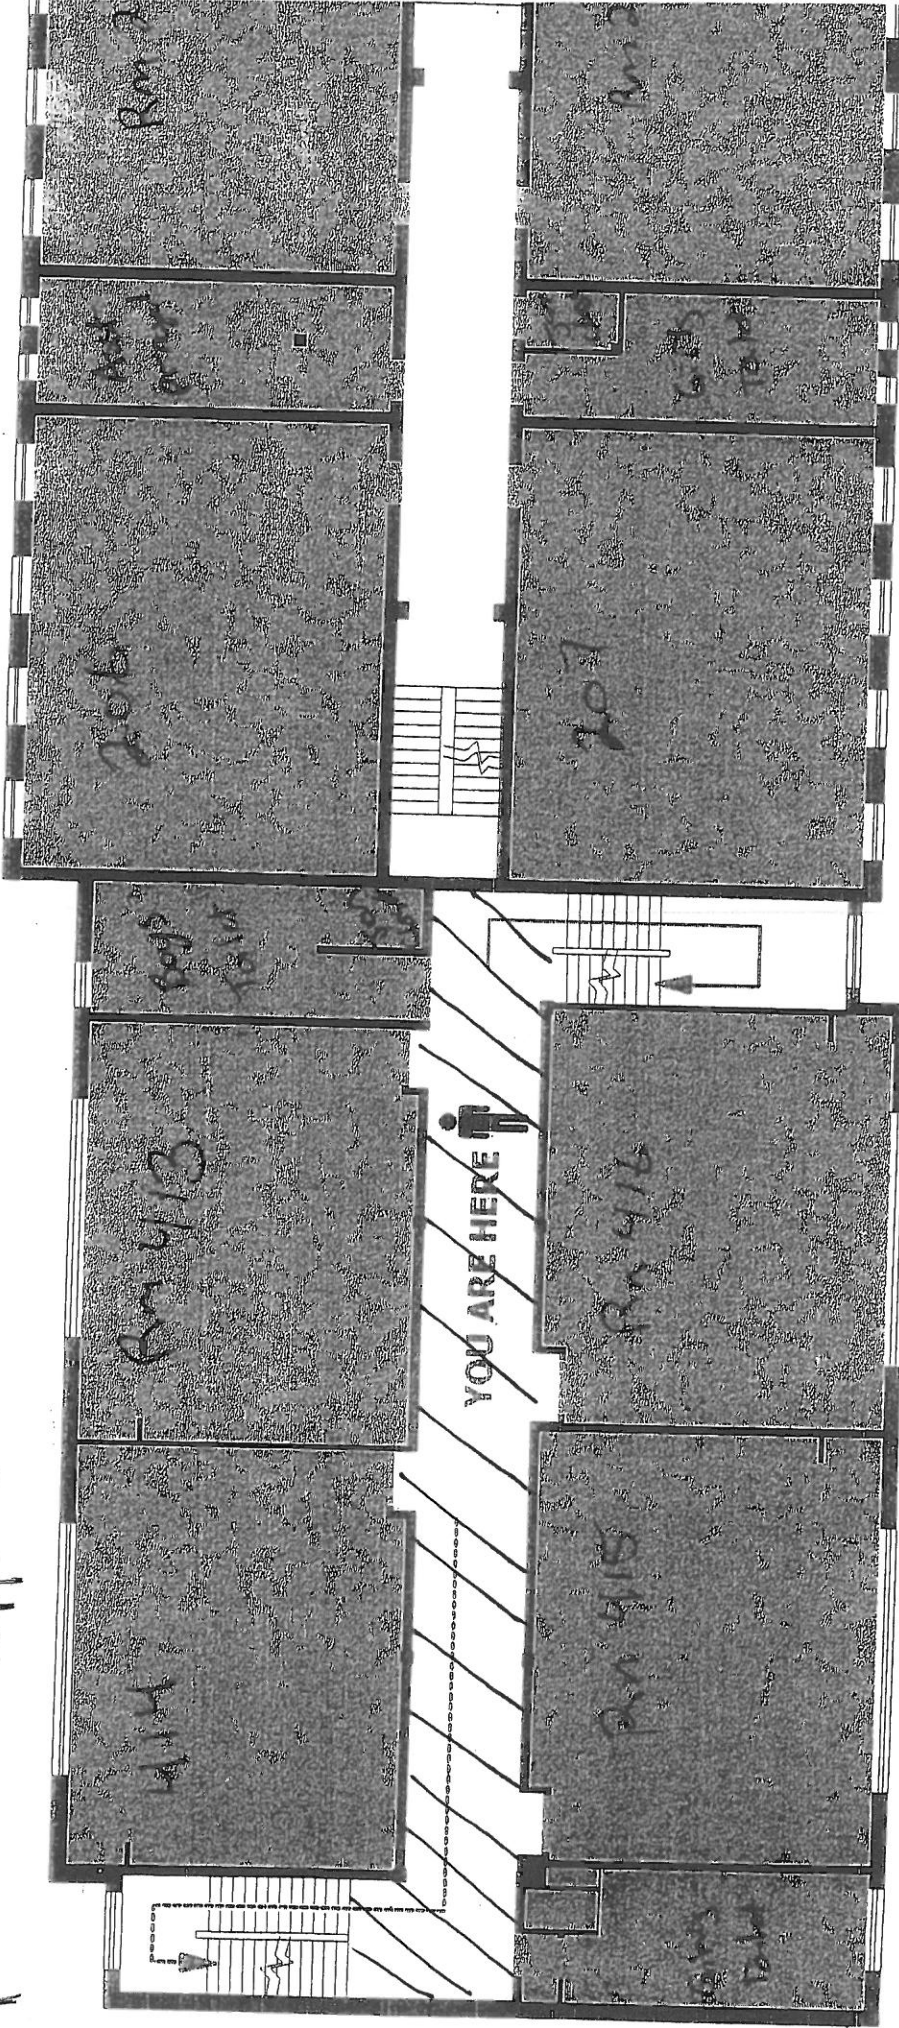
HA # 34 + 35

9x9 Tan w/Red streaks Floor-tile
