**ILLINOIS DEPARTMENT OF PUBLIC HEALTH
AHERA THREE YEAR REINSPECTION
ASBESTOS ABATEMENT PROGRAM
SCHOOL INFORMATION FORM**

THREE-YEAR REINSPECTION

Chicago International Charter - Northtown High School

Tuesday, May 14, 2013

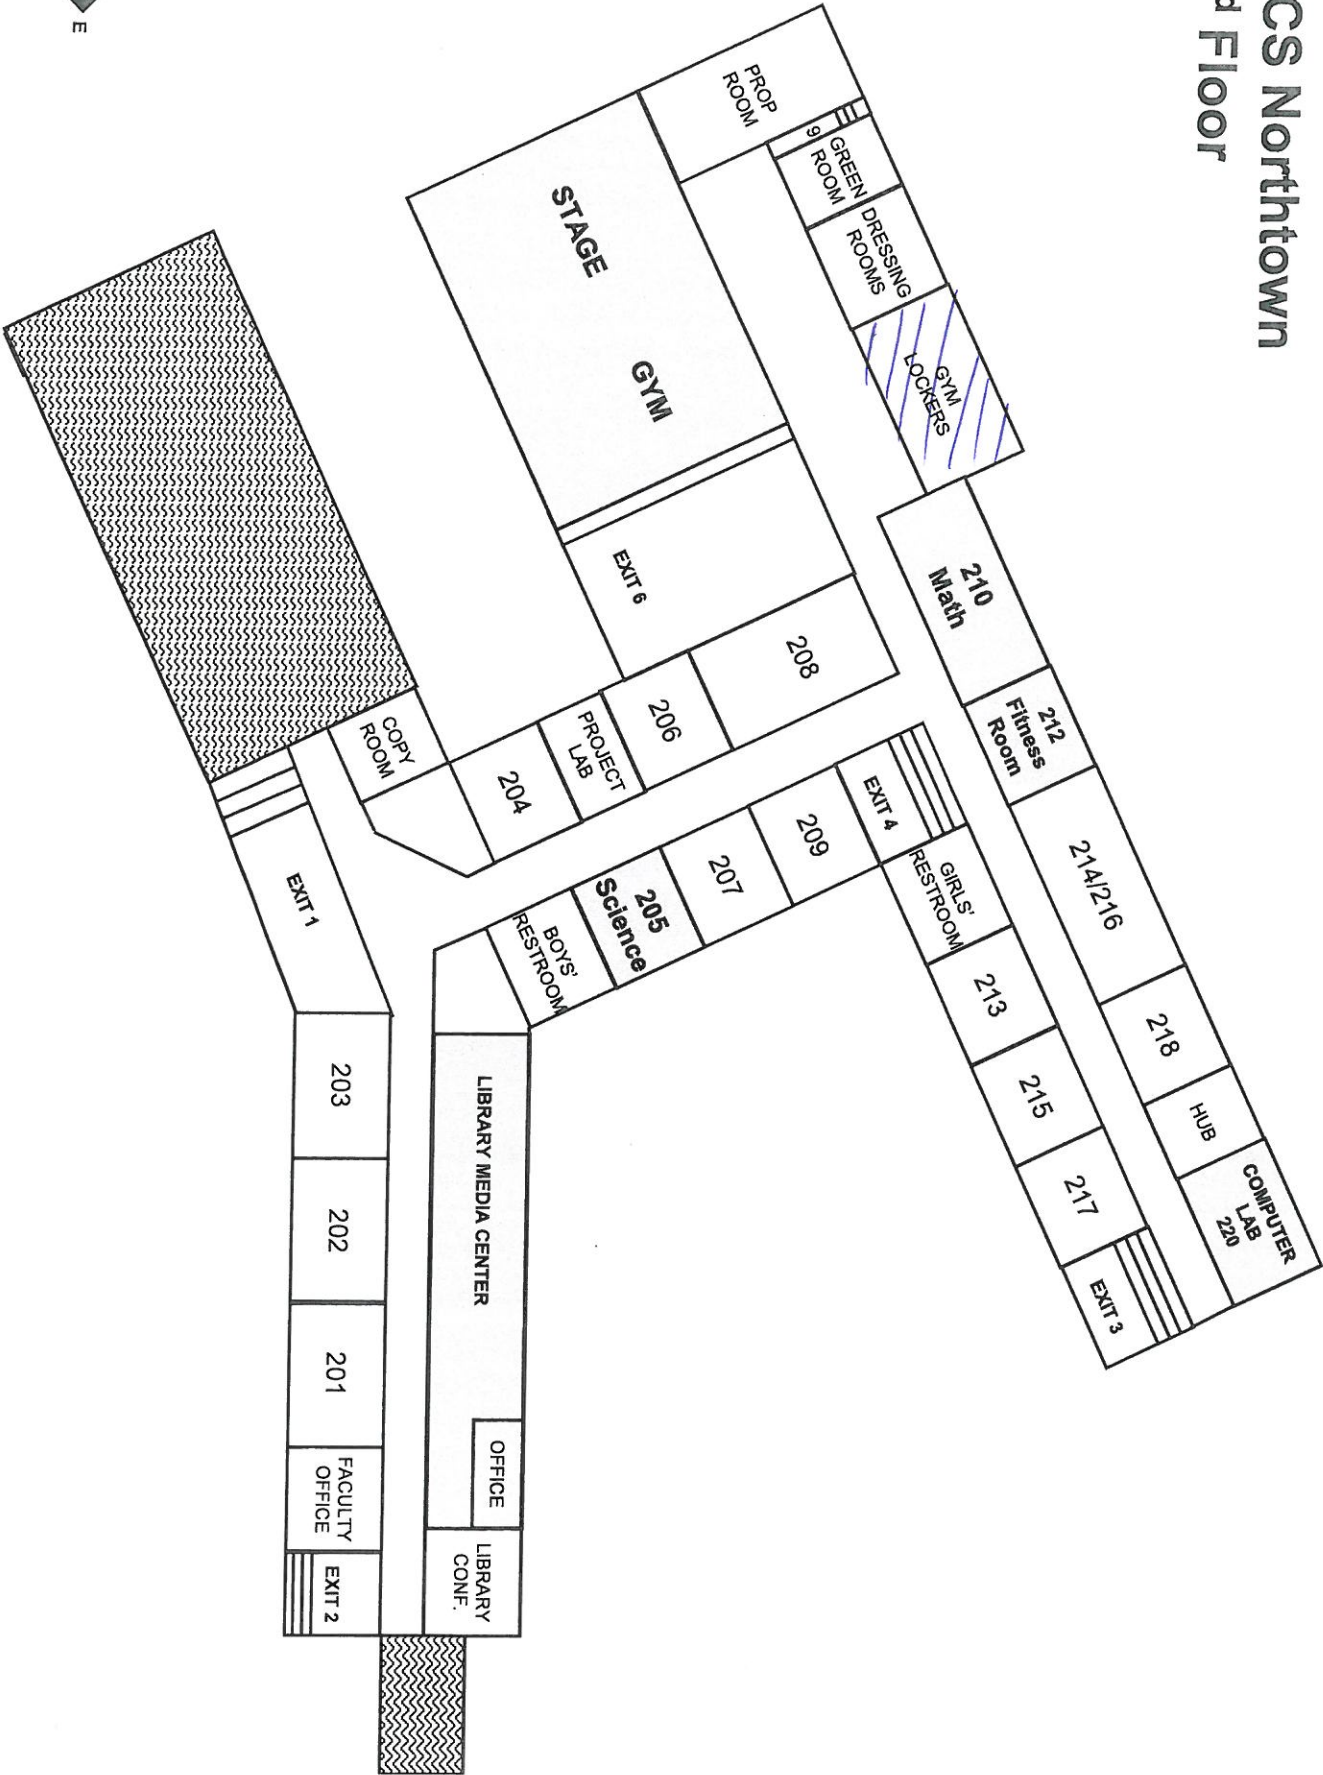
CICS Northtown 2nd Floor

114	Linoleum gray and blue VFT	1,600	SF	Girls and boys locker rooms	Assumed	MISC	No	0	SF	6 ACBM with the potential for damage	Operations and Maintenance
114A	Linoleum gray and blue VFT MASTIC	1,600	SF	Girls and boys locker rooms	Assumed	MISC	No	0	SF	6 ACBM with the potential for damage	Operations and Maintenance
115	1'x1' Ceiling tiles with grooves	40,000	SF	Throughout	Assumed	MISC	Yes	0	SF	6 ACBM with the potential for damage	Operations and Maintenance
116	Drywall system	2,000	SF	Dressing room	Assumed	MISC	Yes	0	SF	6 ACBM with the potential for damage	Operations and Maintenance
117	Black lab table tops	800	SF	Rooms 205, 208, 206	Assumed	MISC	No	0	SF	6 ACBM with the potential for damage	Operations and Maintenance
118	Preformed insulation magblock	500	SF	Janitorial supply room- found below a layer of black duct insulation wrap (HA GC-F01)	Assumed	MISC	Yes		SF	5 ACBM with potential for significant damage	Operations and Maintenance

HA 114 & 114A
 - window gray and blue with MASHC

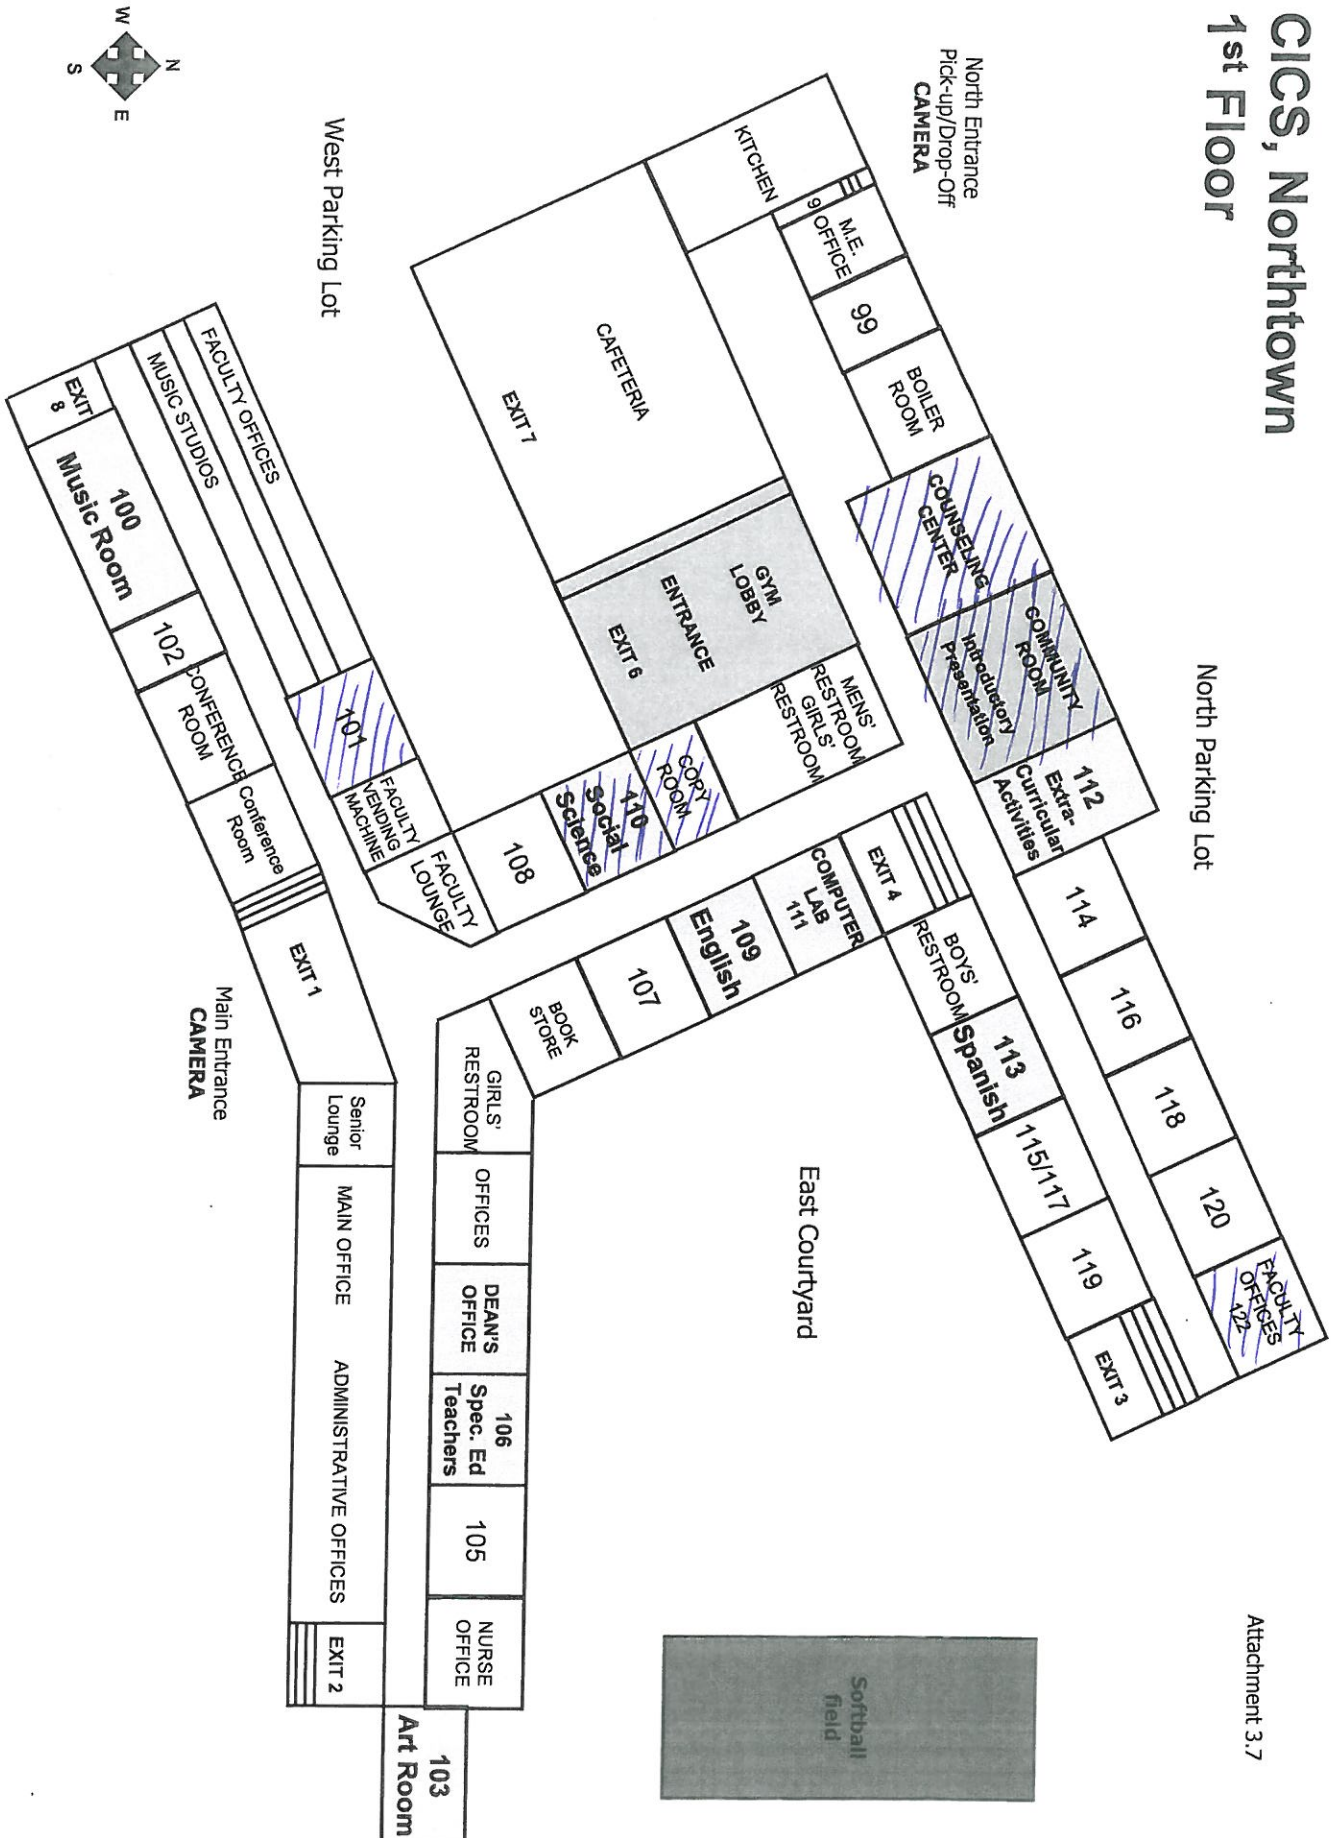
CIGS, Northtown 1st Floor

HA-133 13A
 WF 12x12" light brown w/ white & brown streaks with mastic

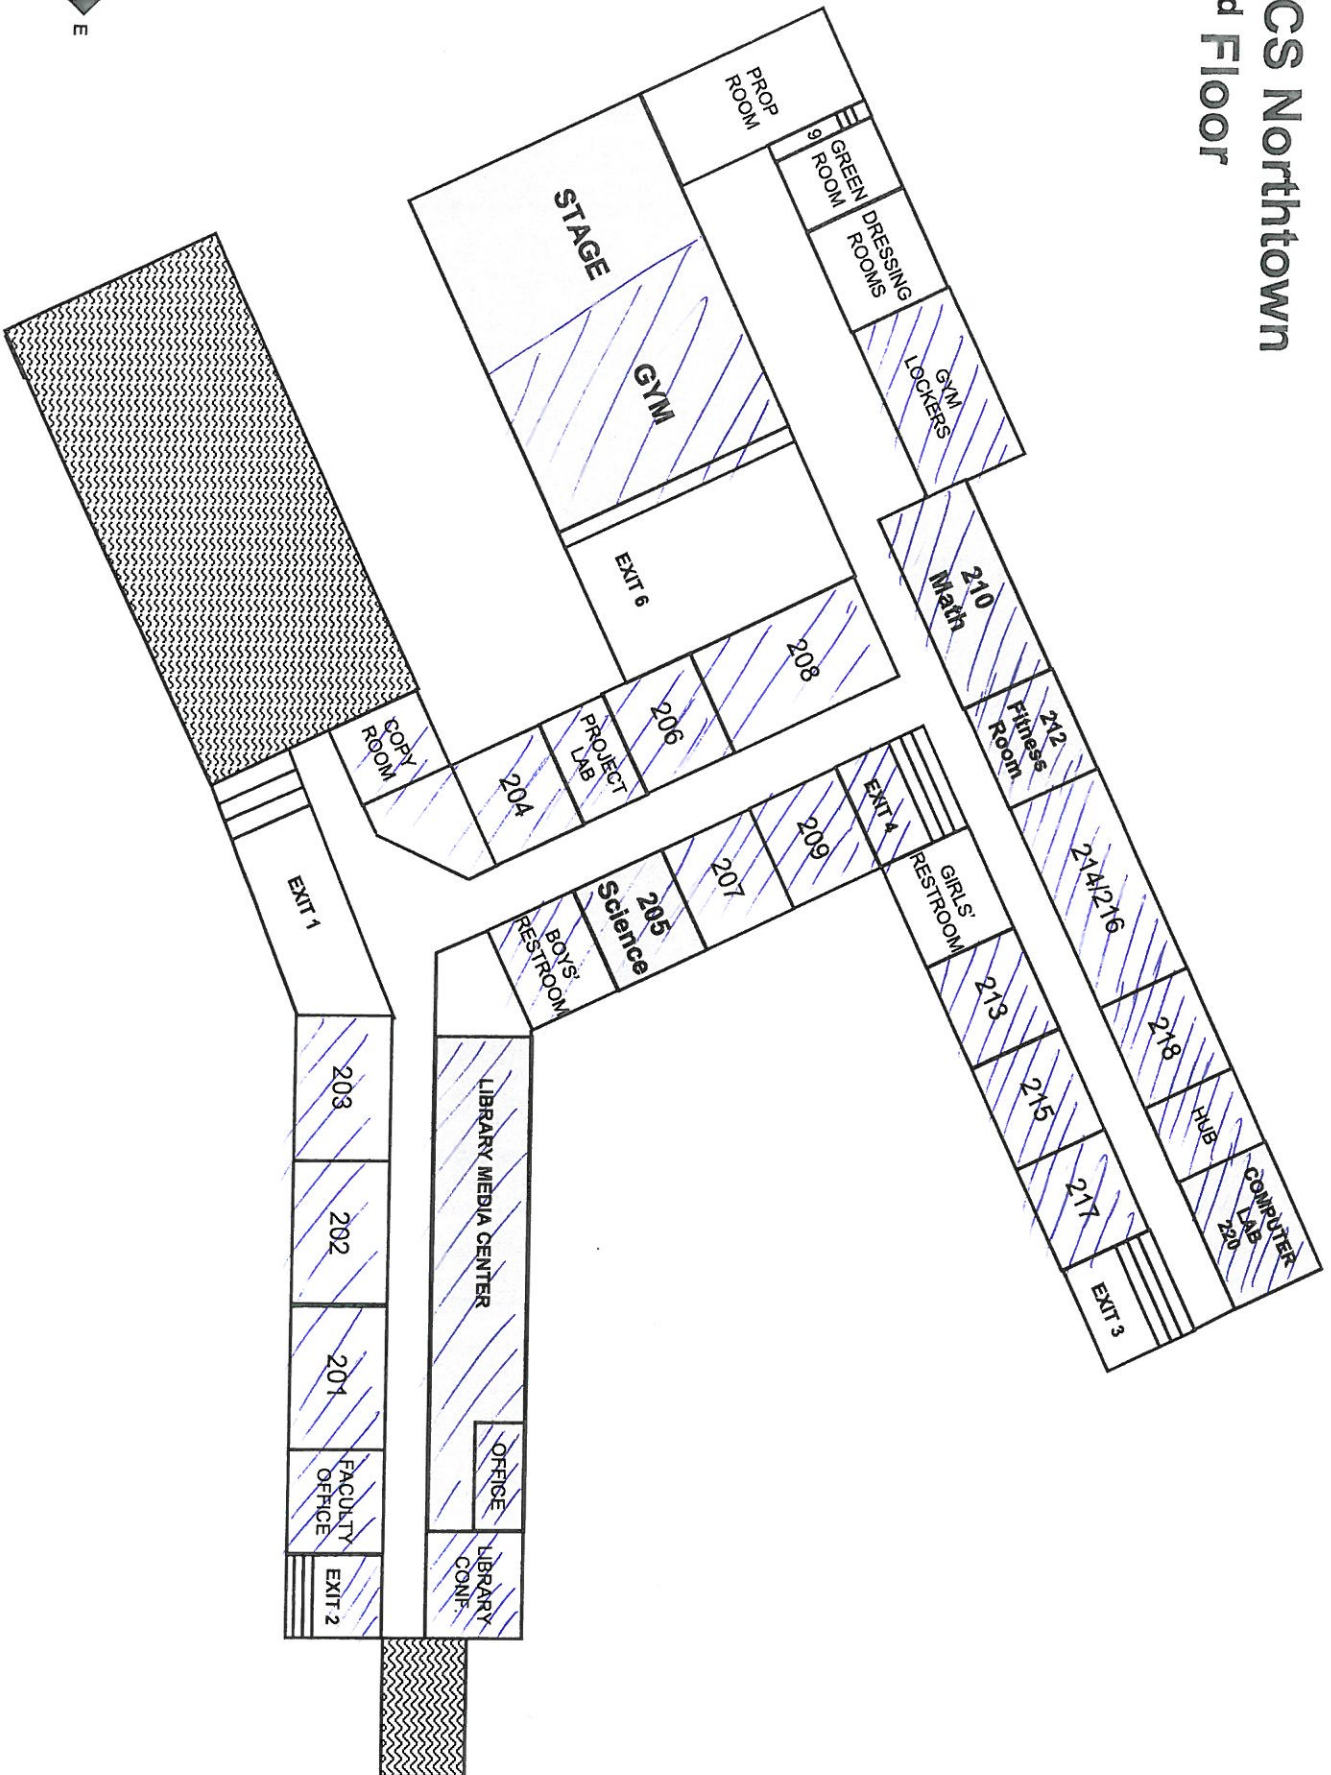
CICS Northtown 2nd Floor

11A-115
 Ceiling tile 1x1 w/ screws

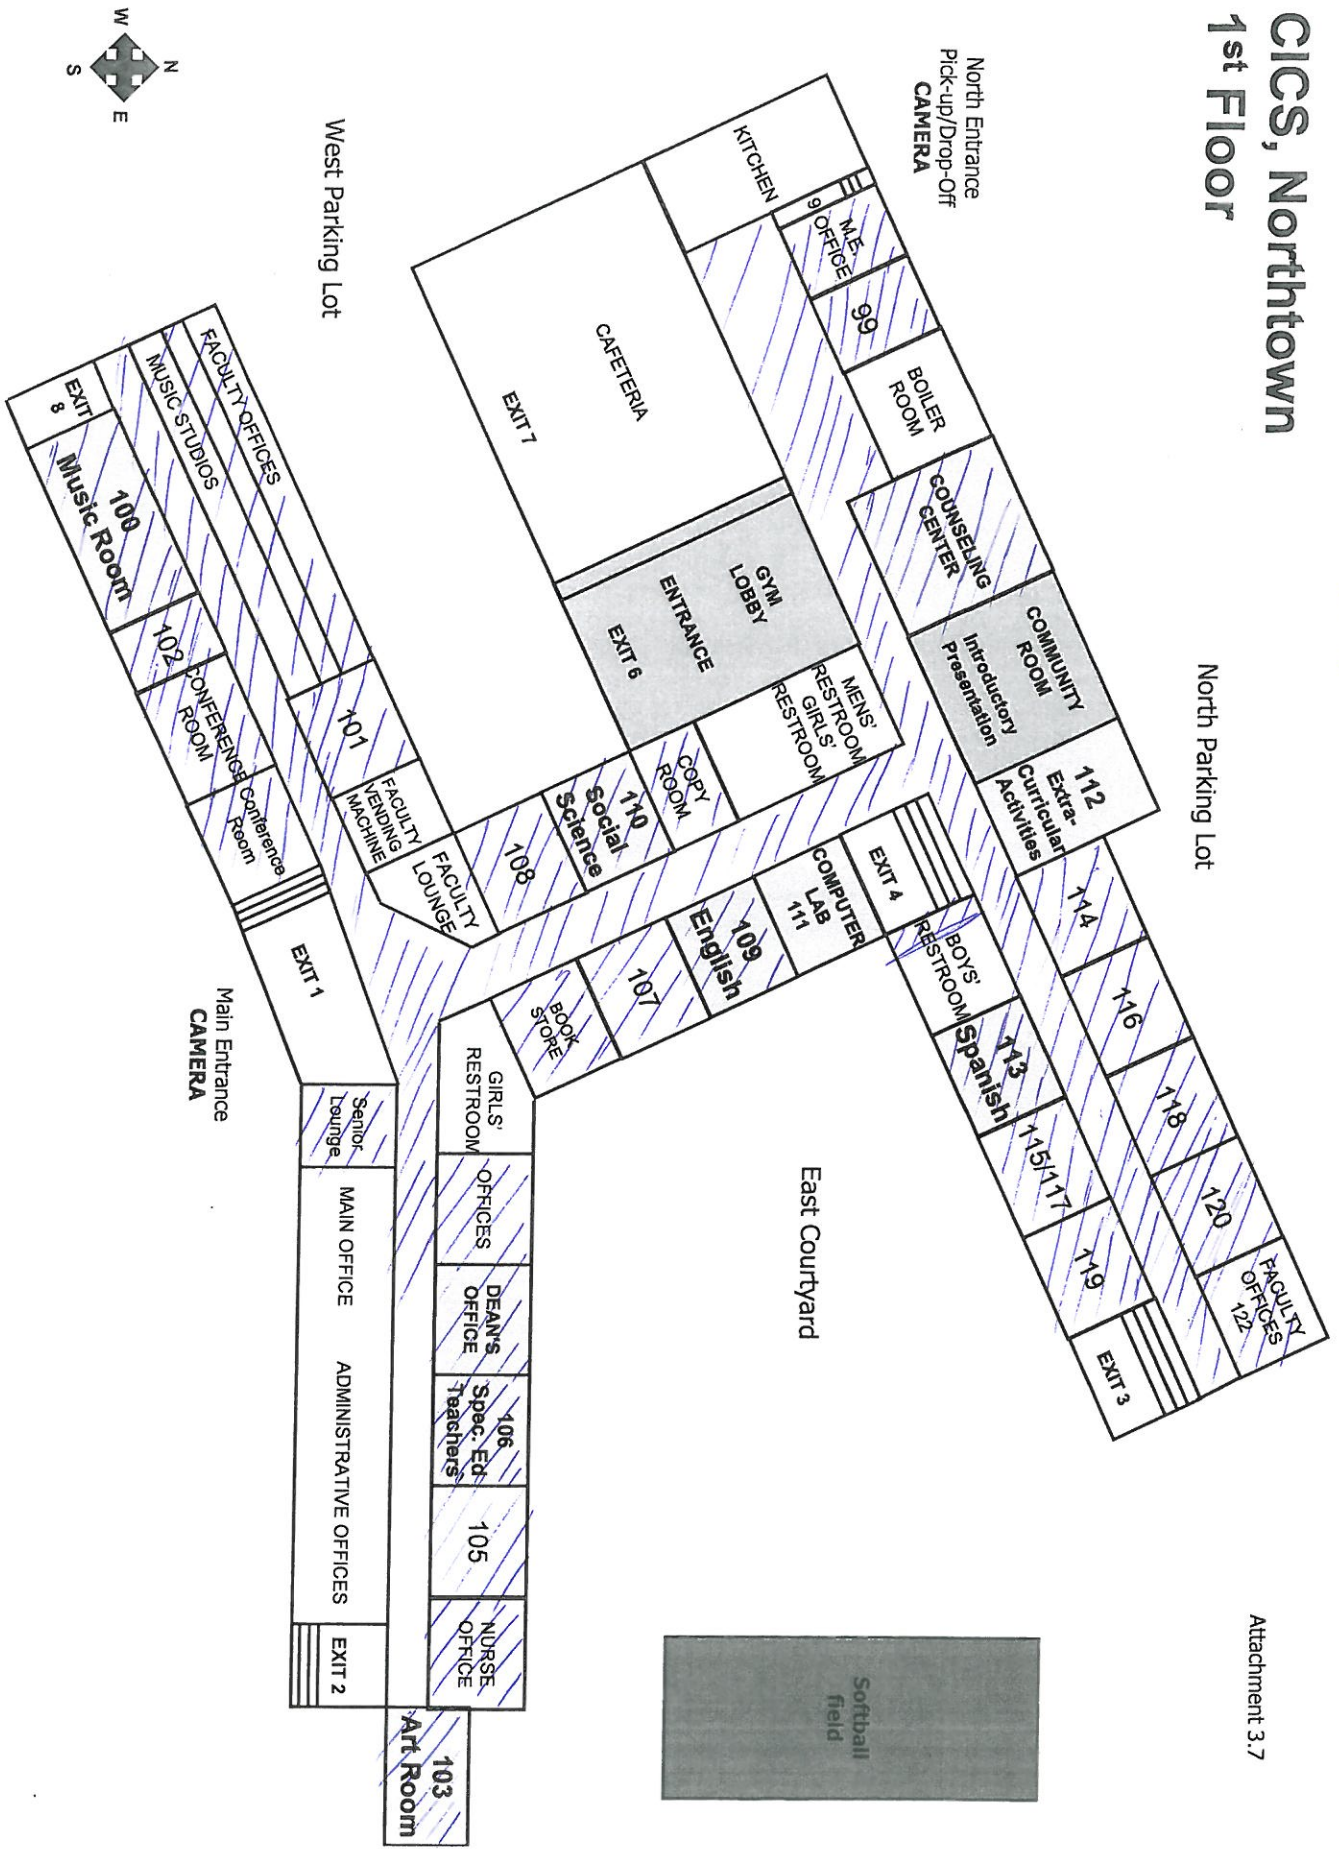
CIGS, Northtown 1st Floor

*114-115
Callins fire 1X1
Callins with grooves*

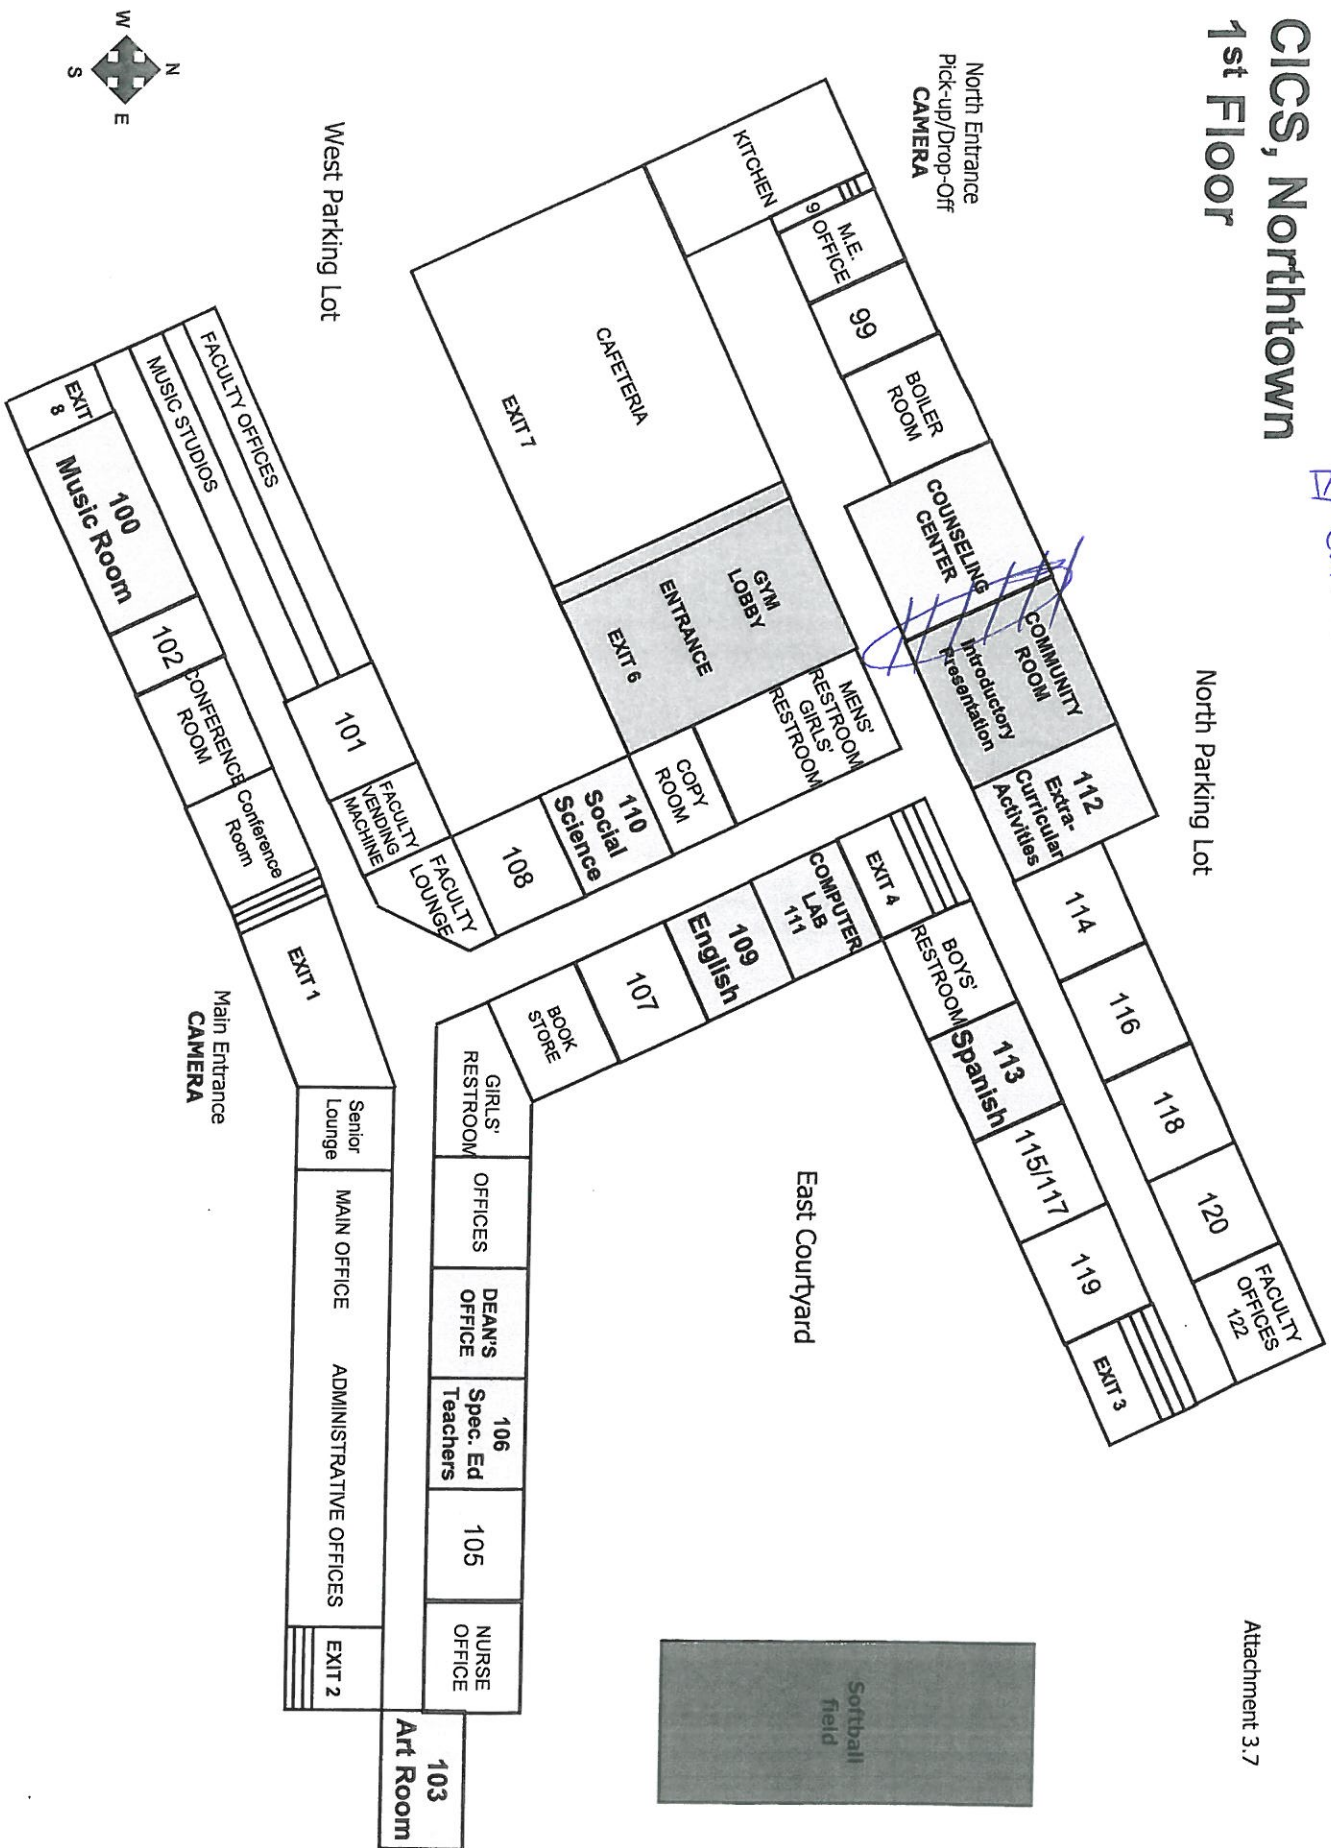
CIGCS, Northtown 1st Floor

HA Num	Material Description	Material Quantity	Material Units	Material Location	Asbestos Type	Material Category	Friable	Damage Quantity	Damage Units	Damage Category	Response
10	Curtain wall	600	SF	Between rm 202 & 203, between room 201 & 202, between counseling center and community room.	Assumed	MISC	No	0	SF	6 ACBM with the potential for damage	Operations and Maintenance
11	12"x12" gray w/ light gray and black specks VFT	800	SF	Room 106, HUB,220	Assumed	MISC	No	0	SF	6 ACBM with the potential for damage	Operations and Maintenance
113	12"x12" light brown w/ white and brown streaks VFT	6,500	SF	Rooms 122, 110, 209, 101, copy room, counseling center, community room, 217, 215, 213, 218, 214, 216, 208	Assumed	MISC	No	0	SF	6 ACBM with the potential for damage	Operations and Maintenance
113A	12"x12" light brown w/ white and brown streaks VFT MASTIC	6,500	SF	Room 122, 110, 209, 101, copy room, counseling center, community room, 217, 215, 213, 218, 214, 216, 208	Assumed	MISC	No	0	SF	6 ACBM with the potential for damage	Operations and Maintenance

11A-10
-curtain wall

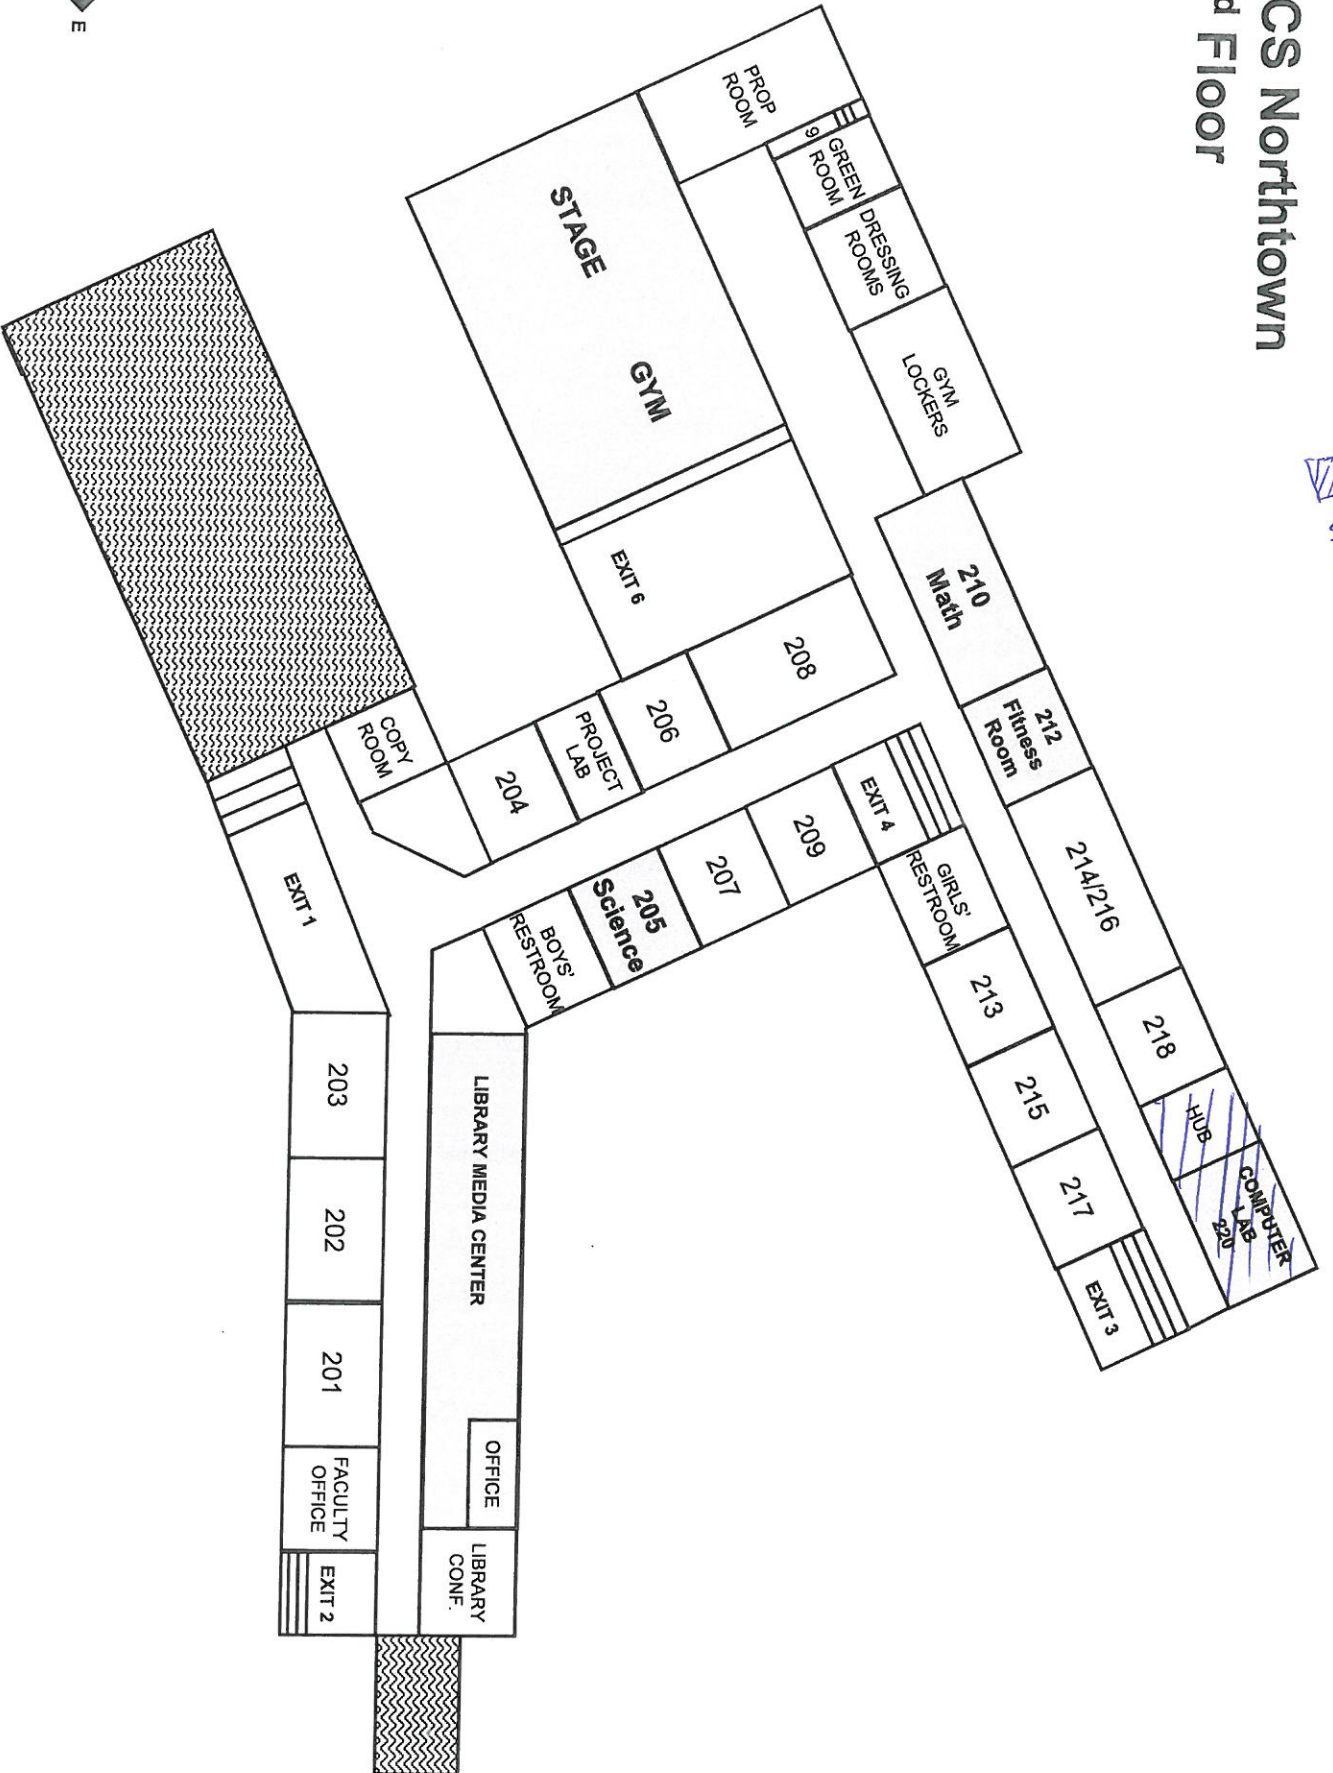
CICS Northtown 2nd Floor

11' x 12' gym and light gray & black spaces with hatched

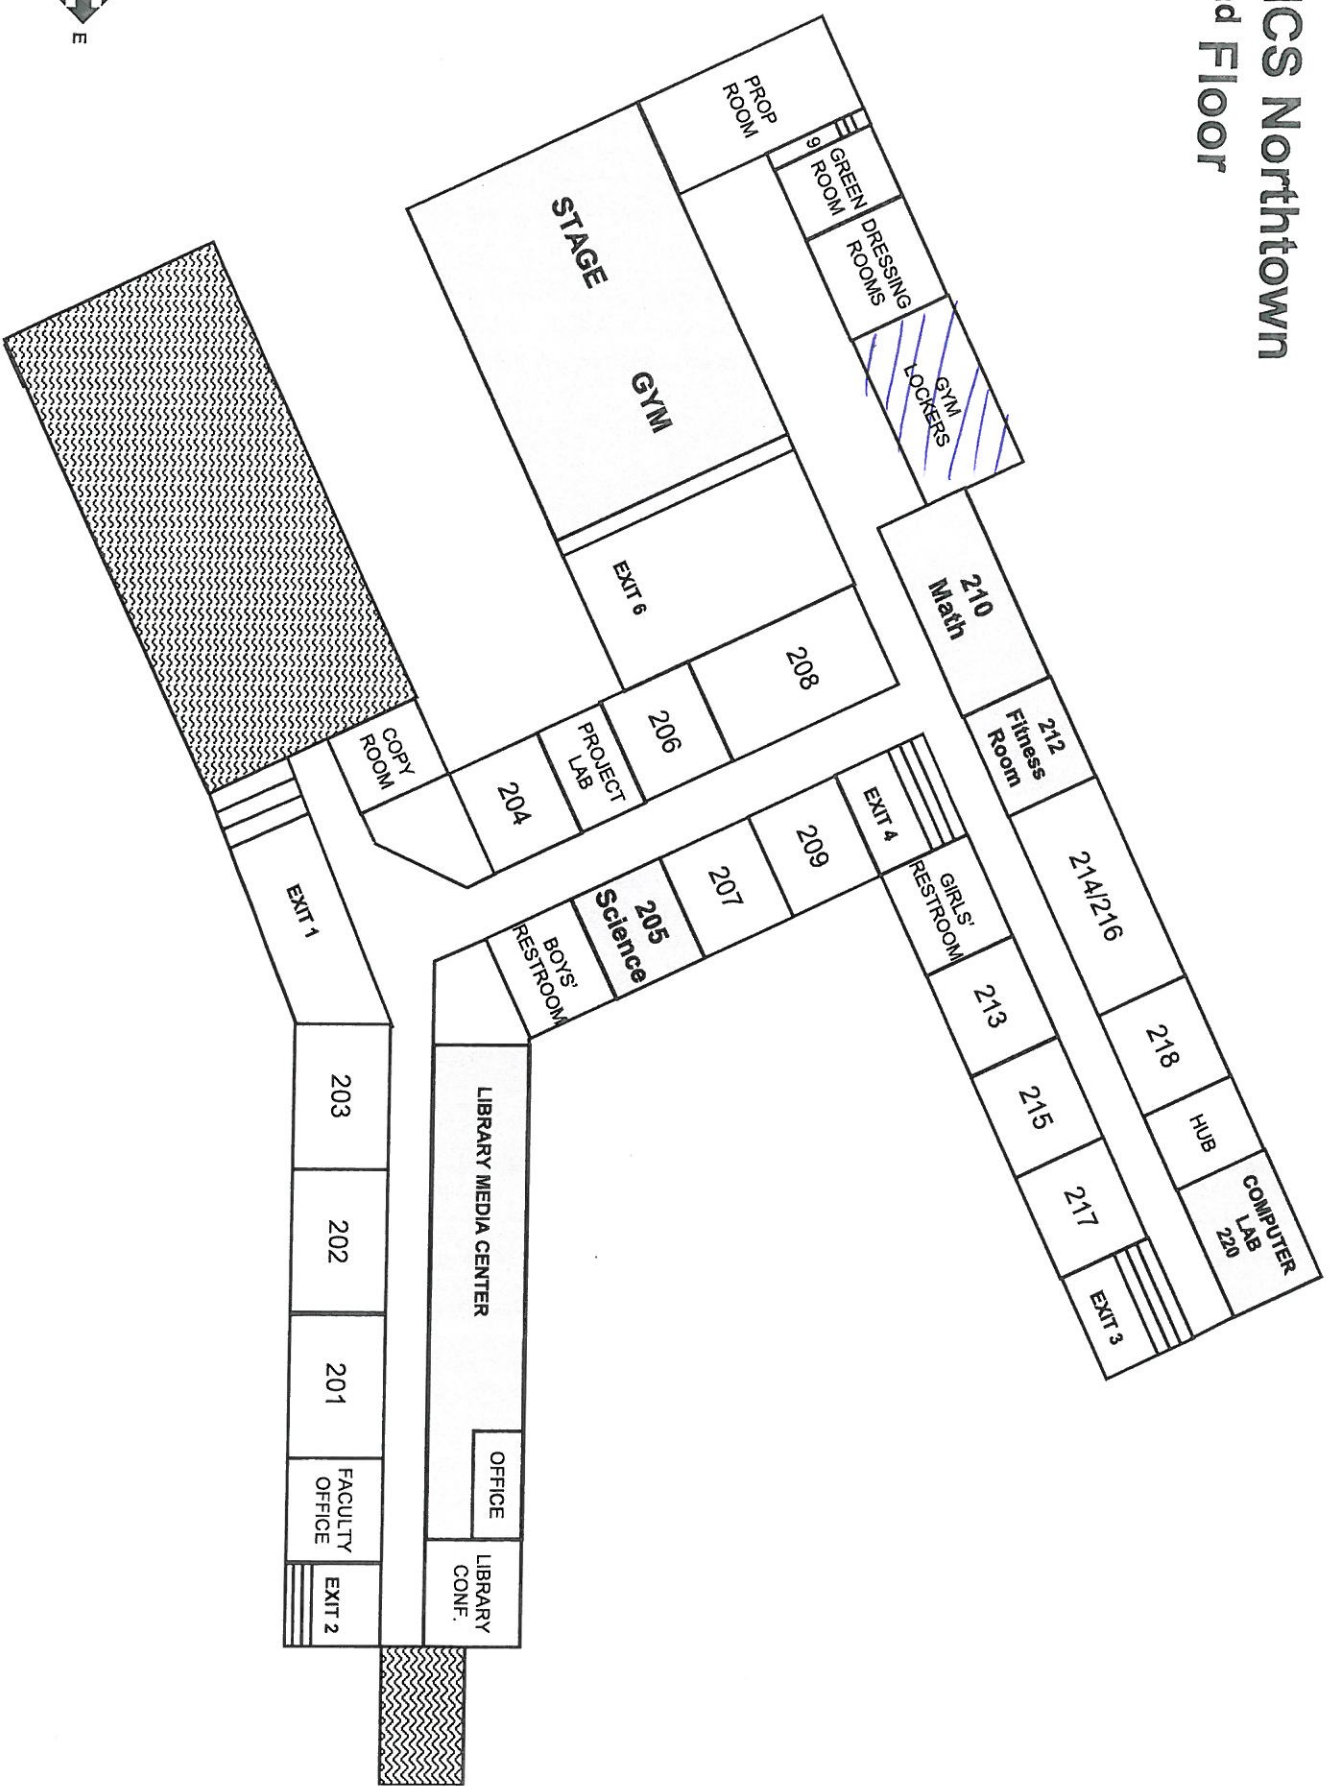
CICS Northtown 2nd Floor

HA 114 & 114A
 - window gray and blue with MASHC

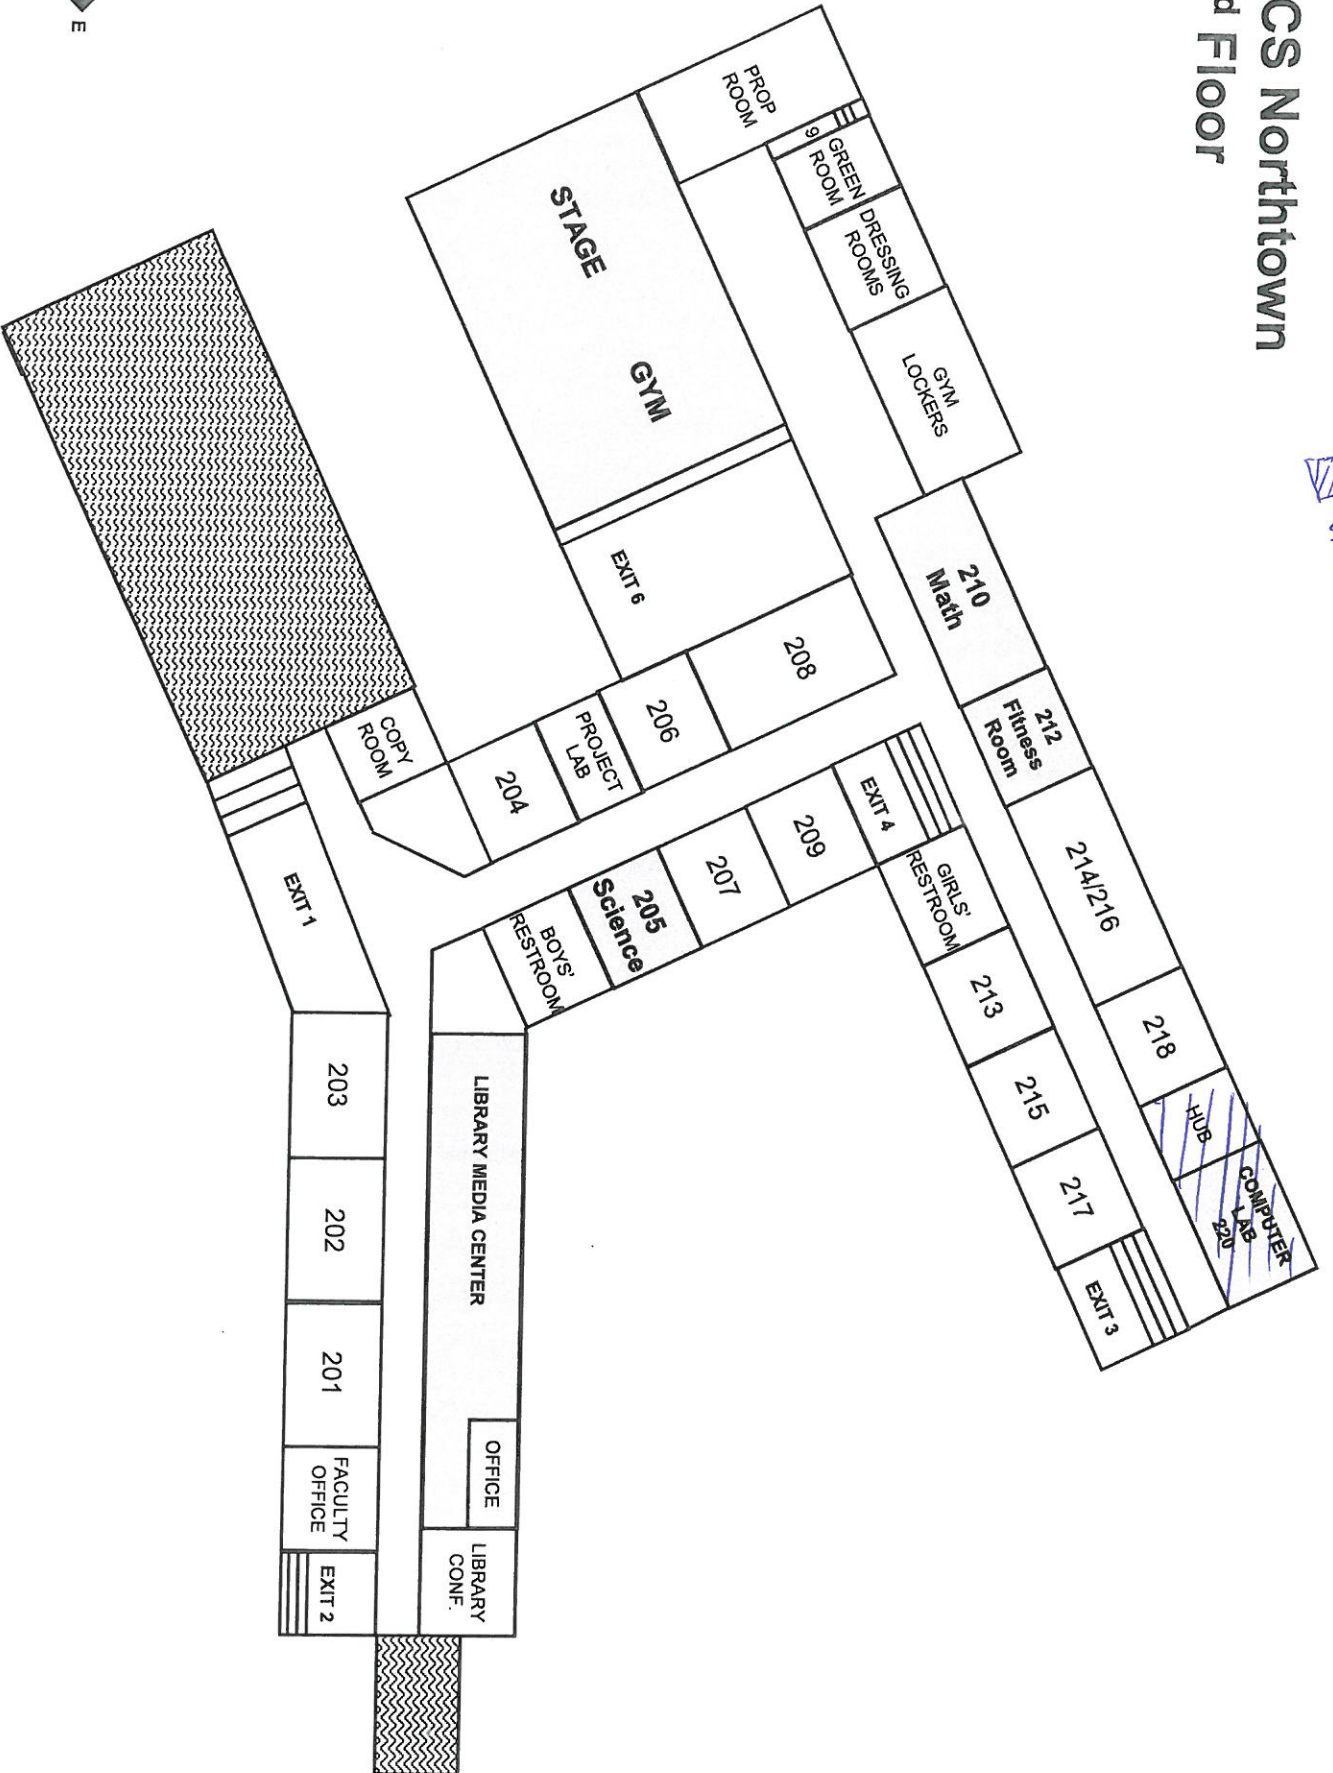
CICS Northtown 2nd Floor

11A 11 311A
 12x12' gym and light gray & black spaces with hatched
