**ILLINOIS DEPARTMENT OF PUBLIC HEALTH
AHERA THREE YEAR REINSPECTION
ASBESTOS ABATEMENT PROGRAM
SCHOOL INFORMATION FORM**

THREE-YEAR REINSPECTION

Chicago International Charter - Wrightwood

Tuesday, August 13, 2013

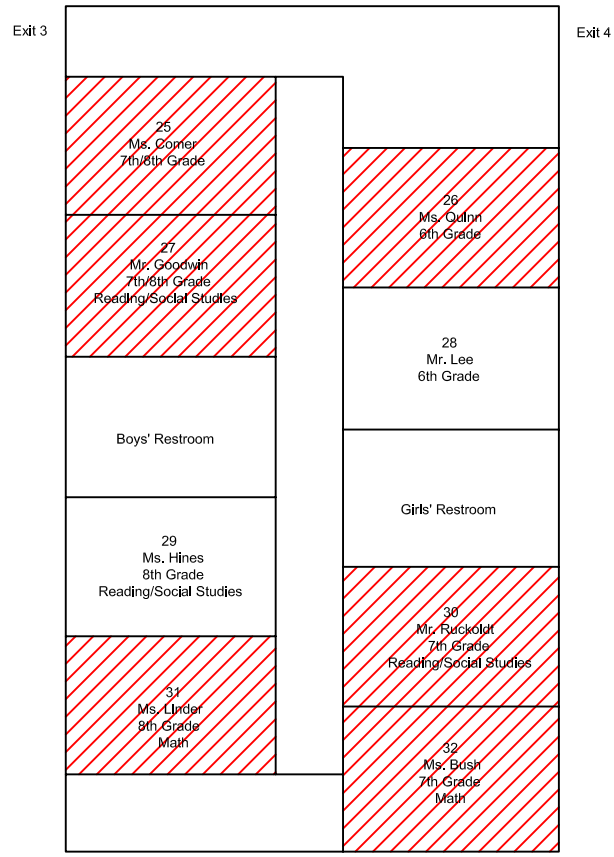
HA-25 1' x 1' White Ceiling Tile with Deep Fissures

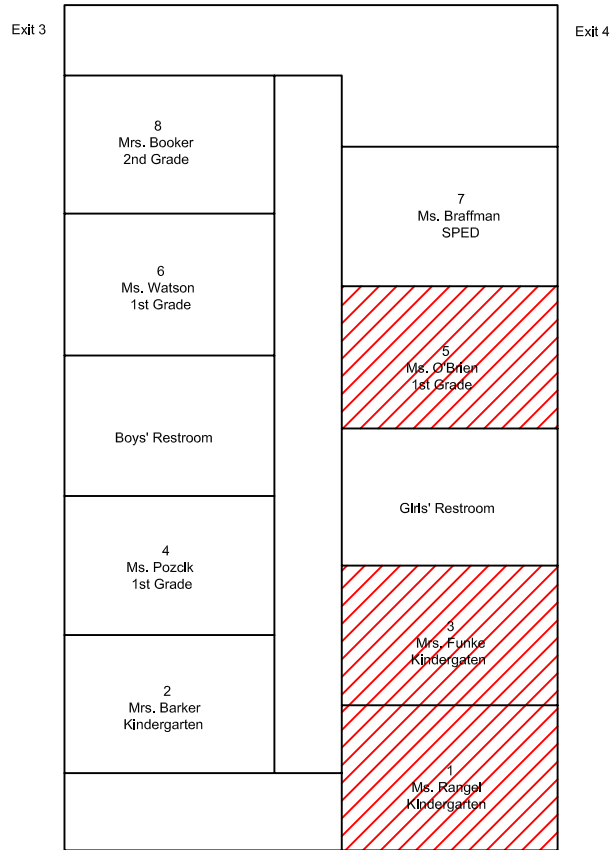
CCA PROJECT NUMBER
A32013-0001-434
DATE
08/15/2013
SHEET NUMBER
HA-27

HA-27 Mastic Associated with 12" x 12" Dark Grey Floor Tile with Black Streaks
