**ILLINOIS DEPARTMENT OF PUBLIC HEALTH
AHERA THREE YEAR REINSPECTION
ASBESTOS ABATEMENT PROGRAM
SCHOOL INFORMATION FORM**

THREE-YEAR REINSPECTION

Avalon Park School

Friday, March 29, 2013

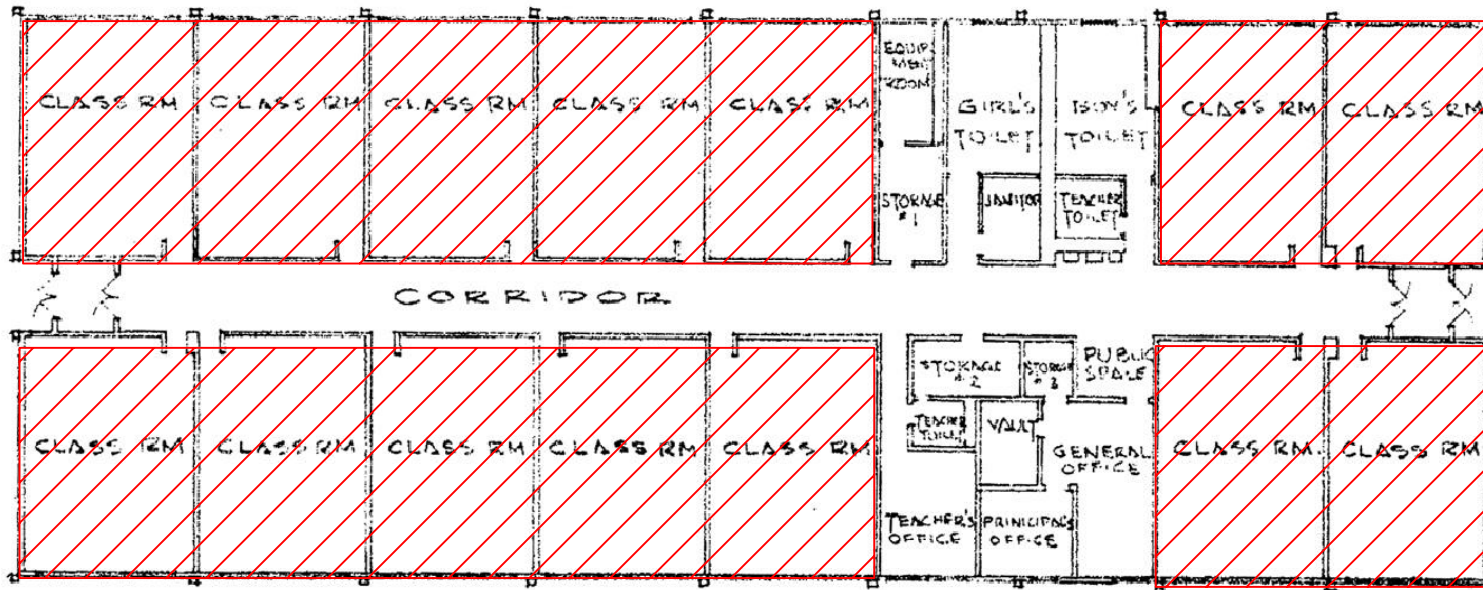
KCPSS 08112013 Three Year AHERA Reinspection Region 5-Avalon Park School-Avalon Park Annex First Flooring

HOMOGENEOUS AREA: **AA-1**
MATERIAL DESCRIPTION: **12" X 12" Floor Tile Mastic**
MATERIAL LOCATION: **All Class Rooms 1971 Modular**
MATERIAL QUANTITY: **11500** MATERIAL UNITS: **SF**
DAMAGE QUANTITY: **0** DAMAGE UNITS: **SF**
