**ILLINOIS DEPARTMENT OF PUBLIC HEALTH  
AHERA THREE YEAR REINSPECTION  
ASBESTOS ABATEMENT PROGRAM  
SCHOOL INFORMATION FORM**

**THREE-YEAR REINSPECTION**

**Gray School**

3730 N Laramie Avenue  
Chicago, IL, 60641

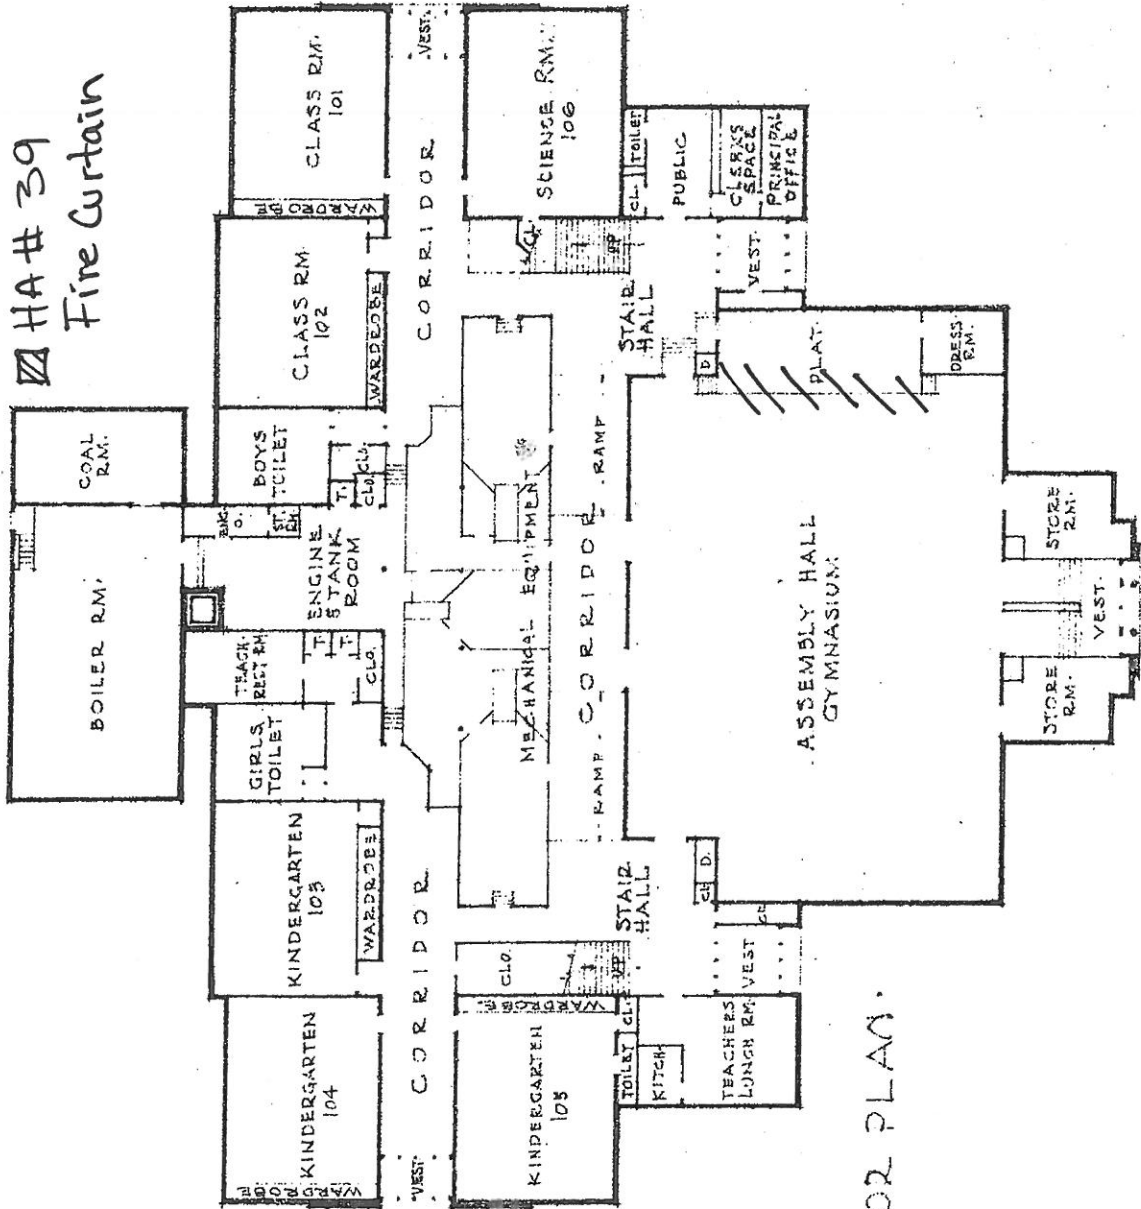
HA # 39  
Fire Curtain

HOMOGENEOUS AREA: **39**  
MATERIAL DESCRIPTION: **Fire Curtain**  
MATERIAL LOCATION: **Assembly Hall Stage (Building 1911)**  
MATERIAL QUANTITY: **1600** MATERIAL UNITS: **SF**  
DAMAGE QUANTITY: **0** DAMAGE UNITS: **SF**
