ILLINOIS DEPARTMENT OF PUBLIC HEALTH
AHERA THREE YEAR REINSPECTION
ASBESTOS ABATEMENT PROGRAM
SCHOOL INFORMATION FORM

THREE-YEAR REINSPECTION

Hendricks Academy

4316 S. Princeton
Chicago, IL, 60609

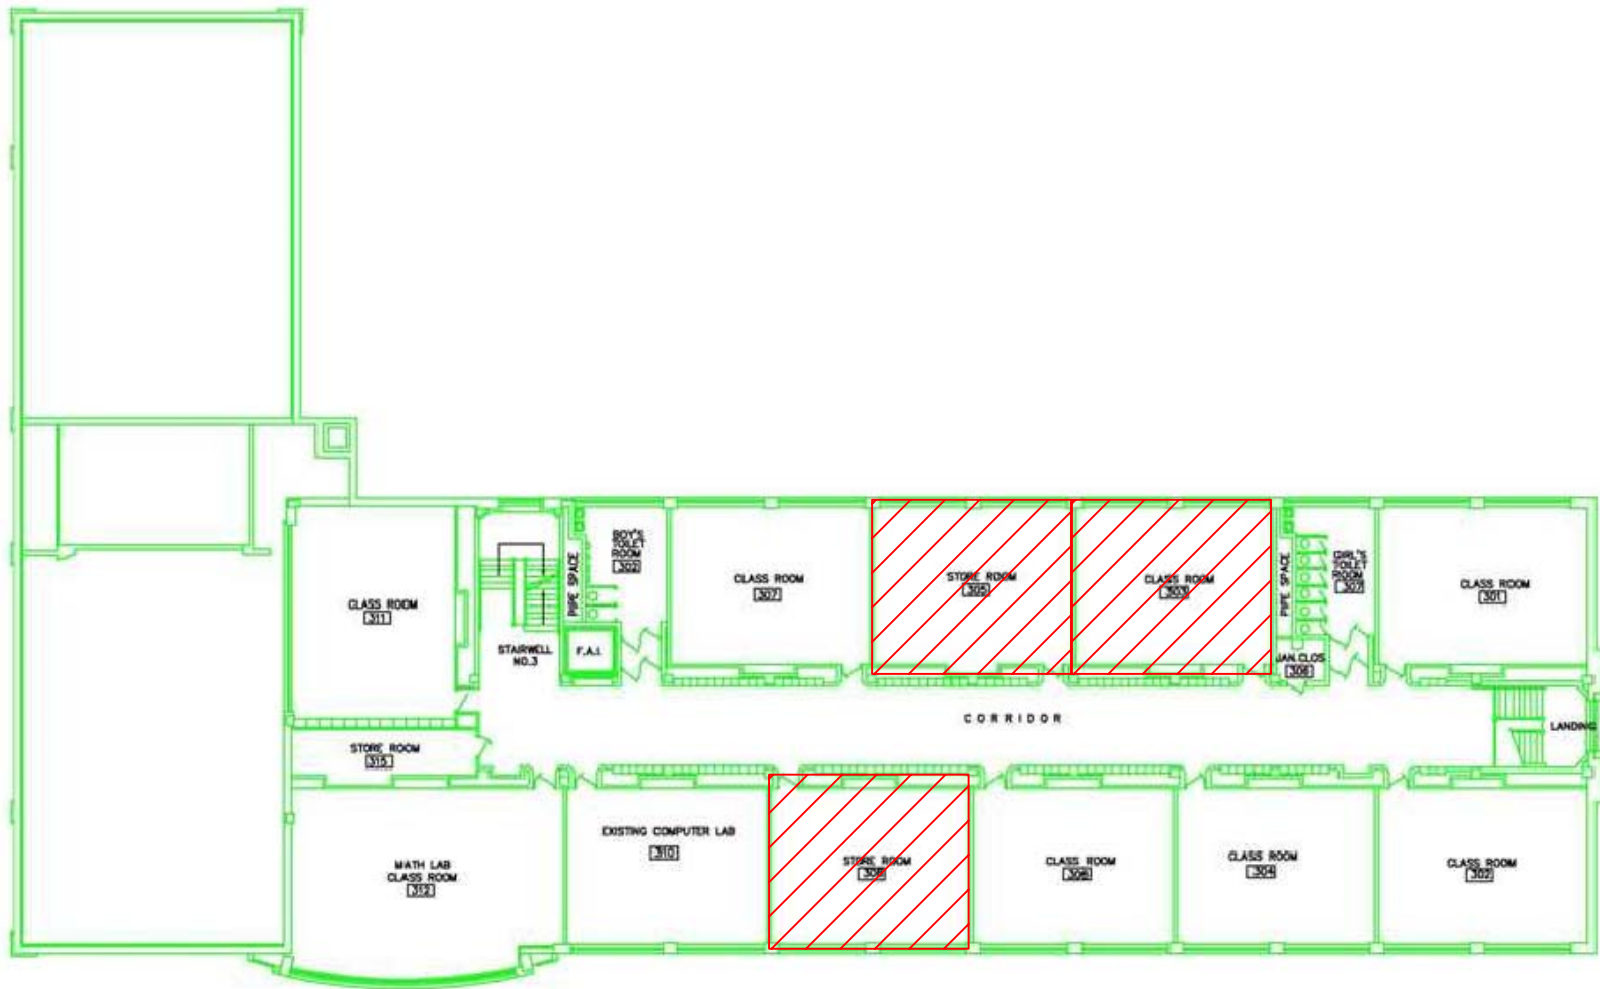
HOMOGENEOUS AREA: **49**
MATERIAL DESCRIPTION: **Gray W/Black Dot linoleum**
MATERIAL LOCATION: **Room 305, 306, 303**
MATERIAL QUANTITY: **3600** MATERIAL UNITS: **SF**
MATERIAL CATEGORY: **MISC** FRIABLE: **No**
ASBESTOS TYPE: **Assumed**
DISTURBANCE POTENTIAL: **LOW** CONDITION:
AHERA DAMAGE CATEGORY: **6 ACBM with the potential for damage**
ACCESSIBILITY: **Within Reach** DAMAGE REASON:
DAMAGE QUANTITY: **0** DAMAGE REASON:
DAMAGE UNITS: **SF**
COMMENTS:

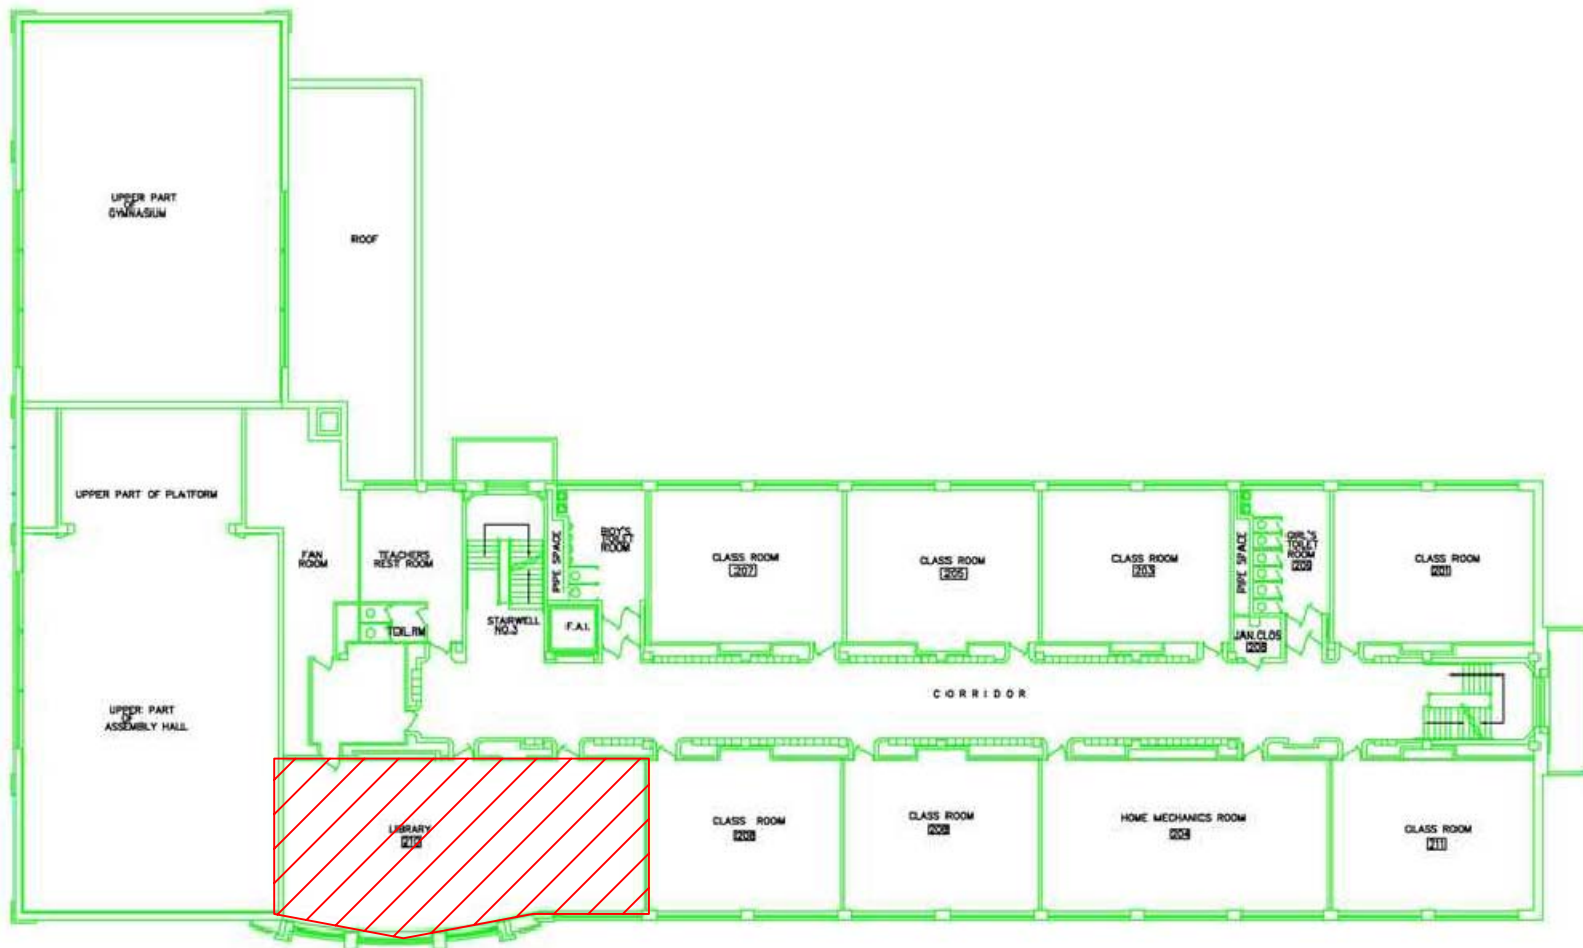
HOMOGENEOUS AREA: **50**
MATERIAL DESCRIPTION: **Blue Carpet Mastic**
MATERIAL LOCATION: **Library**
MATERIAL QUANTITY: **2100** MATERIAL UNITS: **SF**
DAMAGE QUANTITY: **0** DAMAGE UNITS: **SF**
