ILLINOIS DEPARTMENT OF PUBLIC HEALTH
AHERA THREE YEAR REINSPECTION
ASBESTOS ABATEMENT PROGRAM
SCHOOL INFORMATION FORM

THREE-YEAR REINSPECTION

Whitney Young Magnet High School

REPORT DATE:

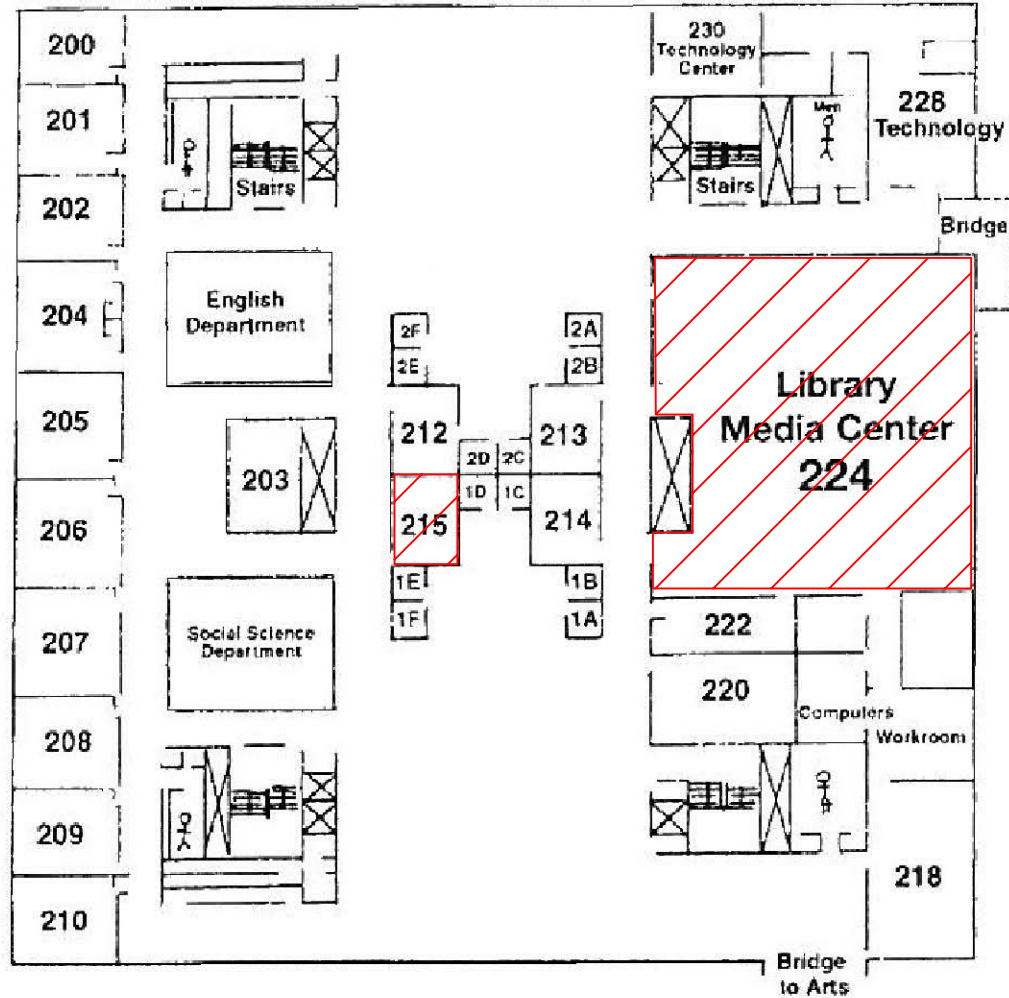
K:\CPS 2011\2013 Three Year\A\Gad Drawings\Region 2\1\Young Magnet High School (Whitney)\Whitney Young Main Bldg 2nd Floor.dwg

HOMOGENEOUS AREA: **170**
MATERIAL DESCRIPTION: **Brown Carpet Mastic**
MATERIAL LOCATION: **224 Library**
MATERIAL QUANTITY: **4800** MATERIAL UNITS: **SF**
MATERIAL CATEGORY: **MISC** FRIABLE: **No**
ASBESTOS TYPE: **Assumed**
DISTURBANCE POTENTIAL: **LOW** CONDITION:
AHERA DAMAGE CATEGORY: **6 ACBM with the potential for damage**
ACCESSIBILITY: **Not Reachable** DAMAGE REASON:
DAMAGE QUANTITY: **0** DAMAGE REASON:
DAMAGE UNITS: **SF**
COMMENTS:

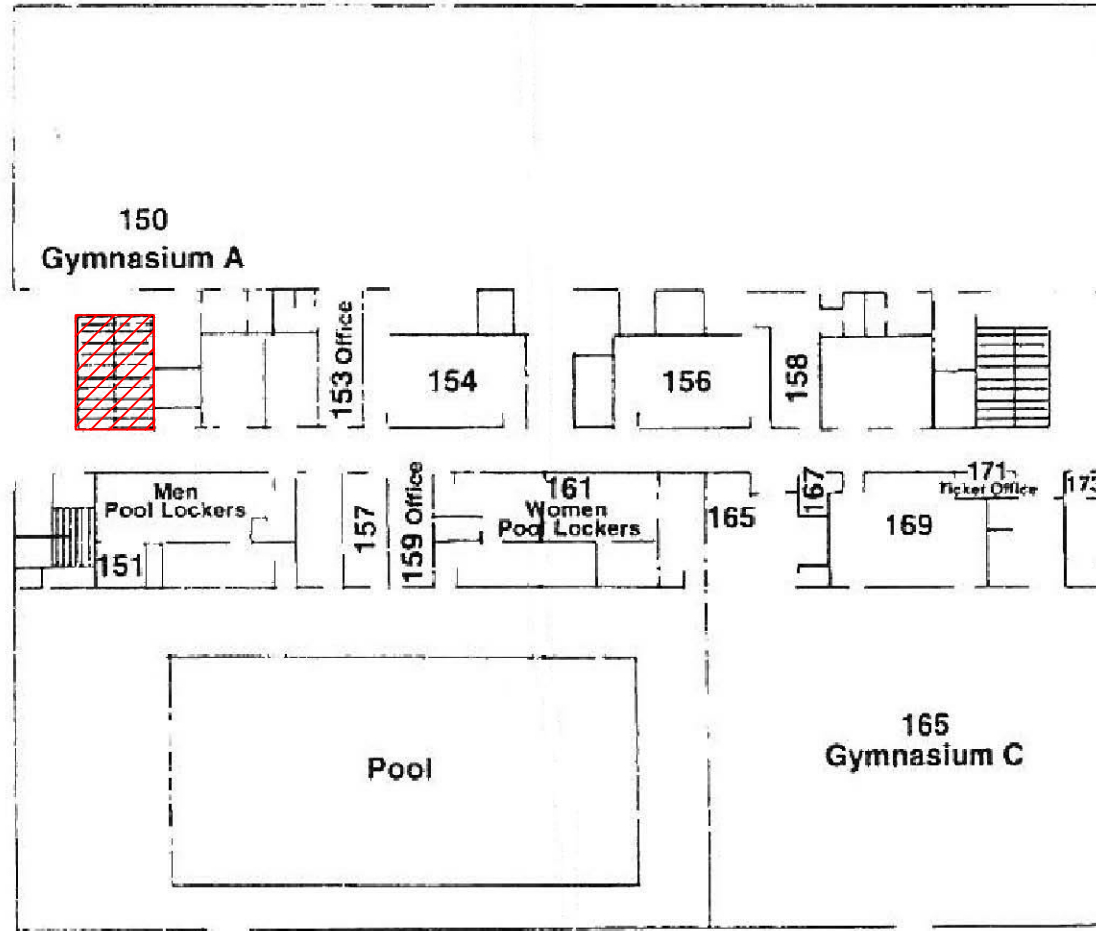
PHYSICAL EDUCATION BUILDING 1ST FLOOR

HOMOGENEOUS AREA: **173**
MATERIAL DESCRIPTION: **Stair Tread Covering Mastic**
MATERIAL LOCATION: **Physical Education Building by Locker Rooms**
MATERIAL QUANTITY: **350** MATERIAL UNITS: **SF**
MATERIAL CATEGORY: **MISC** FRIABLE: **No**
ASBESTOS TYPE: **Assumed**
DISTURBANCE POTENTIAL: **LOW** CONDITION:
AHERA DAMAGE CATEGORY: **6 ACBM with the potential for damage**
ACCESSIBILITY: **Not Reachable** DAMAGE REASON:
DAMAGE QUANTITY: **0** DAMAGE REASON:
DAMAGE UNITS: **SF**
COMMENTS:

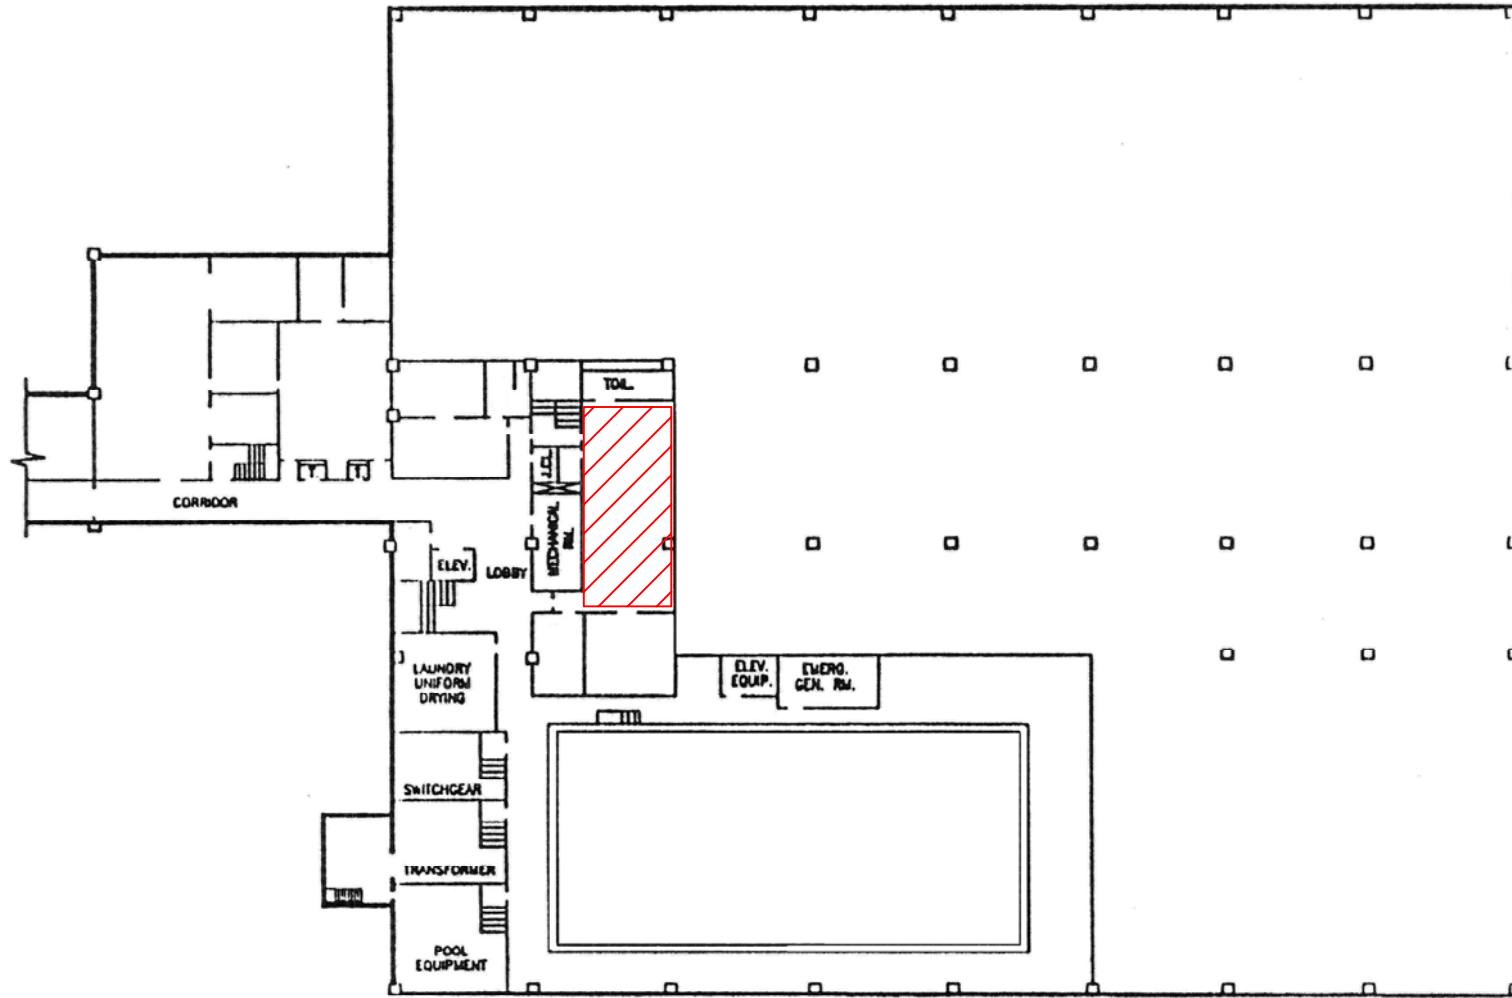
K:\CPS 2011\2013 Three Year\A\Asst Drawings\Region 2\1\Young Magnet High School (Whitney)\Whitney Young Basement.dwg

HOMOGENEOUS AREA: **171**
MATERIAL DESCRIPTION: **Rubber Floor Mastic**
MATERIAL LOCATION: **Room 050**
MATERIAL QUANTITY: **1100** MATERIAL UNITS: **SF**
MATERIAL CATEGORY: **MISC** FRIABLE: **No**
ASBESTOS TYPE: **Assumed**
DISTURBANCE POTENTIAL: **LOW** CONDITION:
AHERA DAMAGE CATEGORY: **6 ACBM with the potential for damage**
ACCESSIBILITY: **Not Reachable** DAMAGE REASON:
DAMAGE QUANTITY: **0** DAMAGE REASON:
DAMAGE UNITS: **SF**
COMMENTS:
