**ILLINOIS DEPARTMENT OF PUBLIC HEALTH
AHERA THREE YEAR REINSPECTION
ASBESTOS ABATEMENT PROGRAM
SCHOOL INFORMATION FORM**

NAME OF SCHOOL DISTRICT: CHICAGO SCHOOL DIST 299
SCHOOL ID NUMBER: 14-016-2990-0018
SCHOOL NAME: St. George Branch (New Armour Annex)
ADDRESS OF SCHOOL: 911 West 32nd Place
CITY: Chicago, IL, 60608

THREE-YEAR REINSPECTION

St. George Branch (New Armour Annex)

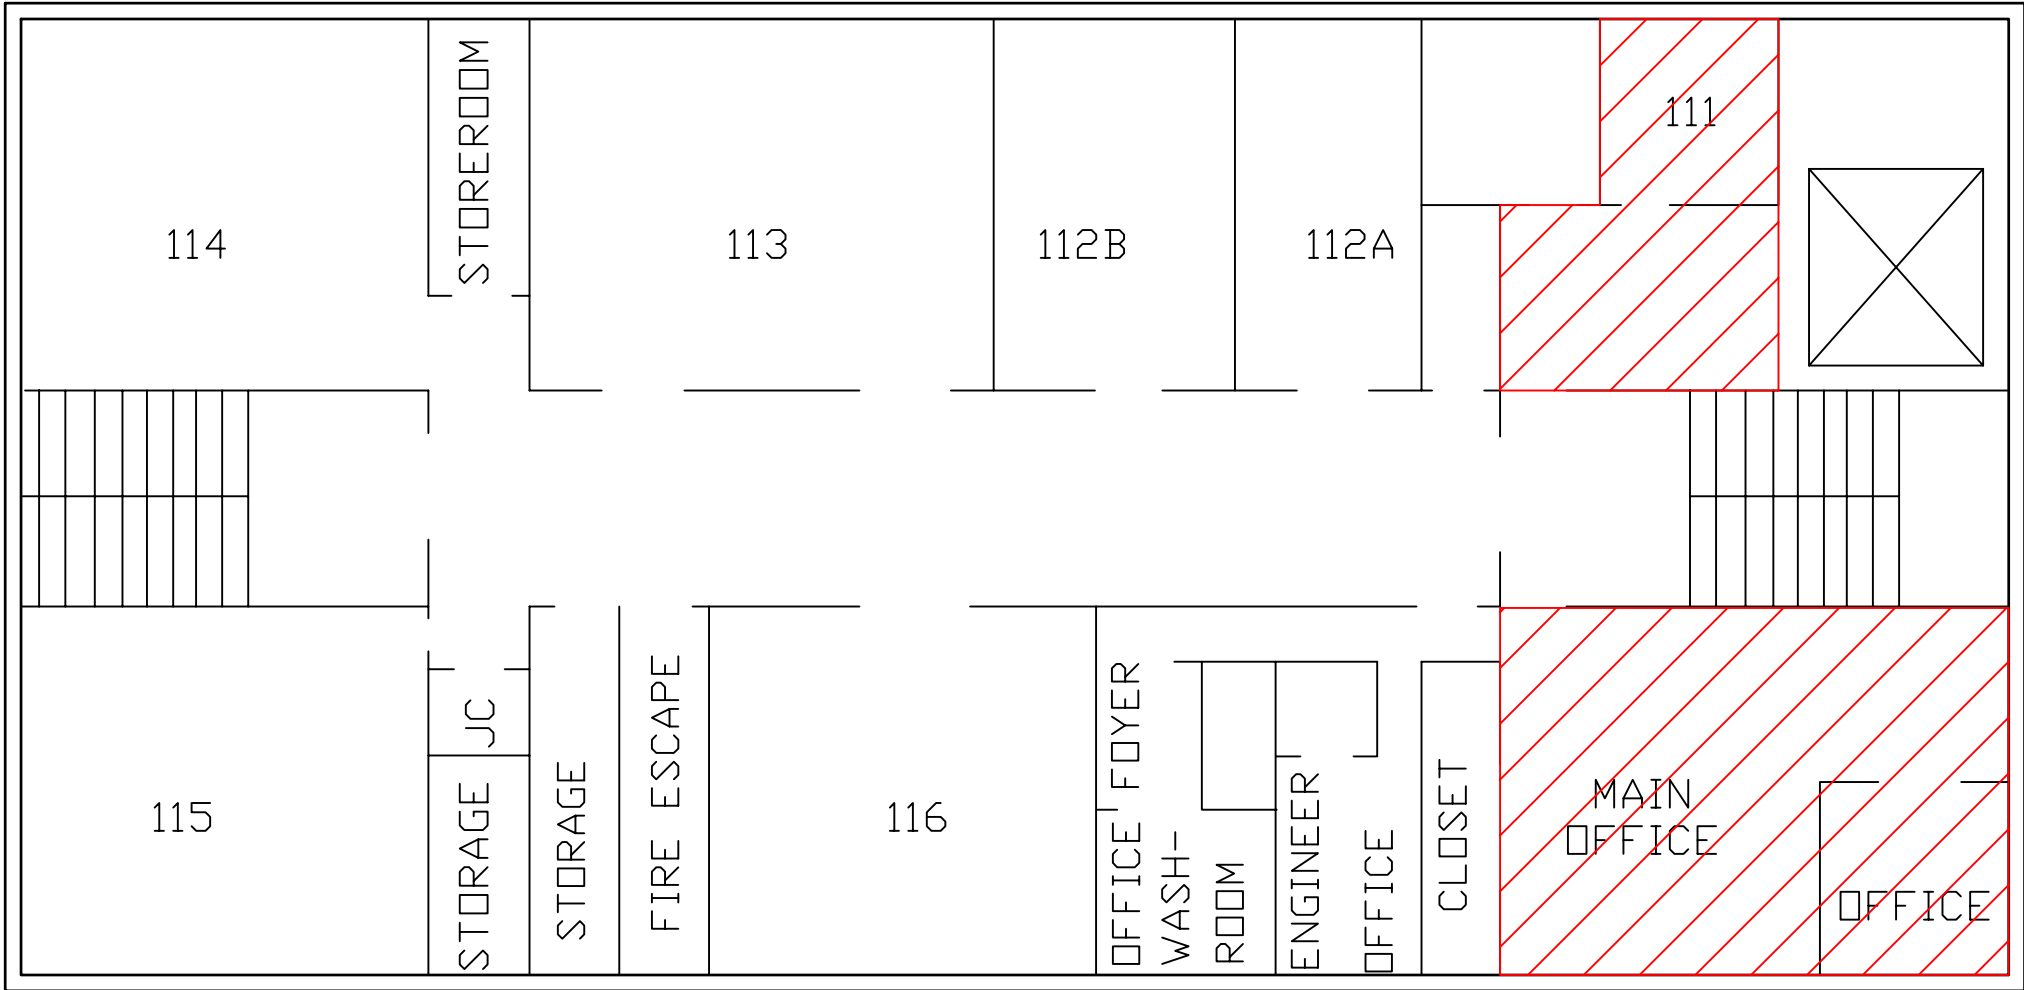
KCPSS 03112013 Three Year Asbestos Inventory Region 41555: George Branch New Annex Annex/Venue Annex (St. George) First Floor.dwg

HOMOGENEOUS AREA: **81**
MATERIAL DESCRIPTION: **12"x12" Green Mottled VFT**
MATERIAL LOCATION: **Office, Principals Office, 1st Floor Elevator Vestibule, Room 111**
MATERIAL QUANTITY: **2000** MATERIAL UNITS: **SF**
DAMAGE QUANTITY: **0** DAMAGE UNITS: **SF**

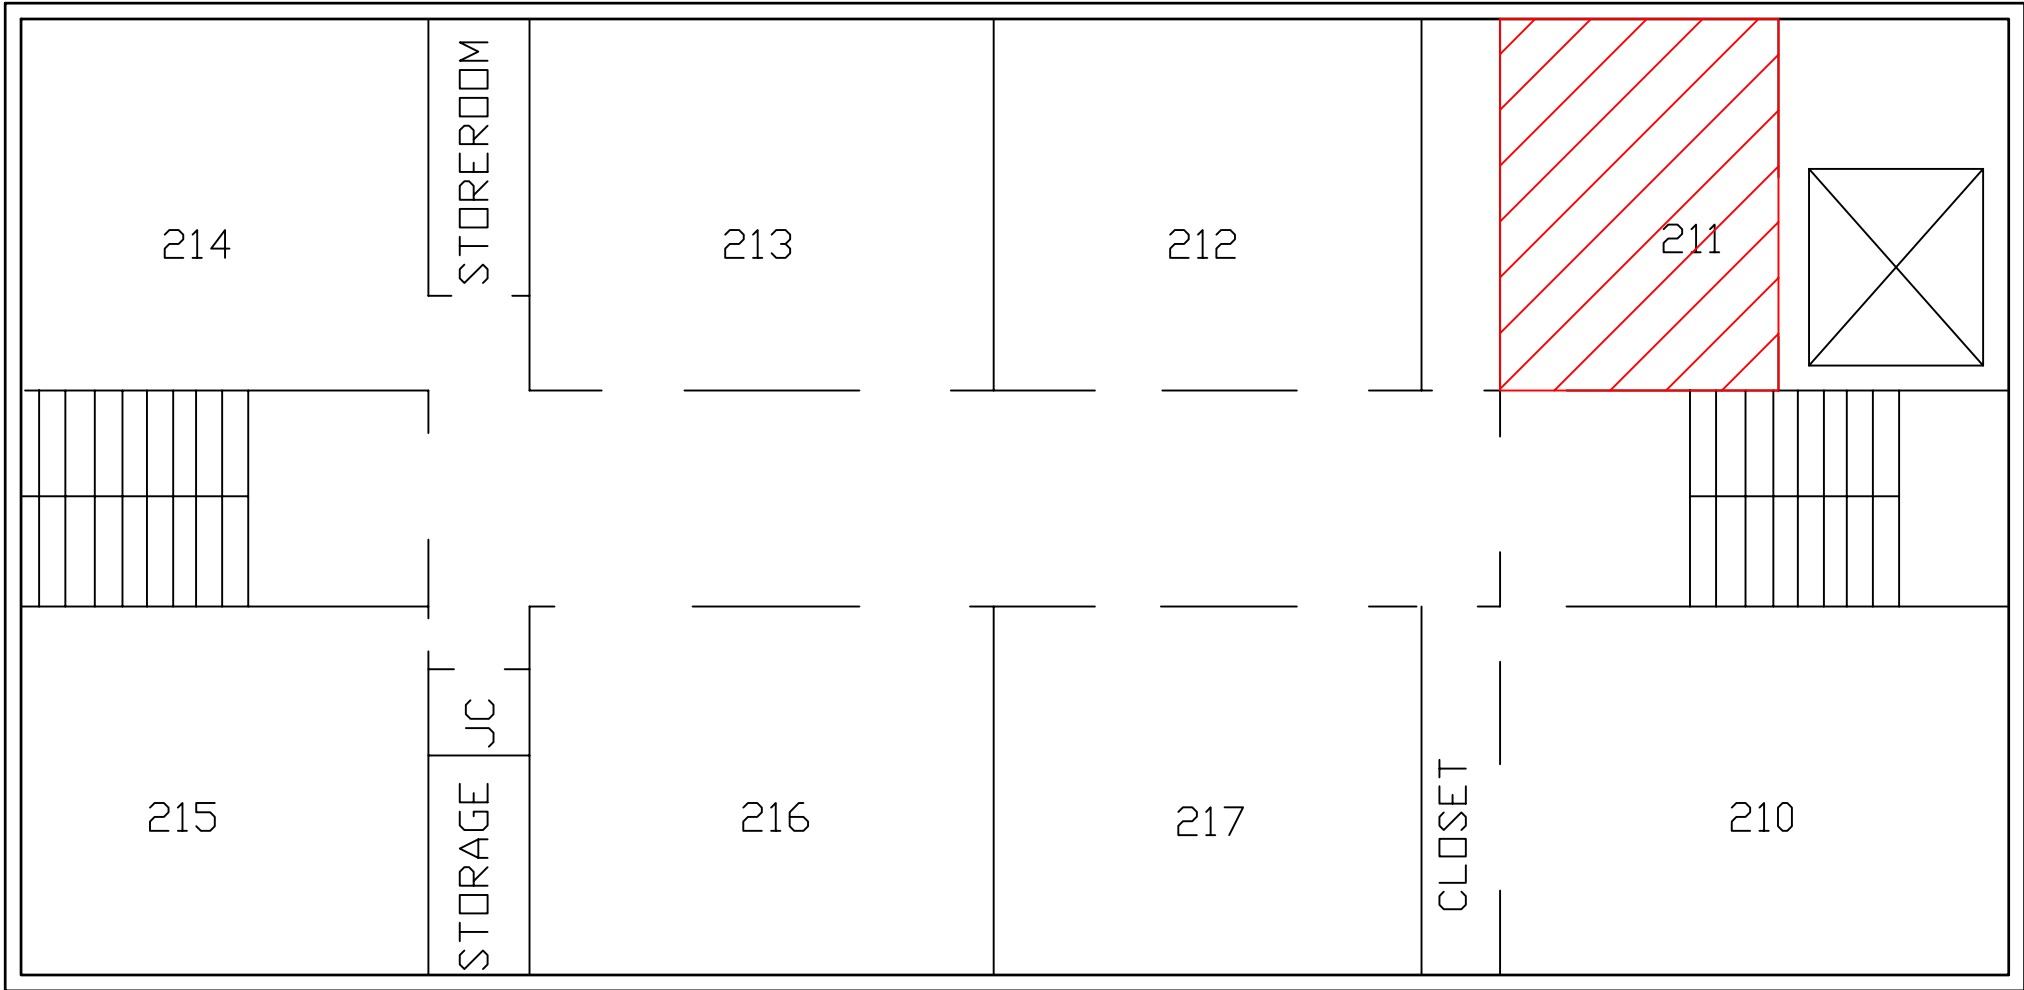
CCA PROJECT NUMBER
A320130001-251
DATE
03/27/2013
SHEET NUMBER
HA-79

HOMOGENEOUS AREA: **79**
MATERIAL DESCRIPTION: **12"x12" Blue Mottled VFT**
MATERIAL LOCATION: **Room 116,211, 2nd Floor Elevator Lobby**
MATERIAL QUANTITY: **1800** MATERIAL UNITS: **SF**
DAMAGE QUANTITY: **0** DAMAGE UNITS: **SF**
