**ILLINOIS DEPARTMENT OF PUBLIC HEALTH
AHERA THREE YEAR REINSPECTION
ASBESTOS ABATEMENT PROGRAM
SCHOOL INFORMATION FORM**

THREE-YEAR REINSPECTION

Hearst School

REPORT DATE:

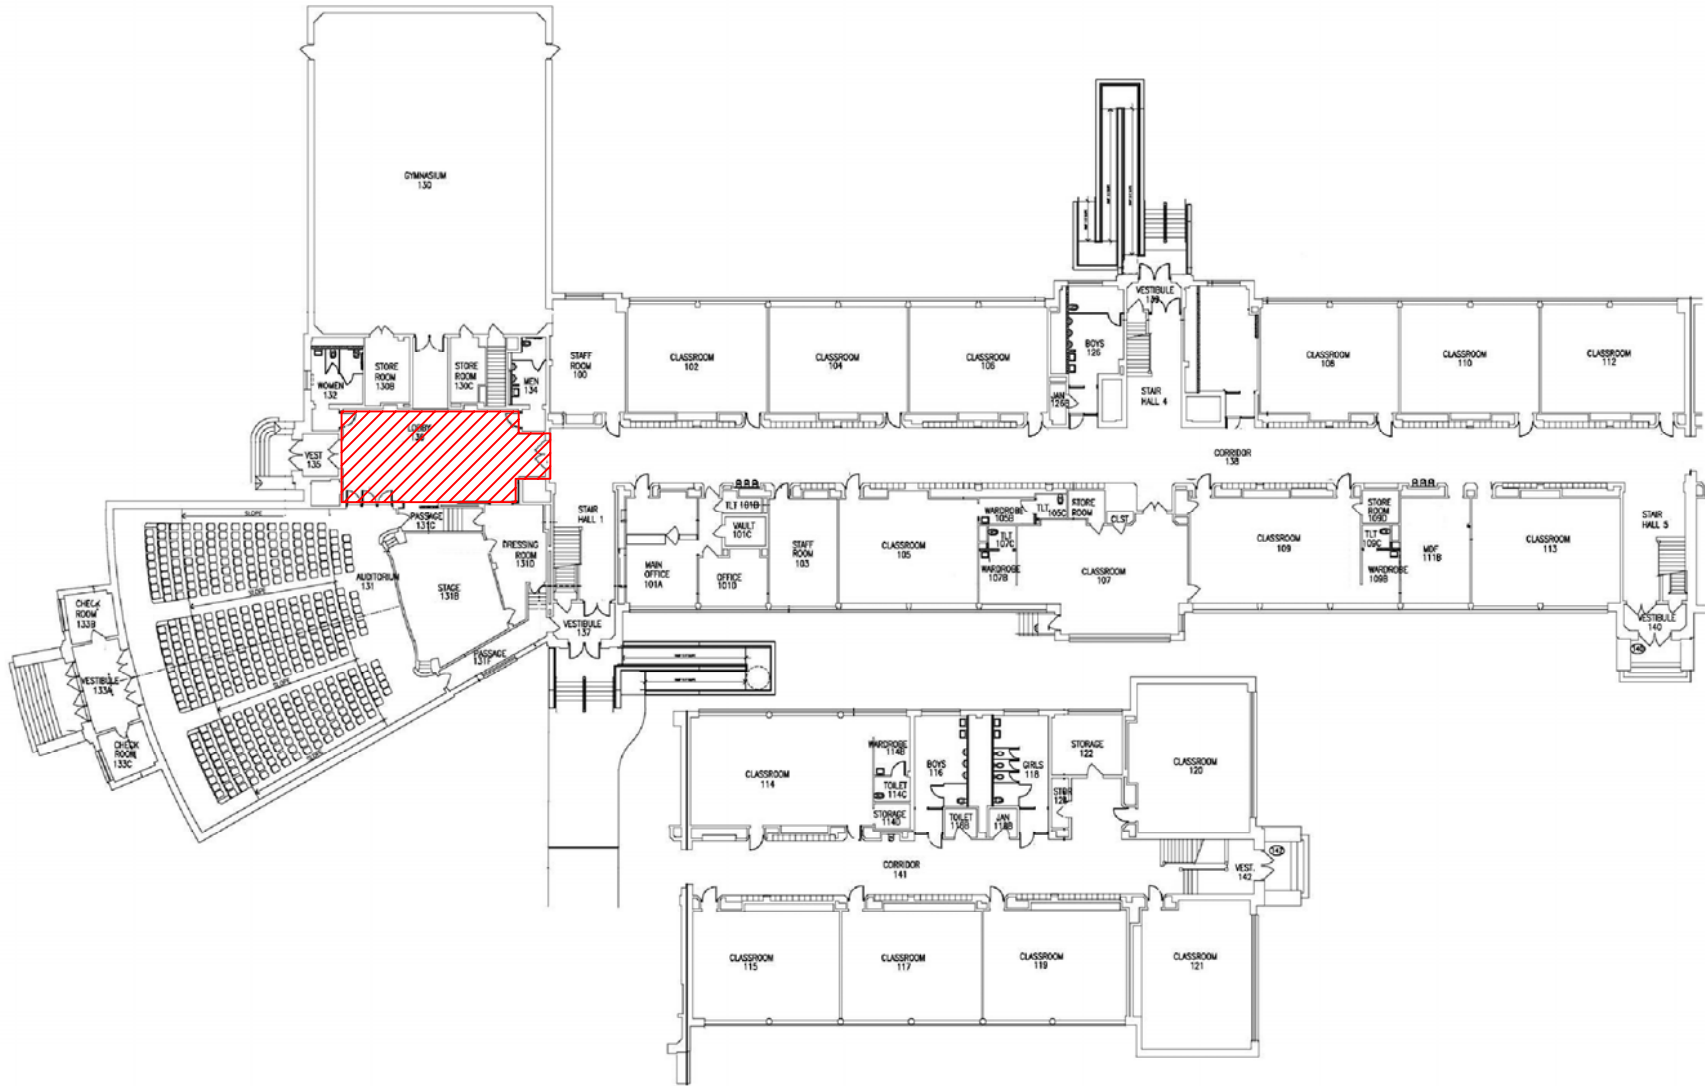
K:\CPS 2011\2013 Three Year\A\Gad Drawings\Region 4\Hearst School\Hearst Main Bldg First Floor.dwg

HOMOGENEOUS AREA: **187**
MATERIAL DESCRIPTION: **Drywall/Drywall Tile**
MATERIAL LOCATION: **Elevator Lobby Annex 1st, 2nd Floor, Elevator Lobby on Basement, 1st, 2nd Floor.**
MATERIAL QUANTITY: **1000** MATERIAL UNITS: **SF**
MATERIAL CATEGORY: **MISC** FRIABLE: **No**
ASBESTOS TYPE: **Assumed**
DISTURBANCE POTENTIAL: **LOW** CONDITION:
AHERA DAMAGE CATEGORY: **6 ACBM with the potential for damage**
ACCESSIBILITY: **Within Reach** DAMAGE REASON:
DAMAGE QUANTITY: **0** DAMAGE REASON:
DAMAGE UNITS: **SF**
COMMENTS:

HOMOGENEOUS AREA: **187**
MATERIAL DESCRIPTION: **Drywall/Drywall Tile**
MATERIAL LOCATION: **Elevator Lobby Annex 1st, 2nd Floor, Elevator Lobby on Basement, 1st, 2nd Floor.**
MATERIAL QUANTITY: **1000** MATERIAL UNITS: **SF**
DAMAGE QUANTITY: **0** DAMAGE UNITS: **SF**

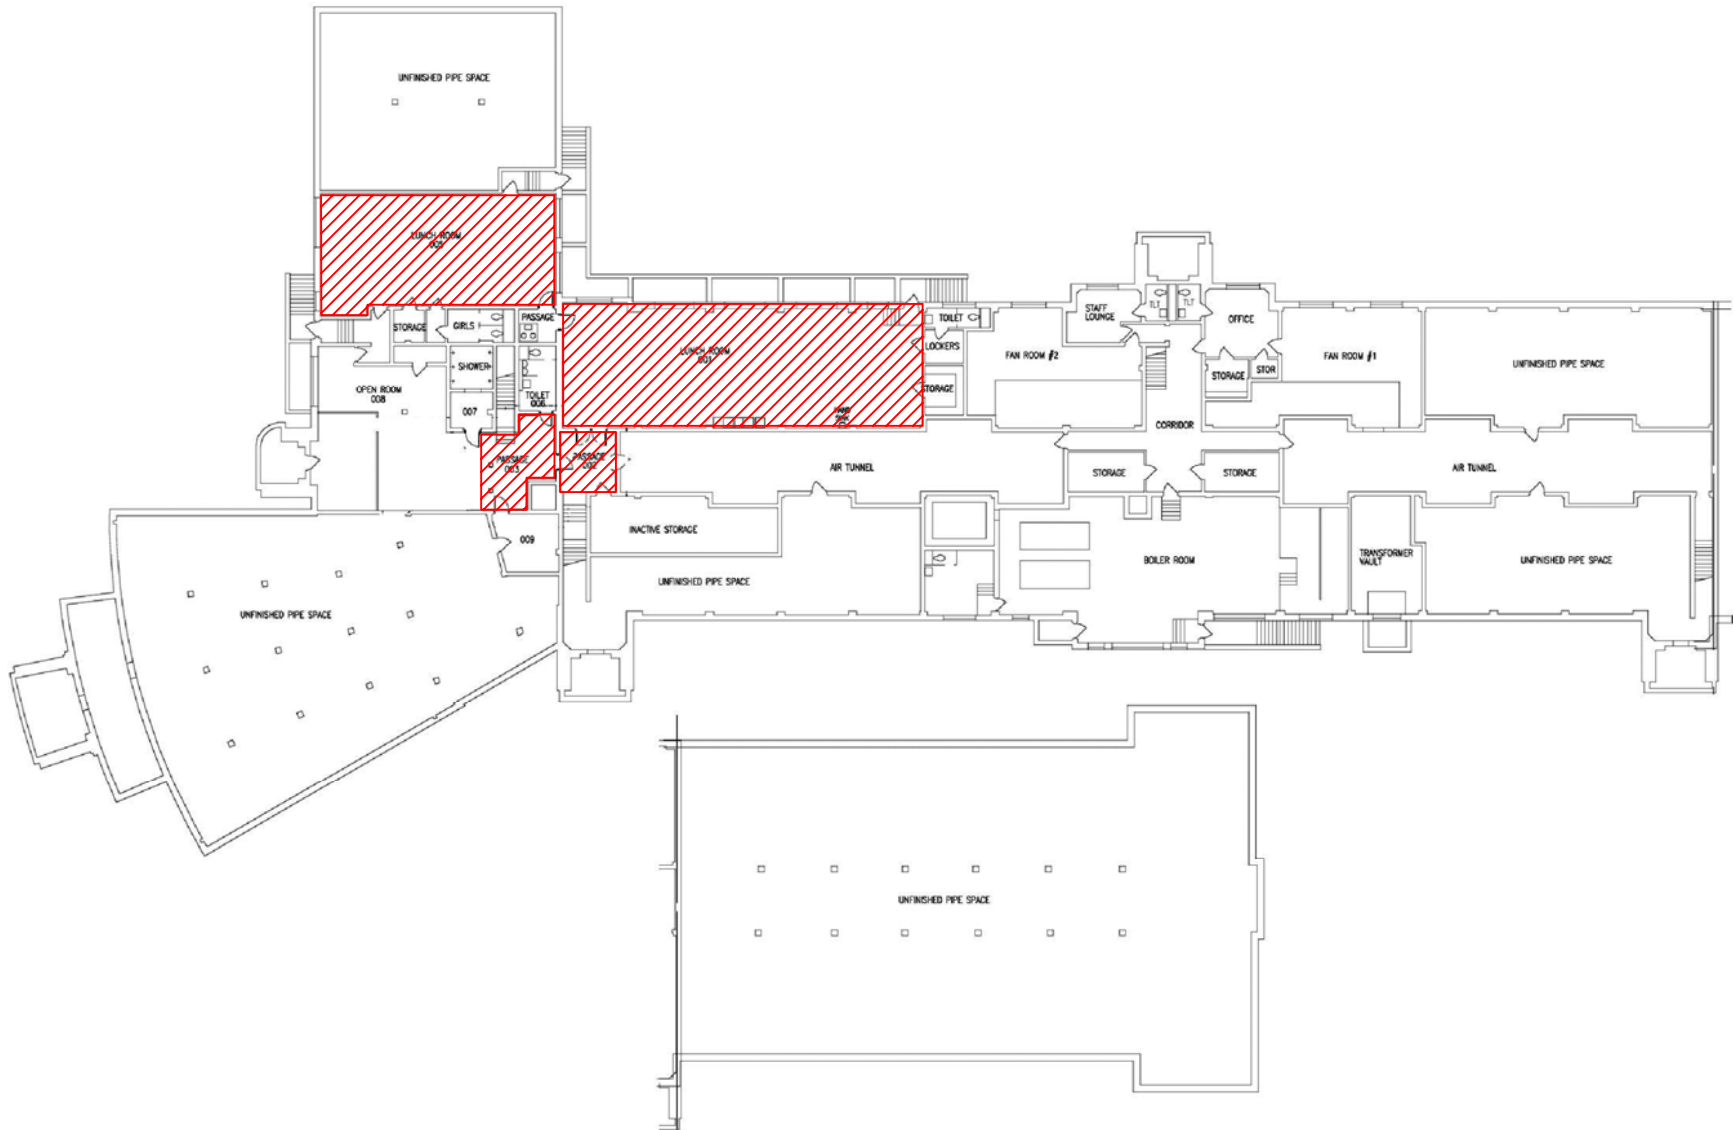
K:\CPS 2011\2013 Three Year\A\Gad Drawings\Region 4\Hearst School\Hearst Main Bldg Basement.dwg

HOMOGENEOUS AREA: **177**
MATERIAL DESCRIPTION: **12"x12" Black with White Spots FT**
MATERIAL LOCATION: **Kitchen, Lunch Room, Elevator Lobby, Basement, 1st-2nd Floor**
MATERIAL QUANTITY: **3000** MATERIAL UNITS: **SF**
MATERIAL CATEGORY: **MISC** FRIABLE: **No**
ASBESTOS TYPE: **Assumed**
DISTURBANCE POTENTIAL: **LOW** CONDITION:
AHERA DAMAGE CATEGORY: **6 ACBM with the potential for damage**
ACCESSIBILITY: **Within Reach** DAMAGE REASON:
DAMAGE QUANTITY: **0** DAMAGE REASON:
DAMAGE UNITS: **SF**
COMMENTS:

HOMOGENEOUS AREA: **177**
MATERIAL DESCRIPTION: **12"x12" Black with White Spots FT**
MATERIAL LOCATION: **Kitchen, Lunch Room, Elevator Lobby, Basement, 1st-2nd Floor**
MATERIAL QUANTITY: **3000** MATERIAL UNITS: **SF**
DAMAGE QUANTITY: **0** DAMAGE UNITS: **SF**

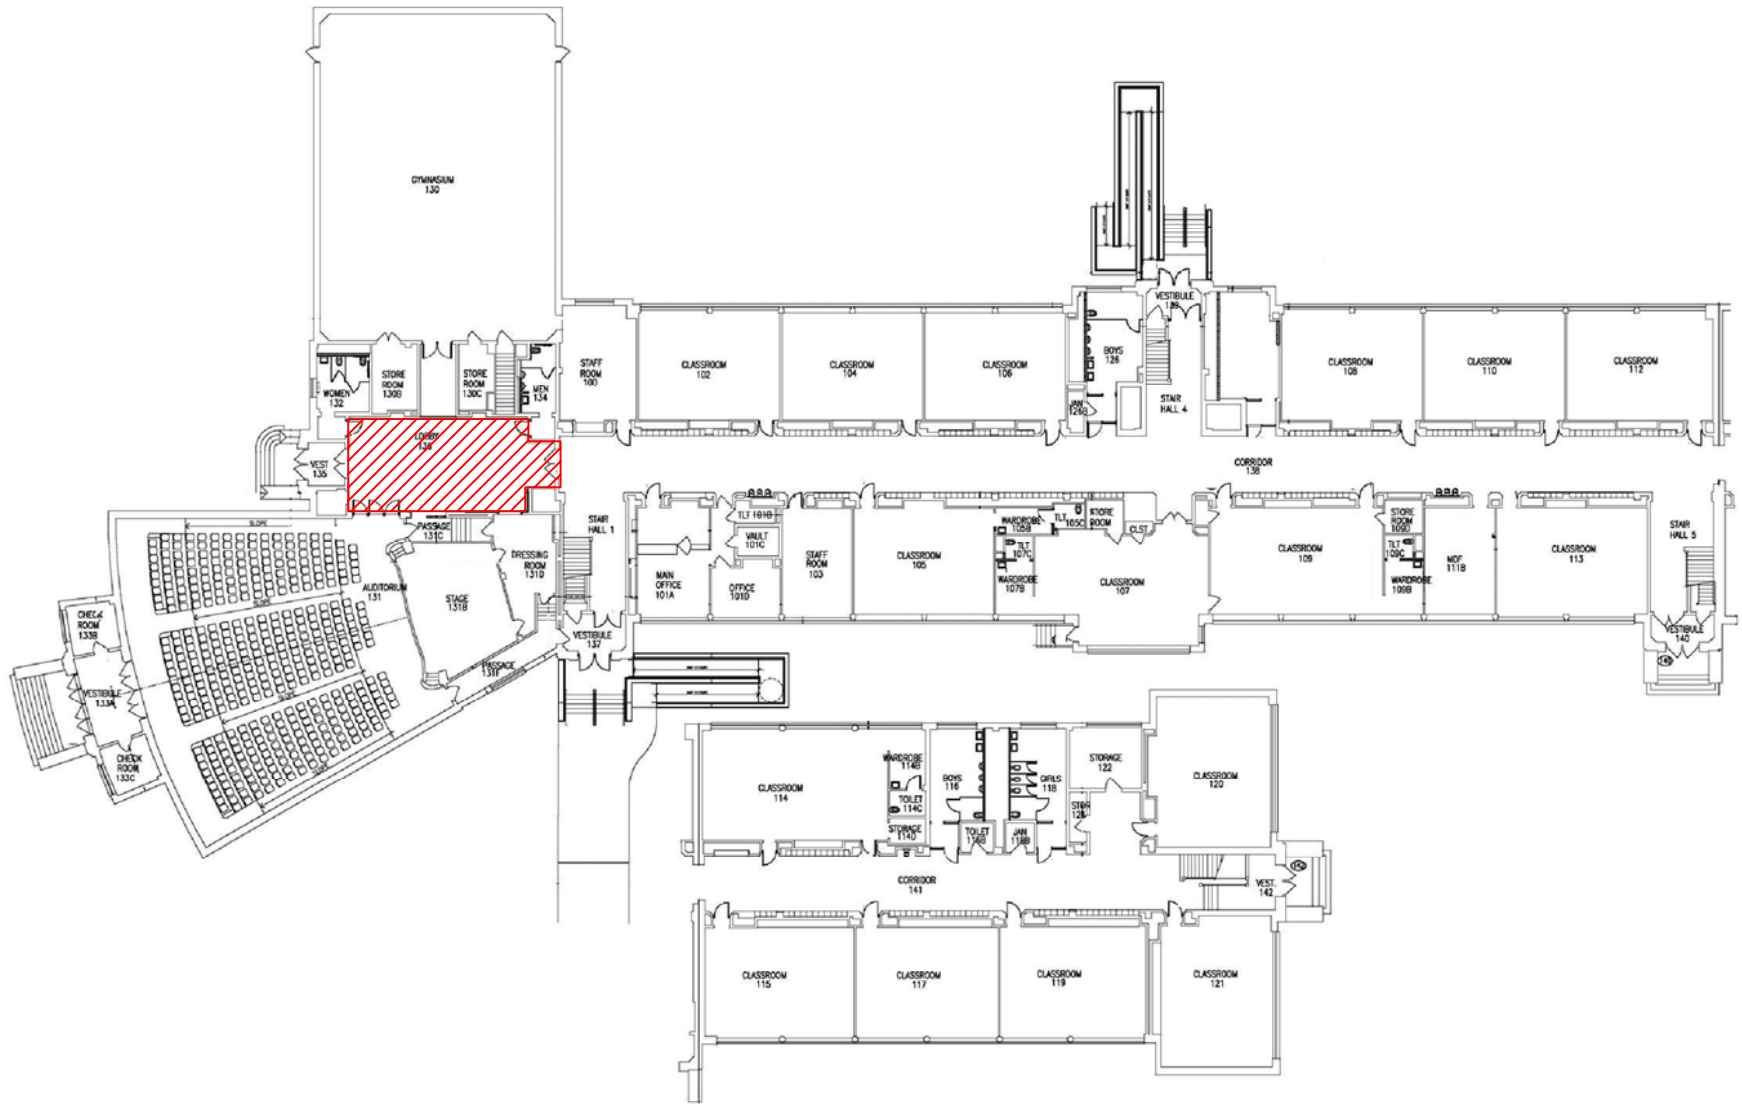
K:\CPS 2011\2013 Three Year\A\Gad Drawings\Region 4\Hearst School\Hearst Main Bldg First Floor.dwg

HOMOGENEOUS AREA: **190**
MATERIAL DESCRIPTION: **12"x12" Blue with White Streaks FT**
MATERIAL LOCATION: **Lobby 136**
MATERIAL QUANTITY: **200** MATERIAL UNITS: **SF**
MATERIAL CATEGORY: **MISC** FRIABLE: **No**
ASBESTOS TYPE: **Assumed**
DISTURBANCE POTENTIAL: **LOW** CONDITION:
AHERA DAMAGE CATEGORY: **6 ACBM with the potential for damage**
ACCESSIBILITY: **Within Reach** DAMAGE REASON:
DAMAGE QUANTITY: **0** DAMAGE REASON:
DAMAGE UNITS: **SF**
COMMENTS:

DAMAGE QUANTITY: **0** DAMAGE UNITS: **SF**

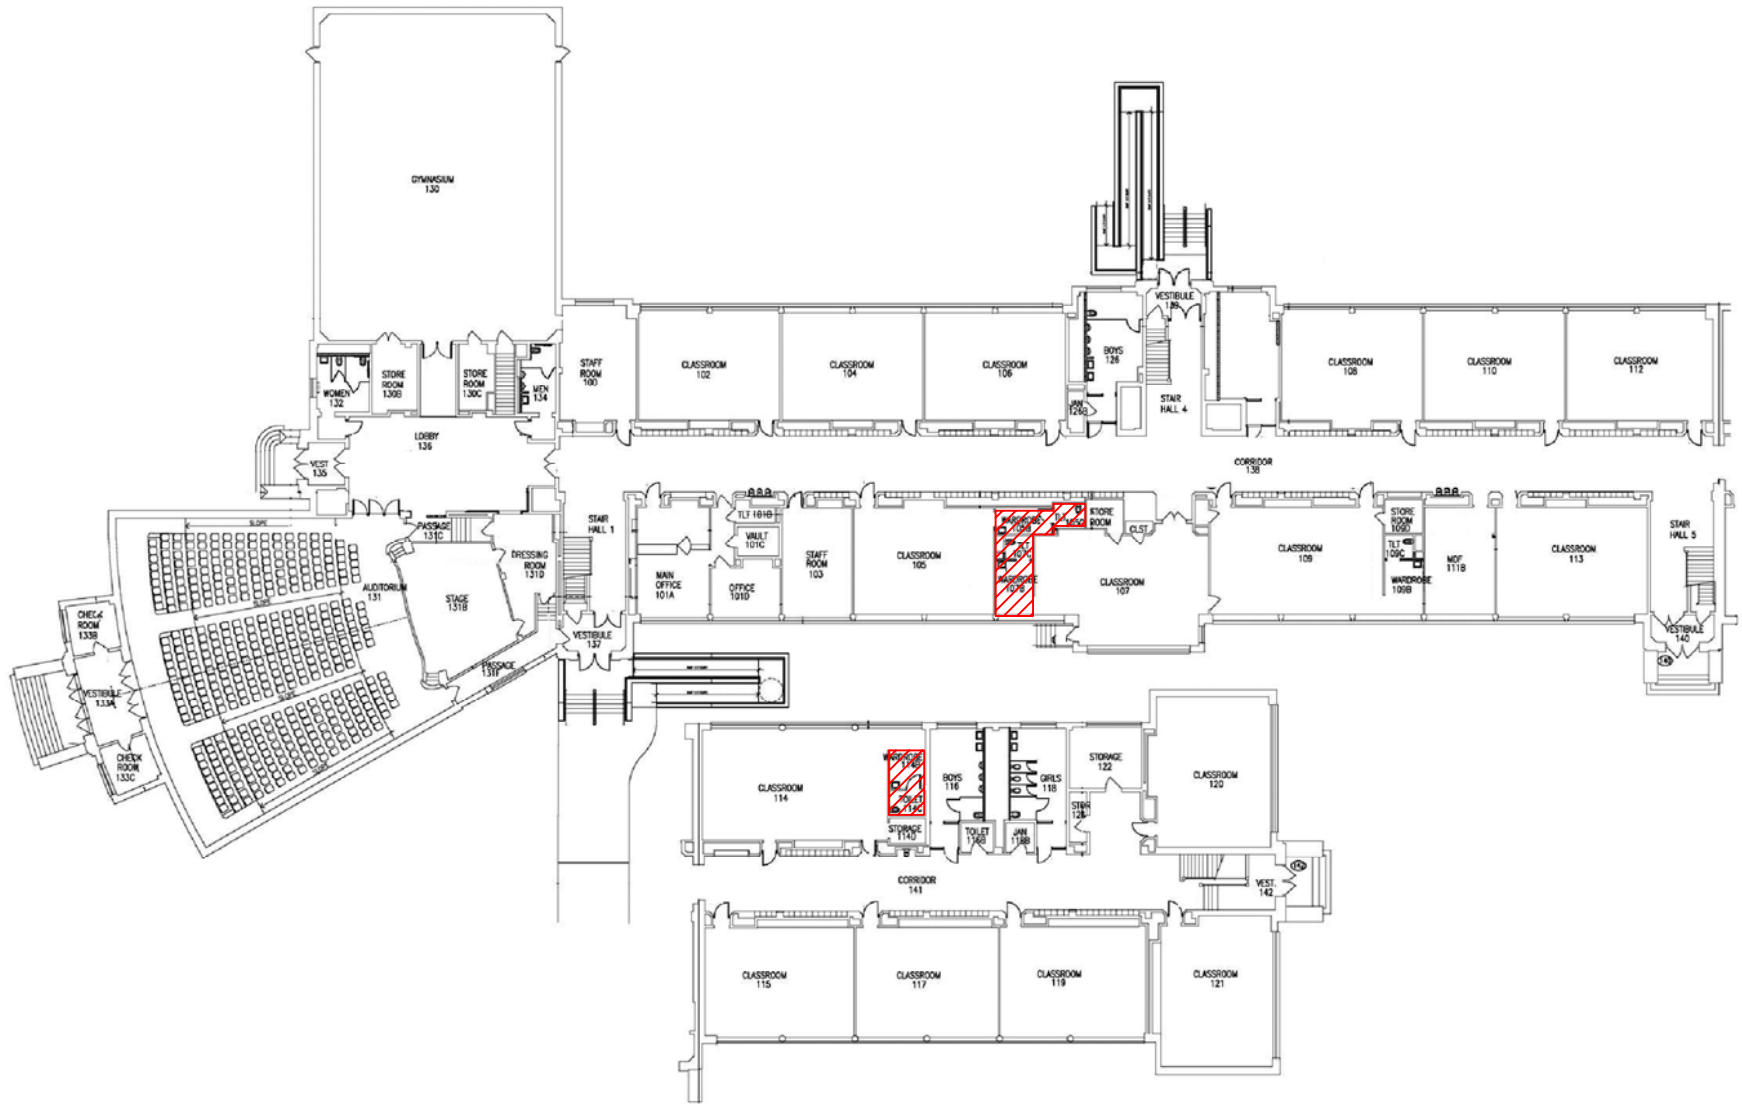
K:\CPS 2011\2013 Three Year\A\Gad Drawings\Region 4\Hearst School\Hearst Main Bldg First Floor.dwg

HOMOGENEOUS AREA: **175**
MATERIAL DESCRIPTION: **12"x12" FT Dark Grey with Dark spots**
MATERIAL LOCATION: **Bathrooms 105, 107, 114**
MATERIAL QUANTITY: **350** MATERIAL UNITS: **SF**
DAMAGE QUANTITY: **0** DAMAGE UNITS: **SF**
