ILLINOIS DEPARTMENT OF PUBLIC HEALTH
AHERA THREE YEAR REINSPECTION
ASBESTOS ABATEMENT PROGRAM
SCHOOL INFORMATION FORM

THREE-YEAR REINSPECTION

Lowell School

3320 W. Hirsch Street
Chicago, IL, 60651

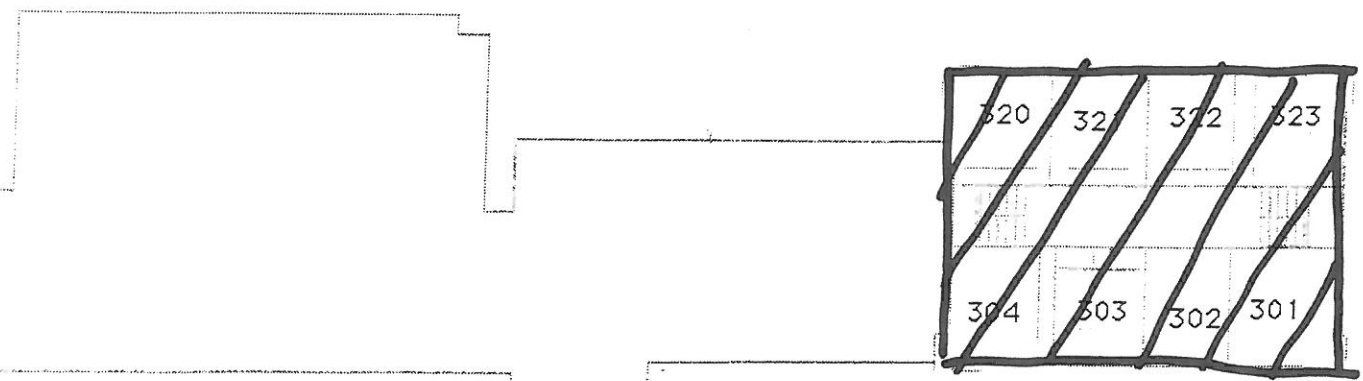
3rd Fl. (Attic)

HOMOGENEOUS AREA: **41**
MATERIAL DESCRIPTION: **2x4 with 2x2 white pinhole pattern**
MATERIAL LOCATION: **3rd Floor - 1894 Bldg**
MATERIAL QUANTITY: **10000** MATERIAL UNITS: **SF**
MATERIAL CATEGORY: **MISC** FRIABLE: **Yes**
ASBESTOS TYPE: **Assumed**
DISTURBANCE POTENTIAL: **LOW** CONDITION:
AHERA DAMAGE CATEGORY: **6 ACBM with the potential for damage**
ACCESSIBILITY: **Barely Reachable** DAMAGE REASON:
DAMAGE QUANTITY: **0** DAMAGE REASON:
DAMAGE UNITS: **SF**
COMMENTS:

HALL: 2x4 w/ 2x2 white PINKHOLE
PATTERN CEILING TILE
