**ILLINOIS DEPARTMENT OF PUBLIC HEALTH
AHERA THREE YEAR REINSPECTION
ASBESTOS ABATEMENT PROGRAM
SCHOOL INFORMATION FORM**

THREE-YEAR REINSPECTION

Chicago International Charter - Irving Park Campus

3820 N. Irving Park Road
Chicago, IL, 60618

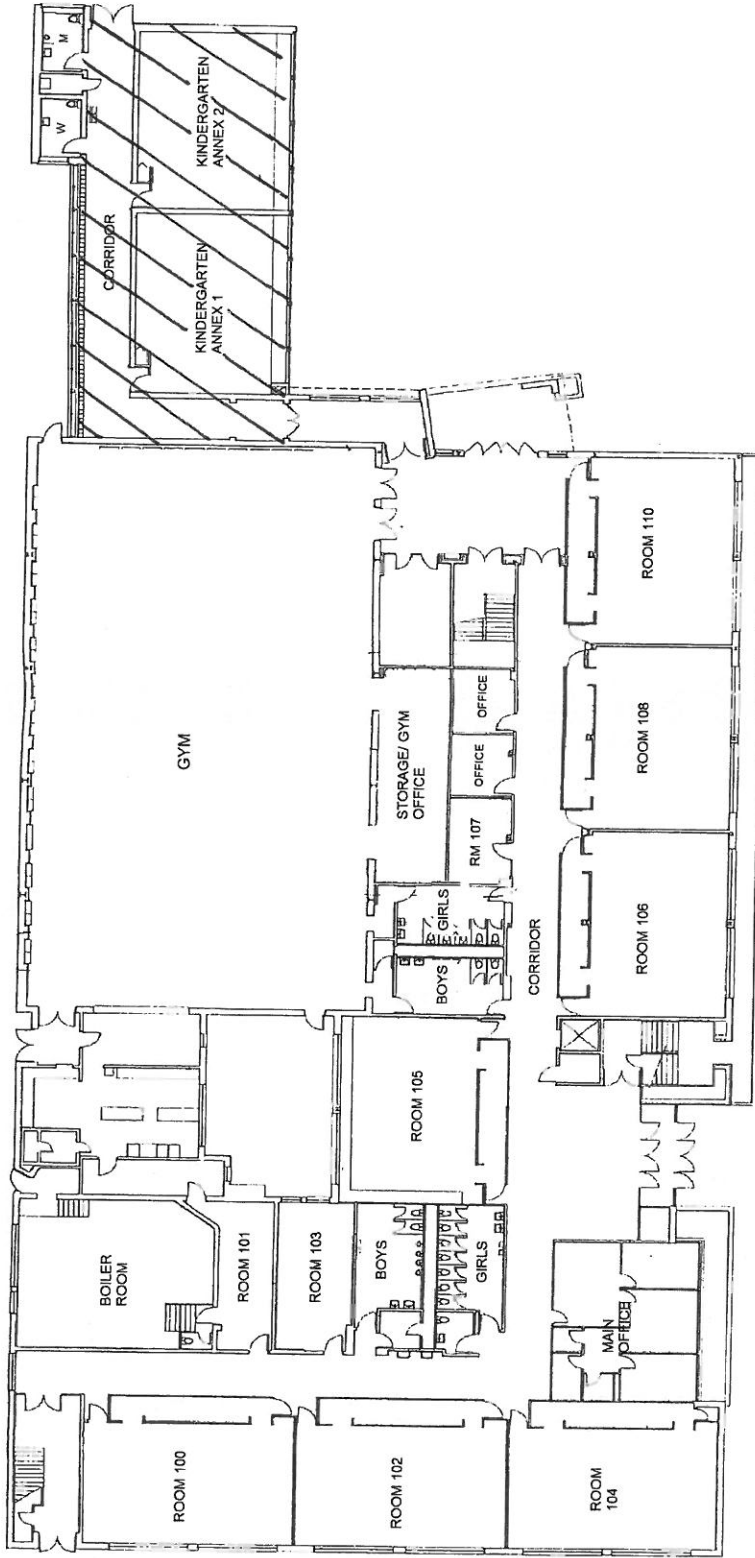
FIRST FLOOR PLAN
SCALE: 1/8" = 1'-0"

HOMOGENEOUS AREA: **18A**
MATERIAL DESCRIPTION: **18"x18" off white w/ blue streaks VFT--Mastic**
MATERIAL LOCATION: **kindergarten rooms annex 1 and 2, corridor-- annex building**
MATERIAL QUANTITY: **2000** MATERIAL UNITS: **SF**
MATERIAL CATEGORY: **MISC** FRIABLE: **No**
ASBESTOS TYPE: **Assumed**
DISTURBANCE POTENTIAL: **LOW** CONDITION:
AHERA DAMAGE CATEGORY: **6 ACBM with the potential for damage**
ACCESSIBILITY: **Barely Reachable** DAMAGE REASON:
DAMAGE QUANTITY: **0** DAMAGE REASON:
DAMAGE UNITS: **SF**
COMMENTS:

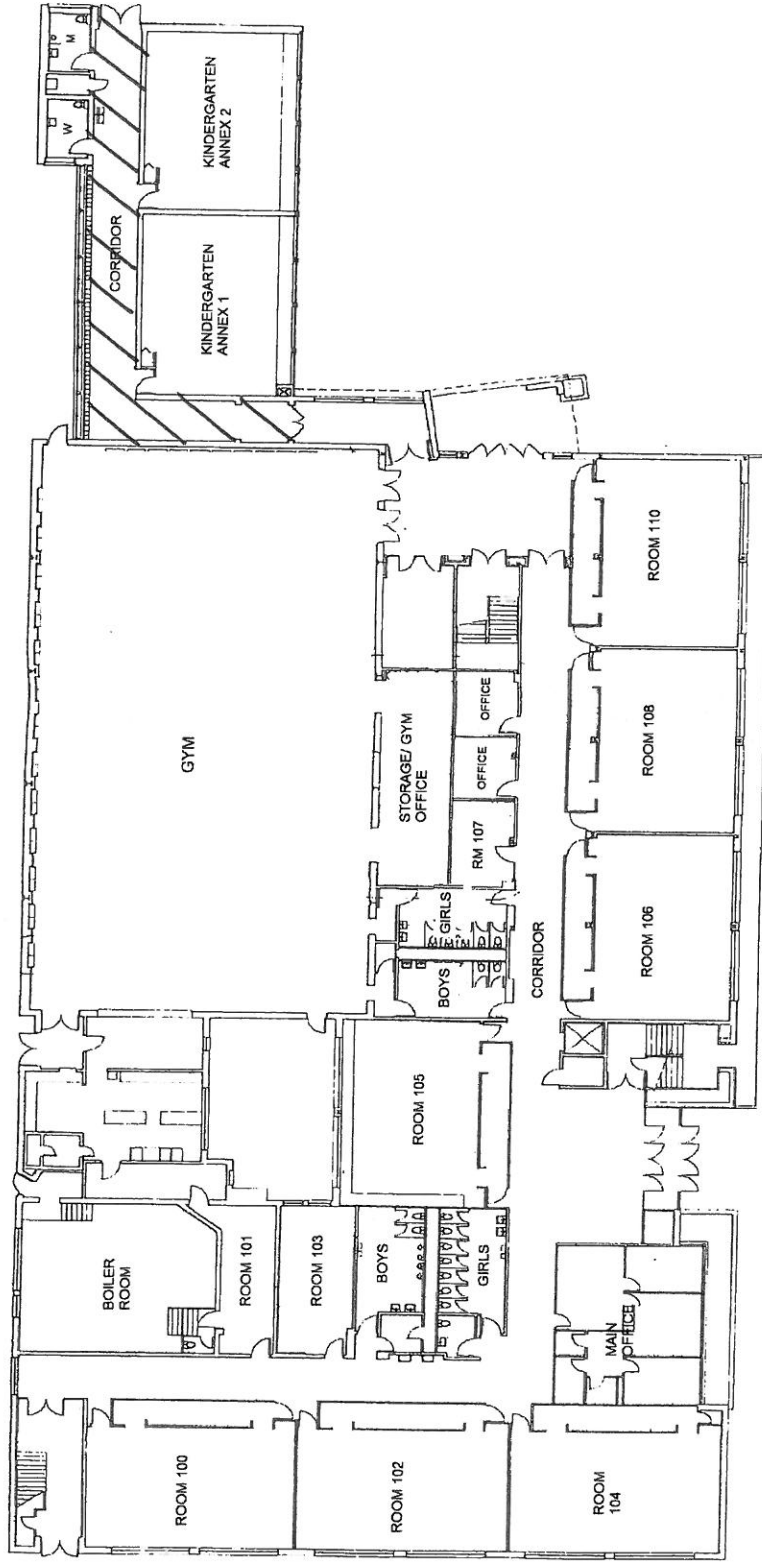
FIRST FLOOR PLAN
SCALE: 3/8" = 1'-0"

HOMOGENEOUS AREA: **20A**
MATERIAL DESCRIPTION: **18"x18" blue streaked VFT--Mastic**
MATERIAL LOCATION: **corridor--annex building**
MATERIAL QUANTITY: **100** MATERIAL UNITS: **SF**
DAMAGE QUANTITY: **0** DAMAGE UNITS: **SF**

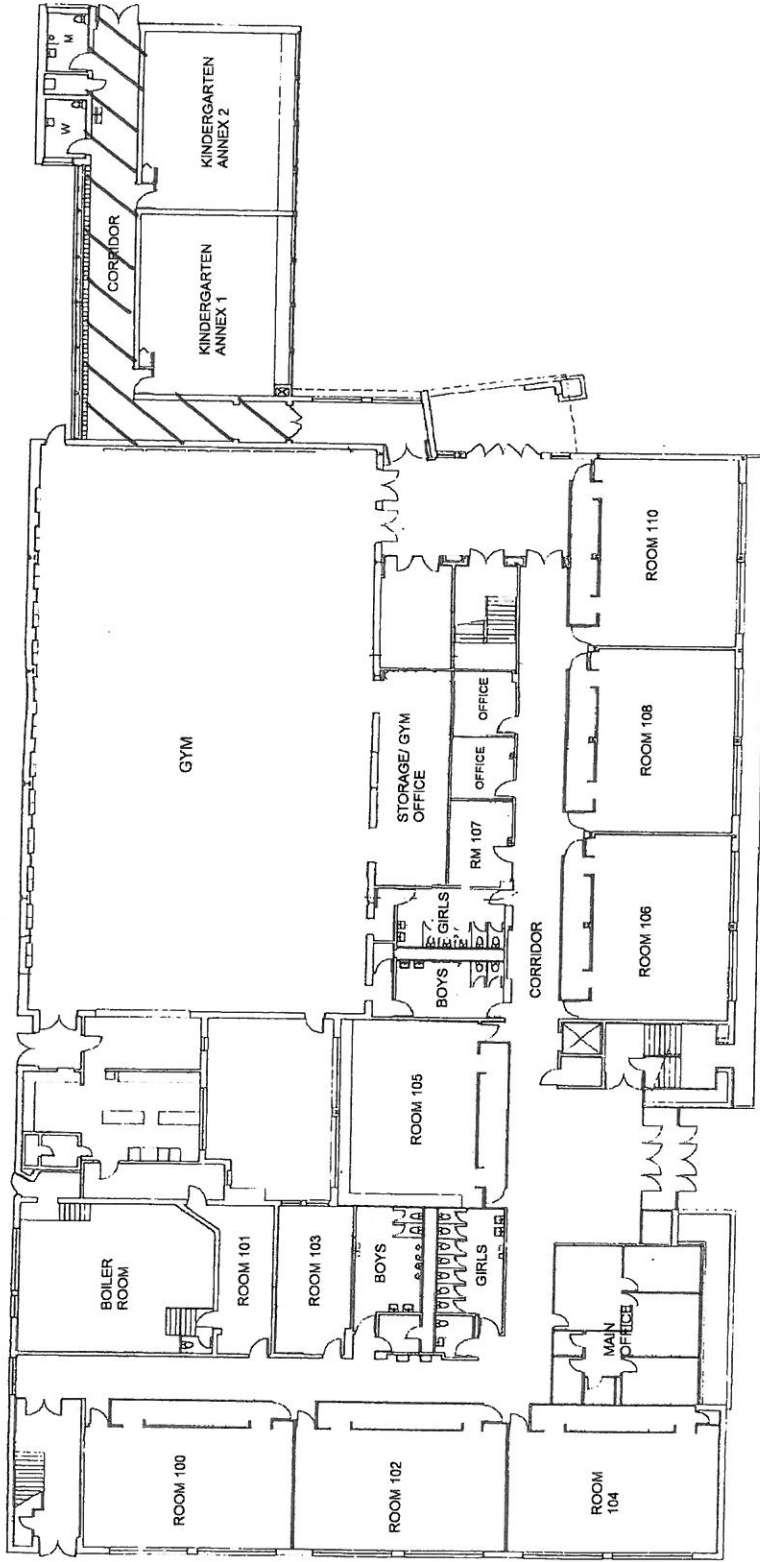
FIRST FLOOR PLAN
SCALE: 3/8" = 1'-0"

HOMOGENEOUS AREA: **19**
MATERIAL DESCRIPTION: **18"x18" Red streaked VFT**
MATERIAL LOCATION: **kindergarten rooms annex 1 and 2, corridor-- annex building**
MATERIAL QUANTITY: **700** MATERIAL UNITS: **SF**
MATERIAL CATEGORY: **MISC** FRIABLE: **No**
ASBESTOS TYPE: **Assumed**
DISTURBANCE POTENTIAL: **LOW** CONDITION:
AHERA DAMAGE CATEGORY: **6 ACBM with the potential for damage**
ACCESSIBILITY: **Within Reach** DAMAGE REASON:
DAMAGE QUANTITY: **0** DAMAGE REASON:
DAMAGE UNITS: **SF**
COMMENTS:
