**ILLINOIS DEPARTMENT OF PUBLIC HEALTH
AHERA THREE YEAR REINSPECTION
ASBESTOS ABATEMENT PROGRAM
SCHOOL INFORMATION FORM**

NAME OF SCHOOL DISTRICT: CHICAGO SCHOOL DIST 299
SCHOOL ID NUMBER: 14-016-2990-2053
SCHOOL NAME: Alcott School
ADDRESS OF SCHOOL: 2625 N. Orchard Street
CITY: Chicago, IL, 60614

DATE REINSPECTION COMPLETED: 4/16/2013 ENROLLMENT 809
IDPH INSPECTOR LICENSE NUMBER: 100-11093
IDPH LICENSED INSPECTOR NAME (Please Print): David Avila
IDPH MP LICENSE NUMBER: 100-01786
IDPH LICENSED MANAGEMENT PLANNER NAME (Please Print): Guillermo Garcia

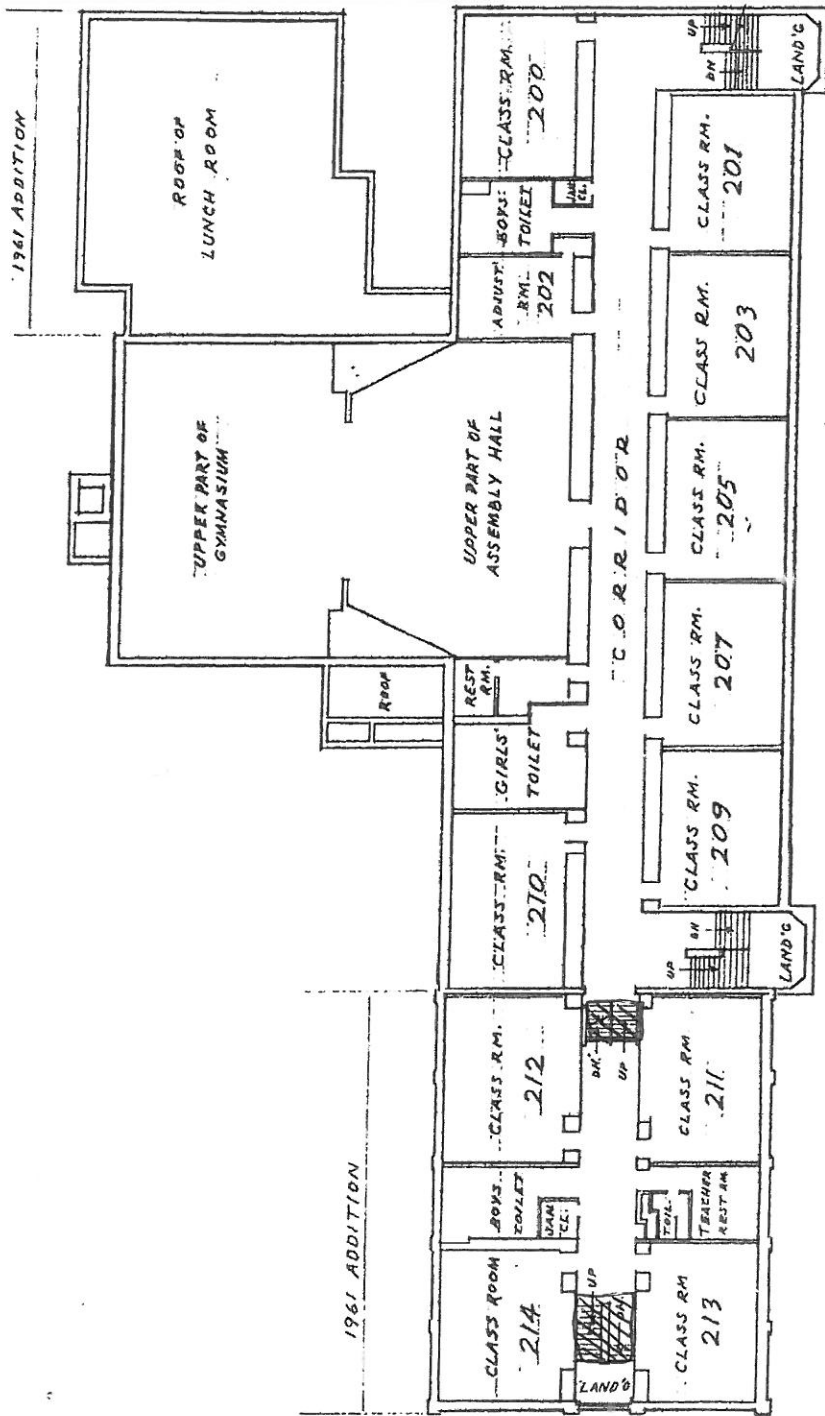
SECOND FLOOR PLAN
SCALE 1/8" = 3'-0"

HA BOTERRAZO

HOMOGENEOUS AREA: **80**
MATERIAL DESCRIPTION: **Terrazo**
MATERIAL LOCATION: **Stairwells and Landings - 1961**
MATERIAL QUANTITY: **2000** MATERIAL UNITS: **SF**
MATERIAL CATEGORY: **MISC** FRIABLE: **No**
ASBESTOS TYPE: **Assumed**
DISTURBANCE POTENTIAL: **LOW** CONDITION:
AHERA DAMAGE CATEGORY: **6 ACBM with the potential for damage**
ACCESSIBILITY: **Within Reach** DAMAGE REASON:
DAMAGE QUANTITY: **0** DAMAGE REASON:
DAMAGE UNITS: **SF**
COMMENTS:

HOMOGENEOUS AREA: **80**
MATERIAL DESCRIPTION: **Terrazo**
MATERIAL LOCATION: **Stairwells and Landings - 1961**
MATERIAL QUANTITY: **2000** MATERIAL UNITS: **SF**
DAMAGE QUANTITY: **0** DAMAGE UNITS: **SF**

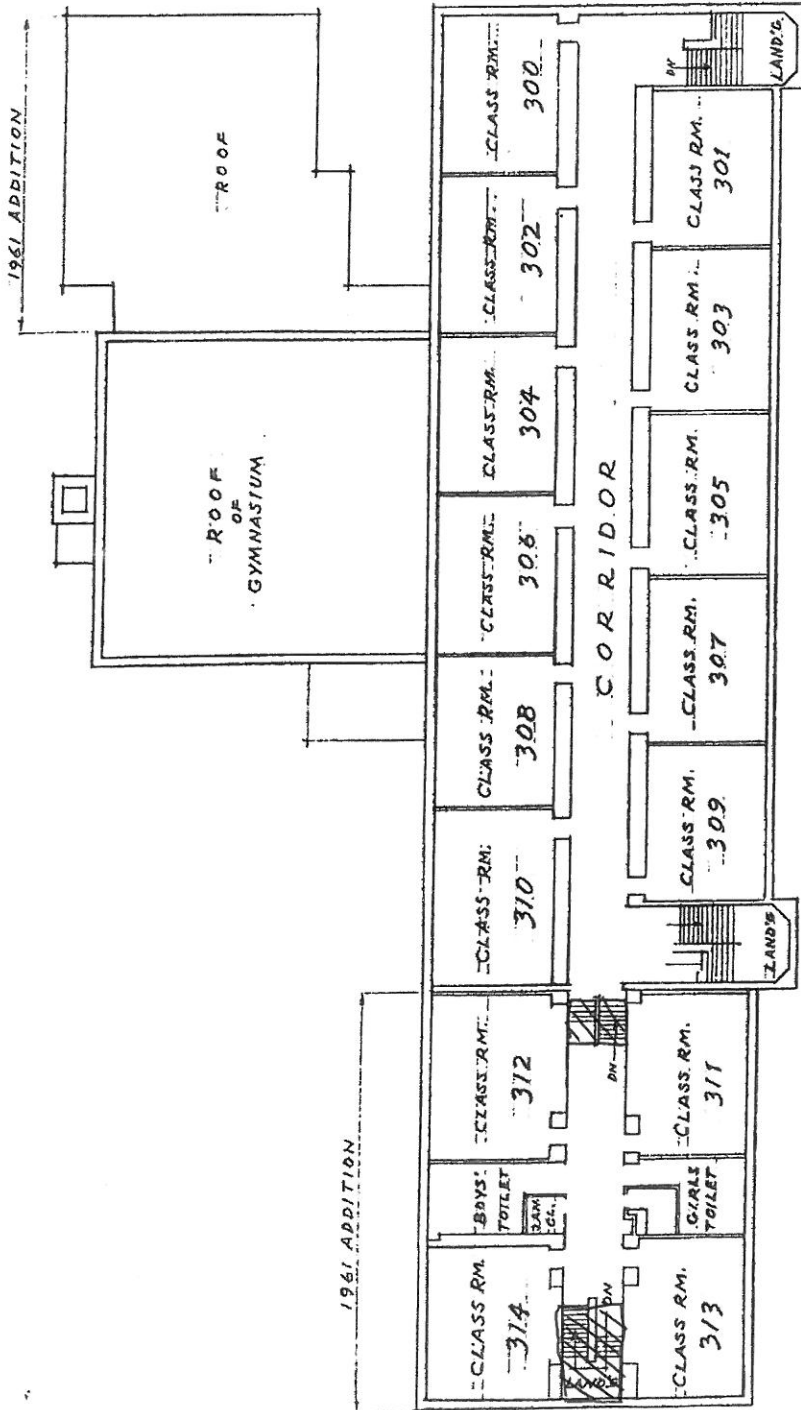
THIRD FLOOR PLAN
SCALE 1/8" = 3'-0"

HABO TERRAZO

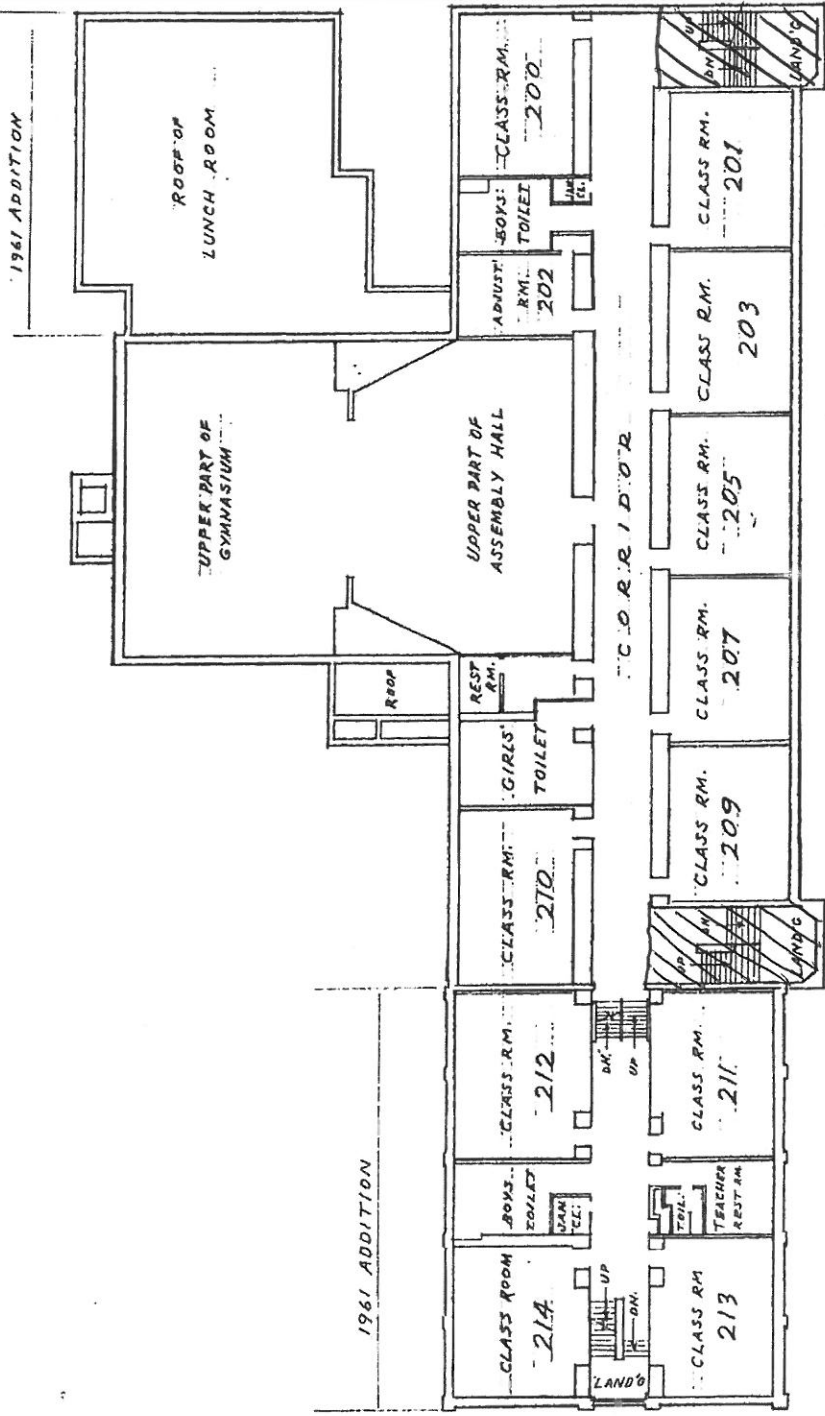
SECOND FLOOR PLAN
SCALE 1/8" = 3'-0"

HABSI TERRAZO

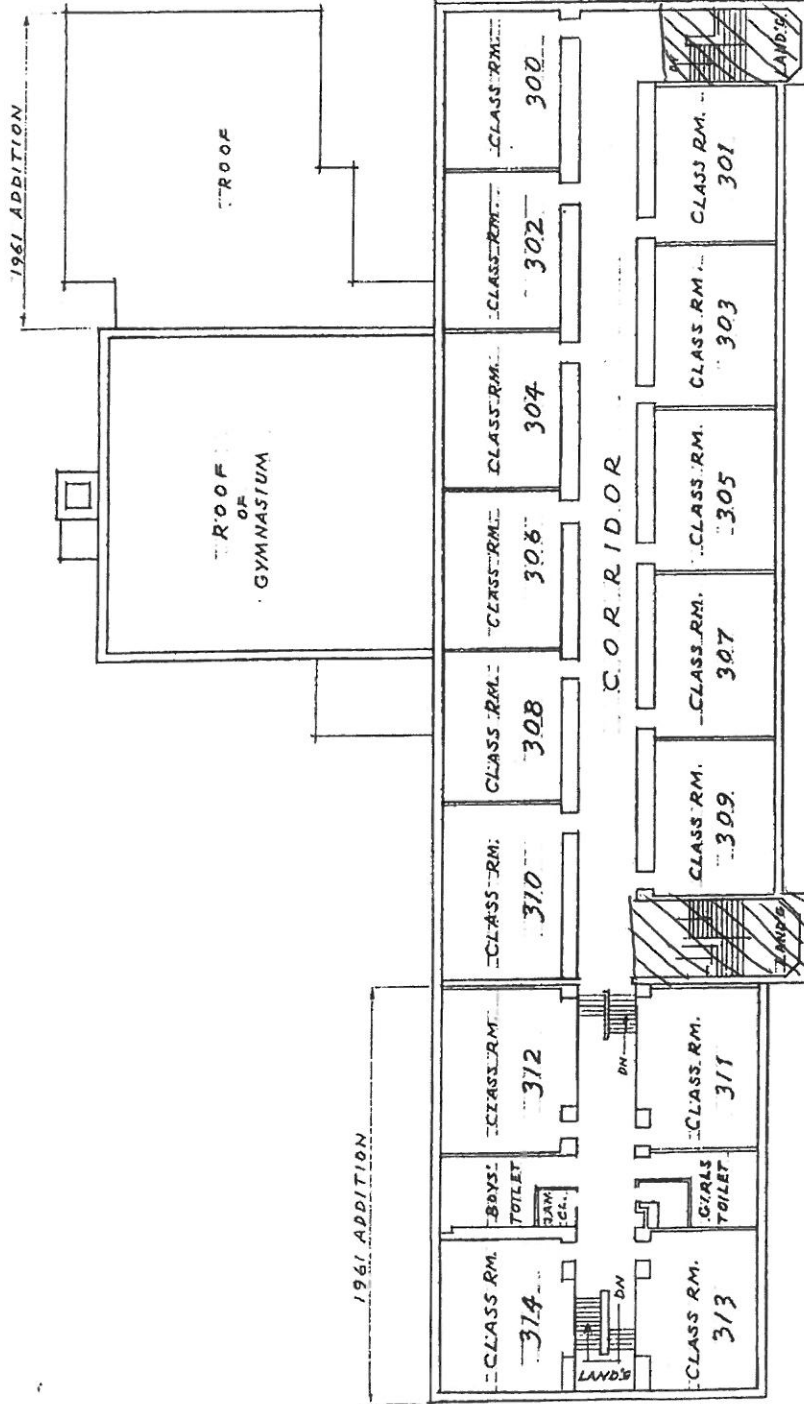
THIRD FLOOR PLAN
SCALE 1/8" = 30'-0"

HABITERRAZO

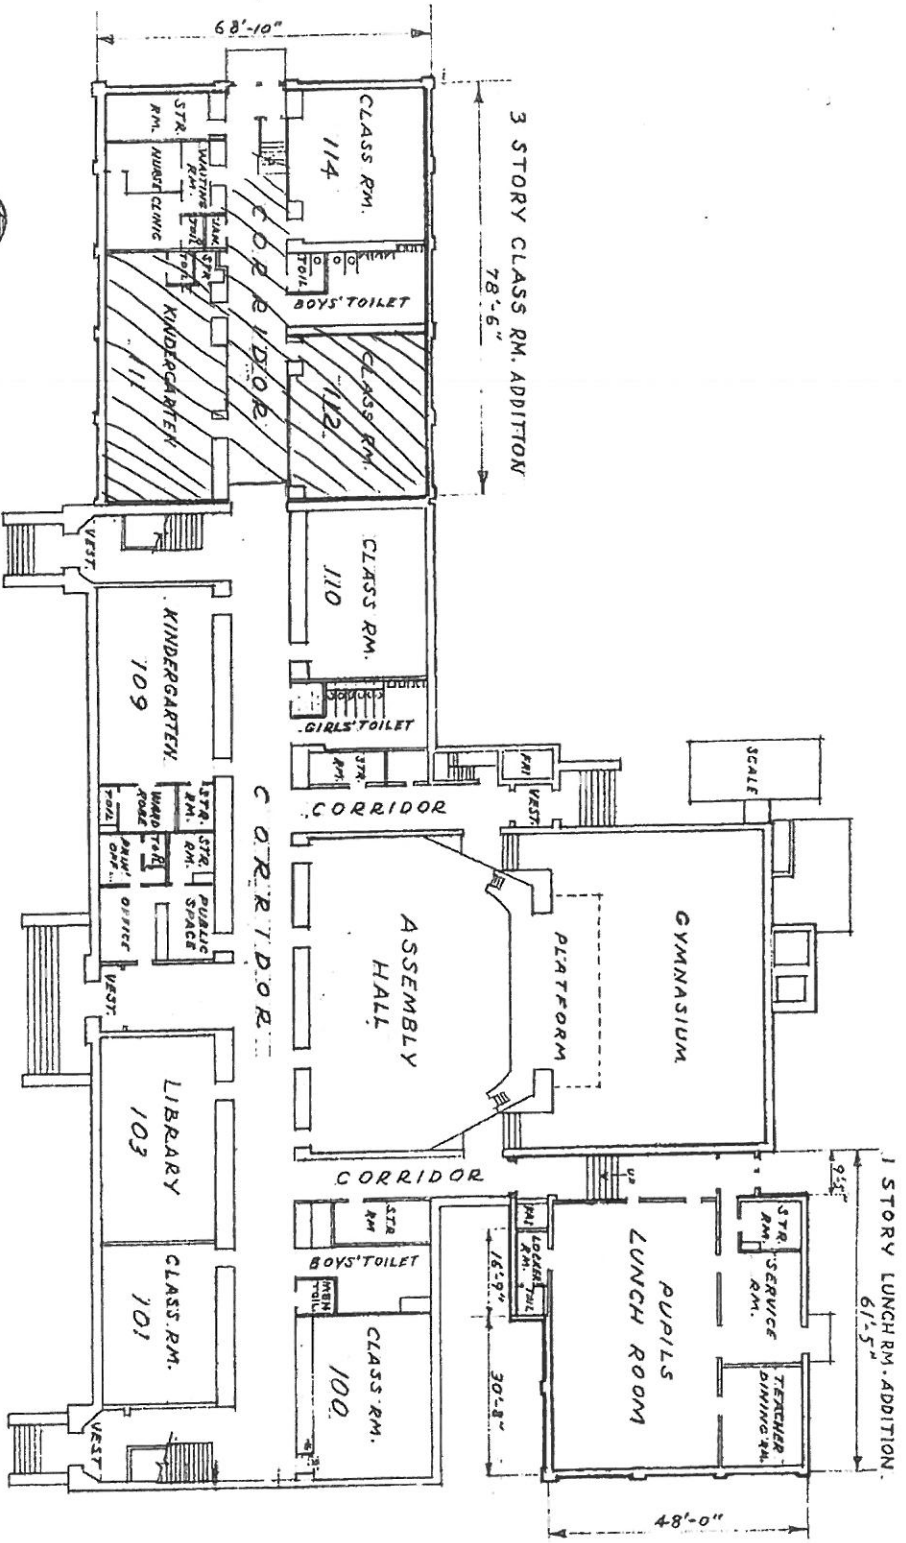
FIRST FLOOR PLAN
SCALE 1" = 30'-0"

CLASS : SCHOOL ~~HA72~~ HA73
 CONST : FIREPROOF
 STORIES : 3
 HEIGHT : 43'-4"

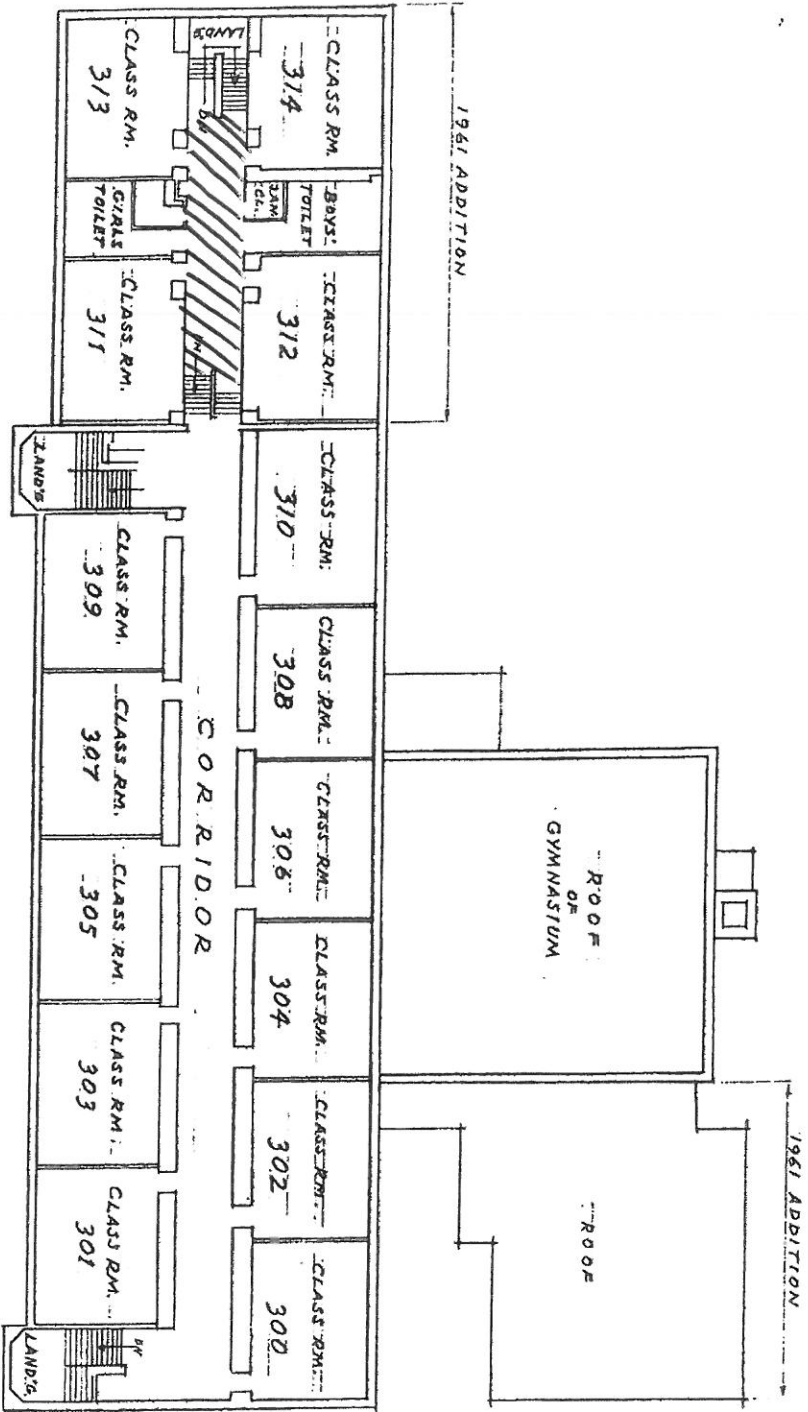
THIRD FLOOR PLAN
SCALE 1" = 30'-0"

- ▨ - 1/2" x 12" REICE SPECLED
- ▨ - HA 73 VFT
- ▨ - HA 73 " " " "
- ▨ - MASTIC
